Profile/Photo Observation Report

Date:	04/25/2018	Weather:		Coding:	PACP 6.0
Pipe Length (ft):	283.0	Owner:	NA	Pre Clean:	Not Known
P.O.#:		Surveyor:	Jen Costello	PSR:	P-505-036-037
Customer:		Clean Date:	01/01/1900	Shape:	C

Street:	Summerlin	Flow Control:	Not Controlled
City:	Hobart, IN	Year Renewed:	
Location:	Light Highway	Tape/Media #:	
Purpose:	Not Known	Dia/Height:	12"
Use:	Sanitary	Material:	PVC
Drain Area:	NA	Lining:	Cured in Place
Category:	NA		
Comment:

Location Details:		Direction of Survey:	Downstream
US MH:	M-505-037	DS MH:	M-505-036
		Total Length Surveyed (ft):	123.7

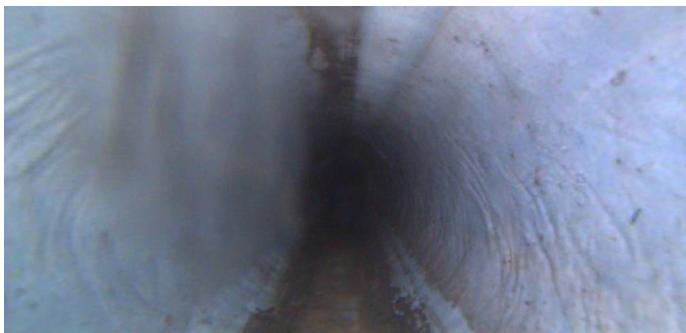
Code: **AMH**
Description: **Manhole**

Distance (ft): **.0**
Structural Grade: **0**
O&M Grade: **0**
Clock Start/From:
Clock To:
1st Value:
2nd Value:
Value Percent:
Continuous Index:
Within 8" of Joint: **NO**
Remarks: **M-505-037**

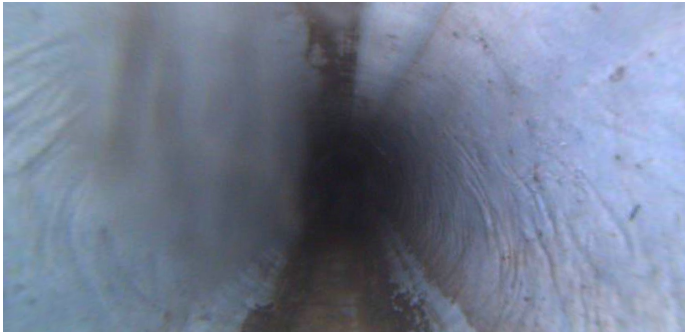
Code:	MWL
Description:	Water Level

Distance (ft):	.0
Structural Grade:	0
O&M Grade:	0
Clock Start/From:	
Clock To:	
1st Value:	
2nd Value:	
Value Percent:	5.000
Continuous Index:	
Within 8" of Joint:	NO
Remarks:

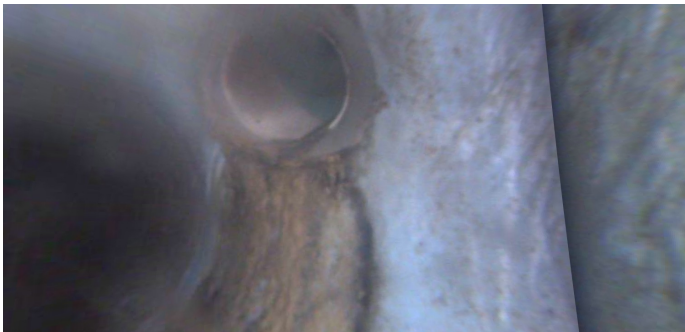
Code:	TF
Description:	Tap Factory

Distance (ft):	6.5
Structural Grade:	0
O&M Grade:	0
Clock Start/From:	10
Clock To:	
1st Value:	4.000
2nd Value:	
Value Percent:	
Continuous Index:	
Within 8" of Joint:	
Remarks:

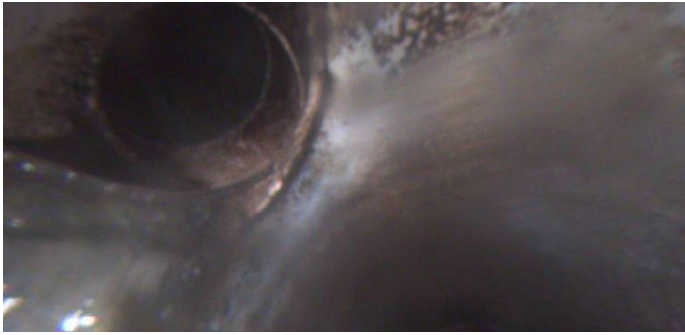
Code: **TFA**
Description: **Tap Factory Active**

Distance (ft): **9.5**
Structural Grade: **0**
O&M Grade: **0**
Clock Start/From: **2**
Clock To:
1st Value: **4.000**
2nd Value:
Value Percent:
Continuous Index:
Within 8" of Joint:
Remarks:

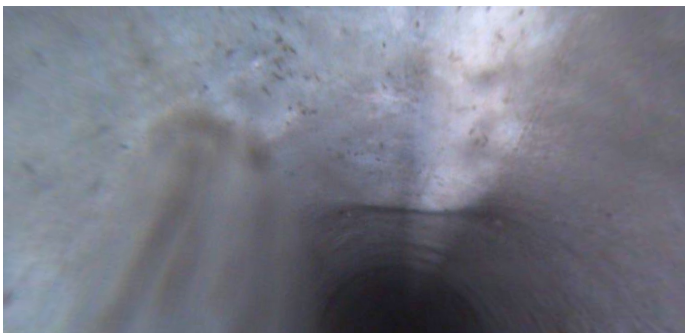
Code: **LFAC**
Description: **Lining Failure Abandoned Connection**

Distance (ft): **12.8**
Structural Grade: **0**
O&M Grade: **0**
Clock Start/From: **12**
Clock To:
1st Value:
2nd Value:
Value Percent:
Continuous Index:
Within 8" of Joint: **NO**
Remarks:

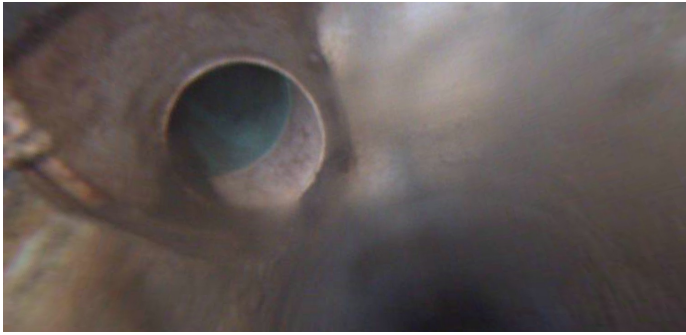
Code: **TFA**
Description: **Tap Factory Active**

Distance (ft): **54.8**
Structural Grade: **0**
O&M Grade: **0**
Clock Start/From: **2**
Clock To:
1st Value: **4.000**
2nd Value:
Value Percent:
Continuous Index:
Within 8" of Joint:
Remarks:

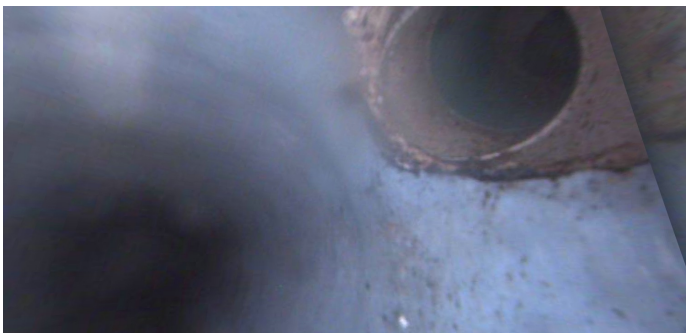
Code: **TF**
Description: **Tap Factory**

Distance (ft): **88.1**
Structural Grade: **0**
O&M Grade: **0**
Clock Start/From: **10**
Clock To:
1st Value: **4.000**
2nd Value:
Value Percent:
Continuous Index:
Within 8" of Joint:
Remarks:

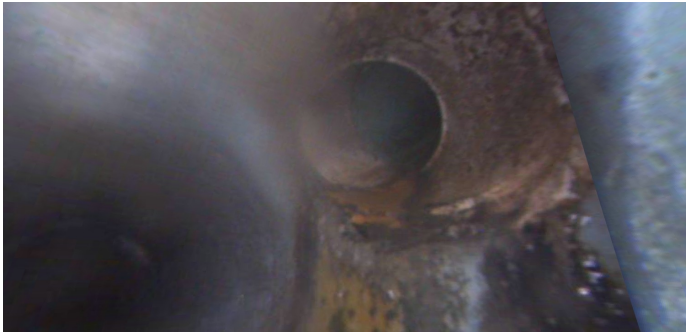
Code: **TFA**
Description: **Tap Factory Active**

Distance (ft): **91.8**
Structural Grade: **0**
O&M Grade: **0**
Clock Start/From: **10**
Clock To:
1st Value: **4.000**
2nd Value:
Value Percent:
Continuous Index:
Within 8" of Joint:
Remarks:

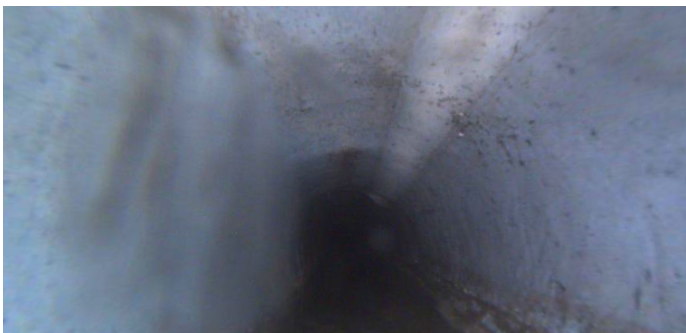
Code: **LFAC**
Description: **Lining Failure Abandoned Connection**

Distance (ft): **117.2**
Structural Grade: **0**
O&M Grade: **0**
Clock Start/From: **12**
Clock To:
1st Value:
2nd Value:
Value Percent:
Continuous Index:
Within 8" of Joint: **NO**
Remarks:

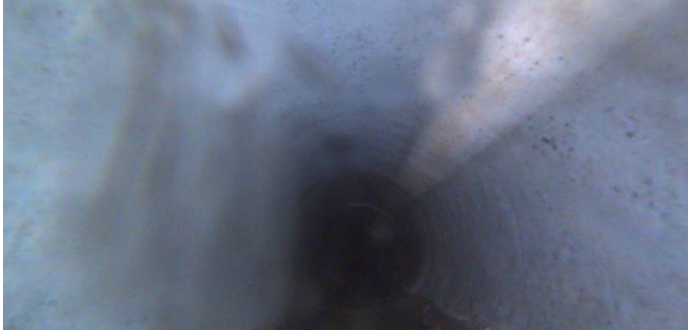
Code:	MSA
Description:	Abandoned Survey
Distance (ft):	123.7
Structural Grade:	0
O&M Grade:	0
Clock Start/From:	
Clock To:	
1st Value:	
2nd Value:	
Value Percent:	
Continuous Index:	
Within 8" of Joint:	NO
Remarks:	unknown
