## Profile/Photo Observation Report

Date:	<b>04/25/2018</b>	Weather:		Coding:	<b>PACP 6.0</b>
Pipe Length (ft):	<b>338.6</b>	Owner:	<b>NA</b>	Pre Clean:	<b>Not Known</b>
P.O.#:		Surveyor:	<b>Jen Costello</b>	PSR:	<b>P-505-038-037</b>
Customer:		Clean Date:	<b>01/01/1900</b>	Shape:	<b>C</b>

Street:	<b>Summerlin</b>	Flow Control:	<b>Not Controlled</b>
City:	<b>Hobart, IN</b>	Year Renewed:	
Location:	<b>Light Highway</b>	Tape/Media #:	
Purpose:	<b>Not Known</b>	Dia/Height:	<b>12"</b>
Use:	<b>Sanitary</b>	Material:	<b>PVC</b>
Drain Area:	<b>NA</b>	Lining:	<b>Cured in Place</b>
Category:	<b>NA</b>		
Comment:

Location Details:		Direction of Survey:	<b>Downstream</b>
US MH:	<b>M-505-037</b>	DS MH:	<b>M-505-038</b>
		Total Length Surveyed (ft):	<b>240.8</b>

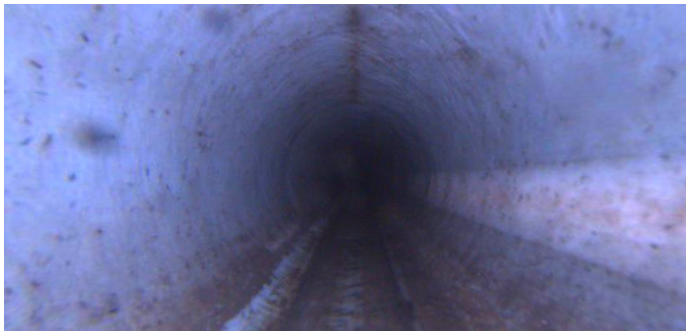
Code: **AMH**  
Description: **Manhole**

Distance (ft): **.0**  
Structural Grade: **0**  
O&M Grade: **0**  
Clock Start/From:  
Clock To:  
1st Value:  
2nd Value:  
Value Percent:  
Continuous Index:  
Within 8" of Joint: **NO**  
Remarks: **M-505-037**

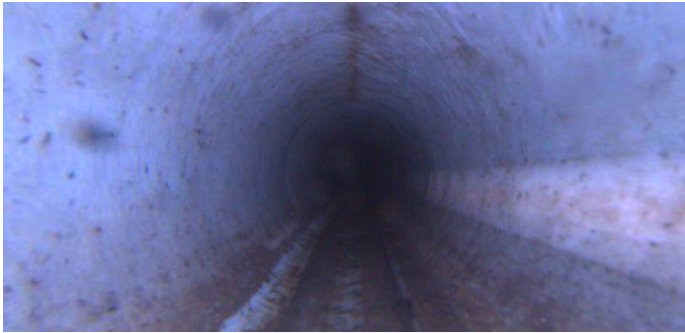
Code:	<b>MWL</b>
Description:	<b>Water Level</b>

Distance (ft):	<b>.0</b>
Structural Grade:	<b>0</b>
O&M Grade:	<b>0</b>
Clock Start/From:	
Clock To:	
1st Value:	
2nd Value:	
Value Percent:	<b>5.000</b>
Continuous Index:	
Within 8" of Joint:	<b>NO</b>
Remarks:

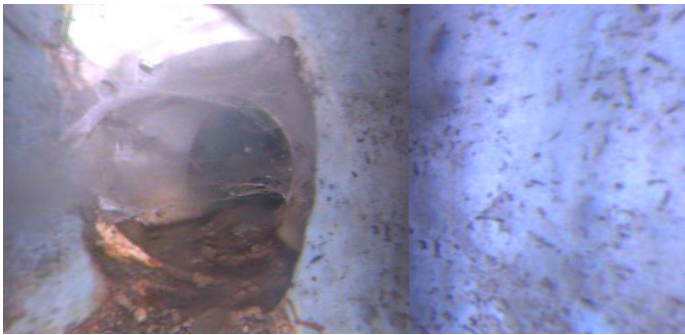
Code:	<b>TB</b>
Description:	<b>Tap Break-in</b>

Distance (ft):	<b>19.8</b>
Structural Grade:	<b>0</b>
O&M Grade:	<b>0</b>
Clock Start/From:	<b>9</b>
Clock To:	
1st Value:	<b>4.000</b>
2nd Value:	
Value Percent:	
Continuous Index:	
Within 8" of Joint:	
Remarks:

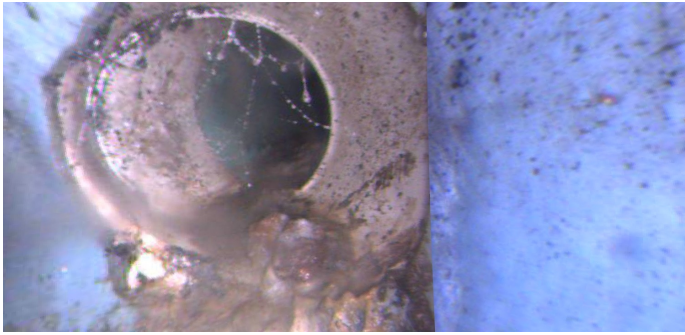
Code: **TB**  
Description: **Tap Break-in**

Distance (ft): **57.4**  
Structural Grade: **0**  
O&M Grade: **0**  
Clock Start/From: **9**  
Clock To:  
1st Value: **4.000**  
2nd Value:  
Value Percent:  
Continuous Index:  
Within 8" of Joint:  
Remarks:

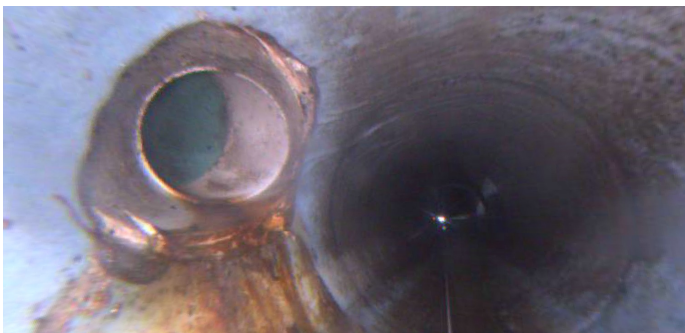
Code: **TBA**  
Description: **Tap Break-in Active**

Distance (ft): **72.6**  
Structural Grade: **0**  
O&M Grade: **0**  
Clock Start/From: **3**  
Clock To:  
1st Value: **4.000**  
2nd Value:  
Value Percent:  
Continuous Index:  
Within 8" of Joint:  
Remarks:

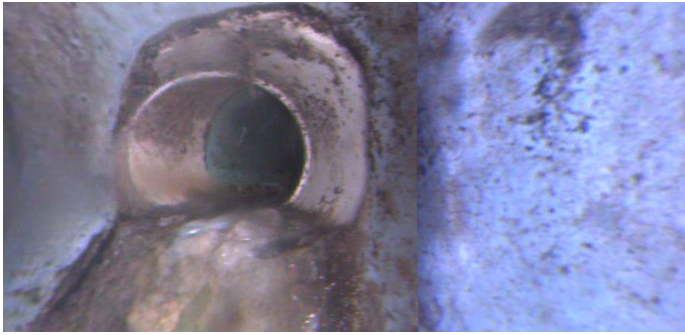
Code: **TBA**  
Description: **Tap Break-in Active**

Distance (ft): **94.8**  
Structural Grade: **0**  
O&M Grade: **0**  
Clock Start/From: **9**  
Clock To:  
1st Value: **4.000**  
2nd Value:  
Value Percent:  
Continuous Index:  
Within 8" of Joint:  
Remarks:

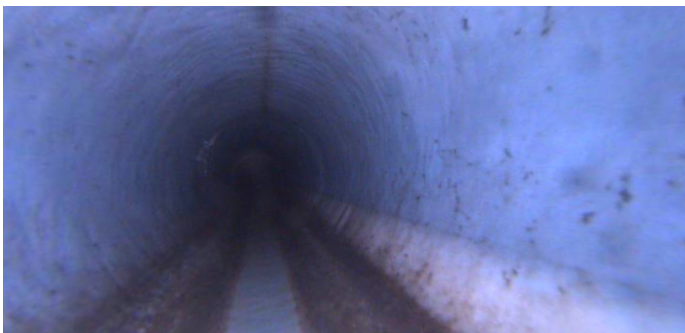
Code: **LFAC**  
Description: **Lining Failure Abandoned Connection**

Distance (ft): **120.6**  
Structural Grade: **0**  
O&M Grade: **0**  
Clock Start/From: **2**  
Clock To:  
1st Value:  
2nd Value:  
Value Percent:  
Continuous Index:  
Within 8" of Joint: **NO**  
Remarks:

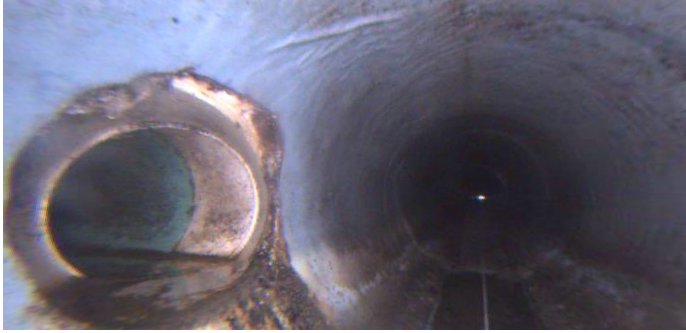
Code: **TB**  
Description: **Tap Break-in**

Distance (ft): **128.6**  
Structural Grade: **0**  
O&M Grade: **0**  
Clock Start/From: **3**  
Clock To:  
1st Value: **4.000**  
2nd Value:  
Value Percent:  
Continuous Index:  
Within 8" of Joint:  
Remarks:

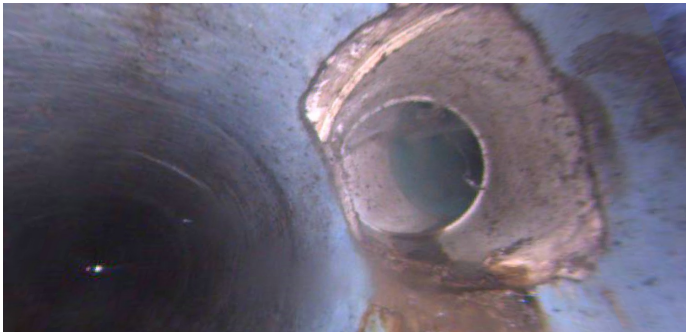
Code: **TBA**  
Description: **Tap Break-in Active**

Distance (ft): **130.9**  
Structural Grade: **0**  
O&M Grade: **0**  
Clock Start/From: **10**  
Clock To:  
1st Value: **4.000**  
2nd Value:  
Value Percent:  
Continuous Index:  
Within 8" of Joint:  
Remarks:

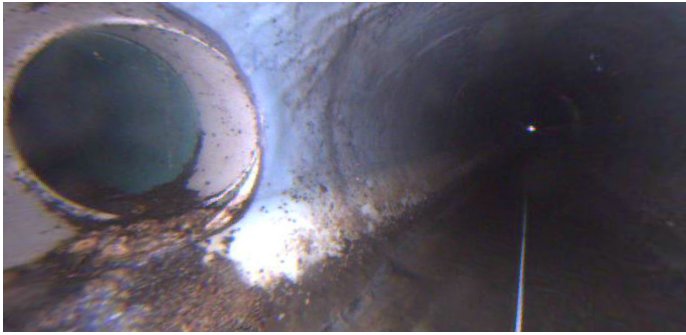
Code: **TB**  
Description: **Tap Break-in**

Distance (ft): **135.3**  
Structural Grade: **0**  
O&M Grade: **0**  
Clock Start/From: **3**  
Clock To:  
1st Value: **4.000**  
2nd Value:  
Value Percent:  
Continuous Index:  
Within 8" of Joint:  
Remarks:

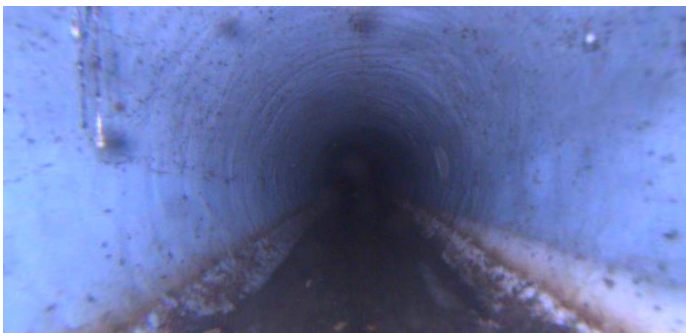
Code: **LFAC**  
Description: **Lining Failure Abandoned Connection**

Distance (ft): **152.4**  
Structural Grade: **0**  
O&M Grade: **0**  
Clock Start/From: **2**  
Clock To:  
1st Value:  
2nd Value:  
Value Percent:  
Continuous Index:  
Within 8" of Joint: **NO**  
Remarks:

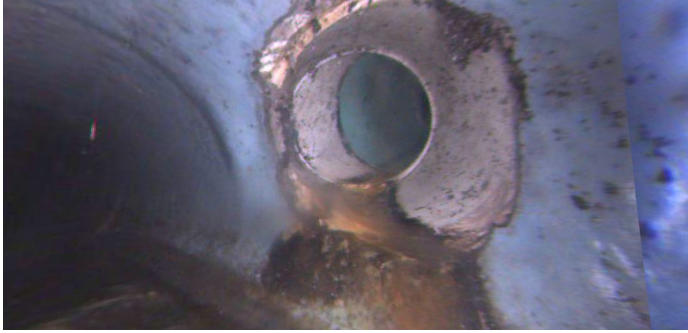
Code: **TBA**  
Description: **Tap Break-in Active**

Distance (ft): **172.6**  
Structural Grade: **0**  
O&M Grade: **0**  
Clock Start/From: **9**  
Clock To:  
1st Value: **4.000**  
2nd Value:  
Value Percent:  
Continuous Index:  
Within 8" of Joint:  
Remarks:

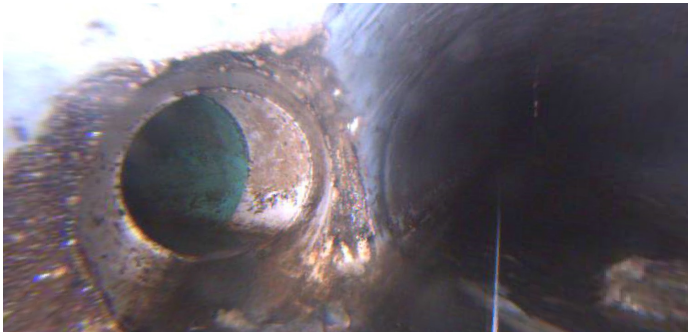
Code: **TBA**  
Description: **Tap Break-in Active**

Distance (ft): **179.1**  
Structural Grade: **0**  
O&M Grade: **0**  
Clock Start/From: **3**  
Clock To:  
1st Value: **4.000**  
2nd Value:  
Value Percent:  
Continuous Index:  
Within 8" of Joint:  
Remarks:

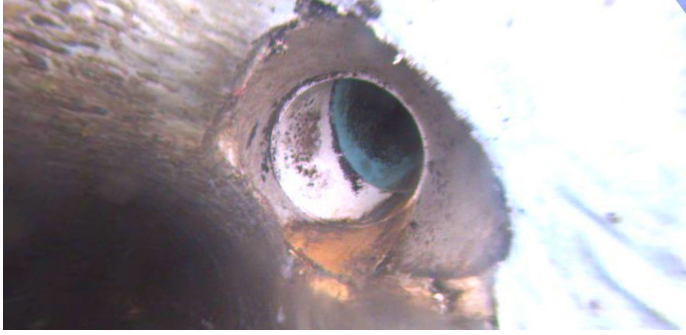
Code: **TF**  
Description: **Tap Factory**

Distance (ft): **207.9**  
Structural Grade: **0**  
O&M Grade: **0**  
Clock Start/From: **10**  
Clock To:  
1st Value: **4.000**  
2nd Value:  
Value Percent:  
Continuous Index:  
Within 8" of Joint:  
Remarks:

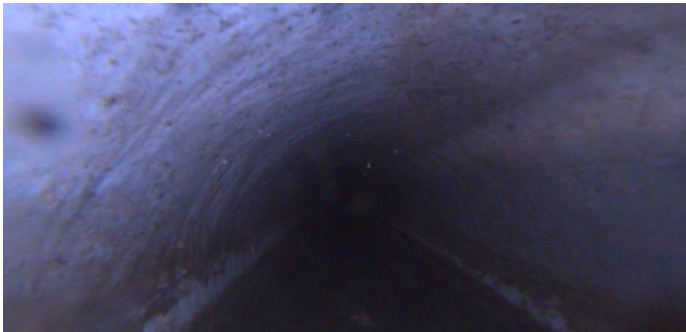
Code: **MSA**  
Description: **Abandoned Survey**

Distance (ft): **240.8**  
Structural Grade: **0**  
O&M Grade: **0**  
Clock Start/From:  
Clock To:  
1st Value:  
2nd Value:  
Value Percent:  
Continuous Index:  
Within 8" of Joint: **NO**  
Remarks: **DSF**
