Profile/Photo Observation Report

Date:	04/25/2018	Weather:		Coding:	PACP 6.0
Pipe Length (ft):	319.8	Owner:	NA	Pre Clean:	Not Known
P.O.#:		Surveyor:	Jen Costello	PSR:	P-505-039-038
Customer:		Clean Date:	01/01/1900	Shape:	C

Street:	Summerlin	Flow Control:	Not Controlled
City:	Hobart, IN	Year Renewed:	
Location:	Light Highway	Tape/Media #:	
Purpose:	Not Known	Dia/Height:	12"
Use:	Sanitary	Material:	PVC
Drain Area:	NA	Lining:	Cured in Place
Category:	NA		
Comment:

Location Details:		Direction of Survey:	Downstream
US MH:	M-505-038	DS MH:	M-505-039
		Total Length Surveyed (ft):	219.1

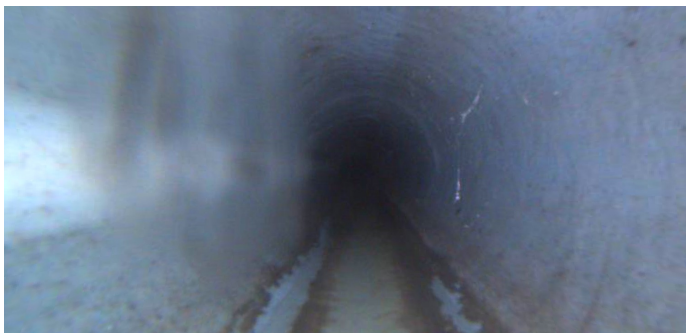
Code: **AMH**
Description: **Manhole**

Distance (ft): **.0**
Structural Grade: **0**
O&M Grade: **0**
Clock Start/From:
Clock To:
1st Value:
2nd Value:
Value Percent:
Continuous Index:
Within 8" of Joint: **NO**
Remarks: **M-505-038**

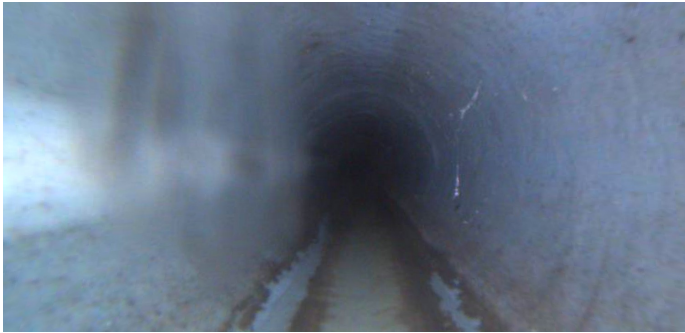
Code:	MWL
Description:	Water Level

Distance (ft):	.0
Structural Grade:	0
O&M Grade:	0
Clock Start/From:	
Clock To:	
1st Value:	
2nd Value:	
Value Percent:	5.000
Continuous Index:	
Within 8" of Joint:	NO
Remarks:

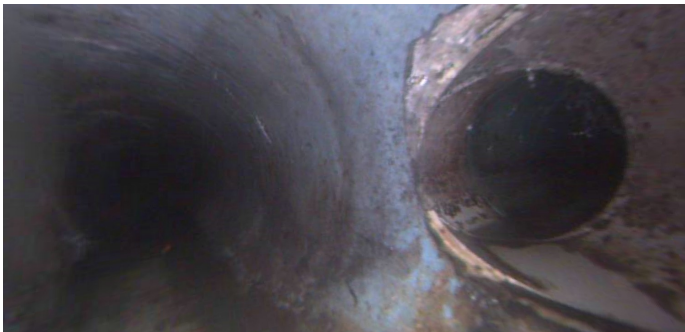
Code:	TB
Description:	Tap Break-in

Distance (ft):	22.0
Structural Grade:	0
O&M Grade:	0
Clock Start/From:	3
Clock To:	
1st Value:	4.000
2nd Value:	
Value Percent:	
Continuous Index:	
Within 8" of Joint:	
Remarks:

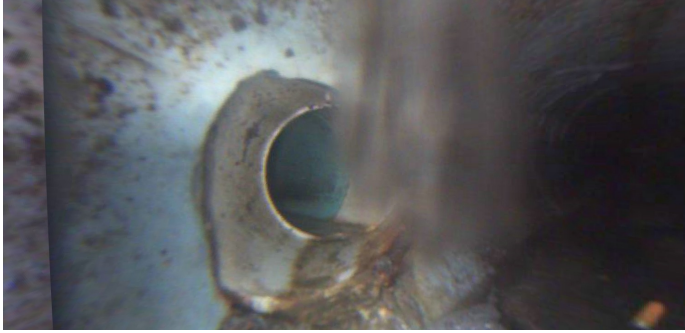
Code: **TB**
Description: **Tap Break-in**

Distance (ft): **23.9**
Structural Grade: **0**
O&M Grade: **0**
Clock Start/From: **9**
Clock To:
1st Value: **4.000**
2nd Value:
Value Percent:
Continuous Index:
Within 8" of Joint:
Remarks:

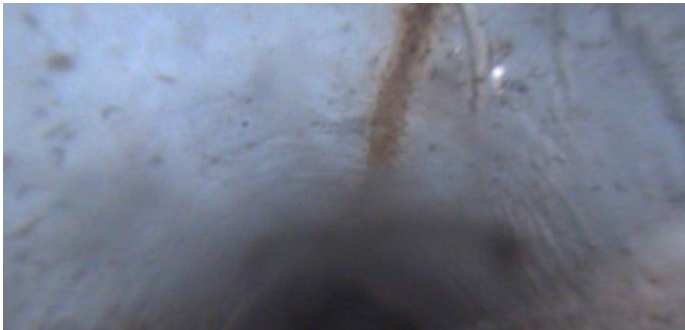
Code: **LFAC**
Description: **Lining Failure Abandoned Connection**

Distance (ft): **25.9**
Structural Grade: **0**
O&M Grade: **0**
Clock Start/From: **9**
Clock To: **12**
1st Value:
2nd Value:
Value Percent:
Continuous Index:
Within 8" of Joint: **NO**
Remarks:

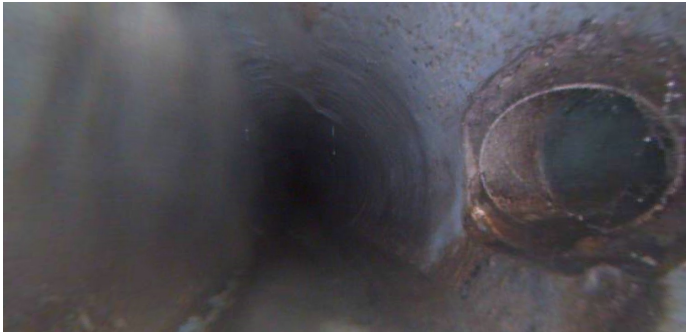
Code: **TB**
Description: **Tap Break-in**

Distance (ft): **56.3**
Structural Grade: **0**
O&M Grade: **0**
Clock Start/From: **3**
Clock To:
1st Value: **4.000**
2nd Value:
Value Percent:
Continuous Index:
Within 8" of Joint:
Remarks:

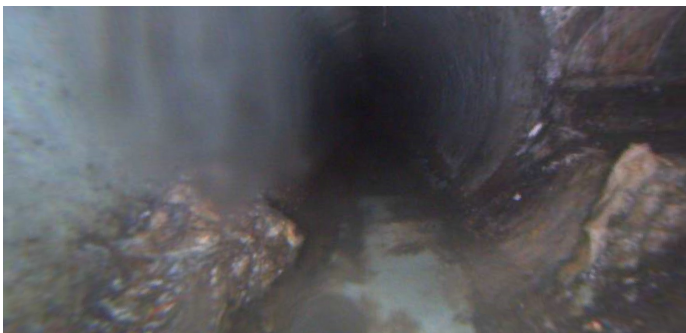
Code: **DAGS**
Description: **Deposits Attached Grease**

Distance (ft): **94.7**
Structural Grade: **0**
O&M Grade: **2**
Clock Start/From: **7**
Clock To: **9**
1st Value:
2nd Value:
Value Percent: **5.000**
Continuous Index:
Within 8" of Joint: **NO**
Remarks:

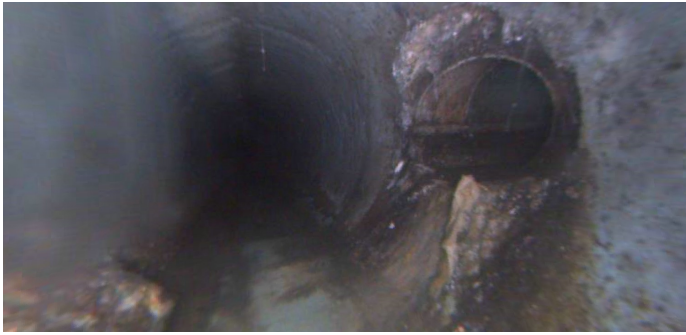
Code: **TBA**
Description: **Tap Break-in Active**

Distance (ft): **94.7**
Structural Grade: **0**
O&M Grade: **0**
Clock Start/From: **3**
Clock To:
1st Value: **4.000**
2nd Value:
Value Percent:
Continuous Index:
Within 8" of Joint:
Remarks:

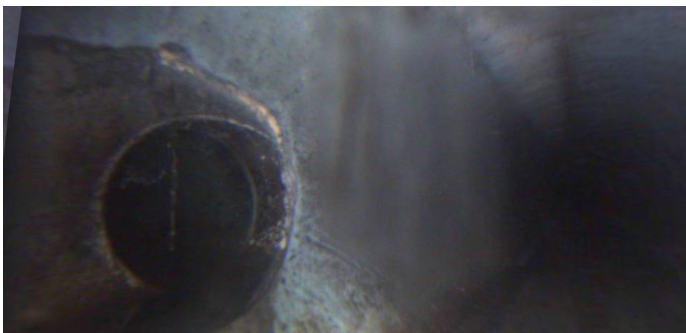
Code: **TBA**
Description: **Tap Break-in Active**

Distance (ft): **115.4**
Structural Grade: **0**
O&M Grade: **0**
Clock Start/From: **9**
Clock To:
1st Value: **4.000**
2nd Value:
Value Percent:
Continuous Index:
Within 8" of Joint:
Remarks:

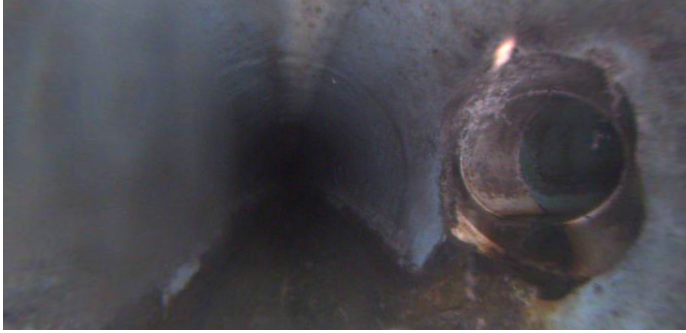
Code: **TBA**
Description: **Tap Break-in Active**

Distance (ft): **135.1**
Structural Grade: **0**
O&M Grade: **0**
Clock Start/From: **3**
Clock To:
1st Value: **4.000**
2nd Value:
Value Percent:
Continuous Index:
Within 8" of Joint:
Remarks:

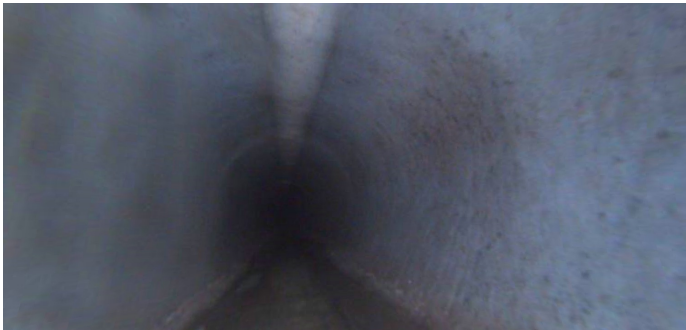
Code: **LFAC**
Description: **Lining Failure Abandoned Connection**

Distance (ft): **138.4**
Structural Grade: **0**
O&M Grade: **0**
Clock Start/From: **3**
Clock To:
1st Value:
2nd Value:
Value Percent:
Continuous Index:
Within 8" of Joint: **NO**
Remarks:

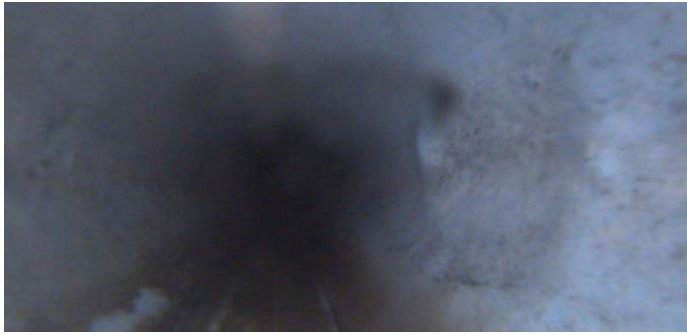
Code:	LFAC
Description:	Lining Failure Abandoned Connection
Distance (ft):	161.8
Structural Grade:	0
O&M Grade:	0
Clock Start/From:	9
Clock To:	
1st Value:	
2nd Value:	
Value Percent:	
Continuous Index:	
Within 8" of Joint:	NO
Remarks:

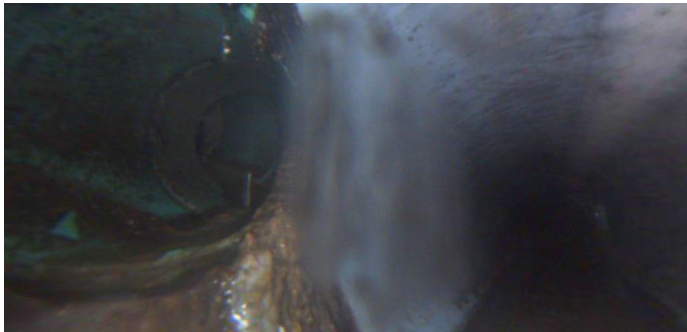
Code:	TBA
Description:	Tap Break-in Active
Distance (ft):	170.5
Structural Grade:	0
O&M Grade:	0
Clock Start/From:	9
Clock To:	
1st Value:	4.000
2nd Value:	
Value Percent:	
Continuous Index:	
Within 8" of Joint:	
Remarks:

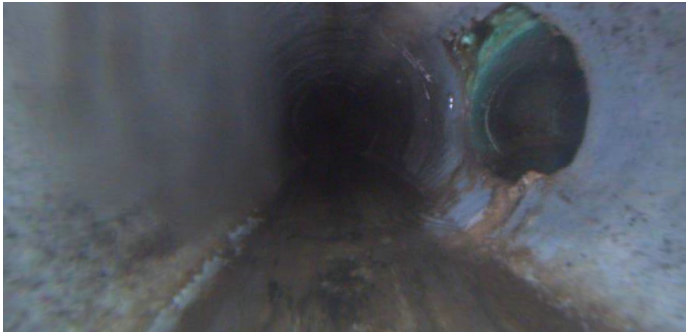
Code: **TBA**
Description: **Tap Break-in Active**

Distance (ft): **173.6**
Structural Grade: **0**
O&M Grade: **0**
Clock Start/From: **3**
Clock To:
1st Value: **4.000**
2nd Value:
Value Percent:
Continuous Index:
Within 8" of Joint:
Remarks:

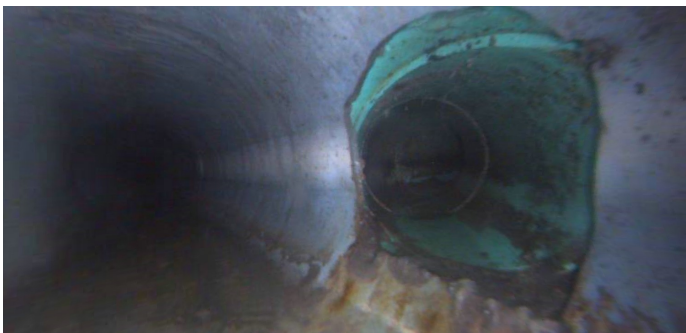
Code: **TB**
Description: **Tap Break-in**

Distance (ft): **214.6**
Structural Grade: **0**
O&M Grade: **0**
Clock Start/From: **3**
Clock To:
1st Value: **4.000**
2nd Value:
Value Percent:
Continuous Index:
Within 8" of Joint:
Remarks:

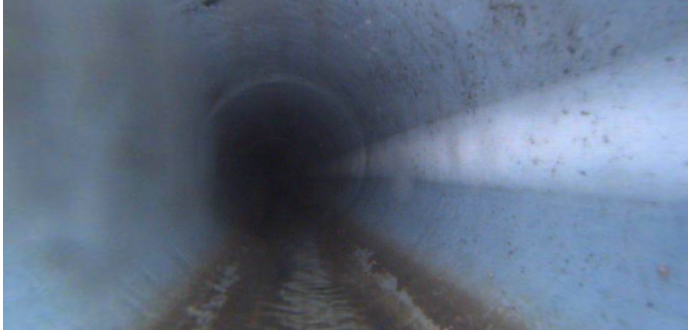
Code: **MSA**
Description: **Abandoned Survey**

Distance (ft): **219.1**
Structural Grade: **0**
O&M Grade: **0**
Clock Start/From:
Clock To:
1st Value:
2nd Value:
Value Percent:
Continuous Index:
Within 8" of Joint: **NO**
Remarks: **unknown**
