## Profile/Photo Observation Report

Street:	<b>S CALIFORNIA ST</b>	Flow Control:	<b>Not Controlled</b>
City:	<b>Hobart, IN</b>	Year Renewed:	
Location:	<b>Light Highway</b>	Tape/Media #:	
Purpose:	<b>Not Known</b>	Dia/Height:	<b>12"</b>
Use:	<b>Sanitary</b>	Material:	<b>PVC</b>
Drain Area:	<b>NA</b>	Lining:	<b>Cured in Place</b>
Category:	<b>NA</b>		
Comment:

Location Details:		Direction of Survey:	<b>Upstream</b>
US MH:	<b>M-505-038</b>	DS MH:	<b>M-505-039</b>
		Total Length Surveyed (ft):	<b>10.8</b>

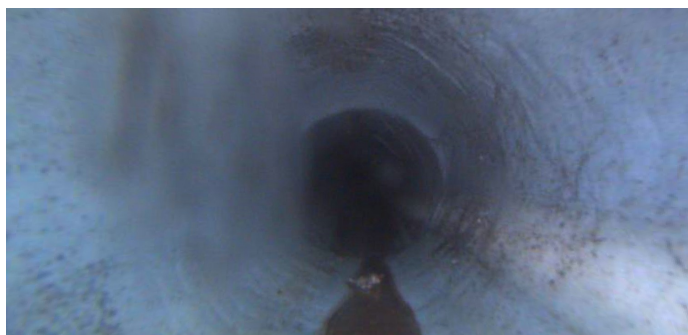
Code: **AMH**  
Description: **Manhole**

Distance (ft): **.0**  
Structural Grade: **0**  
O&M Grade: **0**  
Clock Start/From:  
Clock To:  
1st Value:  
2nd Value:  
Value Percent:  
Continuous Index:  
Within 8" of Joint: **NO**  
Remarks: **M-505-038**

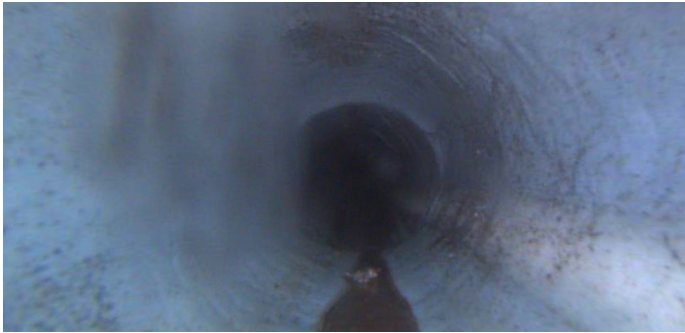
Code:	<b>MWL</b>
Description:	<b>Water Level</b>

Distance (ft):	<b>.0</b>
Structural Grade:	<b>0</b>
O&M Grade:	<b>0</b>
Clock Start/From:	
Clock To:	
1st Value:	
2nd Value:	
Value Percent:	<b>5.000</b>
Continuous Index:	
Within 8" of Joint:	<b>NO</b>
Remarks:

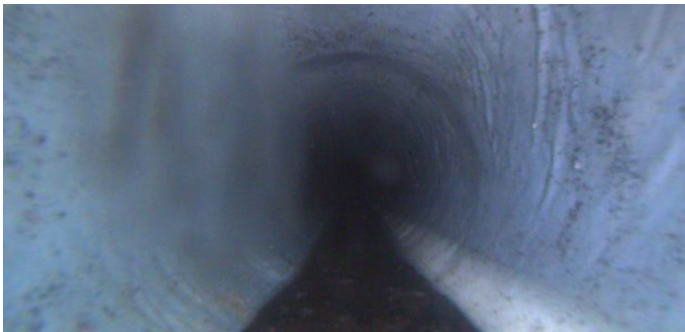
Code:	<b>MSA</b>
Description:	<b>Abandoned Survey</b>

Distance (ft):	<b>10.8</b>
Structural Grade:	<b>0</b>
O&M Grade:	<b>0</b>
Clock Start/From:	
Clock To:	
1st Value:	
2nd Value:	
Value Percent:	
Continuous Index:	
Within 8" of Joint:	<b>NO</b>
Remarks:	<b>unknown</b>
