Profile/Photo Observation Report

Date:	04/16/2018	Weather:		Coding:	PACP 6.0
Pipe Length (ft):		Owner:	City of Hobart	Pre Clean:	No Pre-Cleaning
P.O.#:	55-1	Surveyor:	M. Pielacha	PSR:	M-505-040-M-505-037
Customer:	City of Hobart	Clean Date:		Shape:	C

Street:	Colorado Street	Flow Control:	Not Controlled
City:	Hobart, IN	Year Renewed:	
Location:	Light Highway	Tape/Media #:	DEP 55
Purpose:	Routine Assessment	Dia/Height:	18"
Use:	Sanitary	Material:	VCP
Drain Area:		Lining:

US MH: **M-505-040** DS MH: **M-505-037** Total Length Surveyed (ft): **157.8**

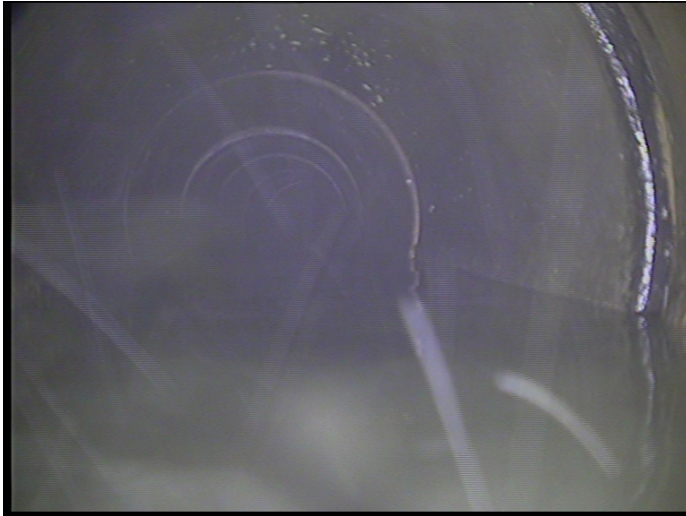
Code: **MWL**
Description: **Water Level**

Distance (ft): **.0**
Structural Grade: **0**
O&M Grade: **0**
Clock Start/From:
Clock To:
1st Value:
2nd Value:
Value Percent: **25.000**
Continuous Index:
Within 8" of Joint: **NO**
Remarks:

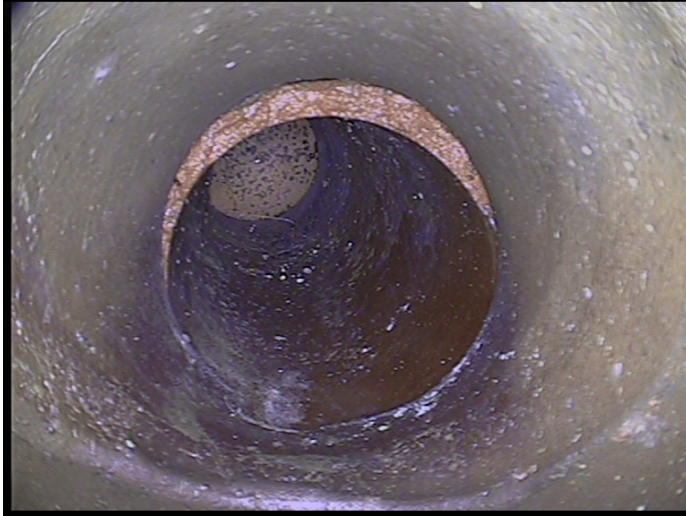
Code: **TFC**
Description: **Tap Factory Capped**

Distance (ft): **86.0**
Structural Grade: **0**
O&M Grade: **0**
Clock Start/From: **11**
Clock To:
1st Value: **4.000**
2nd Value:
Value Percent:
Continuous Index:
Within 8" of Joint: **NO**
Remarks:

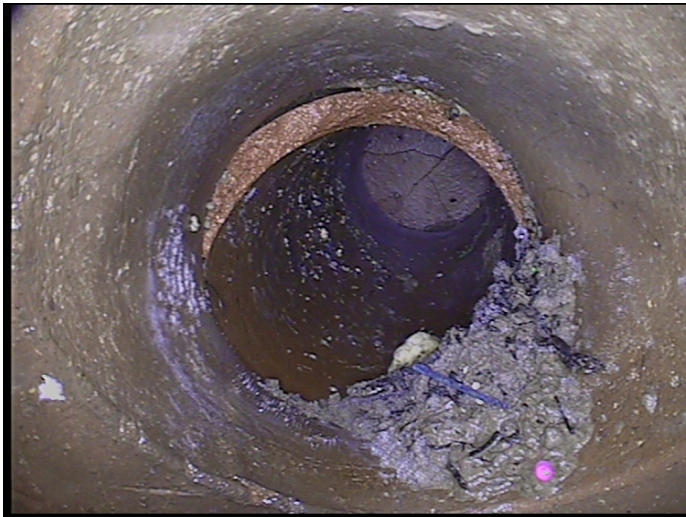
Code: **TFC**
Description: **Tap Factory Capped**

Distance (ft): **88.4**
Structural Grade: **0**
O&M Grade: **0**
Clock Start/From: **2**
Clock To:
1st Value: **4.000**
2nd Value:
Value Percent:
Continuous Index:
Within 8" of Joint: **NO**
Remarks:
