## Profile/Photo Observation Report

Date:	<b>04/16/2018</b>	Weather:		Coding:	<b>PACP 6.0</b>
Pipe Length (ft):		Owner:	<b>City of Hobart</b>	Pre Clean:	<b>No Pre-Cleaning</b>
P.O.#:	<b>55-1</b>	Surveyor:	<b>M. Pielacha</b>	PSR:	<b>M-505-040-M-505-037</b>
Customer:	<b>City of Hobart</b>	Clean Date:		Shape:	<b>C</b>

Street:	<b>Colorado Street</b>	Flow Control:	<b>Not Controlled</b>
City:	<b>Hobart, IN</b>	Year Renewed:	
Location:	<b>Light Highway</b>	Tape/Media #:	<b>DEP 55</b>
Purpose:	<b>Routine Assessment</b>	Dia/Height:	<b>18"</b>
Use:	<b>Sanitary</b>	Material:	<b>VCP</b>
Drain Area:		Lining:	
Category:	<b>NA</b>		
Comment:			
Location Details:		Direction of Survey:	<b>Upstream</b>
US MH:	<b>M-505-040</b>	DS MH:	<b>M-505-037</b>
		Total Length Surveyed (ft):	<b>157.8</b>

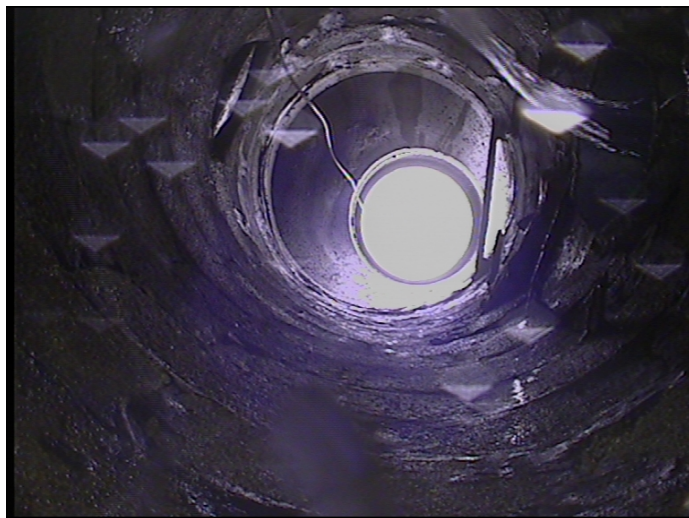
Code: **AMH**  
 Description: **Manhole**

Distance (ft): **.0**  
 Structural Grade: **0**  
 O&M Grade: **0**  
 Clock Start/From:  
 Clock To:  
 1st Value:  
 2nd Value:  
 Value Percent:  
 Continuous Index:  
 Within 8" of Joint: **NO**  
 Remarks: **M-505-037**

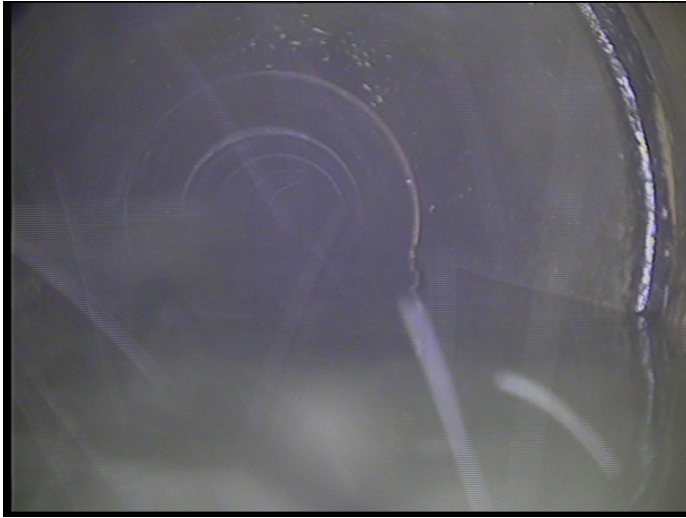
Code: **MWL**  
Description: **Water Level**

Distance (ft): **.0**  
Structural Grade: **0**  
O&M Grade: **0**  
Clock Start/From:  
Clock To:  
1st Value:  
2nd Value:  
Value Percent: **25.000**  
Continuous Index:  
Within 8" of Joint: **NO**  
Remarks:

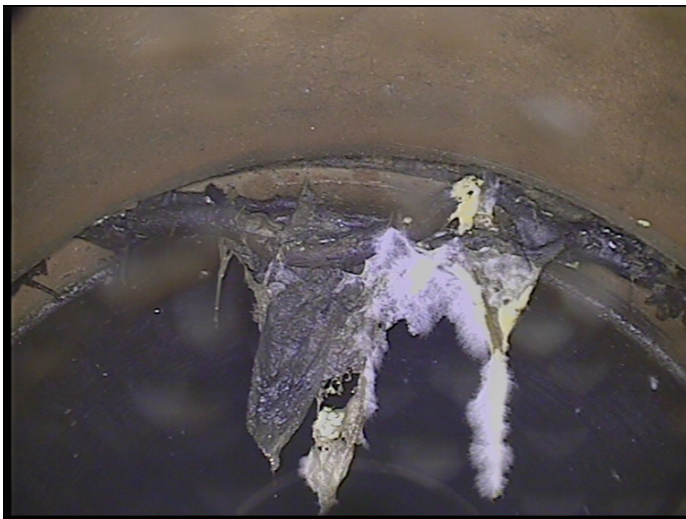
Code: **RTJ**  
Description: **Roots Tap Joint**

Distance (ft): **31.4**  
Structural Grade: **0**  
O&M Grade: **2**  
Clock Start/From: **11**  
Clock To: **1**  
1st Value:  
2nd Value:  
Value Percent: **10.000**  
Continuous Index:  
Within 8" of Joint: **YES**  
Remarks:

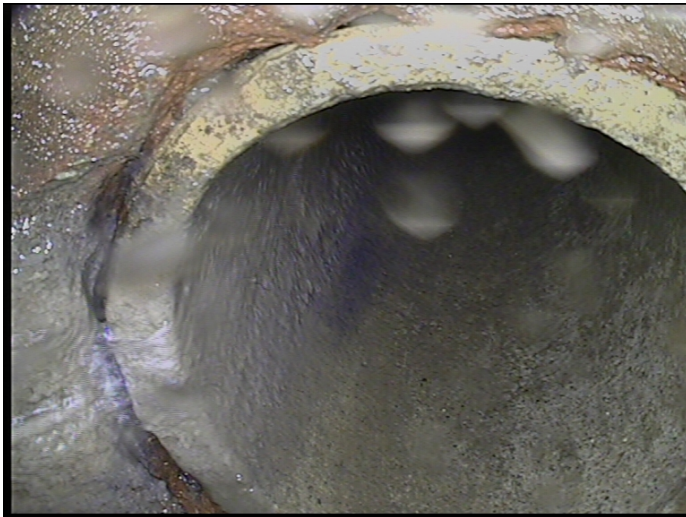
Code: **TBA**  
Description: **Tap Break-in Active**

Distance (ft): **60.1**  
Structural Grade: **0**  
O&M Grade: **0**  
Clock Start/From: **11**  
Clock To:  
1st Value: **4.000**  
2nd Value:  
Value Percent:  
Continuous Index:  
Within 8" of Joint: **NO**  
Remarks:

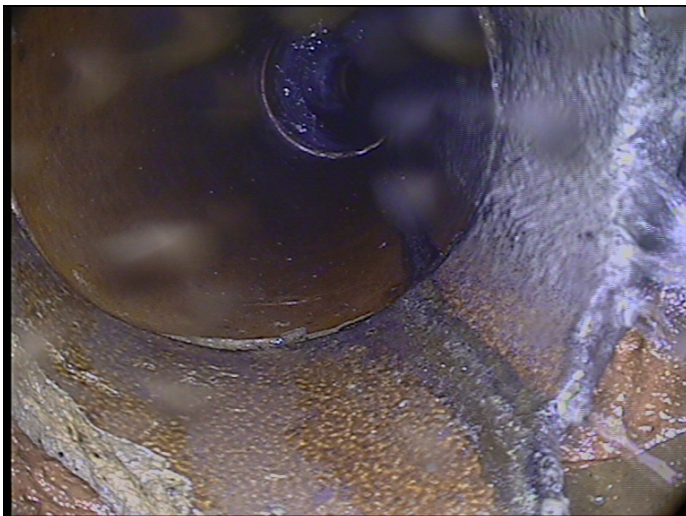
Code: **TBA**  
Description: **Tap Break-in Active**

Distance (ft): **68.3**  
Structural Grade: **0**  
O&M Grade: **0**  
Clock Start/From: **1**  
Clock To:  
1st Value: **4.000**  
2nd Value:  
Value Percent:  
Continuous Index:  
Within 8" of Joint: **NO**  
Remarks:

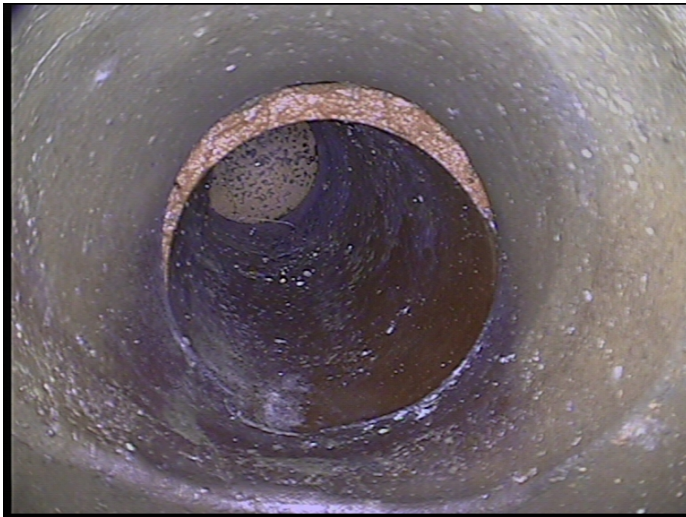
Code: **TFC**  
Description: **Tap Factory Capped**

Distance (ft): **86.0**  
Structural Grade: **0**  
O&M Grade: **0**  
Clock Start/From: **11**  
Clock To:  
1st Value: **4.000**  
2nd Value:  
Value Percent:  
Continuous Index:  
Within 8" of Joint: **NO**  
Remarks:

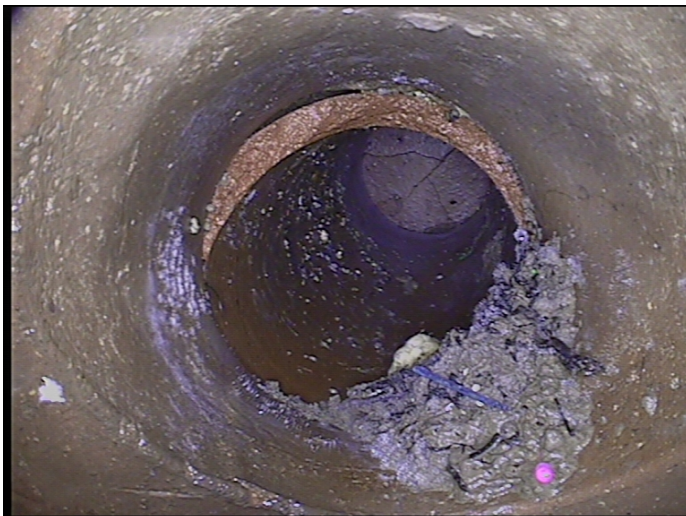
Code: **TFC**  
Description: **Tap Factory Capped**

Distance (ft): **88.4**  
Structural Grade: **0**  
O&M Grade: **0**  
Clock Start/From: **2**  
Clock To:  
1st Value: **4.000**  
2nd Value:  
Value Percent:  
Continuous Index:  
Within 8" of Joint: **NO**  
Remarks:

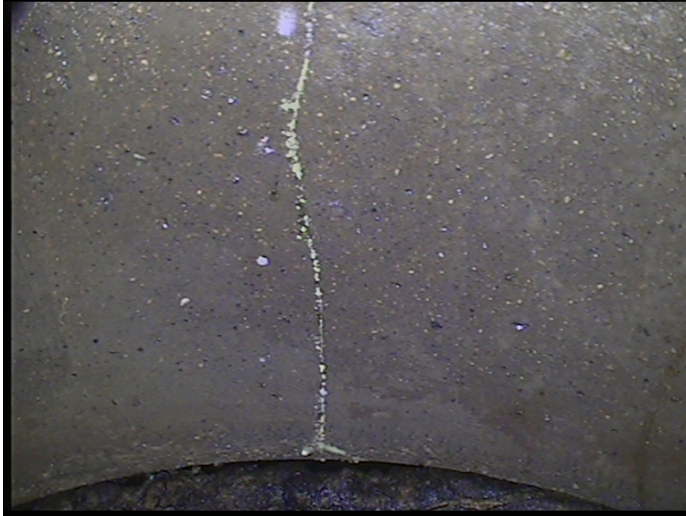
Code: **CL**  
Description: **Crack Longitudinal**

Distance (ft): **140.7**  
Structural Grade: **2**  
O&M Grade: **0**  
Clock Start/From: **11**  
Clock To:  
1st Value:  
2nd Value:  
Value Percent:  
Continuous Index:  
Within 8" of Joint: **YES**  
Remarks:

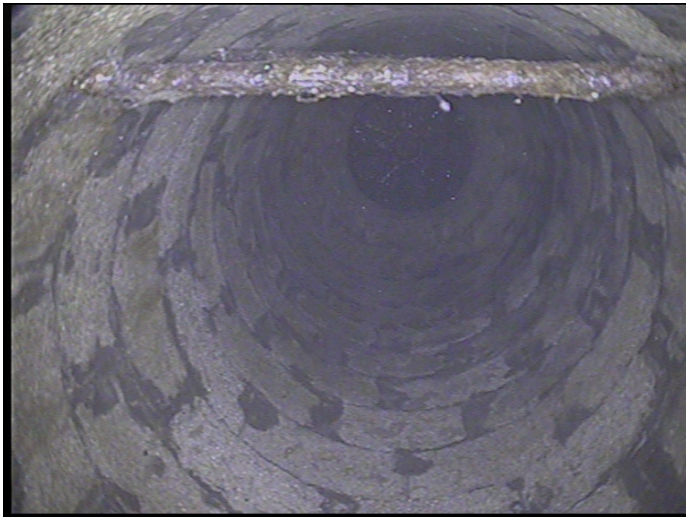
Code: **AMH**  
Description: **Manhole**

Distance (ft): **157.7**  
Structural Grade: **0**  
O&M Grade: **0**  
Clock Start/From:  
Clock To:  
1st Value:  
2nd Value:  
Value Percent:  
Continuous Index:  
Within 8" of Joint: **NO**  
Remarks: **M-505-040**
