Profile/Photo Observation Report

Profile/Photo Observation Report									
Date: Pipe Length (ft P.O.#: Customer:	04/27/2018 :): 124 City of Hobart	Weather: Owner: Surveyor: Clean Date:	City of Hoba M. Pielacha	rt	Coding: Pre Clean: PSR: Shape:	PACP 6.0 Not Known P-505-043-040 C			
Street: 2nd Street + Virginia		nia Street	Flow Control:		Not Controlled				
City:	Hobart, IN		Year Renewed	:					
Location:	Light Highway		Tape/Media#	:	124				
Purpose:	Routine Assessme	nt	Dia/Height:		18"				
Use:	Sanitary		Material:		VCP				
Drain Area:			Lining:						
Category:	NA

Comment:	YES501824 Submi	tal 2							
Location Detai	ls:		Direction of Su	ırvey:	Downstream				
US MH:	M-505-040	DS MH:	M-505-043	Tota	al Length Surveyed (ft)	: 162.4			
D&M Index:	2.75	O&M Quick:	4	132	O&M Rating:	11.00			
structural Index:	0.00	Structural Qu	ick: 0	000	Structural Rating:	0.00			
Overall Index:	2.75	Overall Quick	. 4	132	Overall Rating:	11.00

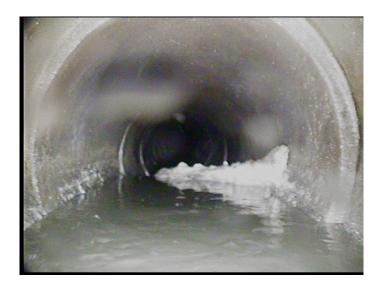
Code: MWL
Description: Water Level

Distance (ft): .0
Structural Grade: 0
O&M Grade: 0
Clock Start/From:

Value Percent: 15.000

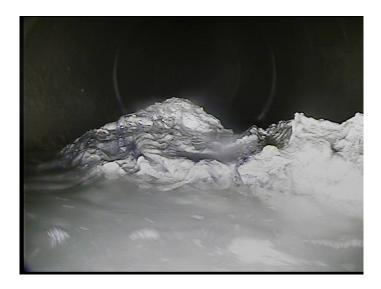
Code: OBZ

Description: Obstacle Other

Distance (ft): 5.7
Structural Grade: 0
O&M Grade: 4
Clock Start/From: 3
Clock To: 8
1st Value:
2nd Value:

Value Percent: 25.000

Within 8" of Joint: NO
Remarks: Debris

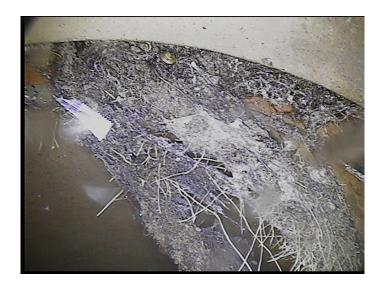
Code: RMJ

Description: **Roots Medium Joint**

Distance (ft): 59.2 Structural Grade: 0 3 O&M Grade: Clock Start/From: 1 Clock To: 5

Value Percent: 15.000 Continuous Index: **S01** Within 8" of Joint: YES

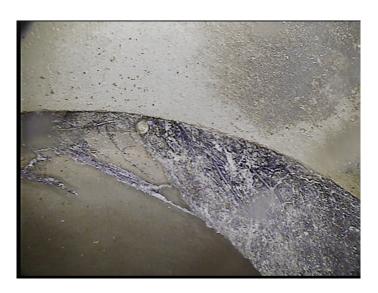
Code: RMJ

Description: **Roots Medium Joint**

Distance (ft): 69.6 Structural Grade: 0 O&M Grade: 3 Clock Start/From: 1 5 Clock To: 1st Value:

Value Percent: 15.000 Continuous Index: F01 Within 8" of Joint: YES

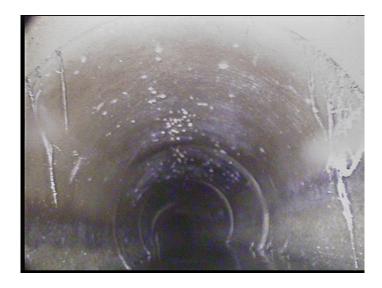
Code: RFJ

Description: Roots Fine Joint

Distance (ft): 81.8
Structural Grade: 0

O&M Grade: 1

Clock Start/From: 10

Clock To: 2

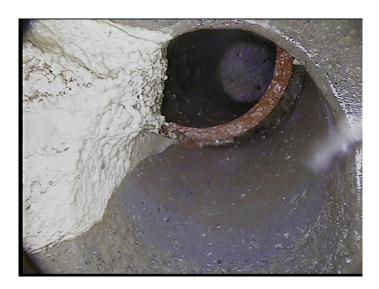
Code: **TF**

Description: Tap Factory

Distance (ft): 91.7
Structural Grade: 0

Clock Start/From: 11

1st Value: **4.000**

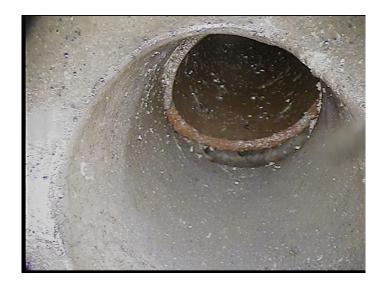
Code: TF

Description: **Tap Factory**

Distance (ft): 94.3 Structural Grade: 0 O&M Grade: 0 Clock Start/From: 1

1st Value: 4.000

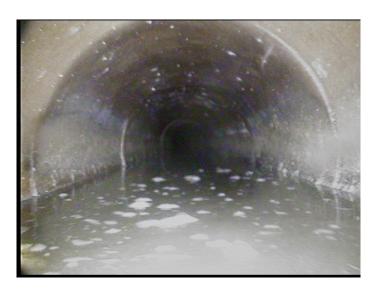
Code: MWL

Description: **Water Level**

Distance (ft): 106.7 Structural Grade: 0 O&M Grade: 0

Value Percent: 20.000

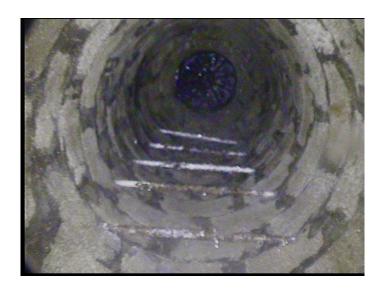
Code: AMH
Description: Manhole

Distance (ft): 162.4
Structural Grade: 0

Remarks: M-505-043
