Profile/Photo Observation Report

| Street: | FOXCROFT STREET | Flow Control: | Not Controlled |
| City: | Hobart, IN | Year Renewed: | |
| US MH: | M-505-043 | DS MH: | M-505-044 |

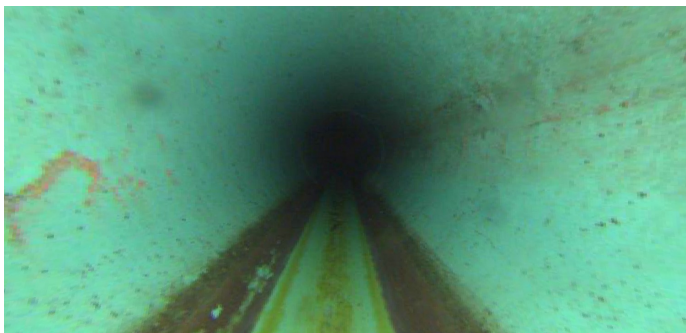
Code: **AMH**
Description: **Manhole**

Distance (ft): **.0**
Structural Grade: **0**
O&M Grade: **0**
Clock Start/From:
Clock To:
1st Value:
2nd Value:
Value Percent:
Continuous Index:
Within 8" of Joint: **NO**
Remarks: **M-505-044**

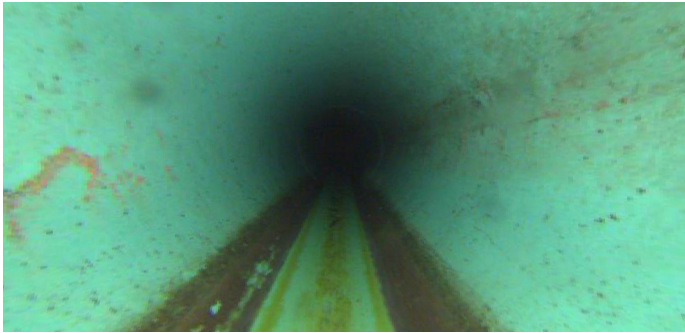
| Code: | MWL |
| Description: | Water Level |

| Value Percent: | 5.000 |

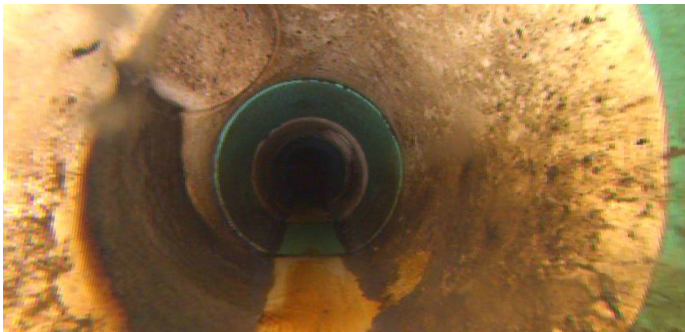
| Code: | TF |
| Description: | Tap Factory |

| Distance (ft): | 27.9 |
| Clock Start/From: | 11 |

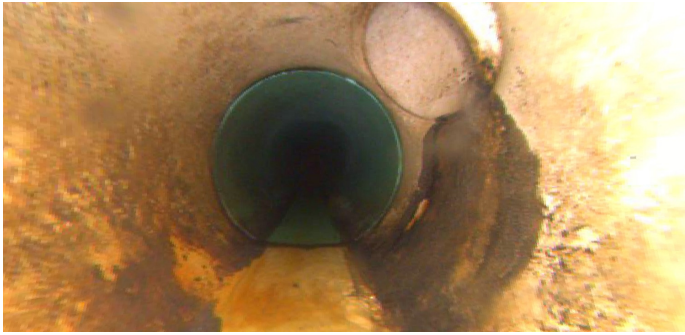
Code: **TF**
Description: **Tap Factory**

Distance (ft): **30.1**
Structural Grade: **0**
O&M Grade: **0**
Clock Start/From: **1**
Clock To:
1st Value: **4.000**
2nd Value:
Value Percent:
Continuous Index:
Within 8" of Joint: **YES**
Remarks:

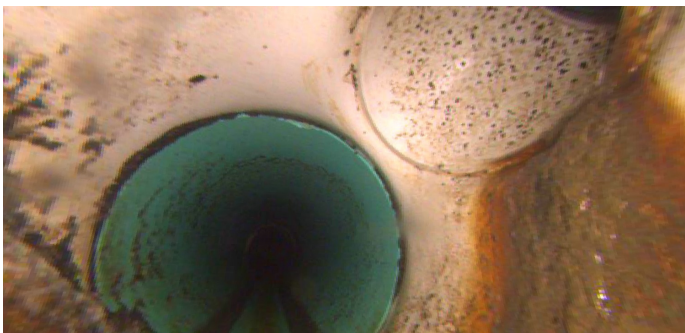
Code: **TF**
Description: **Tap Factory**

Distance (ft): **64.4**
Structural Grade: **0**
O&M Grade: **0**
Clock Start/From: **3**
Clock To:
1st Value: **4.000**
2nd Value:
Value Percent:
Continuous Index:
Within 8" of Joint: **YES**
Remarks:

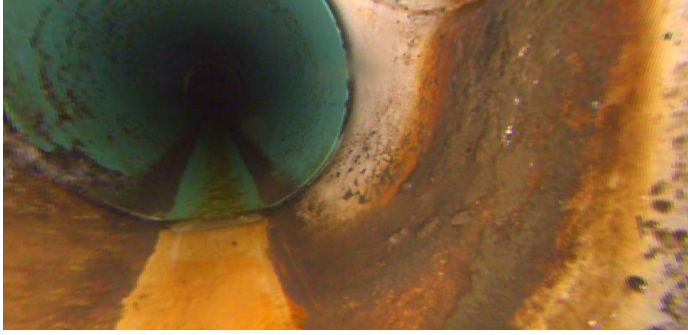
| Code: | DAZ |
| Description: | Deposits Attached Other |
| Distance (ft): | 64.4 |
| O&M Grade: | 2 |
| Clock Start/From: | 2 |
| Clock To: | 5 |
| Value Percent: | 5.000 |

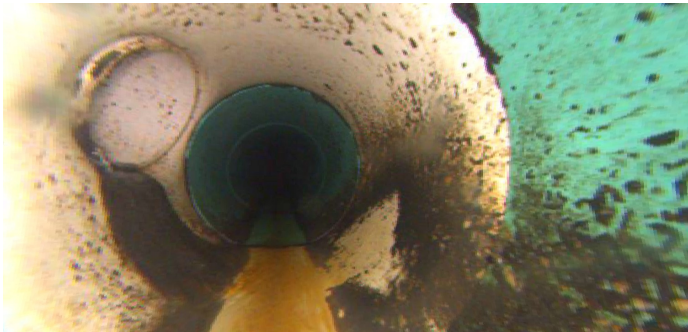
| Code: | TF |
| Description: | Tap Factory |
| Distance (ft): | 69.8 |
| Clock Start/From: | 10 |

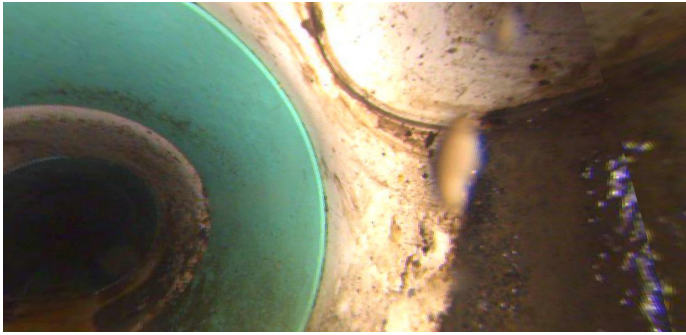
Code: **TF**
Description: **Tap Factory**

Distance (ft): **112.4**
Structural Grade: **0**
O&M Grade: **0**
Clock Start/From: **1**
Clock To:
1st Value: **4.000**
2nd Value:
Value Percent:
Continuous Index:
Within 8" of Joint: **YES**
Remarks:

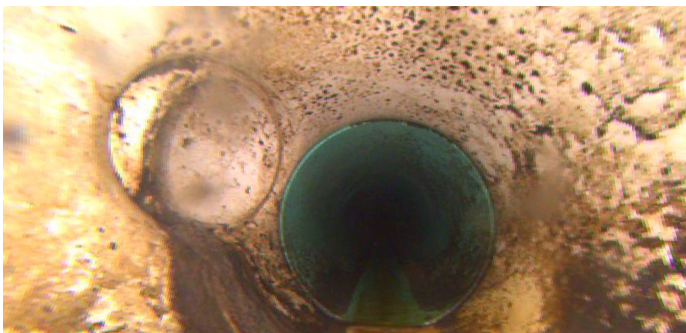
Code: **TF**
Description: **Tap Factory**

Distance (ft): **113.8**
Structural Grade: **0**
O&M Grade: **0**
Clock Start/From: **10**
Clock To:
1st Value: **4.000**
2nd Value:
Value Percent:
Continuous Index:
Within 8" of Joint: **YES**
Remarks:

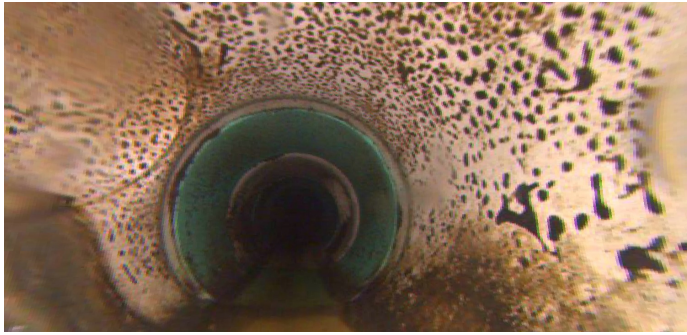
Code: **TF**
Description: **Tap Factory**

Distance (ft): **148.4**
Structural Grade: **0**
O&M Grade: **0**
Clock Start/From: **10**
Clock To:
1st Value: **4.000**
2nd Value:
Value Percent:
Continuous Index:
Within 8" of Joint: **YES**
Remarks:

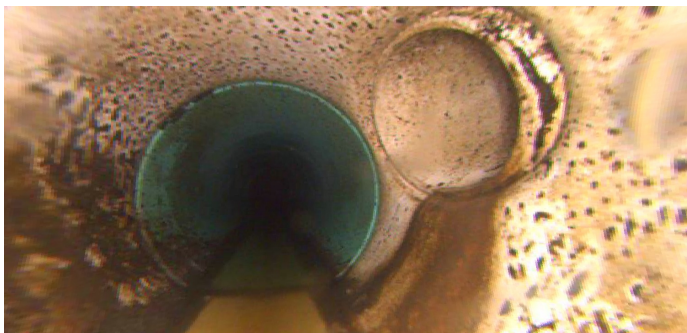
Code: **TF**
Description: **Tap Factory**

Distance (ft): **150.6**
Structural Grade: **0**
O&M Grade: **0**
Clock Start/From: **2**
Clock To:
1st Value: **4.000**
2nd Value:
Value Percent:
Continuous Index:
Within 8" of Joint: **YES**
Remarks:

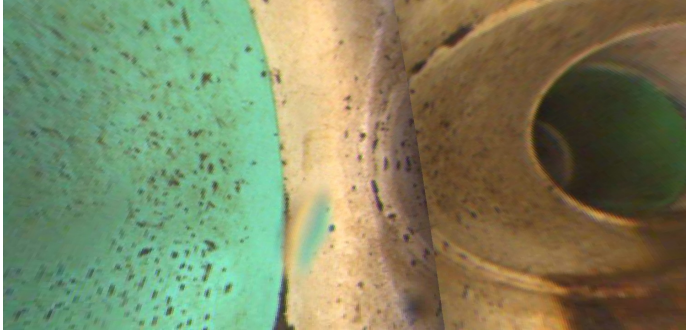
Code: **TF**
Description: **Tap Factory**

Distance (ft): **199.4**
Structural Grade: **0**
O&M Grade: **0**
Clock Start/From: **2**
Clock To:
1st Value: **4.000**
2nd Value:
Value Percent:
Continuous Index:
Within 8" of Joint: **YES**
Remarks:

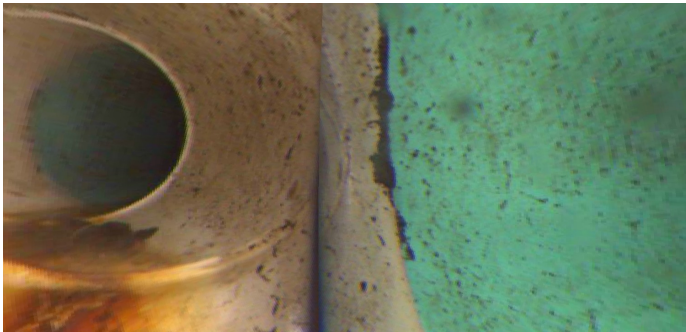
Code: **TF**
Description: **Tap Factory**

Distance (ft): **201.6**
Structural Grade: **0**
O&M Grade: **0**
Clock Start/From: **9**
Clock To:
1st Value: **4.000**
2nd Value:
Value Percent:
Continuous Index:
Within 8" of Joint: **YES**
Remarks:

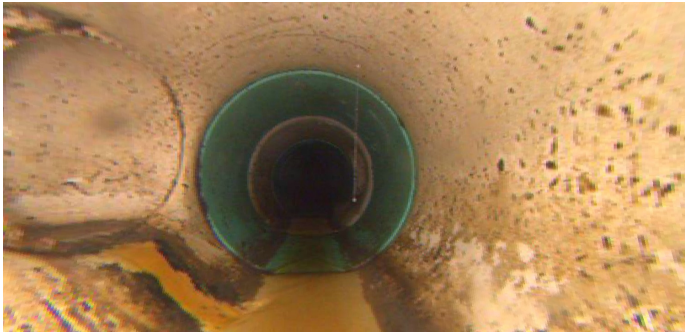
Code: **TF**
Description: **Tap Factory**

Distance (ft): **234.6**
Structural Grade: **0**
O&M Grade: **0**
Clock Start/From: **9**
Clock To:
1st Value: **4.000**
2nd Value:
Value Percent:
Continuous Index:
Within 8" of Joint: **YES**
Remarks:

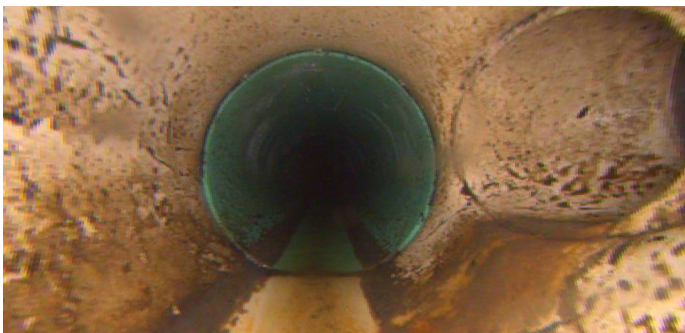
Code: **TF**
Description: **Tap Factory**

Distance (ft): **236.8**
Structural Grade: **0**
O&M Grade: **0**
Clock Start/From: **3**
Clock To:
1st Value: **4.000**
2nd Value:
Value Percent:
Continuous Index:
Within 8" of Joint: **YES**
Remarks:

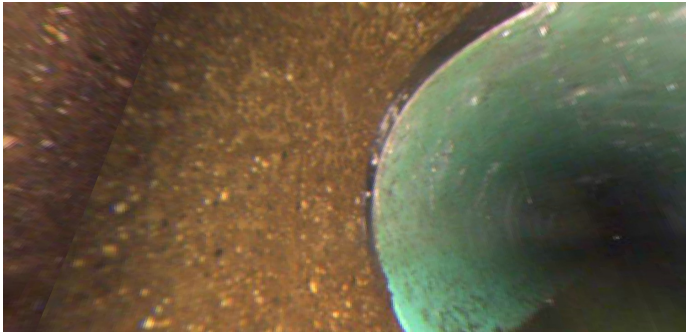
Code: **MMC**
Description: **Material Change**

Distance (ft): **274.6**
Structural Grade: **0**
O&M Grade: **0**
Clock Start/From:
Clock To:
1st Value:
2nd Value:
Value Percent:
Continuous Index:
Within 8" of Joint: **NO**
Remarks: **cp**

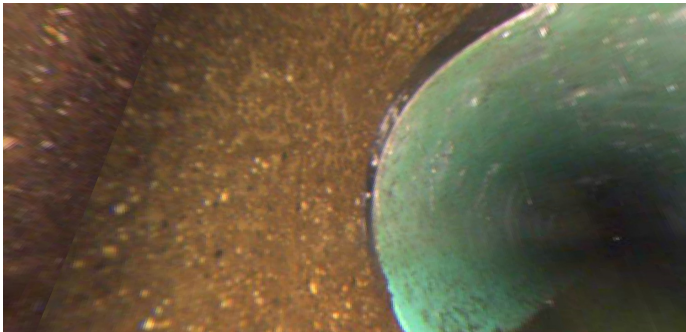
| | Position | Code | Observation | Video (sec) | Grade |
|--|---|---|---|---|---|
| | 274.6 | SAV(S01) | Surface Aggregate Visible | 748 | S 3 |

Code: **SAV**
Description: **Surface Aggregate Visible**

Distance (ft): **274.6**
Structural Grade: **3**
O&M Grade: **0**
Clock Start/From: **7**
Clock To: **5**
1st Value:
2nd Value:
Value Percent:
Continuous Index: **S01**
Within 8" of Joint:
Remarks:

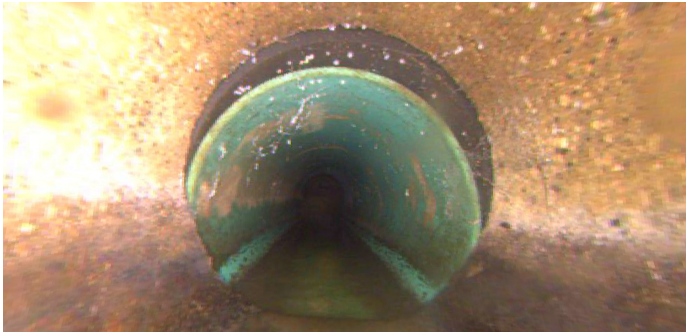
Code: **MMC**
Description: **Material Change**

Distance (ft): **292.5**
Structural Grade: **0**
O&M Grade: **0**
Clock Start/From:
Clock To:
1st Value:
2nd Value:
Value Percent:
Continuous Index:
Within 8" of Joint: **NO**
Remarks: **pvc**

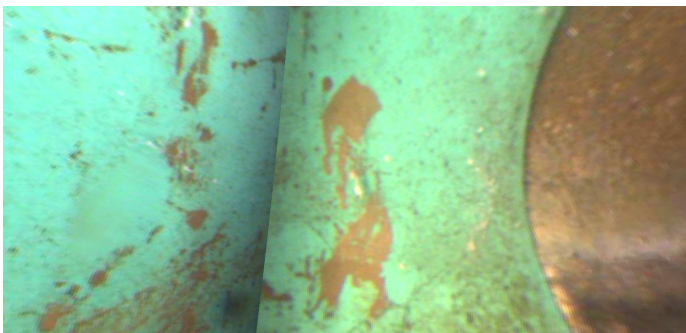
| | Position | Code | Observation | Video (sec) | Grade |
|--|---|---|---|---|---|
| | 294.0 | SAV(F01) | Surface Aggregate Visible | 813 | S 3 |

Code: **SAV**
Description: **Surface Aggregate Visible**

Distance (ft): **294.0**
Structural Grade: **3**
O&M Grade: **0**
Clock Start/From: **7**
Clock To: **5**
1st Value:
2nd Value:
Value Percent:
Continuous Index: **F01**
Within 8" of Joint:
Remarks:

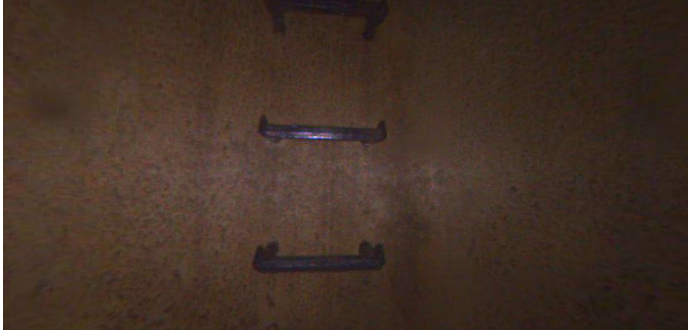
| Code: | AMH |
| Description: | Manhole |
| Distance (ft): | 300.2 |
| Remarks: | M-505-043 |
