Profile/Photo Observation Report

Date:	04/21/2018	Weather:		Coding:	PACP 6.0
Pipe Length (ft):	296.1	Owner:	NA	Pre Clean:	No Pre-Cleaning
P.O.#:		Surveyor:	Byrd Fitzgerald	PSR:	P-505-045-044
Customer:		Clean Date:	01/01/1900	Shape:	C

Street:	S VIRGINIA ST	Flow Control:	Not Controlled
City:	Hobart, IN	Year Renewed:	
Location:	Light Highway	Tape/Media #:	
Purpose:	Routine Assessment	Dia/Height:	12"
Use:	Sanitary	Material:	PVC
Drain Area:	NA	Lining:	
Category:	NA		
Comment:	R_M at 274 ft nothing visible .Flow direction wrong		
Location Details:		Direction of Survey:	Downstream
US MH:	M-505-044	DS MH:	M-505-045
		Total Length Surveyed (ft):	276.1

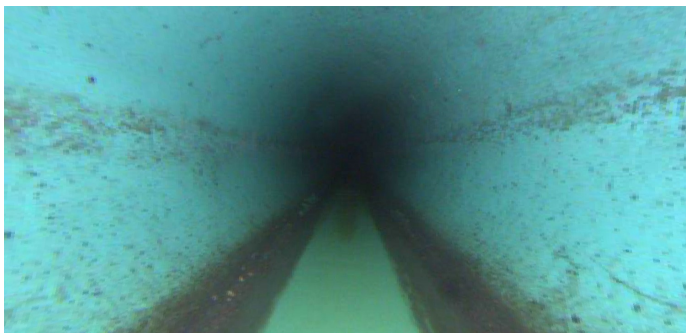
Code: **AMH**
Description: **Manhole**

Distance (ft): **.0**
Structural Grade: **0**
O&M Grade: **0**
Clock Start/From:
Clock To:
1st Value:
2nd Value:
Value Percent:
Continuous Index:
Within 8" of Joint: **NO**
Remarks: **M-505-044**

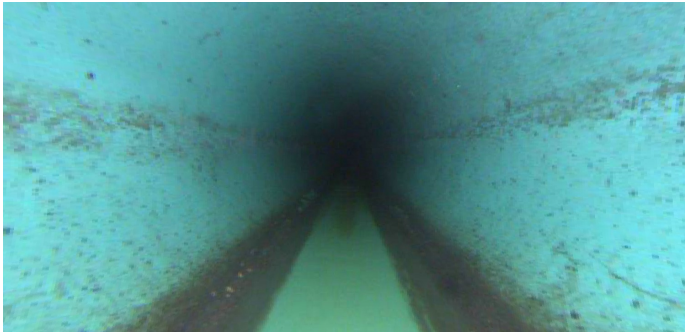
Code:	MWL
Description:	Water Level

Distance (ft):	.0
Structural Grade:	0
O&M Grade:	0
Clock Start/From:	
Clock To:	
1st Value:	
2nd Value:	
Value Percent:	5.000
Continuous Index:	
Within 8" of Joint:	NO
Remarks:

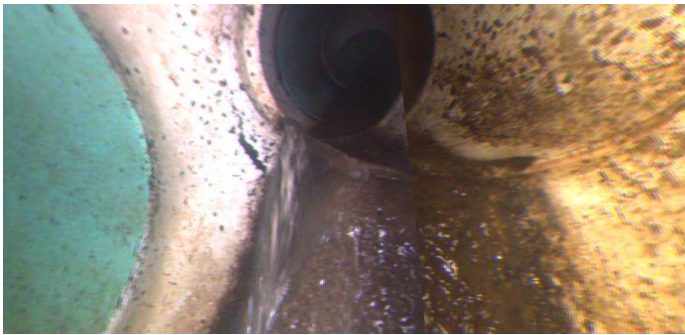
Code:	TFA
Description:	Tap Factory Active

Distance (ft):	10.6
Structural Grade:	0
O&M Grade:	0
Clock Start/From:	2
Clock To:	
1st Value:	4.000
2nd Value:	
Value Percent:	
Continuous Index:	
Within 8" of Joint:	YES
Remarks:

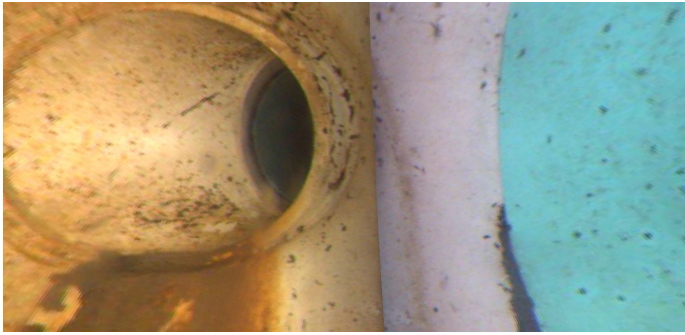
Code: **TF**
Description: **Tap Factory**

Distance (ft): **13.1**
Structural Grade: **0**
O&M Grade: **0**
Clock Start/From: **10**
Clock To:
1st Value: **4.000**
2nd Value:
Value Percent:
Continuous Index:
Within 8" of Joint: **YES**
Remarks:

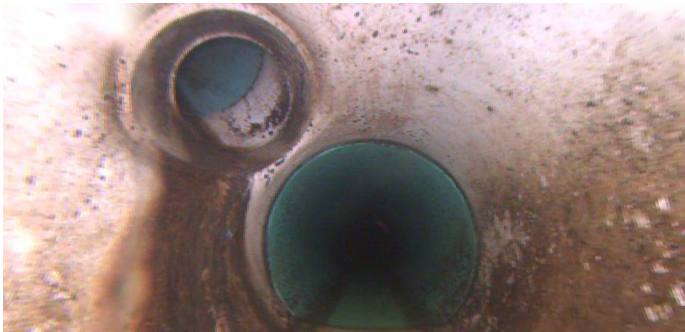
Code: **TF**
Description: **Tap Factory**

Distance (ft): **55.4**
Structural Grade: **0**
O&M Grade: **0**
Clock Start/From: **11**
Clock To:
1st Value: **4.000**
2nd Value:
Value Percent:
Continuous Index:
Within 8" of Joint: **YES**
Remarks:

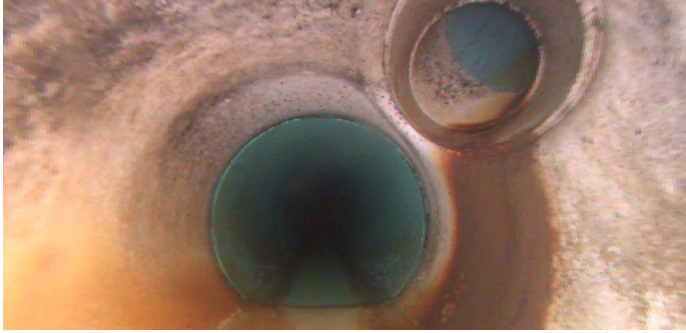
Code: **TF**
Description: **Tap Factory**

Distance (ft): **61.1**
Structural Grade: **0**
O&M Grade: **0**
Clock Start/From: **1**
Clock To:
1st Value: **4.000**
2nd Value:
Value Percent:
Continuous Index:
Within 8" of Joint: **YES**
Remarks:

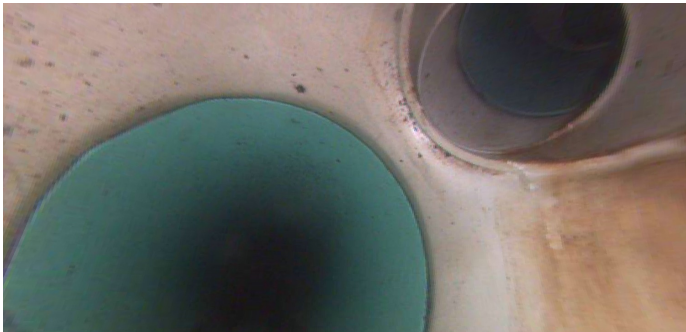
Code: **TF**
Description: **Tap Factory**

Distance (ft): **102.1**
Structural Grade: **0**
O&M Grade: **0**
Clock Start/From: **1**
Clock To:
1st Value: **4.000**
2nd Value:
Value Percent:
Continuous Index:
Within 8" of Joint: **YES**
Remarks:

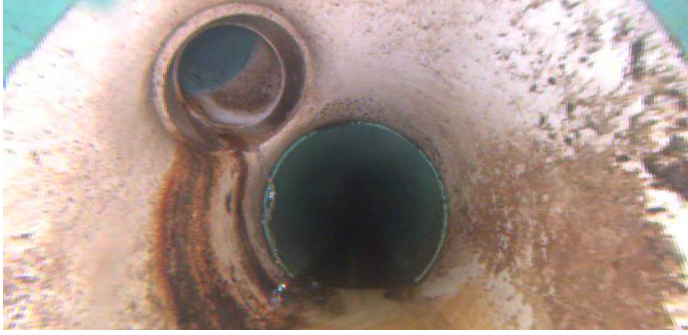
Code: **TFA**
Description: **Tap Factory Active**

Distance (ft): **111.0**
Structural Grade: **0**
O&M Grade: **0**
Clock Start/From: **11**
Clock To:
1st Value: **4.000**
2nd Value:
Value Percent:
Continuous Index:
Within 8" of Joint: **YES**
Remarks:

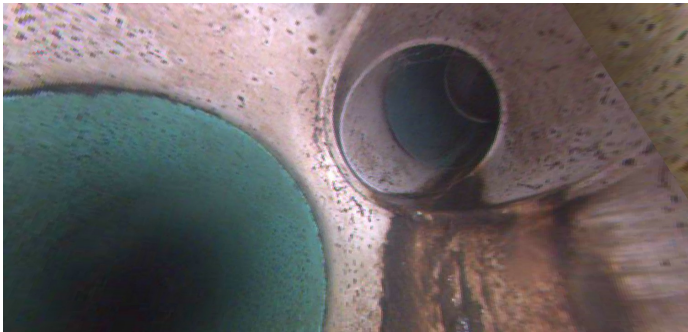
Code: **TF**
Description: **Tap Factory**

Distance (ft): **136.1**
Structural Grade: **0**
O&M Grade: **0**
Clock Start/From: **1**
Clock To:
1st Value: **4.000**
2nd Value:
Value Percent:
Continuous Index:
Within 8" of Joint: **YES**
Remarks:

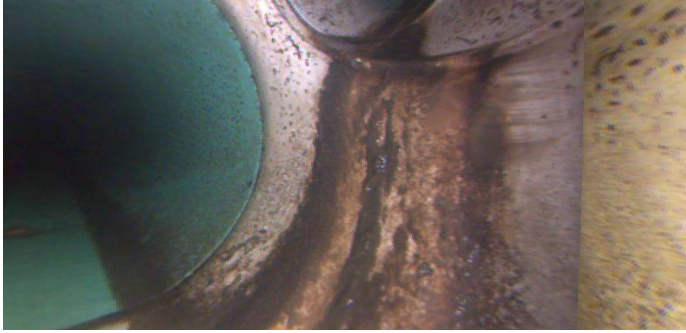
Code: **DAGS**
Description: **Deposits Attached Grease**

Distance (ft): **136.1**
Structural Grade: **0**
O&M Grade: **2**
Clock Start/From: **2**
Clock To: **5**
1st Value:
2nd Value:
Value Percent: **5.000**
Continuous Index:
Within 8" of Joint: **YES**
Remarks:

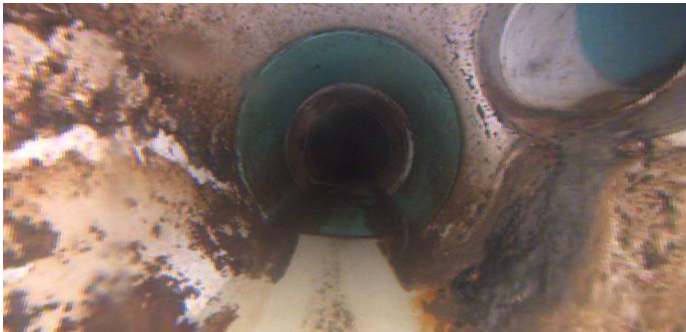
Code: **TF**
Description: **Tap Factory**

Distance (ft): **195.4**
Structural Grade: **0**
O&M Grade: **0**
Clock Start/From: **1**
Clock To:
1st Value: **4.000**
2nd Value:
Value Percent:
Continuous Index:
Within 8" of Joint: **YES**
Remarks:

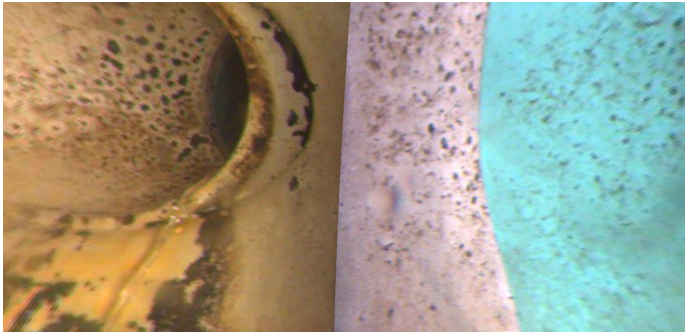
Code: **TFA**
Description: **Tap Factory Active**

Distance (ft): **198.7**
Structural Grade: **0**
O&M Grade: **0**
Clock Start/From: **10**
Clock To:
1st Value: **4.000**
2nd Value:
Value Percent:
Continuous Index:
Within 8" of Joint: **YES**
Remarks:

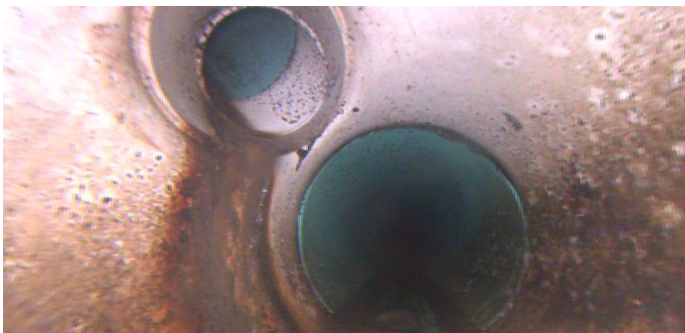
Code: **TF**
Description: **Tap Factory**

Distance (ft): **235.8**
Structural Grade: **0**
O&M Grade: **0**
Clock Start/From: **11**
Clock To:
1st Value: **4.000**
2nd Value:
Value Percent:
Continuous Index:
Within 8" of Joint: **YES**
Remarks:

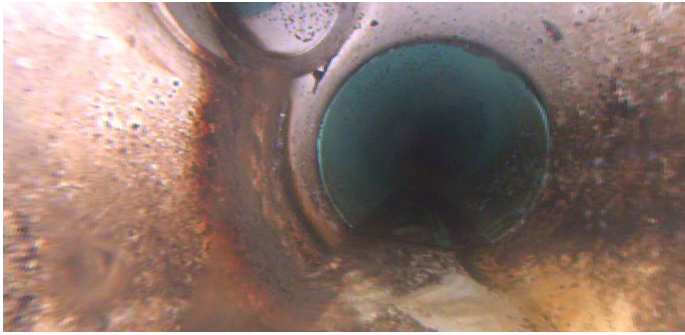
Code: **DAZ**
Description: **Deposits Attached Other**

Distance (ft): **235.8**
Structural Grade: **0**
O&M Grade: **2**
Clock Start/From: **7**
Clock To: **5**
1st Value:
2nd Value:
Value Percent: **5.000**
Continuous Index:
Within 8" of Joint: **NO**
Remarks:

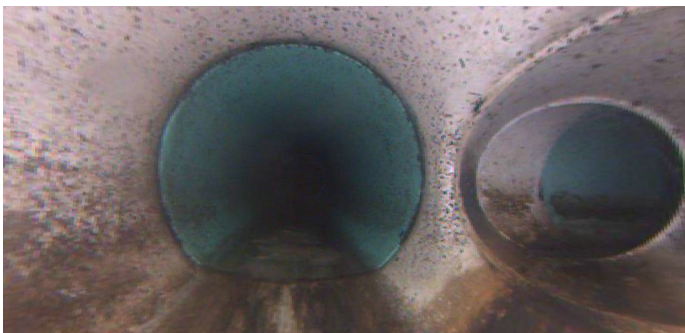
Code: **TF**
Description: **Tap Factory**

Distance (ft): **267.6**
Structural Grade: **0**
O&M Grade: **0**
Clock Start/From: **3**
Clock To:
1st Value: **4.000**
2nd Value:
Value Percent:
Continuous Index:
Within 8" of Joint: **YES**
Remarks:

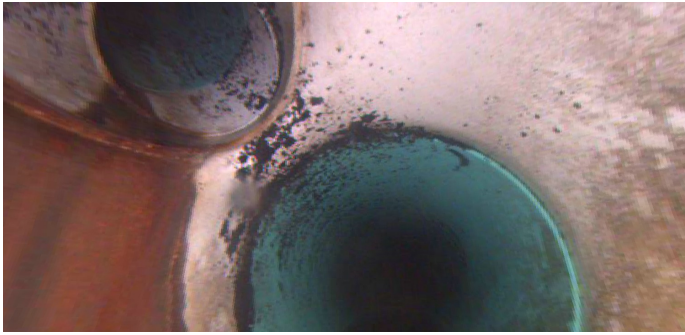
Code: **TF**
Description: **Tap Factory**

Distance (ft): **273.6**
Structural Grade: **0**
O&M Grade: **0**
Clock Start/From: **11**
Clock To:
1st Value: **4.000**
2nd Value:
Value Percent:
Continuous Index:
Within 8" of Joint: **YES**
Remarks:

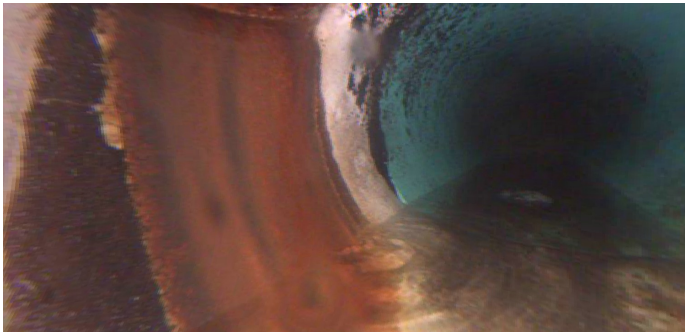
Code: **IS**
Description: **Infil Stain**

Distance (ft): **273.6**
Structural Grade: **0**
O&M Grade: **0**
Clock Start/From: **7**
Clock To: **10**
1st Value:
2nd Value:
Value Percent:
Continuous Index:
Within 8" of Joint:
Remarks:

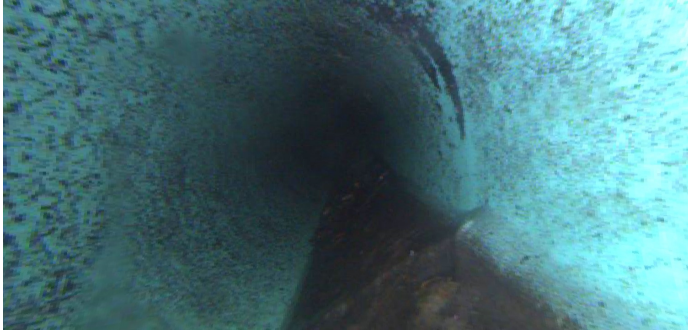
Code:	MSA
Description:	Abandoned Survey
Distance (ft):	276.1
Structural Grade:	0
O&M Grade:	0
Clock Start/From:	
Clock To:	
1st Value:	
2nd Value:	
Value Percent:	
Continuous Index:	
Within 8" of Joint:	NO
Remarks:	camera flipped
