Profile/Photo Observation Report

Street:	Colorado Street	Flow Control:	Not Controlled
City:	Hobart, IN	Year Renewed:	
Location:	Light Highway	Tape/Media #:	DEP 54
Purpose:	Routine Assessment	Dia/Height:	18"
Use:	Sanitary	Material:	VCP
Drain Area:		Lining:

US MH: **M-505-049** DS MH: **M-505-046** Total Length Surveyed (ft): **161.9**

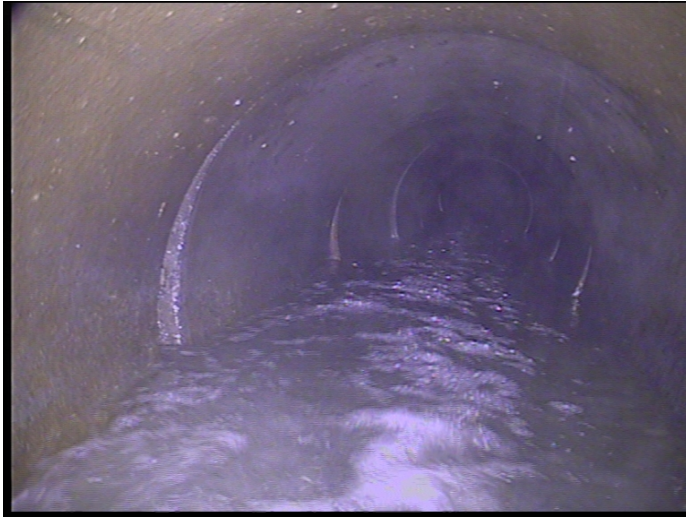
Code: **MWL**
Description: **Water Level**

Distance (ft): **.0**
Structural Grade: **0**
O&M Grade: **0**
Clock Start/From:
Clock To:
1st Value:
2nd Value:
Value Percent: **15.000**
Continuous Index:
Within 8" of Joint: **NO**
Remarks:
