Profile/Photo Observation Report

Street:	Colorado Street	Flow Control:	Not Controlled
City:	Hobart, IN	Year Renewed:	
Location:	Light Highway	Tape/Media #:	DEP 54
Purpose:	Routine Assessment	Dia/Height:	18"
Use:	Sanitary	Material:	VCP
Drain Area:		Lining:

US MH: **M-505-049** DS MH: **M-505-046** Total Length Surveyed (ft): **161.9**

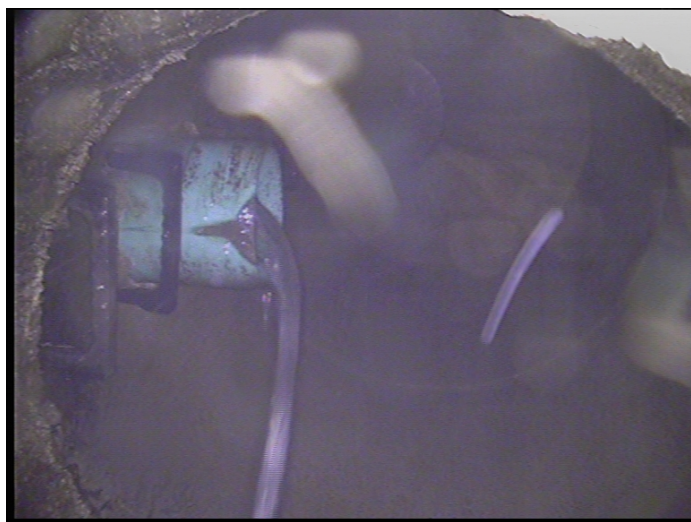
Code: **AMH**
Description: **Manhole**

Distance (ft): **.0**
Structural Grade: **0**
O&M Grade: **0**
Clock Start/From:
Clock To:
1st Value:
2nd Value:
Value Percent:
Continuous Index:
Within 8" of Joint: **NO**
Remarks: **M-505-049**

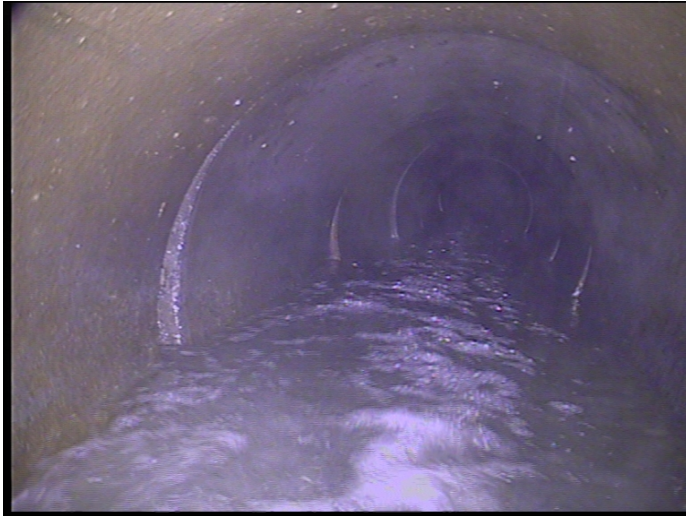
Code: **MWL**
Description: **Water Level**

Distance (ft): **.0**
Structural Grade: **0**
O&M Grade: **0**
Clock Start/From:
Clock To:
1st Value:
2nd Value:
Value Percent: **15.000**
Continuous Index:
Within 8" of Joint: **NO**
Remarks:

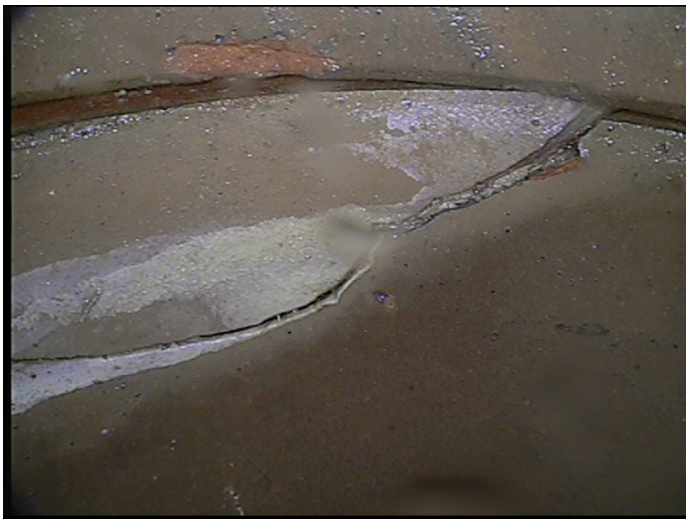
Code: **FC**
Description: **Fracture Circumferential**

Distance (ft): **99.8**
Structural Grade: **2**
O&M Grade: **0**
Clock Start/From: **8**
Clock To: **11**
1st Value:
2nd Value:
Value Percent:
Continuous Index:
Within 8" of Joint: **YES**
Remarks:

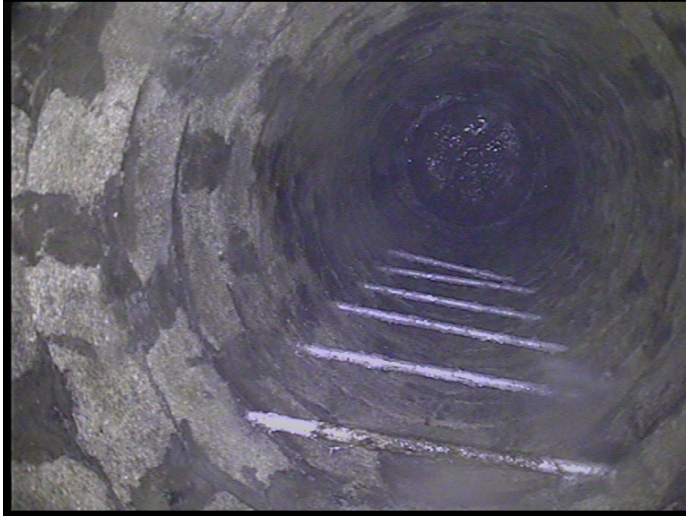
Code:	AMH
Description:	Manhole
Distance (ft):	161.9
Structural Grade:	0
O&M Grade:	0
Clock Start/From:	
Clock To:	
1st Value:	
2nd Value:	
Value Percent:	
Continuous Index:	
Within 8" of Joint:	NO
Remarks:	M-505-046
