## Profile/Photo Observation Report

Date:	<b>04/21/2018</b>	Weather:		Coding:	<b>PACP 6.0</b>
Pipe Length (ft):	<b>175.3</b>	Owner:	<b>NA</b>	Pre Clean:	<b>No Pre-Cleaning</b>
P.O.#:		Surveyor:	<b>Erik Redinger</b>	PSR:	<b>P-505-053.1-053.2</b>
Customer:		Clean Date:	<b>01/01/1900</b>	Shape:	<b>C</b>

Street:	<b>S COLORADO ST</b>	Flow Control:	<b>Not Controlled</b>
City:	<b>Hobart, IN</b>	Year Renewed:	
Location:	<b>Light Highway</b>	Tape/Media #:	
Purpose:	<b>Routine Assessment</b>	Dia/Height:	<b>10"</b>
Use:	<b>Sanitary</b>	Material:	<b>VCP</b>
Drain Area:	<b>NA</b>	Lining:	
Category:	<b>NA</b>		
Comment:	<b>MH_F at 33 ft false 2nd attempt . Flow direction wrong</b>		
Location Details:		Direction of Survey:	<b>Downstream</b>
US MH:	<b>M-505-053.2</b>	DS MH:	<b>M-505-053.1</b>
		Total Length Surveyed (ft):	<b>34.4</b>

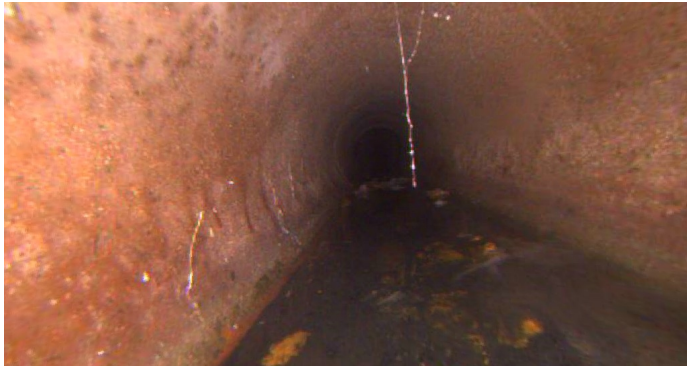
Code: **AMH**  
Description: **Manhole**

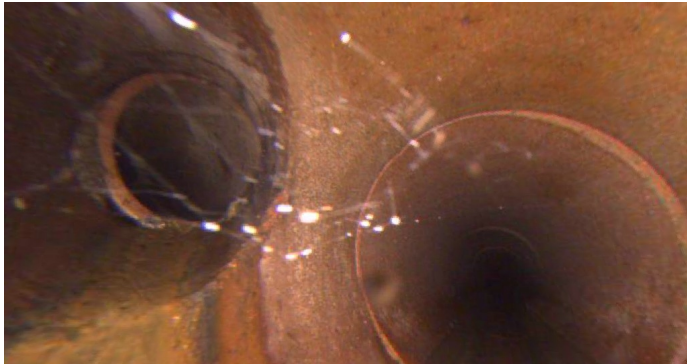
Code: **MWL**  
Description: **Water Level**

Distance (ft): **.0**  
Structural Grade: **0**  
O&M Grade: **0**  
Clock Start/From:  
Clock To:  
1st Value:  
2nd Value:  
Value Percent: **10.000**  
Continuous Index:  
Within 8" of Joint: **NO**  
Remarks:

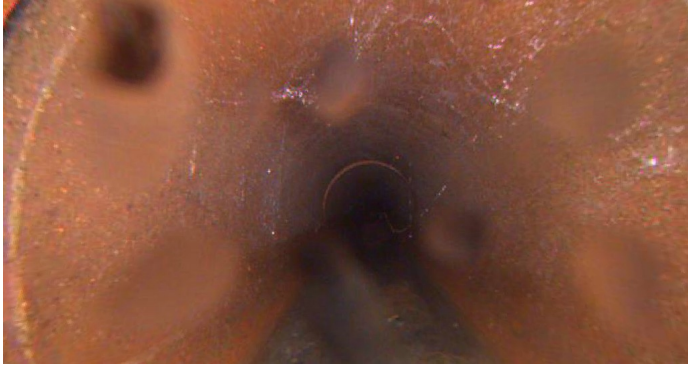
Code: **TF**  
Description: **Tap Factory**

Distance (ft): **9.2**  
Structural Grade: **0**  
O&M Grade: **0**  
Clock Start/From: **10**  
Clock To:  
1st Value: **4.000**  
2nd Value:  
Value Percent:  
Continuous Index:  
Within 8" of Joint:  
Remarks:
