Profile/Photo Observation Report

| P.O.#: | 54-1 | Surveyor: | M. Pielacha | PSR: | M-505-054-M-505-052 |

| Street: | Colorado Street | Flow Control: | Not Controlled |

US MH: **M-505-054** DS MH: **M-505-052** Total Length Surveyed (ft): **154.5**

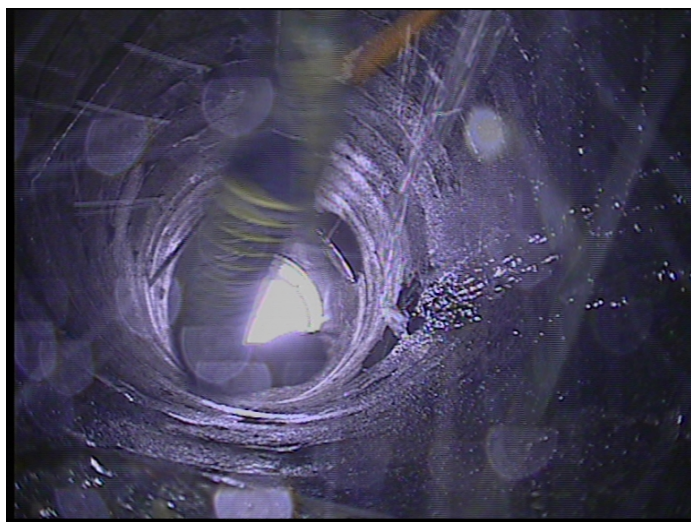
Code: **AMH**
Description: **Manhole**

Distance (ft): **.0**
Structural Grade: **0**
O&M Grade: **0**
Clock Start/From:
Clock To:
1st Value:
2nd Value:
Value Percent:
Continuous Index:
Within 8" of Joint: **NO**
Remarks: **M-505-054**

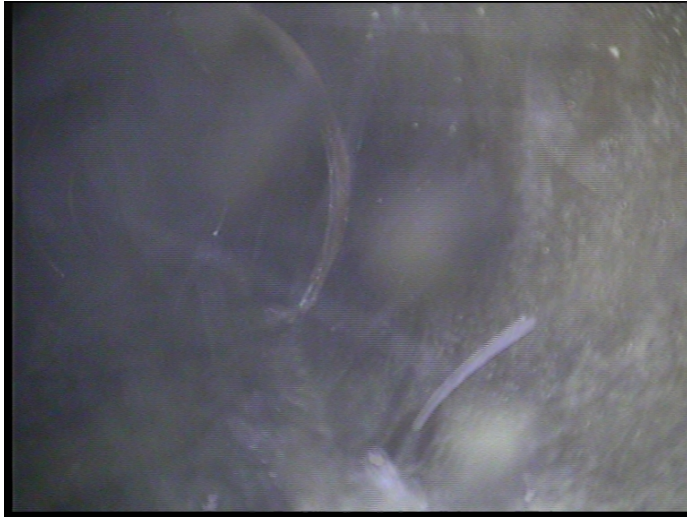
Code: **MWL**
Description: **Water Level**

Distance (ft): **.0**
Structural Grade: **0**
O&M Grade: **0**
Clock Start/From:
Clock To:
1st Value:
2nd Value:
Value Percent: **10.000**
Continuous Index:
Within 8" of Joint: **NO**
Remarks:

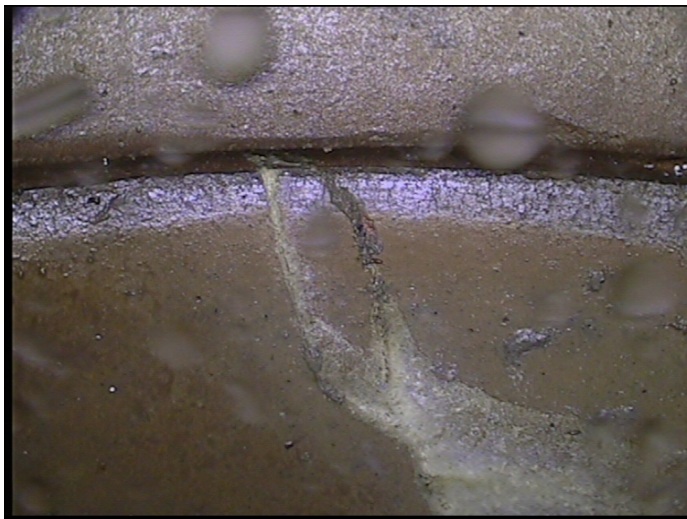
| | Position | Code | Observation | Video (sec) | Grade |
|--|---|---|---|---|---|
| | 48.6 | CL | Crack Longitudinal | 104 | S 2 |

Code: **CL**
Description: **Crack Longitudinal**

Distance (ft): **48.6**
Structural Grade: **2**
O&M Grade: **0**
Clock Start/From: **12**
Clock To:
1st Value:
2nd Value:
Value Percent:
Continuous Index:
Within 8" of Joint: **YES**
Remarks:

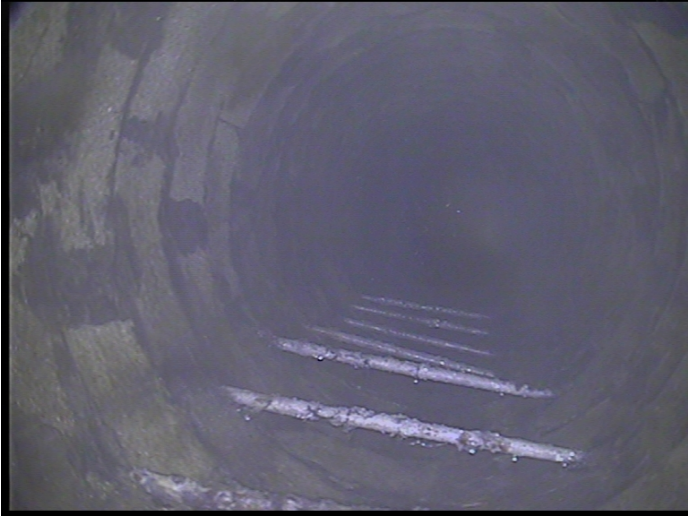
| Description: | Manhole |
| Distance (ft): | 154.5 |
| Remarks: | M-505-052 |
