Profile/Photo Observation Report

Date:	04/16/2018	Weather:		Coding:	PACP 6.0
Pipe Length (ft):		Owner:	City of Hobart	Pre Clean:	No Pre-Cleaning
P.O.#:	54-1	Surveyor:	M. Pielacha	PSR:	M-505-054-M-505-052
Customer:	City of Hobart	Clean Date:		Shape:	C

Street:	Colorado Street	Flow Control:	Not Controlled
City:	Hobart, IN	Year Renewed:	
Location:	Light Highway	Tape/Media #:	DEP 54
Purpose:	Routine Assessment	Dia/Height:	18"
Use:	Sanitary	Material:	VCP
Drain Area:		Lining:

US MH: **M-505-054** DS MH: **M-505-052** Total Length Surveyed (ft): **154.5**

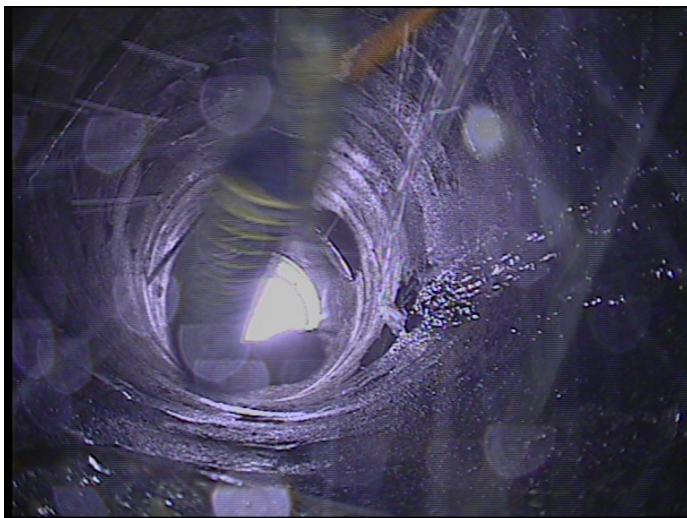
Code: **AMH**
 Description: **Manhole**

Distance (ft): **.0**
 Structural Grade: **0**
 O&M Grade: **0**
 Clock Start/From:
 Clock To:
 1st Value:
 2nd Value:
 Value Percent:
 Continuous Index:
 Within 8" of Joint: **NO**
 Remarks: **M-505-054**

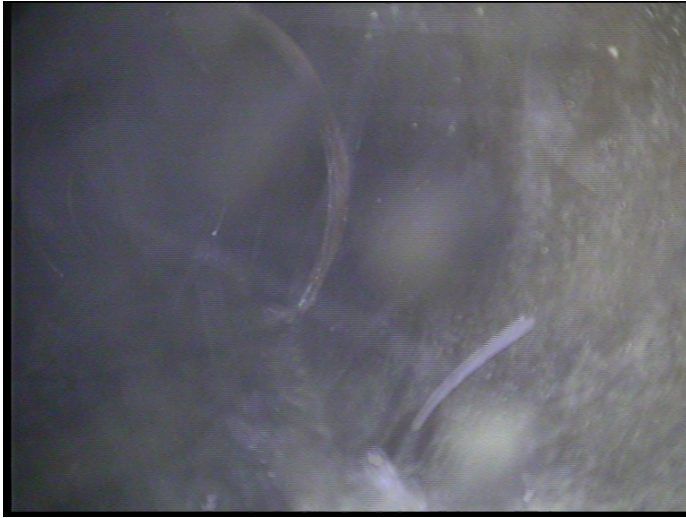
Code: **MWL**
Description: **Water Level**

Distance (ft): **.0**
Structural Grade: **0**
O&M Grade: **0**
Clock Start/From:
Clock To:
1st Value:
2nd Value:
Value Percent: **10.000**
Continuous Index:
Within 8" of Joint: **NO**
Remarks:

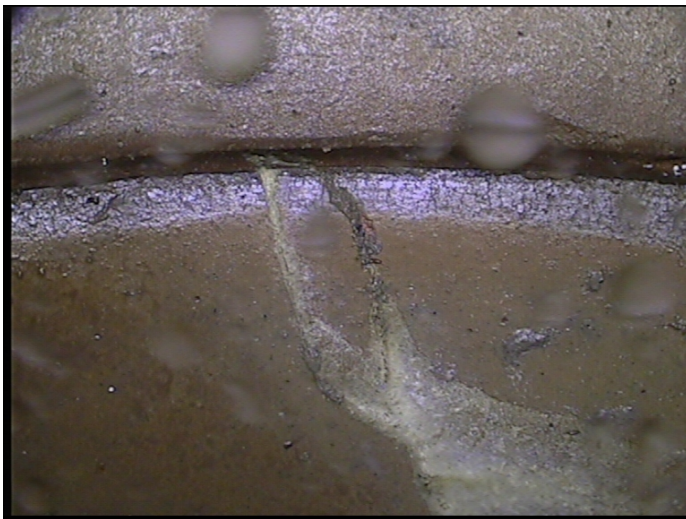
Code: **CL**
Description: **Crack Longitudinal**

Distance (ft): **48.6**
Structural Grade: **2**
O&M Grade: **0**
Clock Start/From: **12**
Clock To:
1st Value:
2nd Value:
Value Percent:
Continuous Index:
Within 8" of Joint: **YES**
Remarks:

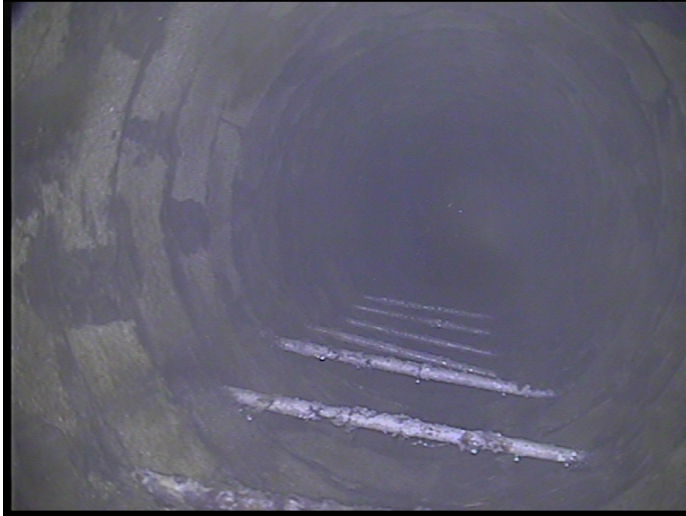
Code:	AMH
Description:	Manhole
Distance (ft):	154.5
Structural Grade:	0
O&M Grade:	0
Clock Start/From:	
Clock To:	
1st Value:	
2nd Value:	
Value Percent:	
Continuous Index:	
Within 8" of Joint:	NO
Remarks:	M-505-052
