Profile/Photo Observation Report

Street:	S COLORADO ST & W 2ND ST	Flow Control:	Not Controlled
City:	Hobart, IN	Year Renewed:	
Location:	Light Highway	Tape/Media #:	
Purpose:	Routine Assessment	Dia/Height:	12"
Use:	Sanitary	Material:	VCP
Drain Area:	NA	Lining:	
Category:	NA		
Comment:

Location Details:		Direction of Survey:	Upstream
US MH:	M-505-054	DS MH:	M-505-053.2
		Total Length Surveyed (ft):	212.6

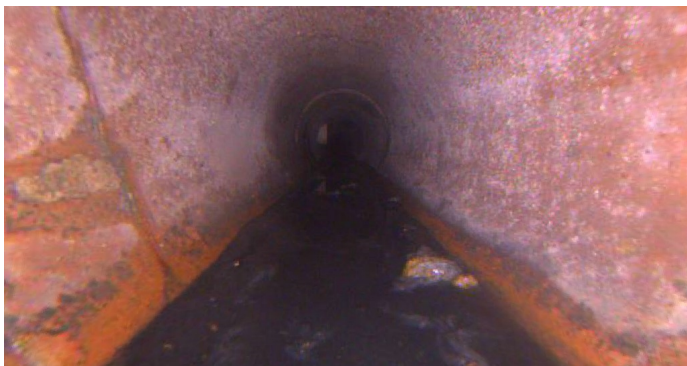
Code: **AMH**
 Description: **Manhole**

Distance (ft): **.0**
 Structural Grade: **0**
 O&M Grade: **0**
 Clock Start/From:
 Clock To:
 1st Value:
 2nd Value:
 Value Percent:
 Continuous Index:
 Within 8" of Joint: **NO**
 Remarks: **M-505-053.2**

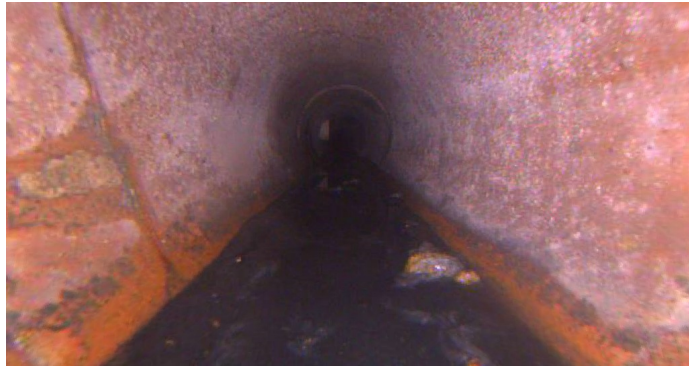
Code: **MWL**
Description: **Water Level**

Distance (ft): **.0**
Structural Grade: **0**
O&M Grade: **0**
Clock Start/From:
Clock To:
1st Value:
2nd Value:
Value Percent: **10.000**
Continuous Index:
Within 8" of Joint: **NO**
Remarks:

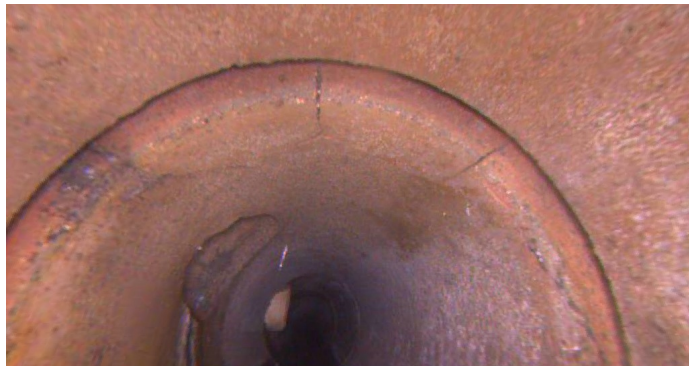
Code: **CM**
Description: **Crack Multiple**

Distance (ft): **4.0**
Structural Grade: **3**
O&M Grade: **0**
Clock Start/From: **7**
Clock To: **5**
1st Value:
2nd Value:
Value Percent:
Continuous Index:
Within 8" of Joint: **YES**
Remarks:

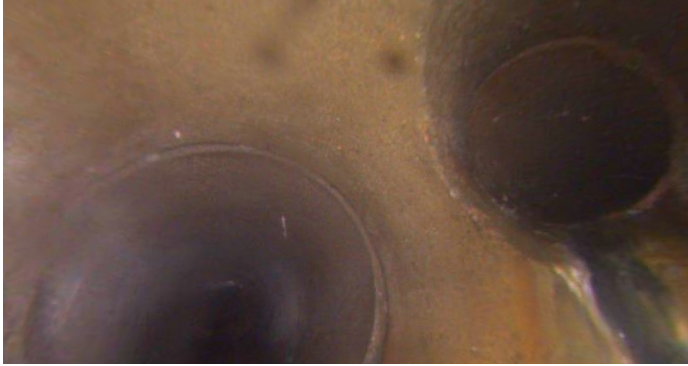
Code: **TF**
Description: **Tap Factory**

Distance (ft): **5.6**
Structural Grade: **0**
O&M Grade: **0**
Clock Start/From: **10**
Clock To:
1st Value: **4.000**
2nd Value:
Value Percent:
Continuous Index:
Within 8" of Joint:
Remarks:

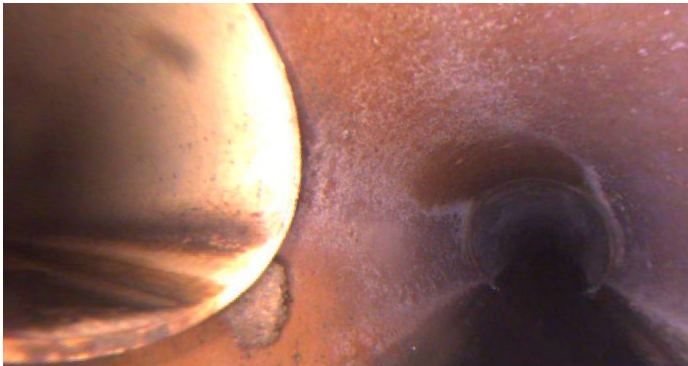
Code: **TBI**
Description: **Tap Break-in Intruding**

Distance (ft): **7.6**
Structural Grade: **0**
O&M Grade: **2**
Clock Start/From: **8**
Clock To:
1st Value: **4.000**
2nd Value: **3.000**
Value Percent:
Continuous Index:
Within 8" of Joint:
Remarks:

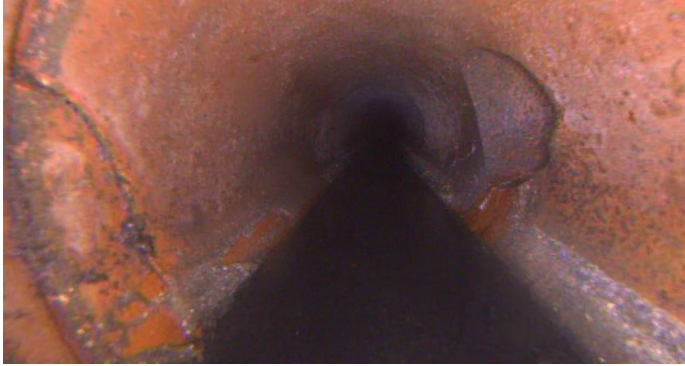
Code: **CS**
Description: **Crack Spiral**

Distance (ft): **35.2**
Structural Grade: **2**
O&M Grade: **0**
Clock Start/From: **7**
Clock To: **10**
1st Value:
2nd Value:
Value Percent:
Continuous Index:
Within 8" of Joint: **YES**
Remarks:

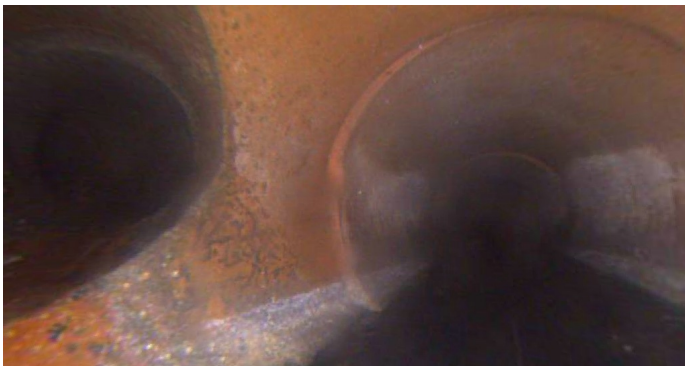
Code: **TF**
Description: **Tap Factory**

Distance (ft): **36.5**
Structural Grade: **0**
O&M Grade: **0**
Clock Start/From: **4**
Clock To:
1st Value: **4.000**
2nd Value:
Value Percent:
Continuous Index:
Within 8" of Joint:
Remarks:

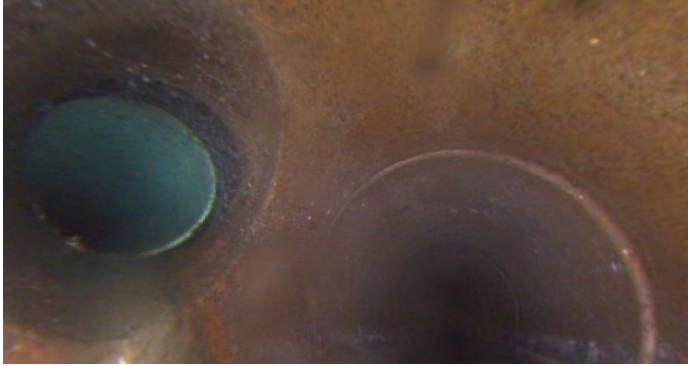
Code: **TF**
Description: **Tap Factory**

Distance (ft): **86.0**
Structural Grade: **0**
O&M Grade: **0**
Clock Start/From: **3**
Clock To:
1st Value: **4.000**
2nd Value:
Value Percent:
Continuous Index:
Within 8" of Joint:
Remarks:

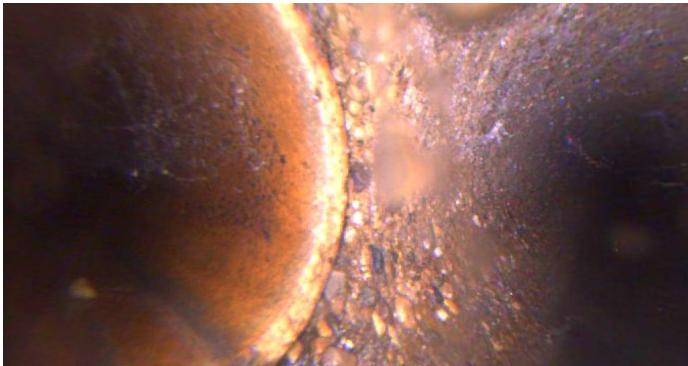
Code: **TB**
Description: **Tap Break-in**

Distance (ft): **111.7**
Structural Grade: **0**
O&M Grade: **0**
Clock Start/From: **8**
Clock To:
1st Value: **4.000**
2nd Value:
Value Percent:
Continuous Index:
Within 8" of Joint:
Remarks:

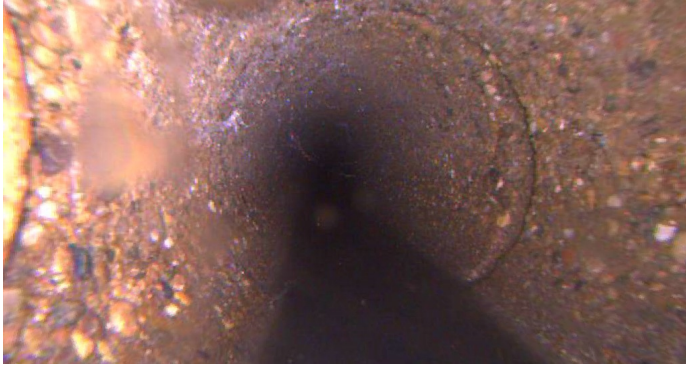
Code: **SAV**
Description: **Surface Aggregate Visible**

Distance (ft): **111.7**
Structural Grade: **3**
O&M Grade: **0**
Clock Start/From: **7**
Clock To: **5**
1st Value:
2nd Value:
Value Percent:
Continuous Index:
Within 8" of Joint:
Remarks:

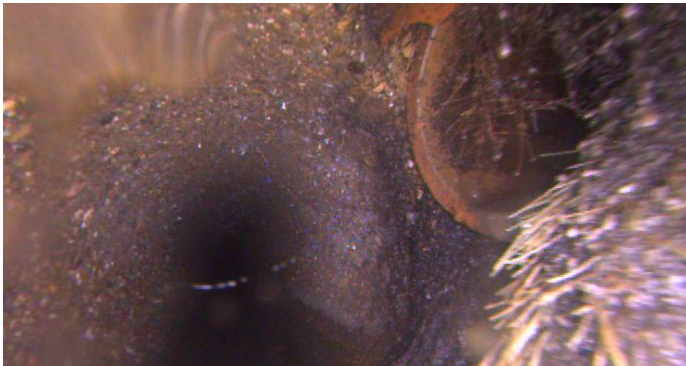
Code: **TBD**
Description: **Tap Break-in Defective**

Distance (ft): **119.0**
Structural Grade: **0**
O&M Grade: **3**
Clock Start/From: **2**
Clock To:
1st Value: **4.000**
2nd Value:
Value Percent:
Continuous Index:
Within 8" of Joint:
Remarks: **RFL**

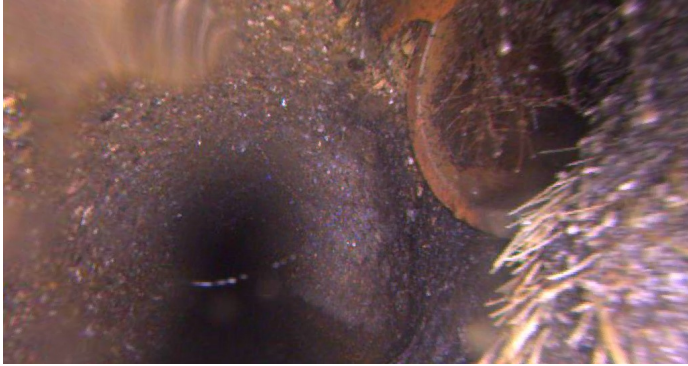
Code: **RFL**
Description: **Roots Fine Lateral**

Distance (ft): **119.0**
Structural Grade: **0**
O&M Grade: **1**
Clock Start/From: **2**
Clock To:
1st Value:
2nd Value:
Value Percent:
Continuous Index:
Within 8" of Joint: **NO**
Remarks:

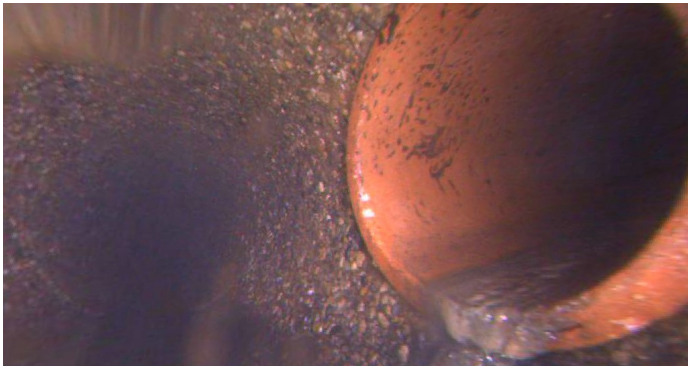
Code: **TB**
Description: **Tap Break-in**

Distance (ft): **164.2**
Structural Grade: **0**
O&M Grade: **0**
Clock Start/From: **3**
Clock To:
1st Value: **4.000**
2nd Value:
Value Percent:
Continuous Index:
Within 8" of Joint:
Remarks:

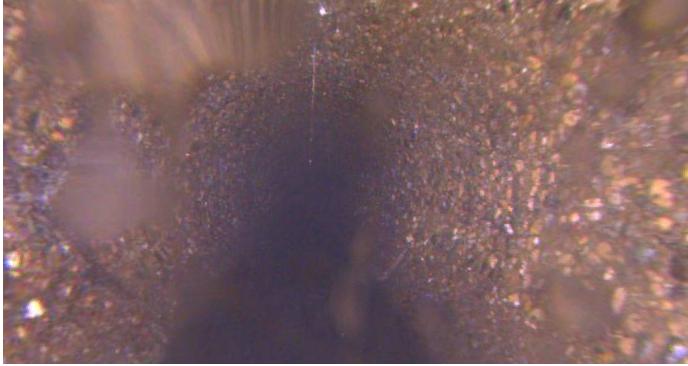
Code: **SAV**
Description: **Surface Aggregate Visible**

Distance (ft): **167.7**
Structural Grade: **3**
O&M Grade: **0**
Clock Start/From: **7**
Clock To: **5**
1st Value:
2nd Value:
Value Percent:
Continuous Index:
Within 8" of Joint: **NO**
Remarks:

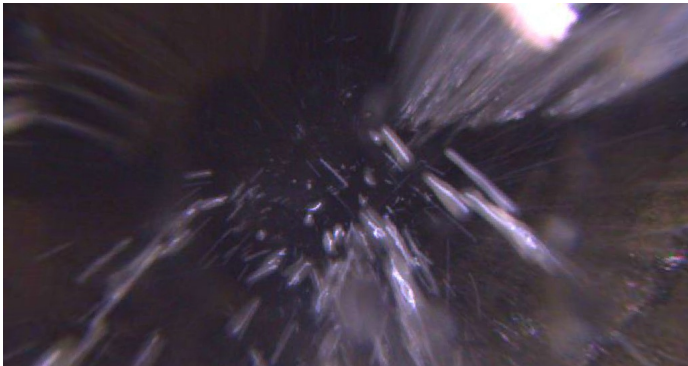
Code: **AMH**
Description: **Manhole**

Distance (ft): **212.6**
Structural Grade: **0**
O&M Grade: **0**
Clock Start/From:
Clock To:
1st Value:
2nd Value:
Value Percent:
Continuous Index:
Within 8" of Joint: **NO**
Remarks: **M-505-054**
