Profile/Photo Observation Report

Street:	FOXCROFT STREET	Flow Control:	Not Controlled
City:	Hobart, IN	Year Renewed:	
Location:	Light Highway	Tape/Media #:	
Purpose:	Routine Assessment	Dia/Height:	12"
Use:	Sanitary	Material:	VCP
Drain Area:	NA	Lining:	
Category:	NA		
Comment:

Location Details:		Direction of Survey:	Upstream
US MH:	M-505-054	DS MH:	M-505-053.2
		Total Length Surveyed (ft):	212.6

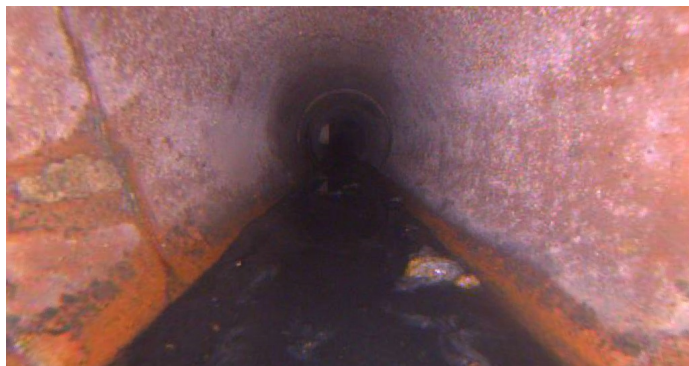
Code: **AMH**
Description: **Manhole**

Distance (ft): **.0**
Structural Grade: **0**
O&M Grade: **0**
Clock Start/From:
Clock To:
1st Value:
2nd Value:
Value Percent:
Continuous Index:
Within 8" of Joint: **NO**
Remarks: **M-505-053.2**

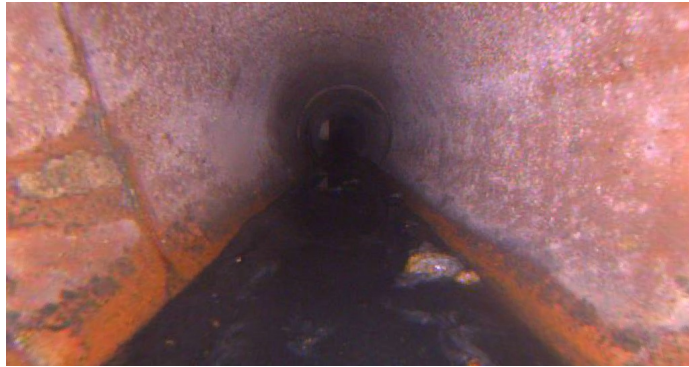
Code: **MWL**
Description: **Water Level**

Distance (ft): **.0**
Structural Grade: **0**
O&M Grade: **0**
Clock Start/From:
Clock To:
1st Value:
2nd Value:
Value Percent: **10.000**
Continuous Index:
Within 8" of Joint: **NO**
Remarks:

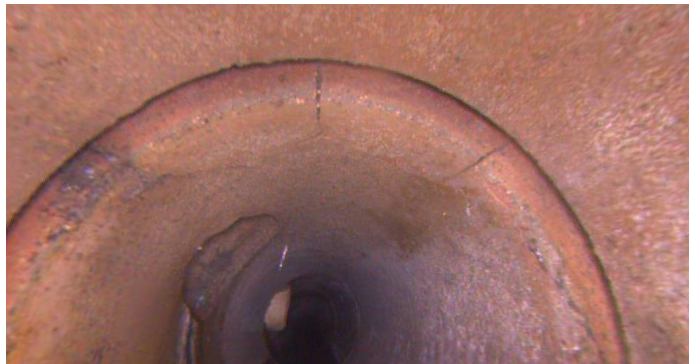
Code: **CM**
Description: **Crack Multiple**

Distance (ft): **4.0**
Structural Grade: **3**
O&M Grade: **0**
Clock Start/From: **7**
Clock To: **5**
1st Value:
2nd Value:
Value Percent:
Continuous Index:
Within 8" of Joint: **YES**
Remarks:

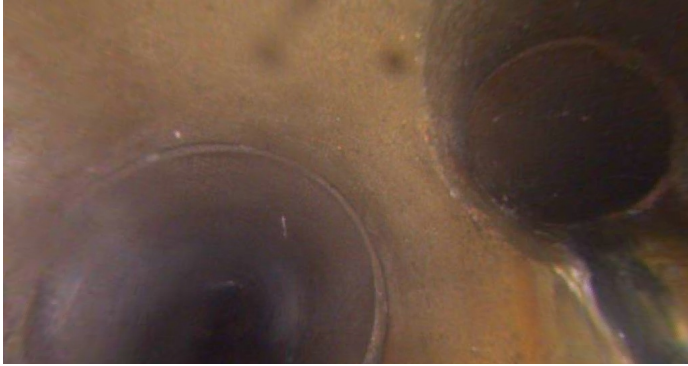
Code: **TF**
Description: **Tap Factory**

Distance (ft): **5.6**
Structural Grade: **0**
O&M Grade: **0**
Clock Start/From: **10**
Clock To:
1st Value: **4.000**
2nd Value:
Value Percent:
Continuous Index:
Within 8" of Joint:
Remarks:

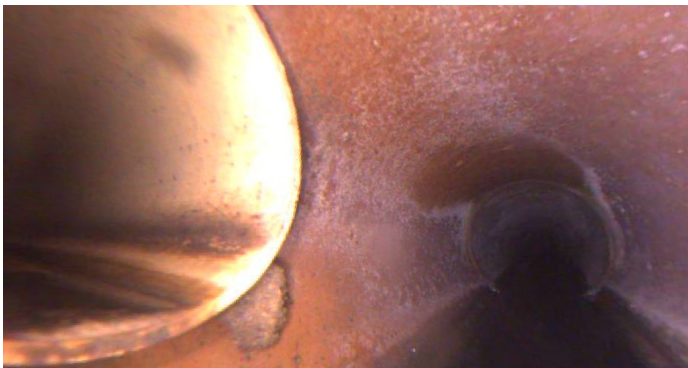
Code: **TBI**
Description: **Tap Break-in Intruding**

Distance (ft): **7.6**
Structural Grade: **0**
O&M Grade: **2**
Clock Start/From: **8**
Clock To:
1st Value: **4.000**
2nd Value: **3.000**
Value Percent:
Continuous Index:
Within 8" of Joint:
Remarks:

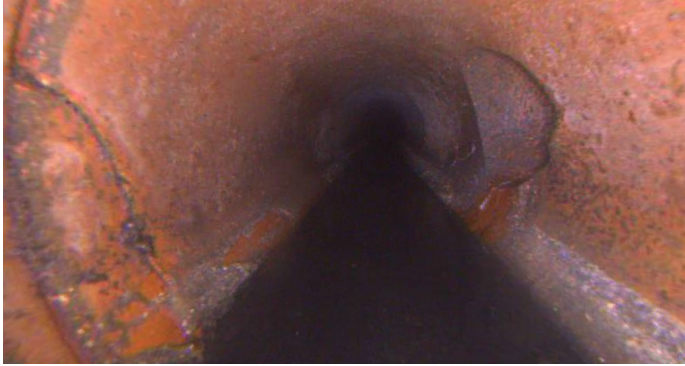
Code: **CS**
Description: **Crack Spiral**

Distance (ft): **35.2**
Structural Grade: **2**
O&M Grade: **0**
Clock Start/From: **7**
Clock To: **10**
1st Value:
2nd Value:
Value Percent:
Continuous Index:
Within 8" of Joint: **YES**
Remarks:

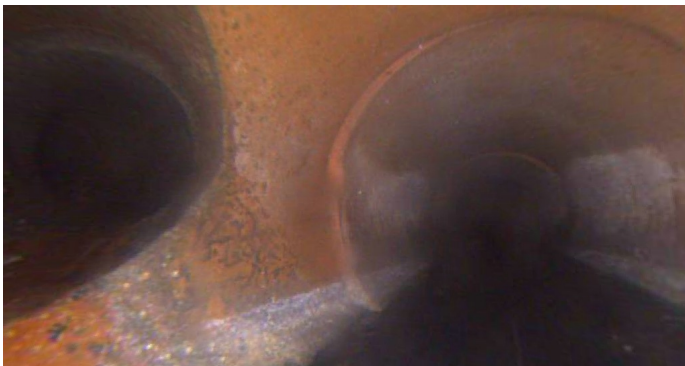
Code: **TF**
Description: **Tap Factory**

Distance (ft): **36.5**
Structural Grade: **0**
O&M Grade: **0**
Clock Start/From: **4**
Clock To:
1st Value: **4.000**
2nd Value:
Value Percent:
Continuous Index:
Within 8" of Joint:
Remarks:

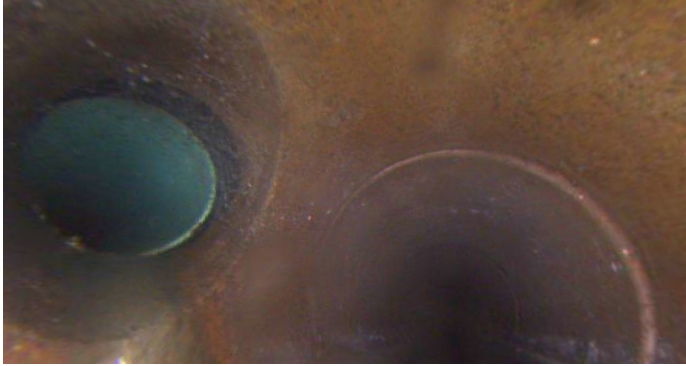
Code: **TF**
Description: **Tap Factory**

Distance (ft): **86.0**
Structural Grade: **0**
O&M Grade: **0**
Clock Start/From: **3**
Clock To:
1st Value: **4.000**
2nd Value:
Value Percent:
Continuous Index:
Within 8" of Joint:
Remarks:

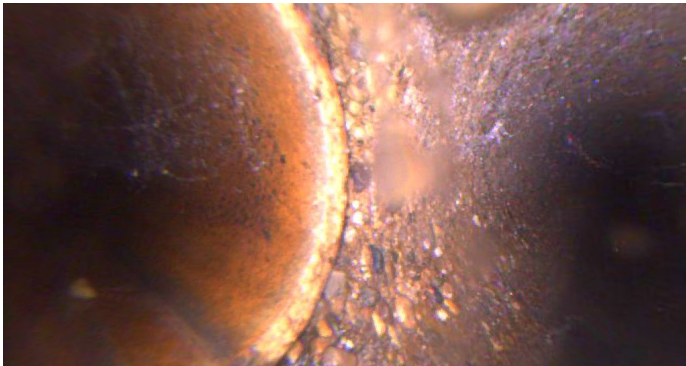
Code: **TB**
Description: **Tap Break-in**

Distance (ft): **111.7**
Structural Grade: **0**
O&M Grade: **0**
Clock Start/From: **8**
Clock To:
1st Value: **4.000**
2nd Value:
Value Percent:
Continuous Index:
Within 8" of Joint:
Remarks:

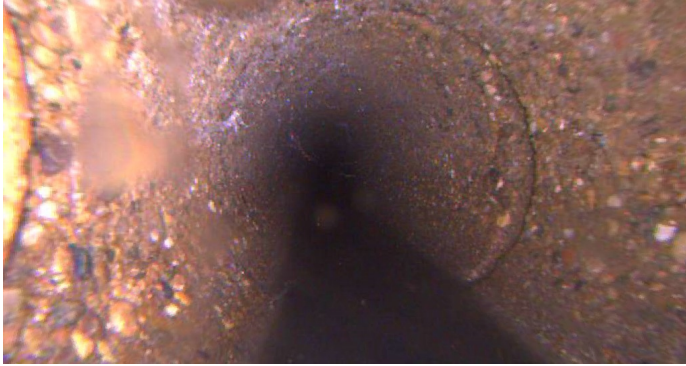
Code: **SAV**
Description: **Surface Aggregate Visible**

Distance (ft): **111.7**
Structural Grade: **3**
O&M Grade: **0**
Clock Start/From: **7**
Clock To: **5**
1st Value:
2nd Value:
Value Percent:
Continuous Index:
Within 8" of Joint:
Remarks:

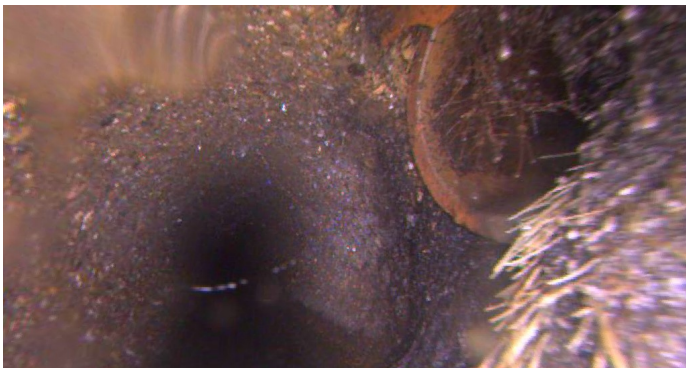
Code: **TBD**
Description: **Tap Break-in Defective**

Distance (ft): **119.0**
Structural Grade: **0**
O&M Grade: **3**
Clock Start/From: **2**
Clock To:
1st Value: **4.000**
2nd Value:
Value Percent:
Continuous Index:
Within 8" of Joint:
Remarks: **RFL**

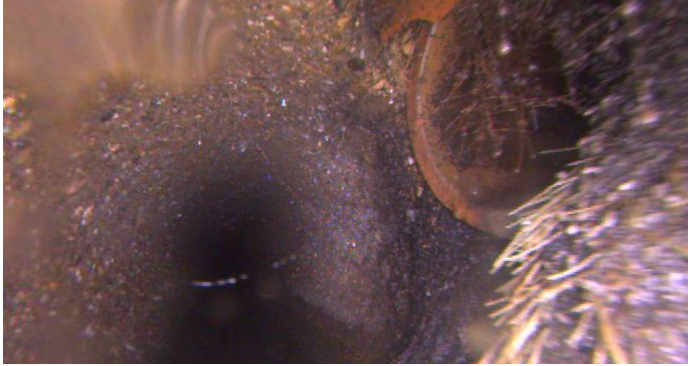
Code: **RFL**
Description: **Roots Fine Lateral**

Distance (ft): **119.0**
Structural Grade: **0**
O&M Grade: **1**
Clock Start/From: **2**
Clock To:
1st Value:
2nd Value:
Value Percent:
Continuous Index:
Within 8" of Joint: **NO**
Remarks:

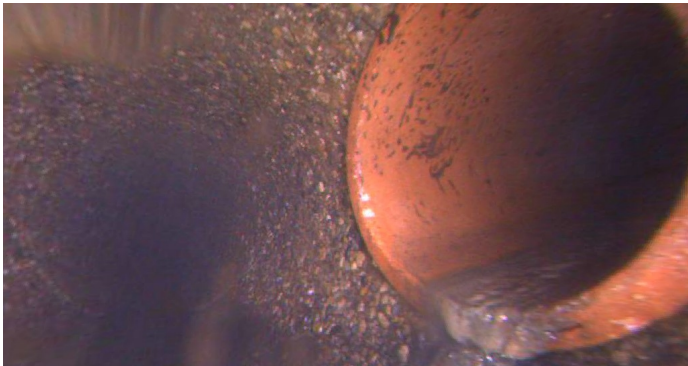
Code: **TB**
Description: **Tap Break-in**

Distance (ft): **164.2**
Structural Grade: **0**
O&M Grade: **0**
Clock Start/From: **3**
Clock To:
1st Value: **4.000**
2nd Value:
Value Percent:
Continuous Index:
Within 8" of Joint:
Remarks:

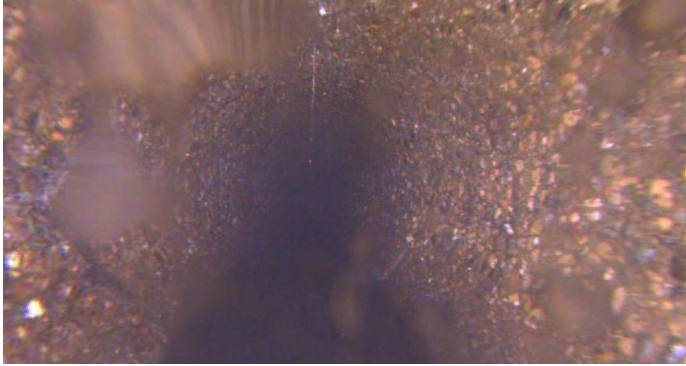
Code: **SAV**
Description: **Surface Aggregate Visible**

Distance (ft): **167.7**
Structural Grade: **3**
O&M Grade: **0**
Clock Start/From: **7**
Clock To: **5**
1st Value:
2nd Value:
Value Percent:
Continuous Index:
Within 8" of Joint: **NO**
Remarks:

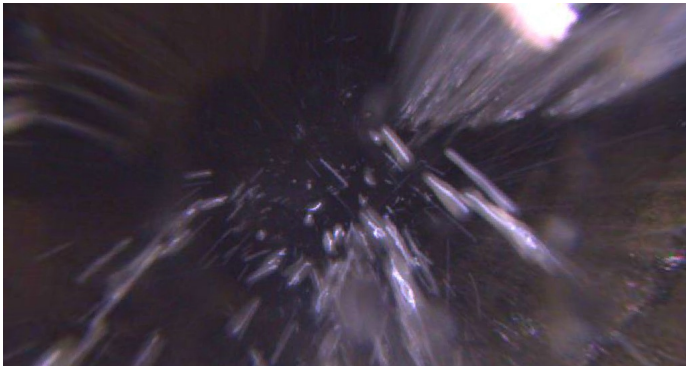
Code: **AMH**
Description: **Manhole**

Distance (ft): **212.6**
Structural Grade: **0**
O&M Grade: **0**
Clock Start/From:
Clock To:
1st Value:
2nd Value:
Value Percent:
Continuous Index:
Within 8" of Joint: **NO**
Remarks: **M-505-054**
