# Profile/Photo Observation Report

Date:	11/02/2021	Weather:		Coding:	PACP 7.0
Pipe Length (ft):	291.8	Owner:	City of Hobart	Pre Clean:	Heavy Cleaning
P.O.#:	YES502259	Surveyor:	S. Bucklin	PSR:	P-505-059-054
Customer:	City of Hobart	Clean Date:	10/28/2021	Shape:	C

Street:	West 2nd Street	Flow Control:	Not Controlled
City:	Hobart, IN	Year Renewed:	
Location:	Local rural streets with light traffic, t	Tape/Media #:	
Purpose:	Routine Assessment	Dia/Height:	10"
Use:	Sanitary Sewage Pipe	Material:	VCP
Drain Area:		Lining:	None
Category:	NA		
Comment:			
Location Details:		Direction of Survey:	Downstream
US MH:	M-505-059	DS MH:	M-505-054
		Total Length Surveyed (ft):	291.8

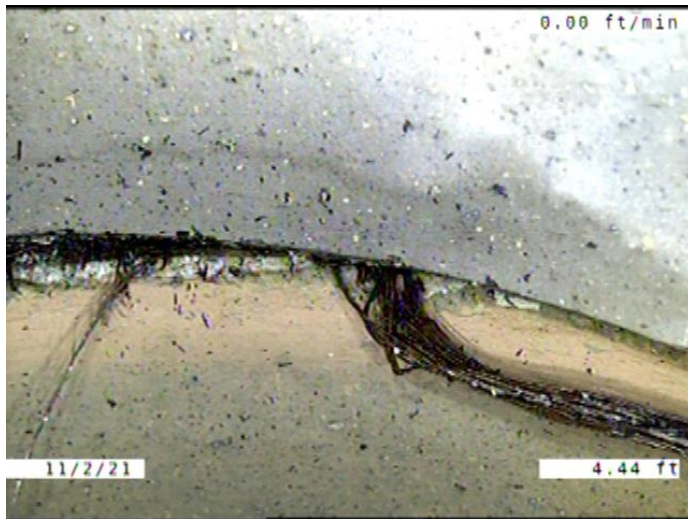
Code: **RFJ**  
 Description: **Roots Fine Joint**

Distance (ft): **4.4**  
 Structural Grade: **0**  
 O&M Grade: **1**  
 Clock Start/From: **11**  
 Clock To: **3**  
 1st Value:  
 2nd Value:  
 Value Percent:  
 Continuous Index:  
 Within 8" of Joint: **YES**  
 Remarks:

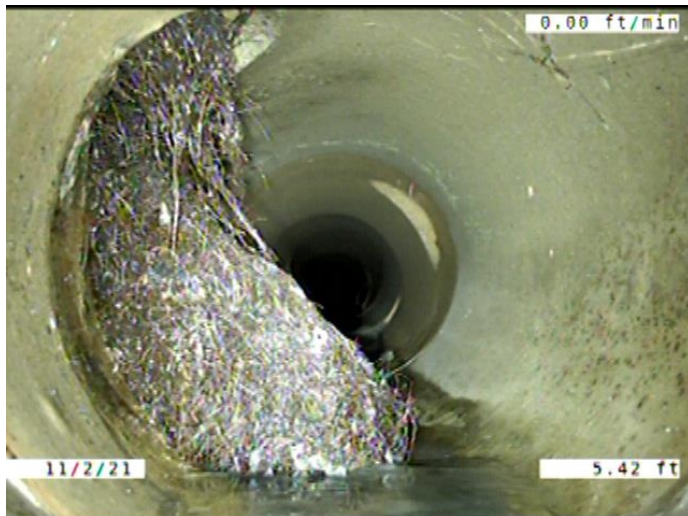
Code: **RML**  
 Description: **Roots Medium Lateral**

Distance (ft): **5.1**  
 Structural Grade: **0**  
 O&M Grade: **3**  
 Clock Start/From: **10**  
 Clock To: **11**  
 1st Value:  
 2nd Value:  
 Value Percent: **35.000**  
 Continuous Index:  
 Within 8" of Joint: **NO**  
 Remarks:

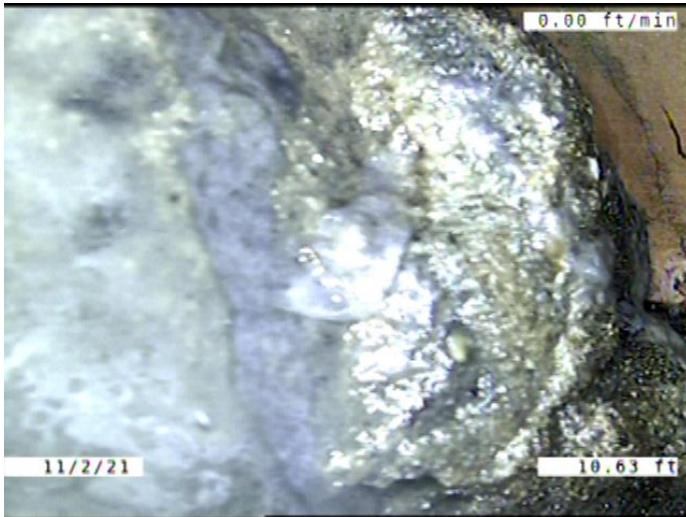
Code: **DAE**  
 Description: **Deposits Attached Encrustation**

Distance (ft): **10.6**  
 Structural Grade: **0**  
 O&M Grade: **2**  
 Clock Start/From: **4**  
 Clock To: **8**  
 1st Value:  
 2nd Value:  
 Value Percent: **5.000**  
 Continuous Index:  
 Within 8" of Joint: **YES**  
 Remarks:

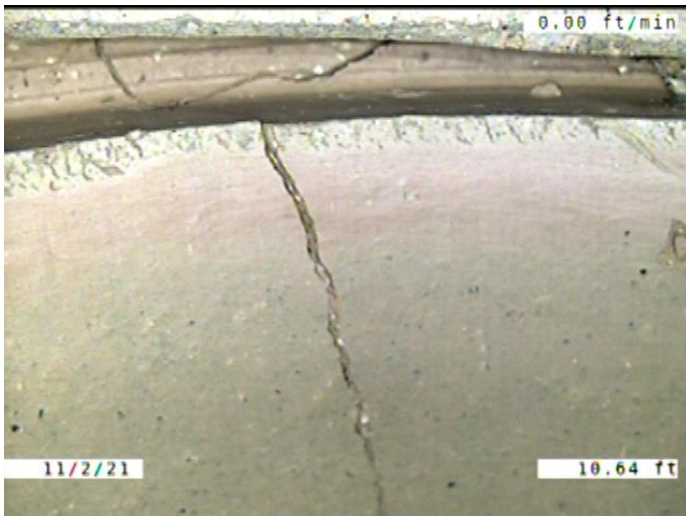
Code: **FM**  
 Description: **Fracture Multiple**

Distance (ft): **10.6**  
 Structural Grade: **4**  
 O&M Grade: **0**  
 Clock Start/From: **8**  
 Clock To: **4**  
 1st Value:  
 2nd Value:  
 Value Percent:  
 Continuous Index:  
 Within 8" of Joint: **YES**  
 Remarks:

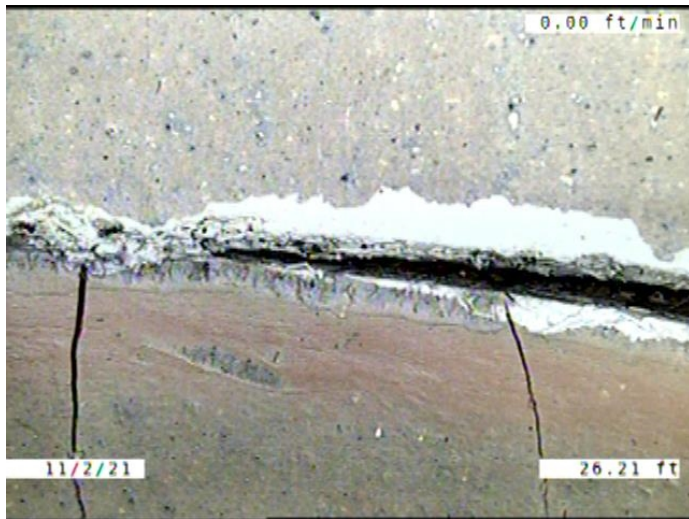
Code: **DAE**  
 Description: **Deposits Attached Encrustation**

Distance (ft): **26.2**  
 Structural Grade: **0**  
 O&M Grade: **2**  
 Clock Start/From: **9**  
 Clock To: **3**  
 1st Value:  
 2nd Value:  
 Value Percent: **5.000**  
 Continuous Index:  
 Within 8" of Joint: **YES**  
 Remarks:

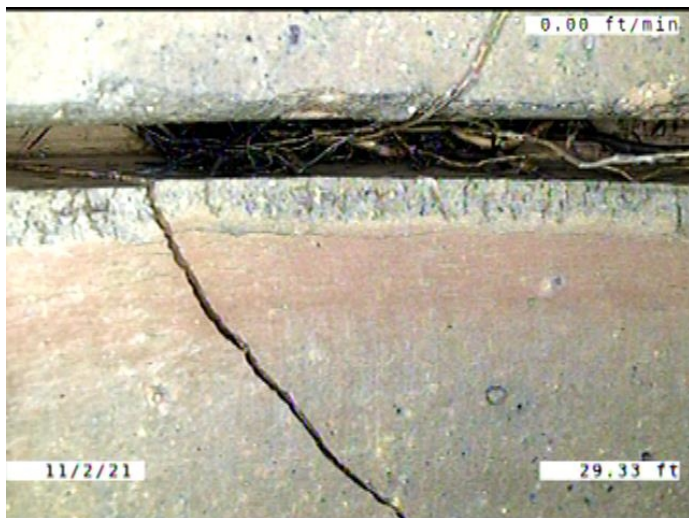
Code: **RFJ**  
 Description: **Roots Fine Joint**

Distance (ft): **29.3**  
 Structural Grade: **0**  
 O&M Grade: **1**  
 Clock Start/From: **9**  
 Clock To: **10**  
 1st Value:  
 2nd Value:  
 Value Percent:  
 Continuous Index:  
 Within 8" of Joint: **YES**  
 Remarks:

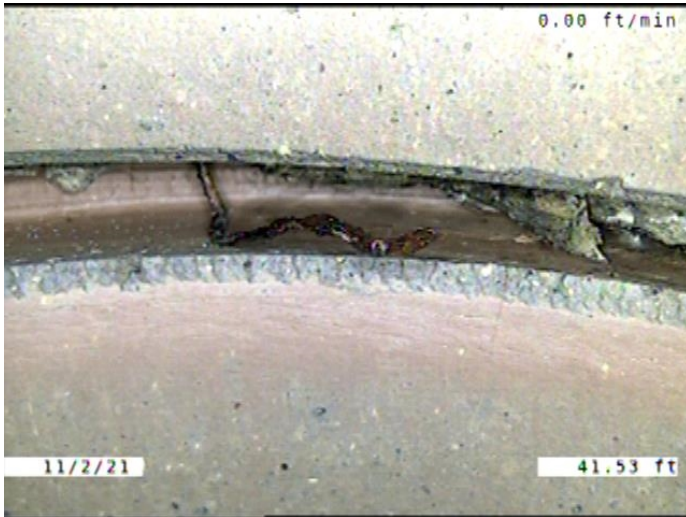
Code: **RFJ**  
Description: **Roots Fine Joint**

Distance (ft): **41.5**  
Structural Grade: **0**  
O&M Grade: **1**  
Clock Start/From: **1**  
Clock To:  
1st Value:  
2nd Value:  
Value Percent:  
Continuous Index:  
Within 8" of Joint: **YES**  
Remarks:

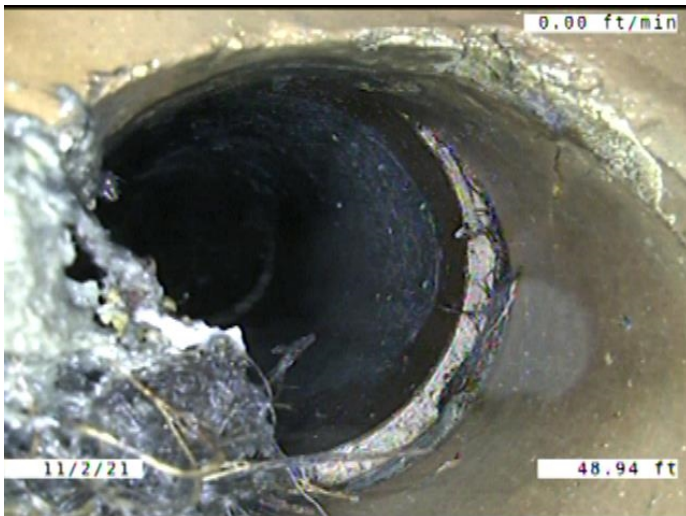
Code: **TFD**  
Description: **Tap Factory Defective**

Distance (ft): **48.9**  
Structural Grade: **0**  
O&M Grade: **3**  
Clock Start/From: **10**  
Clock To:  
1st Value: **4.000**  
2nd Value:  
Value Percent:  
Continuous Index:  
Within 8" of Joint: **YES**  
Remarks: **OFFSET. ROOTS GROWING FROM THE JOINT AND INTO THE MAIN**

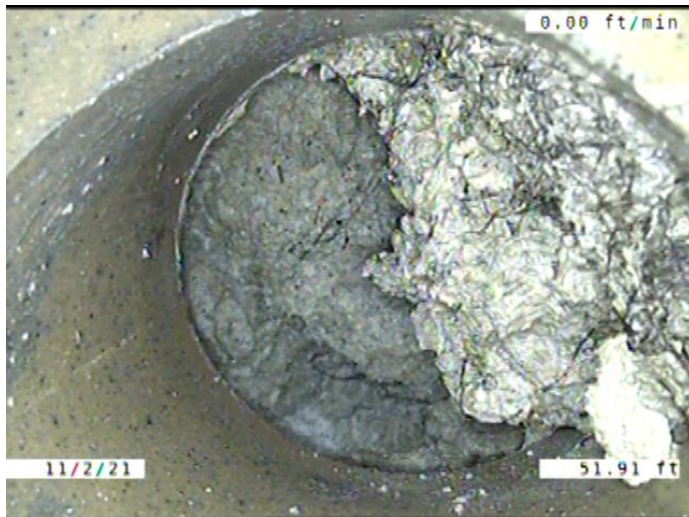
Code:	<b>TFD</b>
Description:	<b>Tap Factory Defective</b>
Distance (ft):	<b>51.9</b>
Structural Grade:	<b>0</b>
O&M Grade:	<b>3</b>
Clock Start/From:	<b>1</b>
Clock To:	
1st Value:	<b>4.000</b>
2nd Value:	
Value Percent:	
Continuous Index:	
Within 8" of Joint:	<b>YES</b>
Remarks:	<b>SOIL VISIBLE. ROOTS GROWING INTO THE TAP. LOOKS TO BE 100% P</b>

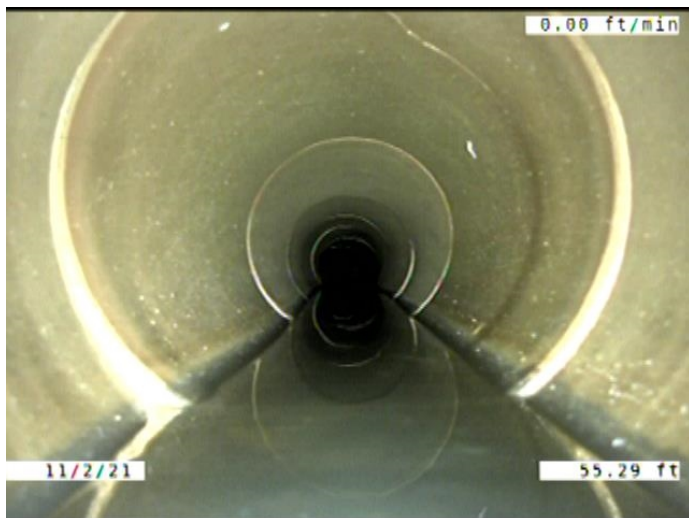
Code:	<b>MWLS</b>
Description:	<b>Miscellaneous Water Level Sag</b>
Distance (ft):	<b>55.3</b>
Structural Grade:	<b>2</b>
O&M Grade:	<b>0</b>
Clock Start/From:	
Clock To:	
1st Value:	
2nd Value:	
Value Percent:	<b>15.000</b>
Continuous Index:	<b>F01</b>
Within 8" of Joint:	<b>NO</b>
Remarks:

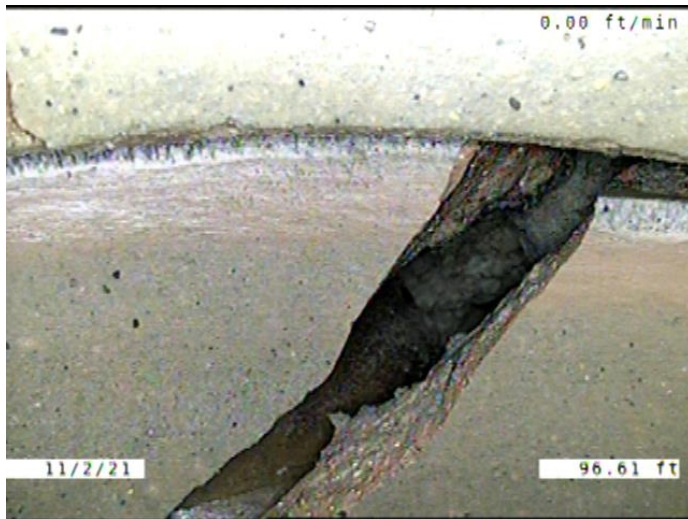
Code: **BSV**  
 Description: **Broken Soil Visible**

Distance (ft): **96.6**  
 Structural Grade: **5**  
 O&M Grade: **0**  
 Clock Start/From: **7**  
 Clock To: **11**  
 1st Value:  
 2nd Value:  
 Value Percent:  
 Continuous Index:  
 Within 8" of Joint: **YES**  
 Remarks:

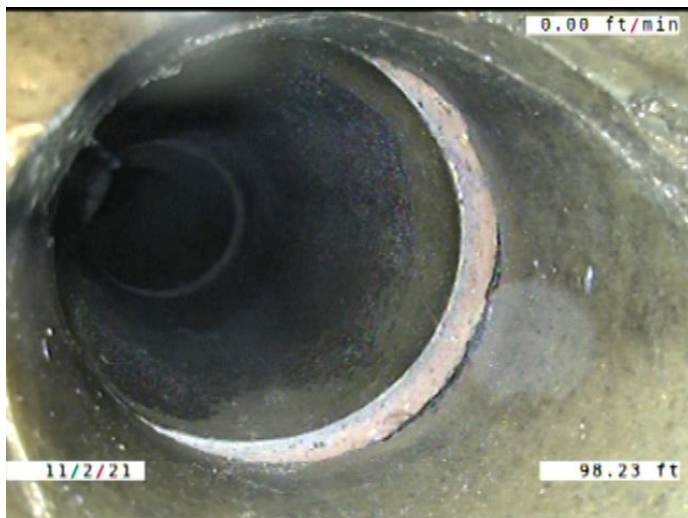
Code: **TFD**  
 Description: **Tap Factory Defective**

Distance (ft): **98.2**  
 Structural Grade: **0**  
 O&M Grade: **3**  
 Clock Start/From: **11**  
 Clock To:  
 1st Value: **4.000**  
 2nd Value:  
 Value Percent:  
 Continuous Index:  
 Within 8" of Joint: **YES**  
 Remarks: **BROKEN. OFFSET. CONSTANTLY RUNNING WATER.**

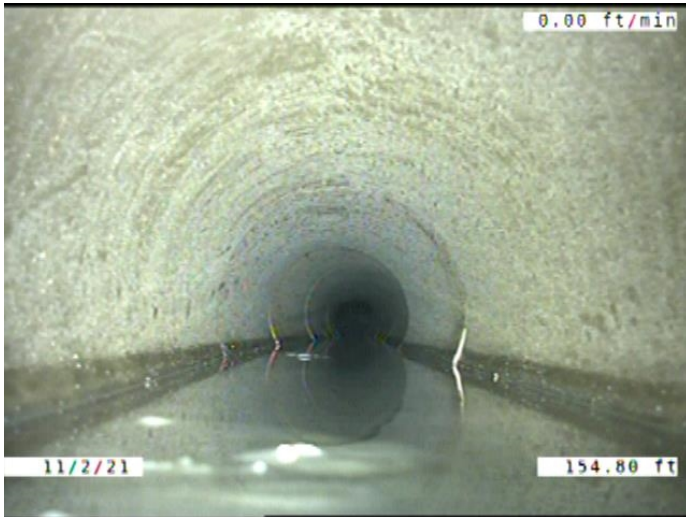
Code: **MWLS**  
Description: **Miscellaneous Water Level Sag**

Distance (ft): **154.8**  
Structural Grade: **2**  
O&M Grade: **0**  
Clock Start/From:  
Clock To:  
1st Value:  
2nd Value:  
Value Percent: **15.000**  
Continuous Index: **S03**  
Within 8" of Joint: **NO**  
Remarks:

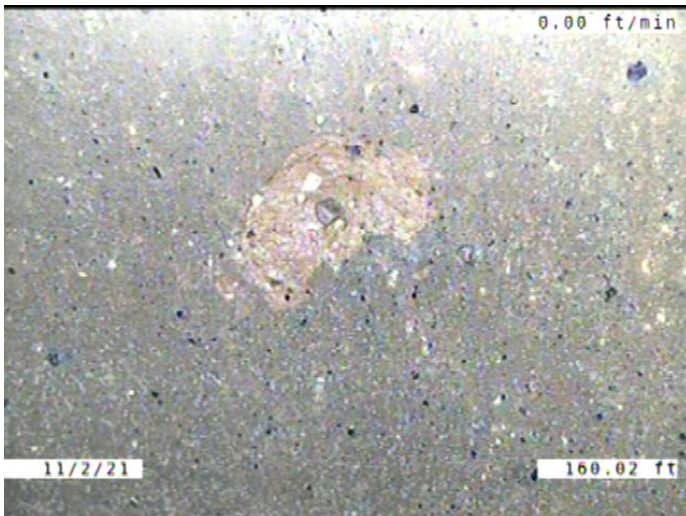
Code: **SSS**  
Description: **Surface Damage Surface Spalling**

Distance (ft): **160.0**  
Structural Grade: **2**  
O&M Grade: **0**  
Clock Start/From: **2**  
Clock To:  
1st Value:  
2nd Value:  
Value Percent:  
Continuous Index:  
Within 8" of Joint: **YES**  
Remarks:

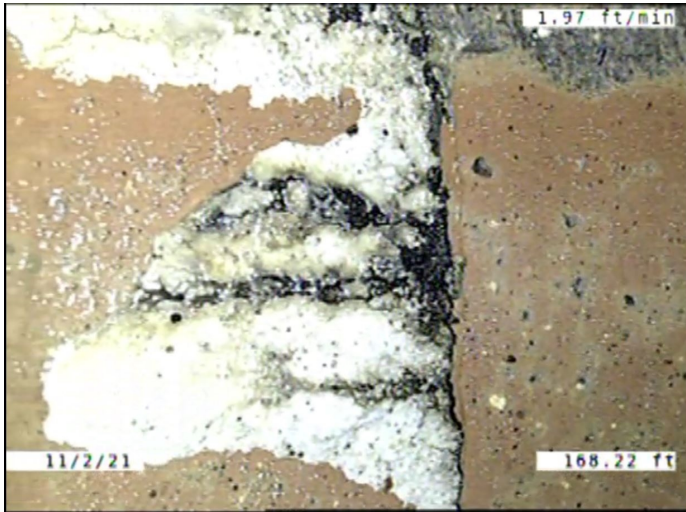
Code: **FM**  
 Description: **Fracture Multiple**

Distance (ft): **168.2**  
 Structural Grade: **4**  
 O&M Grade: **0**  
 Clock Start/From: **7**  
 Clock To: **4**  
 1st Value:  
 2nd Value:  
 Value Percent:  
 Continuous Index: **F02**  
 Within 8" of Joint: **YES**  
 Remarks: **Wandering**

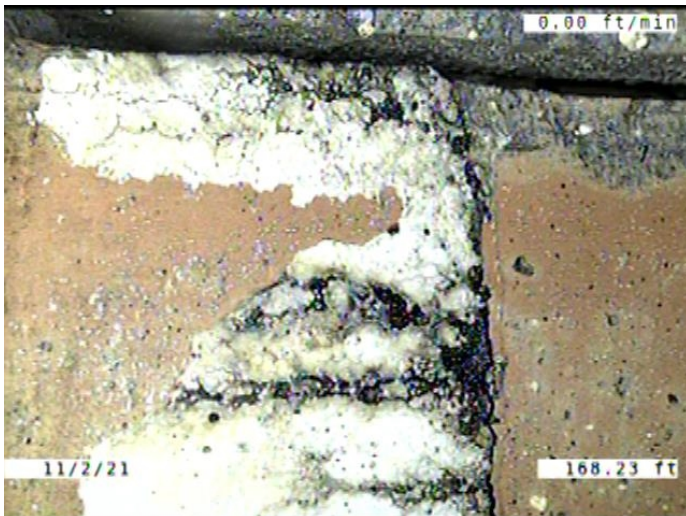
Code: **DAE**  
 Description: **Deposits Attached Encrustation**

Distance (ft): **168.2**  
 Structural Grade: **0**  
 O&M Grade: **2**  
 Clock Start/From: **8**  
 Clock To: **9**  
 1st Value:  
 2nd Value:  
 Value Percent: **5.000**  
 Continuous Index:  
 Within 8" of Joint: **YES**  
 Remarks:

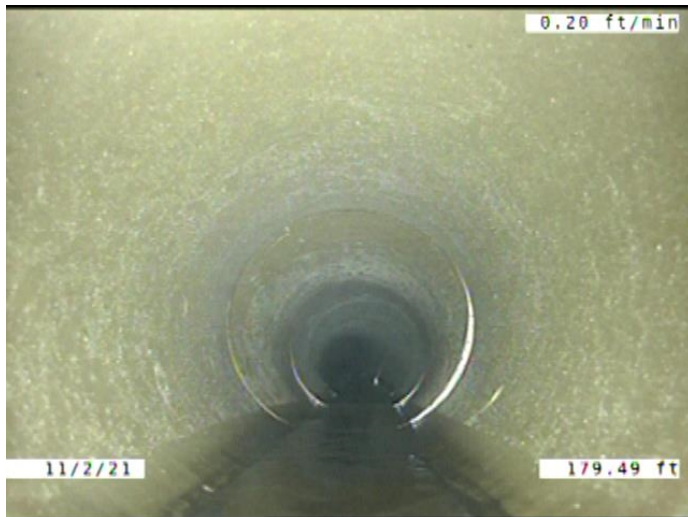
Code: **MWLS**  
 Description: **Miscellaneous Water Level Sag**

Distance (ft): **179.5**  
 Structural Grade: **2**  
 O&M Grade: **0**  
 Clock Start/From:  
 Clock To:  
 1st Value:  
 2nd Value:  
 Value Percent: **15.000**  
 Continuous Index: **F03**  
 Within 8" of Joint: **NO**  
 Remarks:

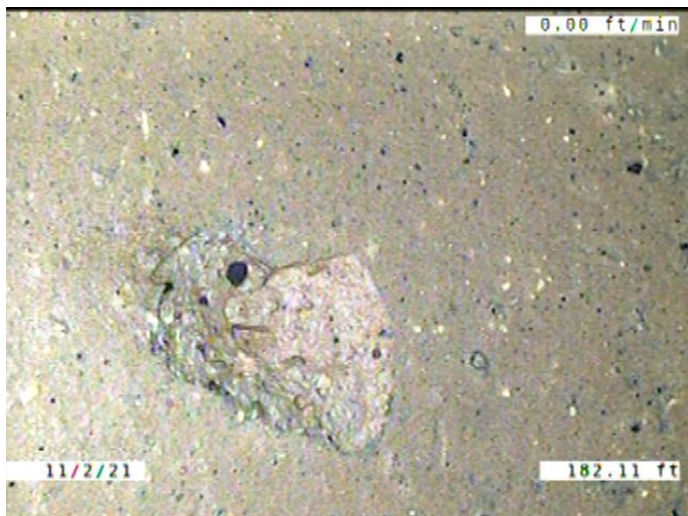
Code: **SSS**  
 Description: **Surface Damage Surface Spalling**

Distance (ft): **182.1**  
 Structural Grade: **2**  
 O&M Grade: **0**  
 Clock Start/From: **3**  
 Clock To:  
 1st Value:  
 2nd Value:  
 Value Percent:  
 Continuous Index:  
 Within 8" of Joint: **NO**  
 Remarks:

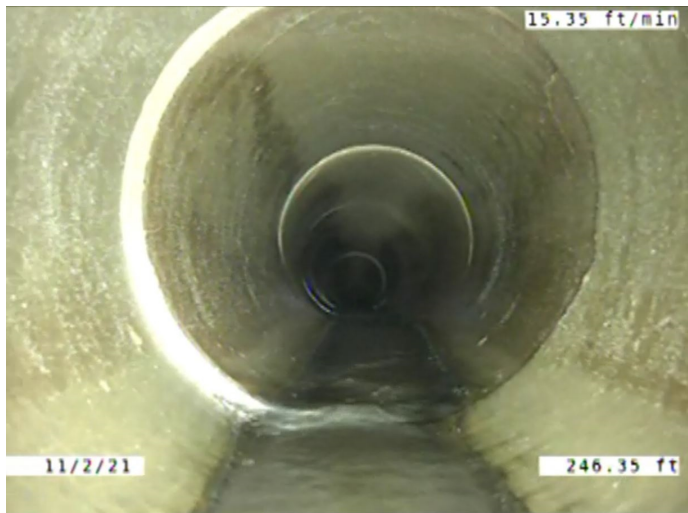
Code: **CM**  
 Description: **Crack Multiple**

Distance (ft): **246.4**  
 Structural Grade: **3**  
 O&M Grade: **0**  
 Clock Start/From: **7**  
 Clock To: **5**  
 1st Value:  
 2nd Value:  
 Value Percent:  
 Continuous Index: **S04**  
 Within 8" of Joint: **YES**  
 Remarks: **Wandering**

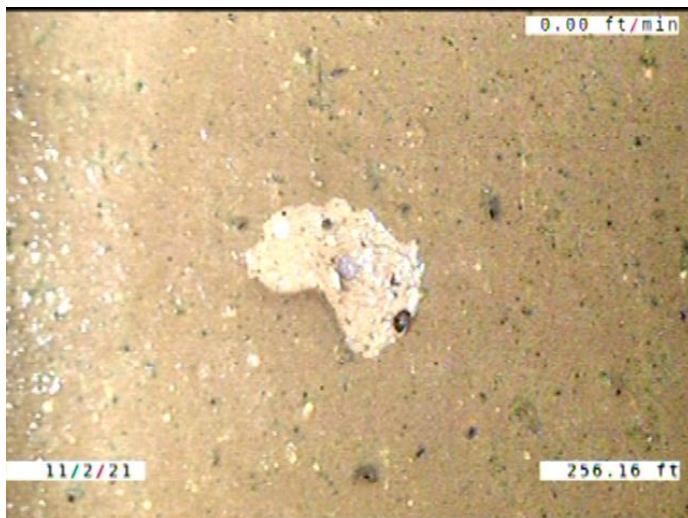
Code: **SSS**  
 Description: **Surface Damage Surface Spalling**

Distance (ft): **256.2**  
 Structural Grade: **2**  
 O&M Grade: **0**  
 Clock Start/From: **3**  
 Clock To:  
 1st Value:  
 2nd Value:  
 Value Percent:  
 Continuous Index:  
 Within 8" of Joint: **NO**  
 Remarks:

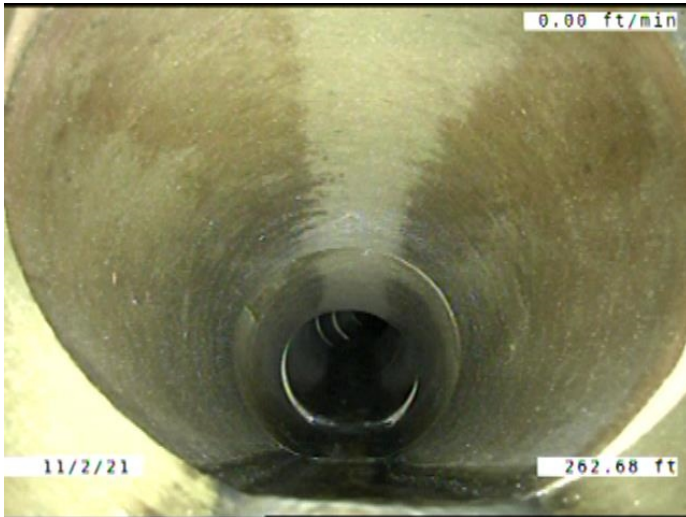
Code: **LD**  
Description: **Line Down**

Distance (ft): **262.7**  
Structural Grade: **0**  
O&M Grade: **2**  
Clock Start/From:  
Clock To:  
1st Value:  
2nd Value:  
Value Percent: **15.000**  
Continuous Index:  
Within 8" of Joint: **NO**  
Remarks:

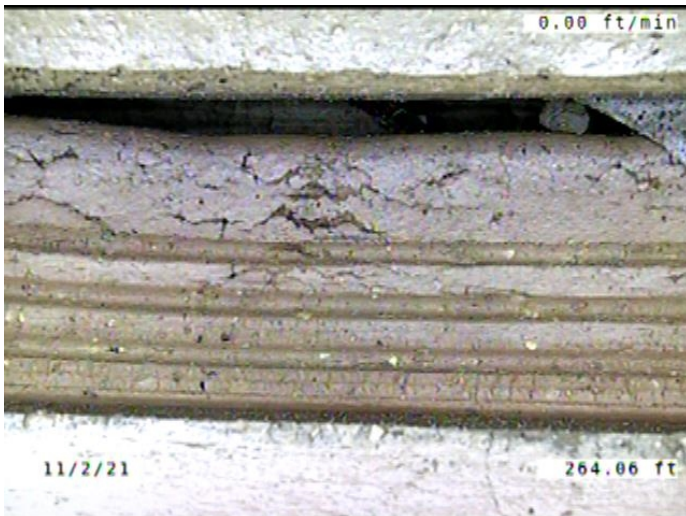
Code: **JAL**  
Description: **Joint Angular Large**

Distance (ft): **264.1**  
Structural Grade: **4**  
O&M Grade: **0**  
Clock Start/From:  
Clock To:  
1st Value:  
2nd Value:  
Value Percent:  
Continuous Index:  
Within 8" of Joint: **NO**  
Remarks: **SOIL VISIBLE**
