Profile/Photo Observation Report

Date:	11/02/2021	Weather:		Coding:	PACP 7.0
Pipe Length (ft):	291.8	Owner:	City of Hobart	Pre Clean:	Heavy Cleaning
P.O.#:	YES502259	Surveyor:	S. Bucklin	PSR:	P-505-059-054
Customer:	City of Hobart	Clean Date:	10/28/2021	Shape:	C

Street:	West 2nd Street	Flow Control:	Not Controlled
City:	Hobart, IN	Year Renewed:	
Location:	Local rural streets with light traffic, t	Tape/Media #:	
Purpose:	Routine Assessment	Dia/Height:	10"
Use:	Sanitary Sewage Pipe	Material:	VCP
Drain Area:		Lining:	None
Category:	NA		
Comment:			
Location Details:		Direction of Survey:	Downstream
US MH:	M-505-059	DS MH:	M-505-054
		Total Length Surveyed (ft):	291.8

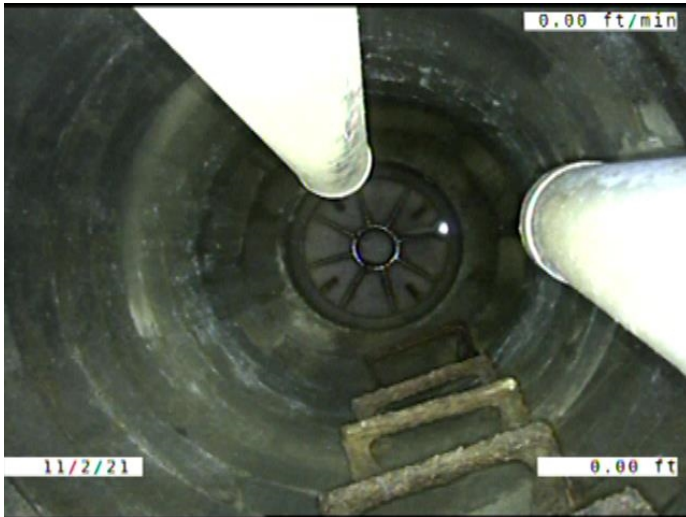
Code: **AMH**
 Description: **Manhole**

Distance (ft): **.0**
 Structural Grade: **0**
 O&M Grade: **0**
 Clock Start/From:
 Clock To:
 1st Value:
 2nd Value:
 Value Percent:
 Continuous Index:
 Within 8" of Joint: **NO**
 Remarks: **M-505-059**

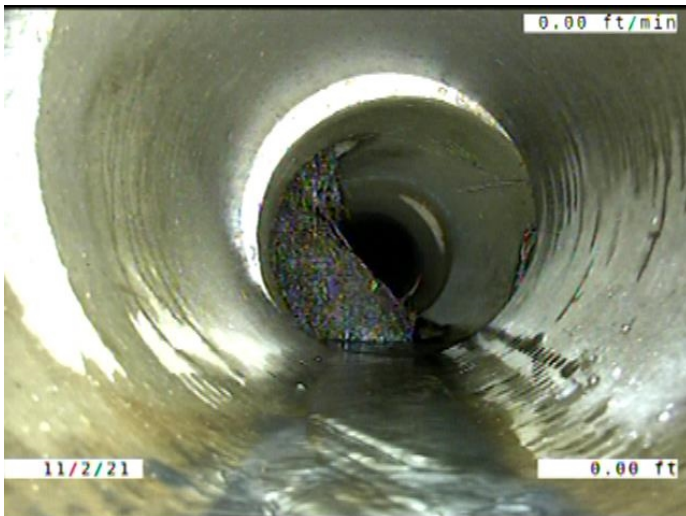
Code: **MWL**
 Description: **Miscellaneous Water Level**

Distance (ft): **.0**
 Structural Grade: **0**
 O&M Grade: **0**
 Clock Start/From:
 Clock To:
 1st Value:
 2nd Value:
 Value Percent: **5.000**
 Continuous Index:
 Within 8" of Joint: **NO**
 Remarks:

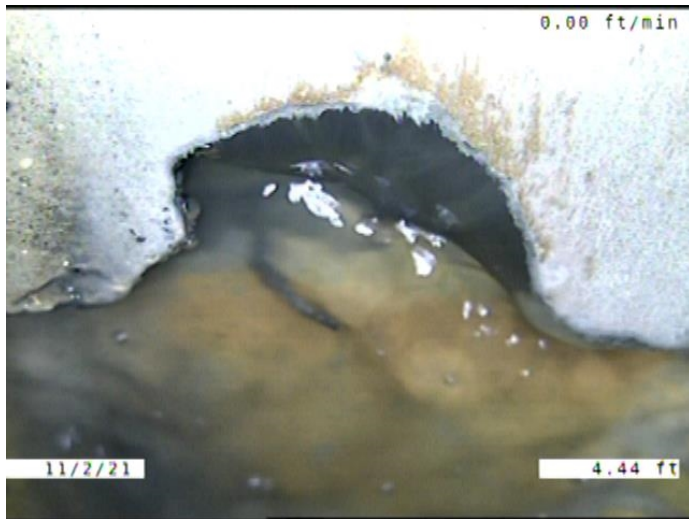
Code: **SMW**
 Description: **Surface Damage Missing Wall**

Distance (ft): **4.4**
 Structural Grade: **5**
 O&M Grade: **0**
 Clock Start/From: **6**
 Clock To:
 1st Value:
 2nd Value:
 Value Percent:
 Continuous Index:
 Within 8" of Joint: **YES**
 Remarks:

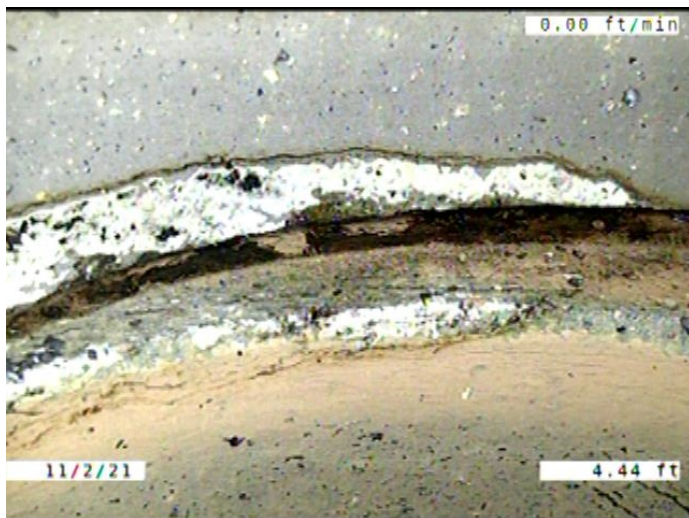
Code: **DAE**
 Description: **Deposits Attached Encrustation**

Distance (ft): **4.4**
 Structural Grade: **0**
 O&M Grade: **2**
 Clock Start/From: **8**
 Clock To: **11**
 1st Value:
 2nd Value:
 Value Percent: **5.000**
 Continuous Index:
 Within 8" of Joint: **YES**
 Remarks:

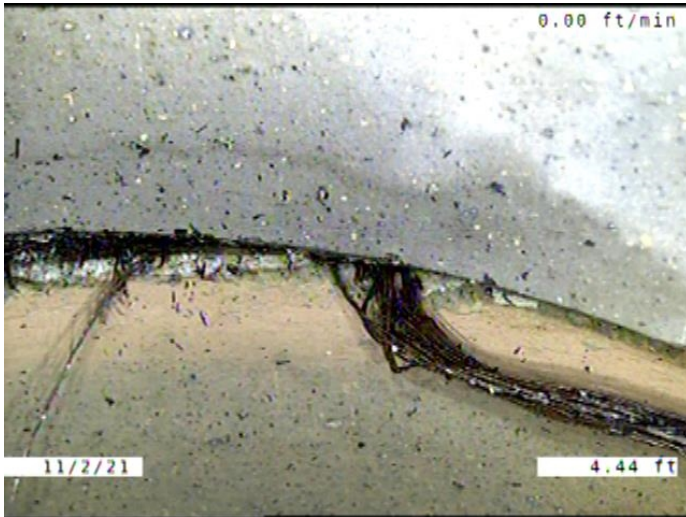
Code: **RFJ**
 Description: **Roots Fine Joint**

Distance (ft): **4.4**
 Structural Grade: **0**
 O&M Grade: **1**
 Clock Start/From: **11**
 Clock To: **3**
 1st Value:
 2nd Value:
 Value Percent:
 Continuous Index:
 Within 8" of Joint: **YES**
 Remarks:

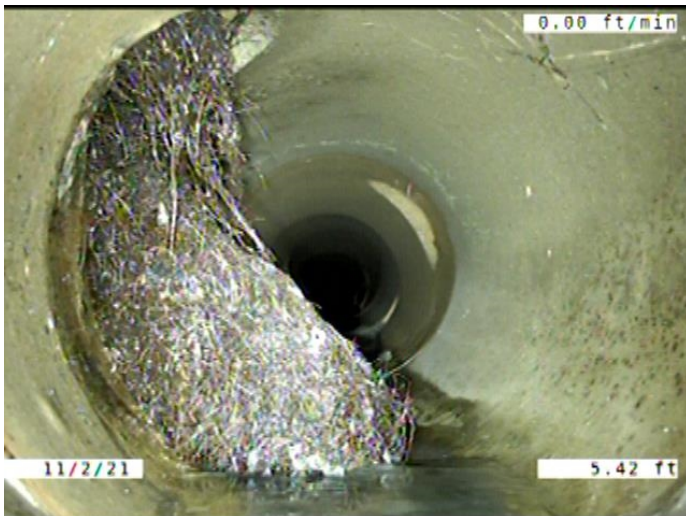
Code: **RML**
 Description: **Roots Medium Lateral**

Distance (ft): **5.1**
 Structural Grade: **0**
 O&M Grade: **3**
 Clock Start/From: **10**
 Clock To: **11**
 1st Value:
 2nd Value:
 Value Percent: **35.000**
 Continuous Index:
 Within 8" of Joint: **NO**
 Remarks:

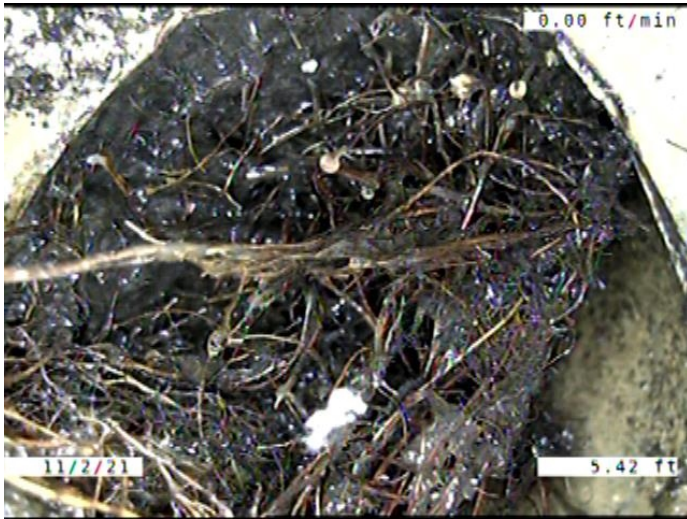
Code: **TFD**
 Description: **Tap Factory Defective**

Distance (ft): **5.4**
 Structural Grade: **0**
 O&M Grade: **3**
 Clock Start/From: **11**
 Clock To:
 1st Value: **4.000**
 2nd Value:
 Value Percent:
 Continuous Index:
 Within 8" of Joint: **YES**
 Remarks: **ROOTS GROWING OUT OF THE TAP INTO THE MAIN. LOOKS TO BE 100%**

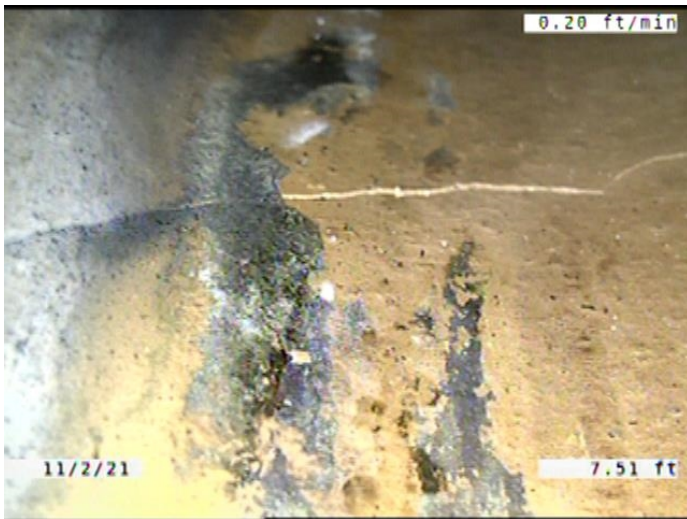
Code: **FM**
 Description: **Fracture Multiple**

Distance (ft): **7.5**
 Structural Grade: **4**
 O&M Grade: **0**
 Clock Start/From: **3**
 Clock To: **9**
 1st Value:
 2nd Value:
 Value Percent:
 Continuous Index:
 Within 8" of Joint: **YES**
 Remarks:

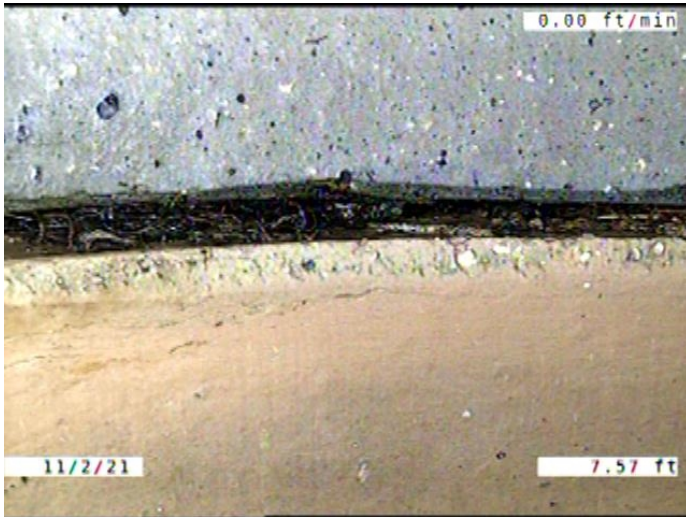
Code: **RFJ**
 Description: **Roots Fine Joint**

Distance (ft): **7.6**
 Structural Grade: **0**
 O&M Grade: **1**
 Clock Start/From: **9**
 Clock To: **3**
 1st Value:
 2nd Value:
 Value Percent:
 Continuous Index:
 Within 8" of Joint: **YES**
 Remarks:

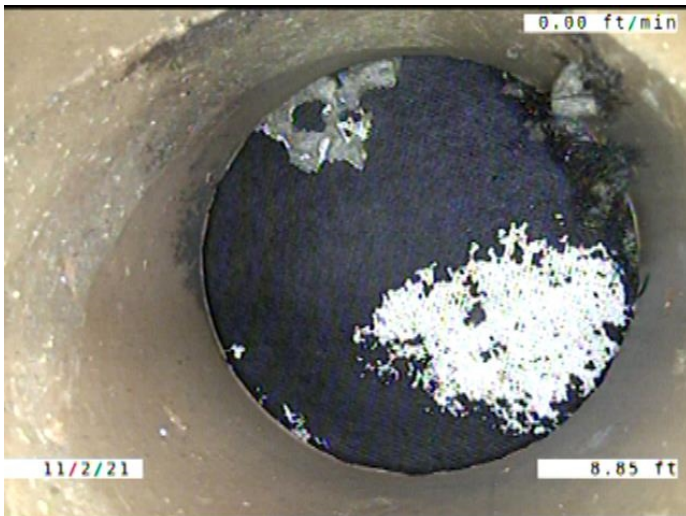
Code: **TFC**
 Description: **Tap Factory Capped**

Distance (ft): **8.8**
 Structural Grade: **0**
 O&M Grade: **0**
 Clock Start/From: **1**
 Clock To:
 1st Value: **4.000**
 2nd Value:
 Value Percent:
 Continuous Index:
 Within 8" of Joint: **YES**
 Remarks: **CAP LOOKS TO BE FABRIC. ROOTS GROWING AROUND THE CAP**

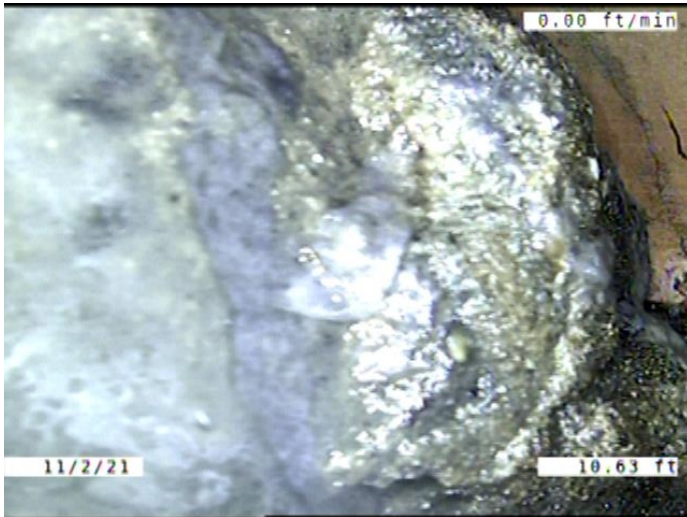
Code: **DAE**
 Description: **Deposits Attached Encrustation**

Distance (ft): **10.6**
 Structural Grade: **0**
 O&M Grade: **2**
 Clock Start/From: **4**
 Clock To: **8**
 1st Value:
 2nd Value:
 Value Percent: **5.000**
 Continuous Index:
 Within 8" of Joint: **YES**
 Remarks:

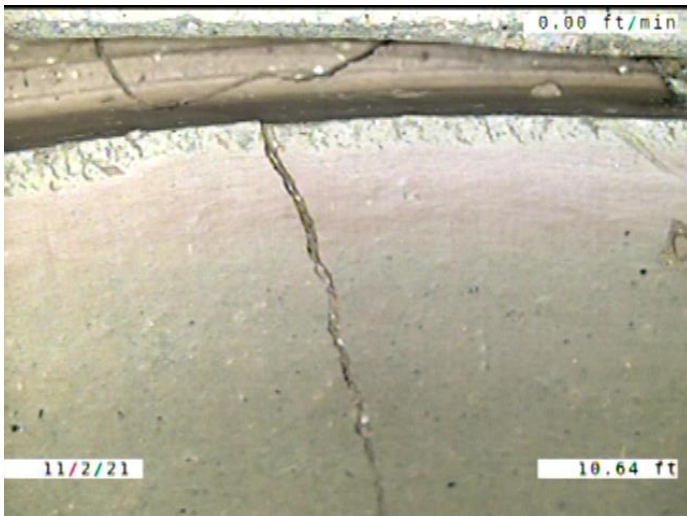
Code: **FM**
 Description: **Fracture Multiple**

Distance (ft): **10.6**
 Structural Grade: **4**
 O&M Grade: **0**
 Clock Start/From: **8**
 Clock To: **4**
 1st Value:
 2nd Value:
 Value Percent:
 Continuous Index:
 Within 8" of Joint: **YES**
 Remarks:

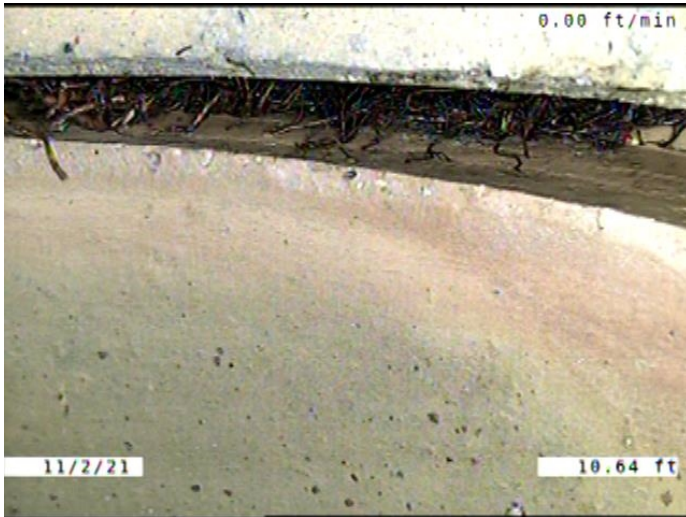
Code: **RFJ**
Description: **Roots Fine Joint**

Distance (ft): **10.6**
Structural Grade: **0**
O&M Grade: **1**
Clock Start/From: **1**
Clock To: **3**
1st Value:
2nd Value:
Value Percent:
Continuous Index:
Within 8" of Joint: **YES**
Remarks:

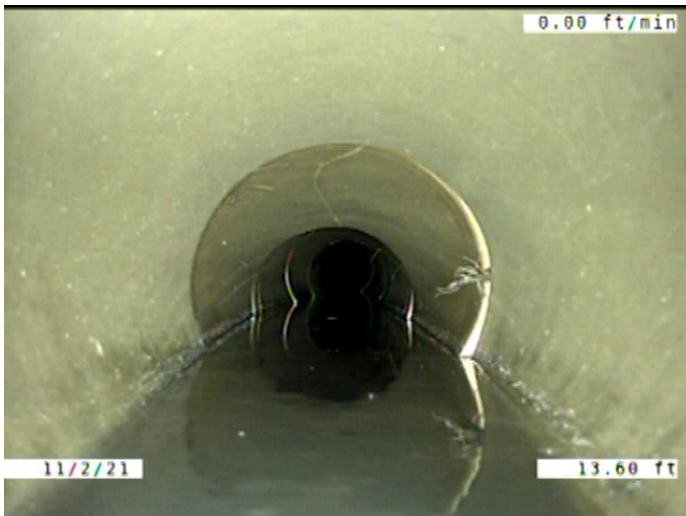
Code: **MWLS**
Description: **Miscellaneous Water Level Sag**

Distance (ft): **13.6**
Structural Grade: **2**
O&M Grade: **0**
Clock Start/From:
Clock To:
1st Value:
2nd Value:
Value Percent: **15.000**
Continuous Index: **S01**
Within 8" of Joint: **NO**
Remarks:

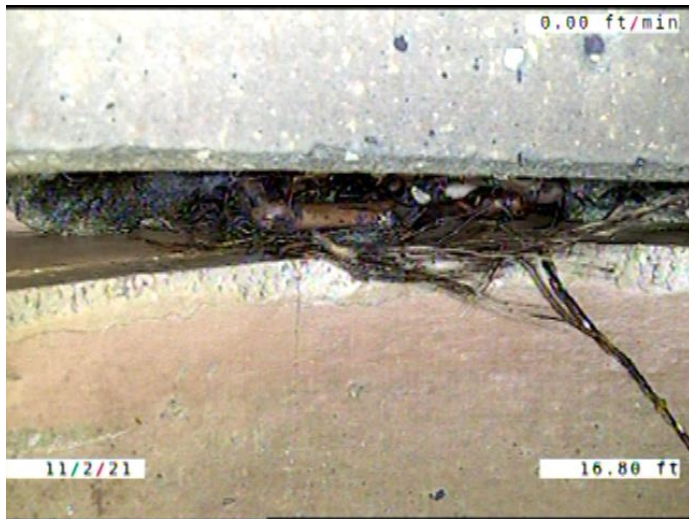
Code: **RFJ**
 Description: **Roots Fine Joint**

Distance (ft): **16.8**
 Structural Grade: **0**
 O&M Grade: **1**
 Clock Start/From: **10**
 Clock To: **3**
 1st Value:
 2nd Value:
 Value Percent:
 Continuous Index:
 Within 8" of Joint: **YES**
 Remarks:

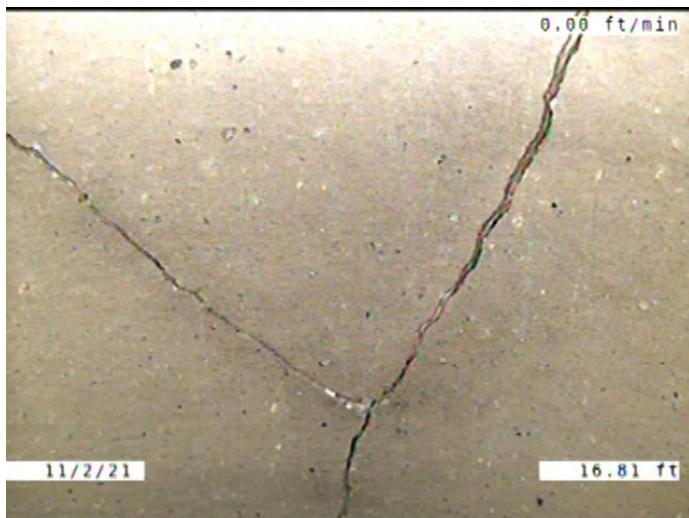
Code: **FM**
 Description: **Fracture Multiple**

Distance (ft): **16.8**
 Structural Grade: **4**
 O&M Grade: **0**
 Clock Start/From: **7**
 Clock To: **4**
 1st Value:
 2nd Value:
 Value Percent:
 Continuous Index: **S02**
 Within 8" of Joint: **YES**
 Remarks: **Wandering**

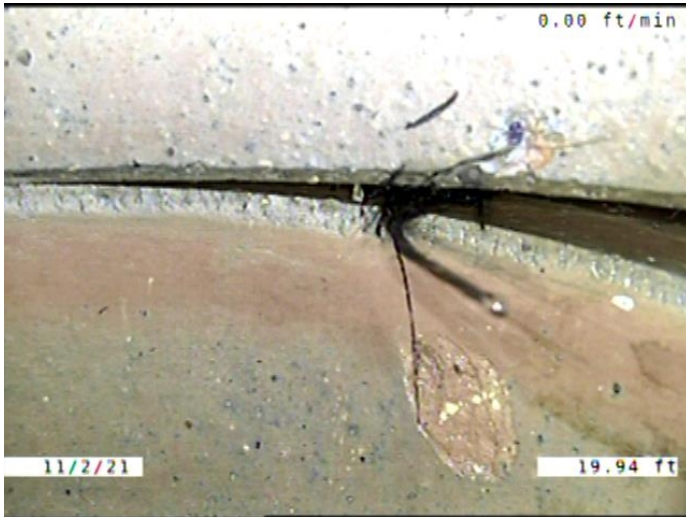
Code: **RFJ**
 Description: **Roots Fine Joint**

Distance (ft): **19.9**
 Structural Grade: **0**
 O&M Grade: **1**
 Clock Start/From: **2**
 Clock To:
 1st Value:
 2nd Value:
 Value Percent:
 Continuous Index:
 Within 8" of Joint: **YES**
 Remarks:

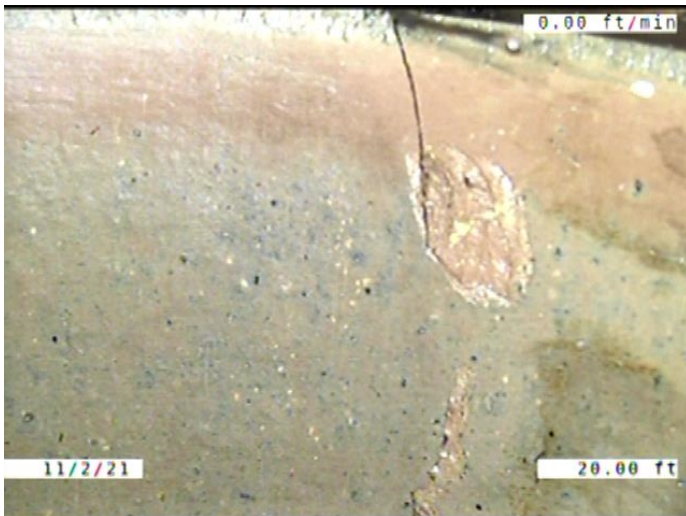
Code: **SSS**
 Description: **Surface Damage Surface Spalling**

Distance (ft): **20.0**
 Structural Grade: **2**
 O&M Grade: **0**
 Clock Start/From: **2**
 Clock To: **3**
 1st Value:
 2nd Value:
 Value Percent:
 Continuous Index:
 Within 8" of Joint: **YES**
 Remarks:

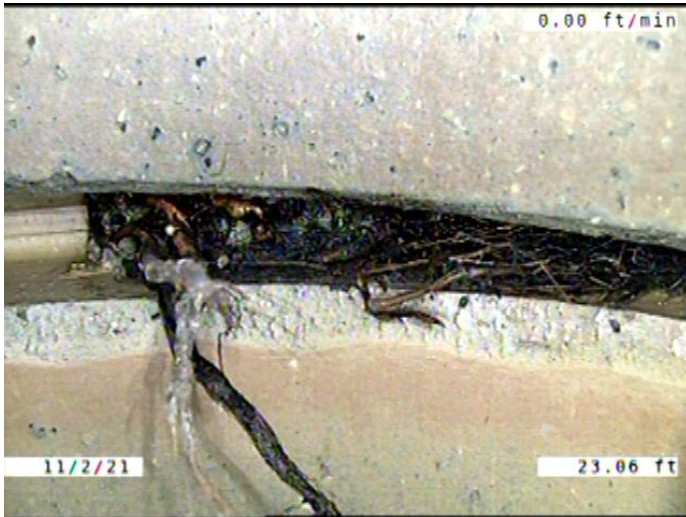
Code: **RFJ**
 Description: **Roots Fine Joint**

Distance (ft): **23.1**
 Structural Grade: **0**
 O&M Grade: **1**
 Clock Start/From: **1**
 Clock To: **2**
 1st Value:
 2nd Value:
 Value Percent:
 Continuous Index:
 Within 8" of Joint: **YES**
 Remarks:

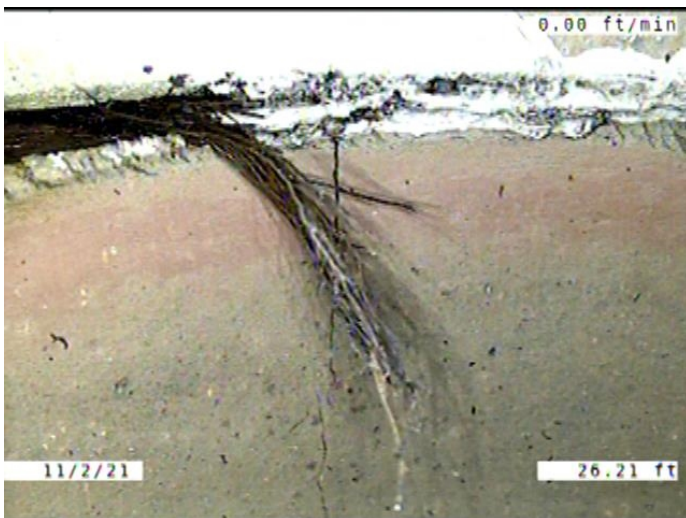
Code: **RFJ**
 Description: **Roots Fine Joint**

Distance (ft): **26.2**
 Structural Grade: **0**
 O&M Grade: **1**
 Clock Start/From: **10**
 Clock To:
 1st Value:
 2nd Value:
 Value Percent:
 Continuous Index:
 Within 8" of Joint: **YES**
 Remarks:

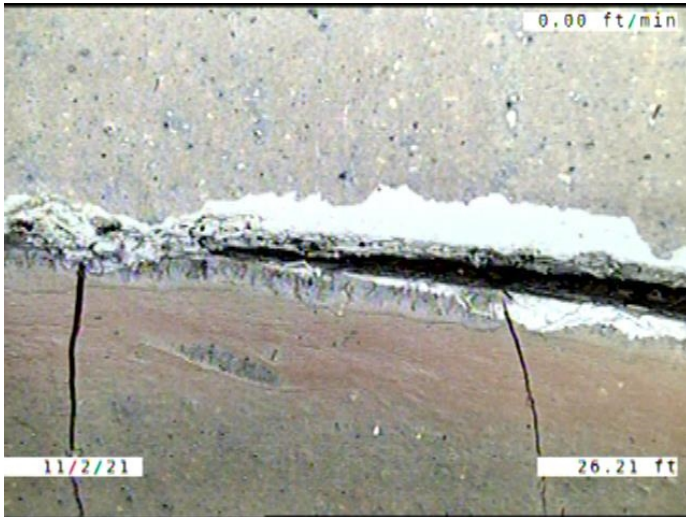
Code: **DAE**
 Description: **Deposits Attached Encrustation**

Distance (ft): **26.2**
 Structural Grade: **0**
 O&M Grade: **2**
 Clock Start/From: **9**
 Clock To: **3**
 1st Value:
 2nd Value:
 Value Percent: **5.000**
 Continuous Index:
 Within 8" of Joint: **YES**
 Remarks:

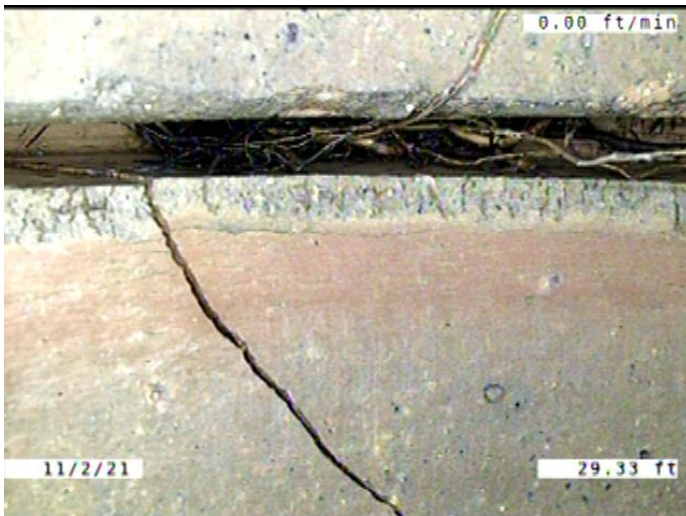
Code: **RFJ**
 Description: **Roots Fine Joint**

Distance (ft): **29.3**
 Structural Grade: **0**
 O&M Grade: **1**
 Clock Start/From: **9**
 Clock To: **10**
 1st Value:
 2nd Value:
 Value Percent:
 Continuous Index:
 Within 8" of Joint: **YES**
 Remarks:

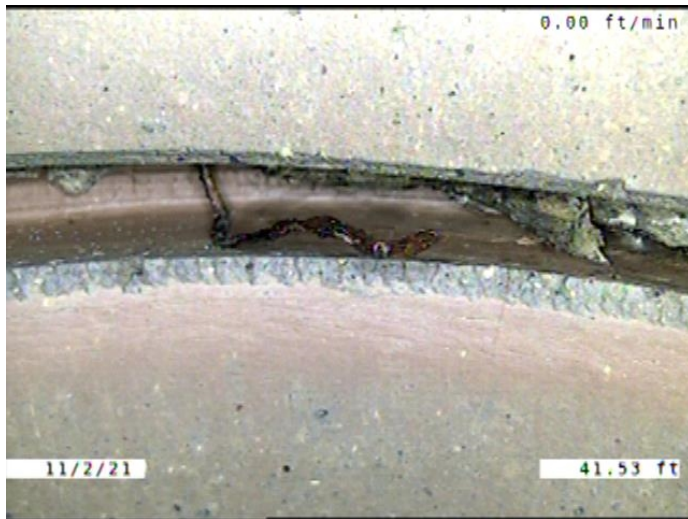
Code: **RFJ**
 Description: **Roots Fine Joint**

Distance (ft): **41.5**
 Structural Grade: **0**
 O&M Grade: **1**
 Clock Start/From: **1**
 Clock To:
 1st Value:
 2nd Value:
 Value Percent:
 Continuous Index:
 Within 8" of Joint: **YES**
 Remarks:

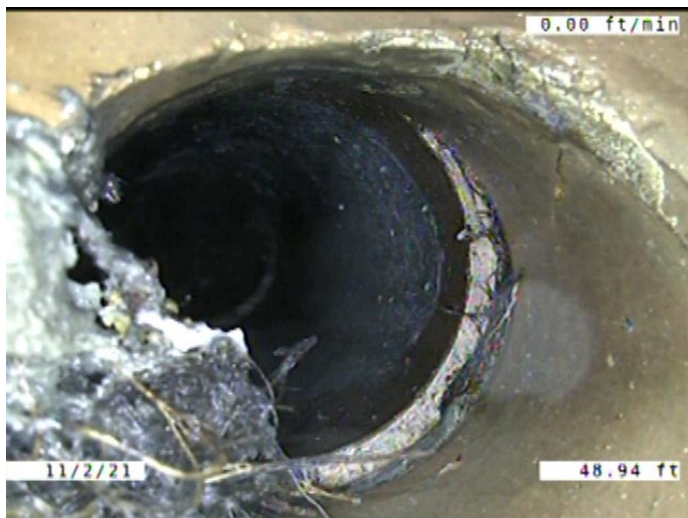
Code: **TFD**
 Description: **Tap Factory Defective**

Distance (ft): **48.9**
 Structural Grade: **0**
 O&M Grade: **3**
 Clock Start/From: **10**
 Clock To:
 1st Value: **4.000**
 2nd Value:
 Value Percent:
 Continuous Index:
 Within 8" of Joint: **YES**
 Remarks: **OFFSET. ROOTS GROWING FROM THE JOINT AND INTO THE MAIN**

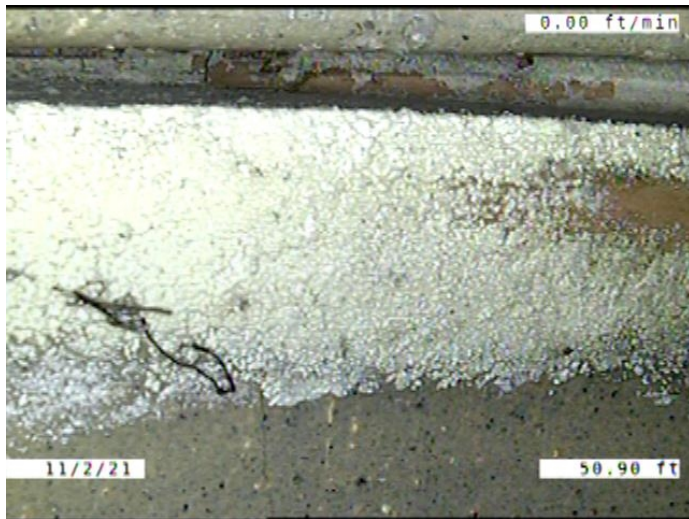
Code: **DAE**
 Description: **Deposits Attached Encrustation**

Distance (ft): **50.9**
 Structural Grade: **0**
 O&M Grade: **2**
 Clock Start/From: **8**
 Clock To: **10**
 1st Value:
 2nd Value:
 Value Percent: **5.000**
 Continuous Index:
 Within 8" of Joint: **YES**
 Remarks:

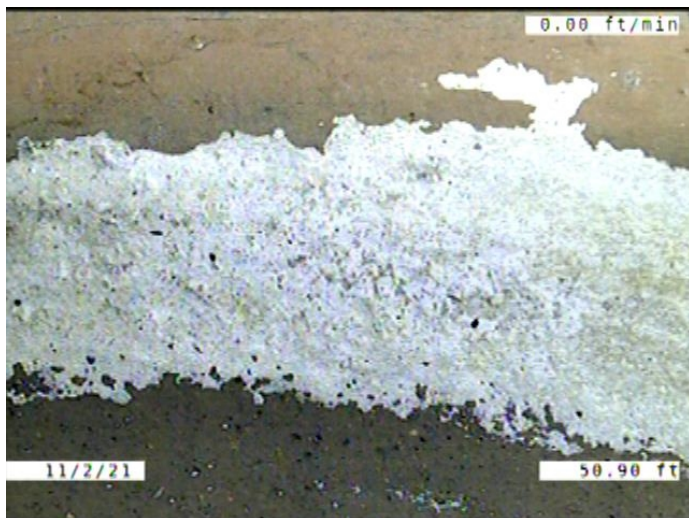
Code: **DAE**
 Description: **Deposits Attached Encrustation**

Distance (ft): **50.9**
 Structural Grade: **0**
 O&M Grade: **2**
 Clock Start/From: **2**
 Clock To: **4**
 1st Value:
 2nd Value:
 Value Percent: **5.000**
 Continuous Index:
 Within 8" of Joint: **YES**
 Remarks:

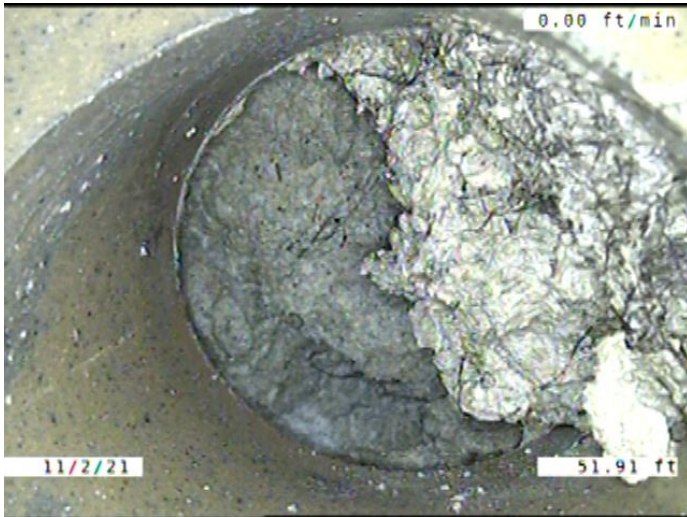
Code:	TFD
Description:	Tap Factory Defective
Distance (ft):	51.9
Structural Grade:	0
O&M Grade:	3
Clock Start/From:	1
Clock To:	
1st Value:	4.000
2nd Value:	
Value Percent:	
Continuous Index:	
Within 8" of Joint:	YES
Remarks:	SOIL VISIBLE. ROOTS GROWING INTO THE TAP. LOOKS TO BE 100% P

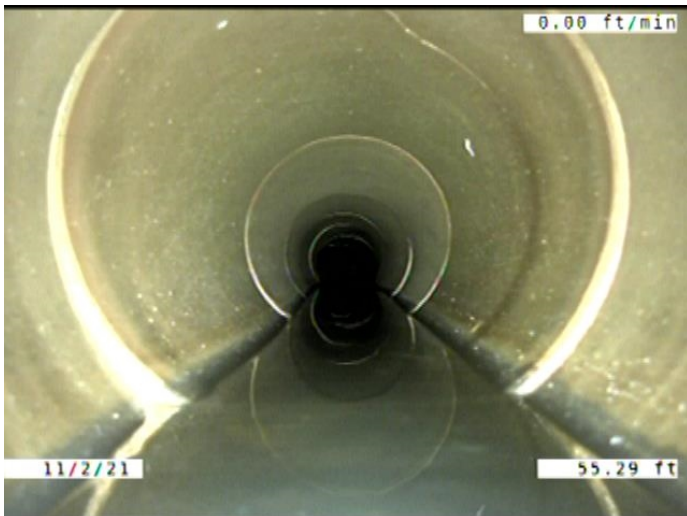
Code:	MWLS
Description:	Miscellaneous Water Level Sag
Distance (ft):	55.3
Structural Grade:	2
O&M Grade:	0
Clock Start/From:	
Clock To:	
1st Value:	
2nd Value:	
Value Percent:	15.000
Continuous Index:	F01
Within 8" of Joint:	NO
Remarks:

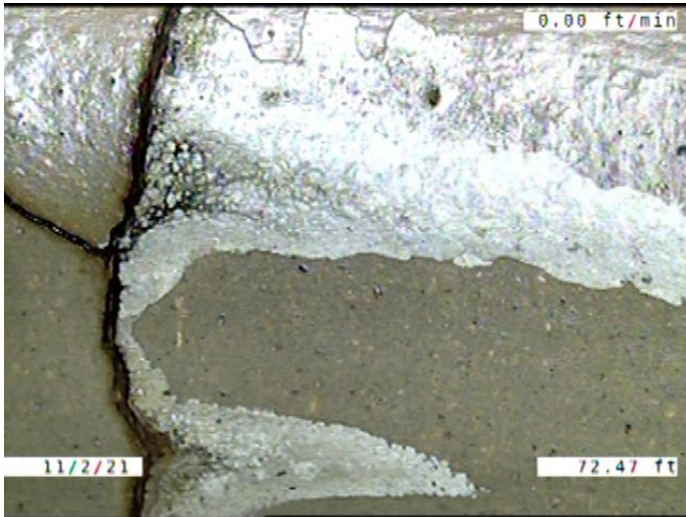
Code: **DAE**
 Description: **Deposits Attached Encrustation**

Distance (ft): **72.5**
 Structural Grade: **0**
 O&M Grade: **2**
 Clock Start/From: **12**
 Clock To: **2**
 1st Value:
 2nd Value:
 Value Percent: **5.000**
 Continuous Index:
 Within 8" of Joint: **YES**
 Remarks:

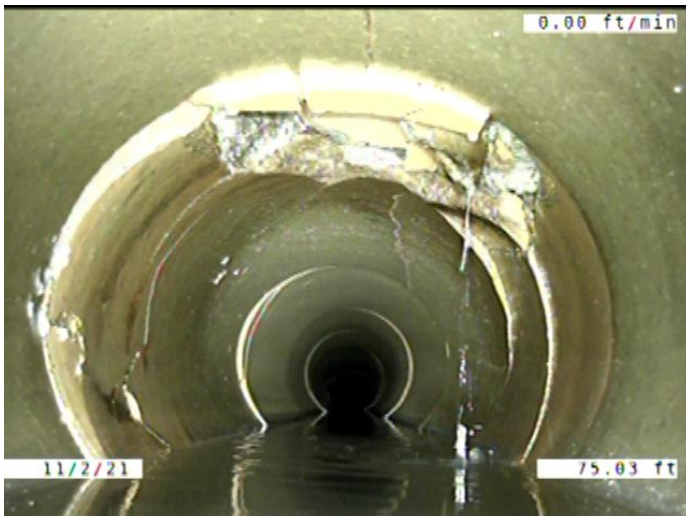
Code: **DR**
 Description: **Deformed Rigid**

Distance (ft): **75.0**
 Structural Grade: **4**
 O&M Grade: **0**
 Clock Start/From:
 Clock To:
 1st Value:
 2nd Value:
 Value Percent: **5.000**
 Continuous Index:
 Within 8" of Joint: **NO**
 Remarks:

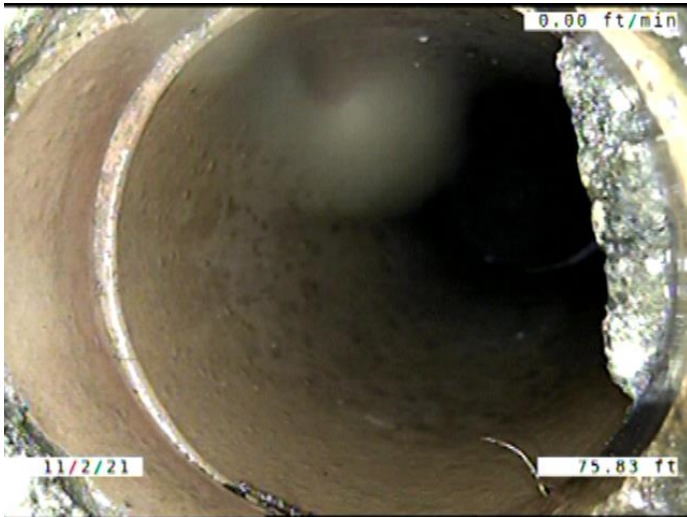
Code: **TBD**
 Description: **Tap Break-in/Hammer Defective**

Distance (ft): **75.8**
 Structural Grade: **0**
 O&M Grade: **3**
 Clock Start/From: **1**
 Clock To:
 1st Value: **4.000**
 2nd Value:
 Value Percent:
 Continuous Index:
 Within 8" of Joint: **YES**
 Remarks: **CONSTANTLY RUNNING WATER.**

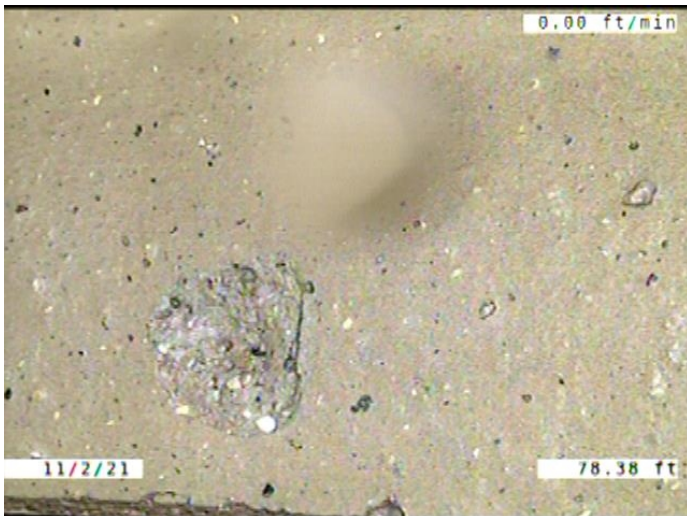
Code: **SSS**
 Description: **Surface Damage Surface Spalling**

Distance (ft): **78.4**
 Structural Grade: **2**
 O&M Grade: **0**
 Clock Start/From: **2**
 Clock To:
 1st Value:
 2nd Value:
 Value Percent:
 Continuous Index:
 Within 8" of Joint: **YES**
 Remarks:

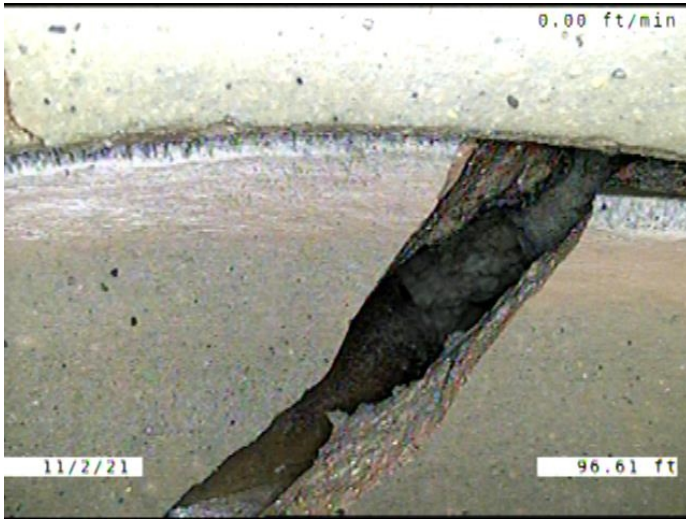
Code: **BSV**
 Description: **Broken Soil Visible**

Distance (ft): **96.6**
 Structural Grade: **5**
 O&M Grade: **0**
 Clock Start/From: **7**
 Clock To: **11**
 1st Value:
 2nd Value:
 Value Percent:
 Continuous Index:
 Within 8" of Joint: **YES**
 Remarks:

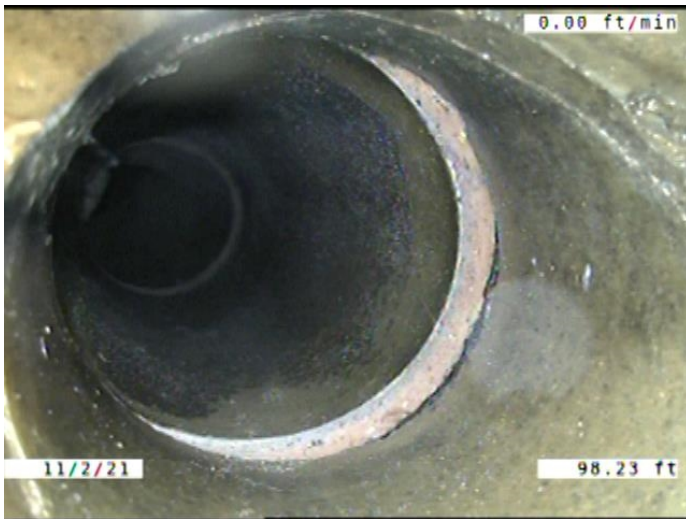
Code: **TFD**
 Description: **Tap Factory Defective**

Distance (ft): **98.2**
 Structural Grade: **0**
 O&M Grade: **3**
 Clock Start/From: **11**
 Clock To:
 1st Value: **4.000**
 2nd Value:
 Value Percent:
 Continuous Index:
 Within 8" of Joint: **YES**
 Remarks: **BROKEN. OFFSET. CONSTANTLY RUNNING WATER.**

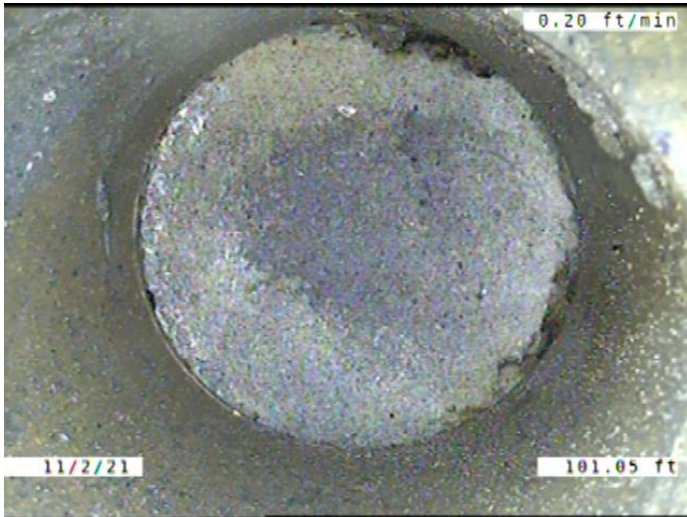
Code: **TFC**
Description: **Tap Factory Capped**

Distance (ft): **101.0**
Structural Grade: **0**
O&M Grade: **0**
Clock Start/From: **2**
Clock To:
1st Value: **4.000**
2nd Value:
Value Percent:
Continuous Index:
Within 8" of Joint: **YES**
Remarks:

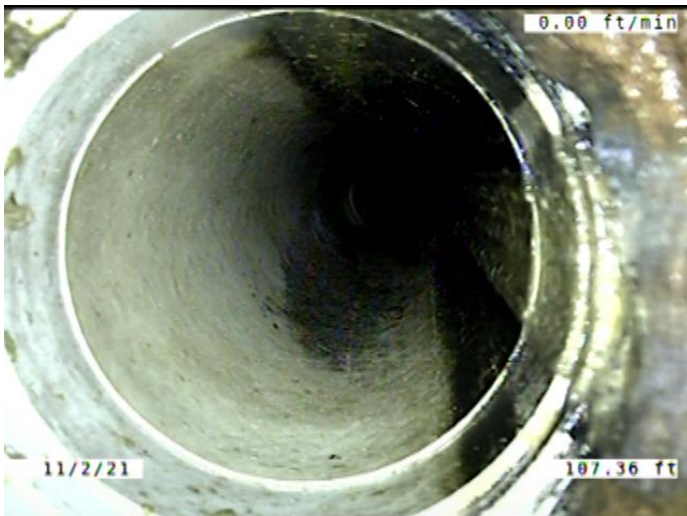
Code: **TB**
Description: **Tap Break-in/Hammer**

Distance (ft): **107.4**
Structural Grade: **0**
O&M Grade: **0**
Clock Start/From: **1**
Clock To:
1st Value: **4.000**
2nd Value:
Value Percent:
Continuous Index:
Within 8" of Joint: **YES**
Remarks:

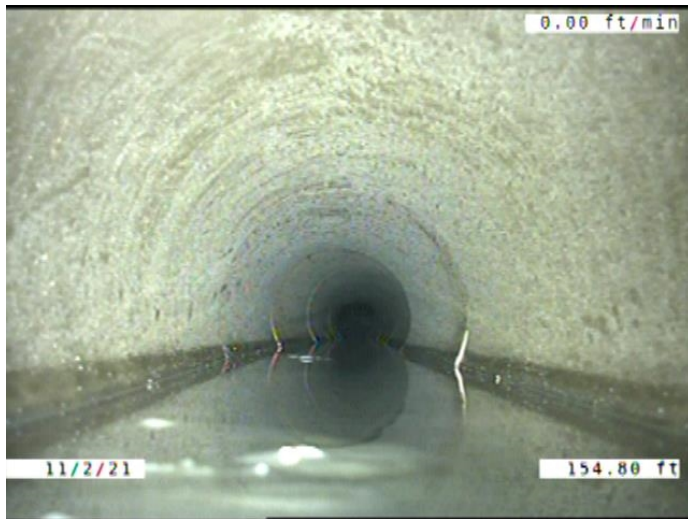
Code: **MWLS**
 Description: **Miscellaneous Water Level Sag**

Distance (ft): **154.8**
 Structural Grade: **2**
 O&M Grade: **0**
 Clock Start/From:
 Clock To:
 1st Value:
 2nd Value:
 Value Percent: **15.000**
 Continuous Index: **S03**
 Within 8" of Joint: **NO**
 Remarks:

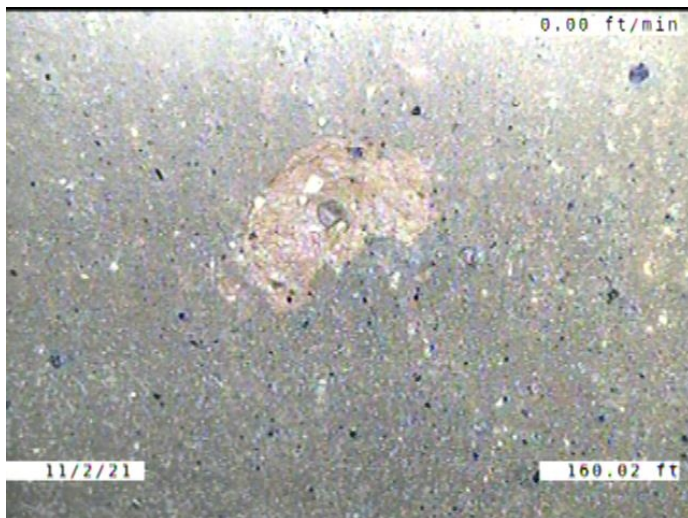
Code: **SSS**
 Description: **Surface Damage Surface Spalling**

Distance (ft): **160.0**
 Structural Grade: **2**
 O&M Grade: **0**
 Clock Start/From: **2**
 Clock To:
 1st Value:
 2nd Value:
 Value Percent:
 Continuous Index:
 Within 8" of Joint: **YES**
 Remarks:

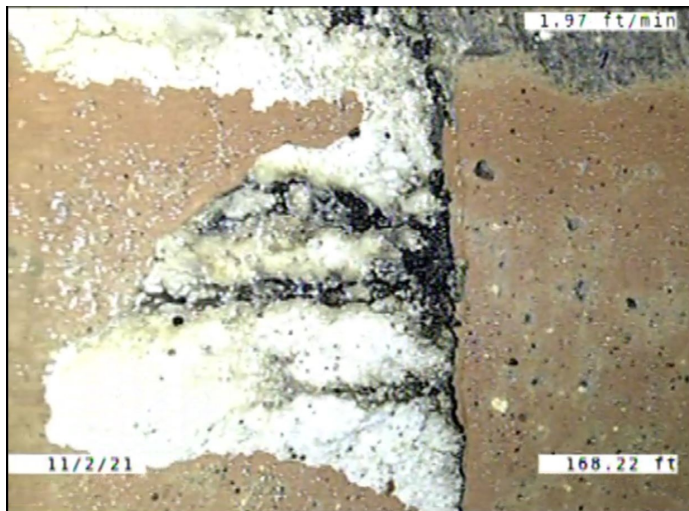
Code: **FM**
 Description: **Fracture Multiple**

Distance (ft): **168.2**
 Structural Grade: **4**
 O&M Grade: **0**
 Clock Start/From: **7**
 Clock To: **4**
 1st Value:
 2nd Value:
 Value Percent:
 Continuous Index: **F02**
 Within 8" of Joint: **YES**
 Remarks: **Wandering**

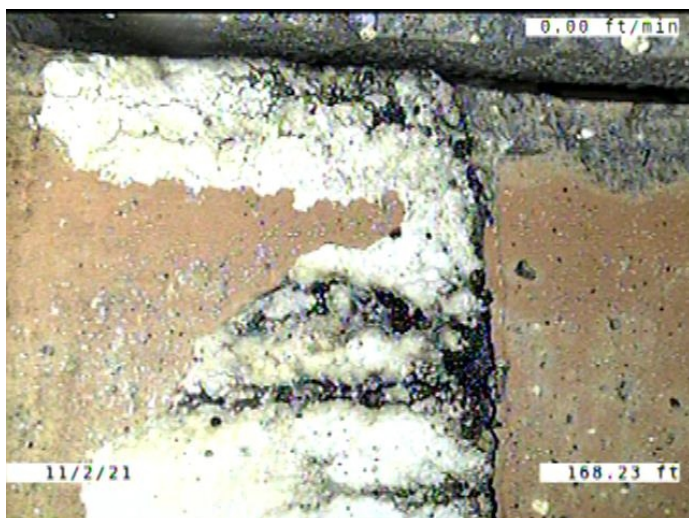
Code: **DAE**
 Description: **Deposits Attached Encrustation**

Distance (ft): **168.2**
 Structural Grade: **0**
 O&M Grade: **2**
 Clock Start/From: **8**
 Clock To: **9**
 1st Value:
 2nd Value:
 Value Percent: **5.000**
 Continuous Index:
 Within 8" of Joint: **YES**
 Remarks:

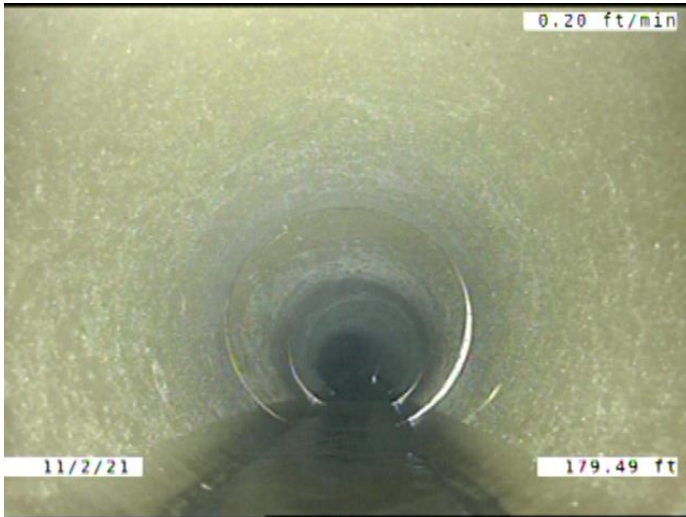
Code: **MWLS**
 Description: **Miscellaneous Water Level Sag**

Distance (ft): **179.5**
 Structural Grade: **2**
 O&M Grade: **0**
 Clock Start/From:
 Clock To:
 1st Value:
 2nd Value:
 Value Percent: **15.000**
 Continuous Index: **F03**
 Within 8" of Joint: **NO**
 Remarks:

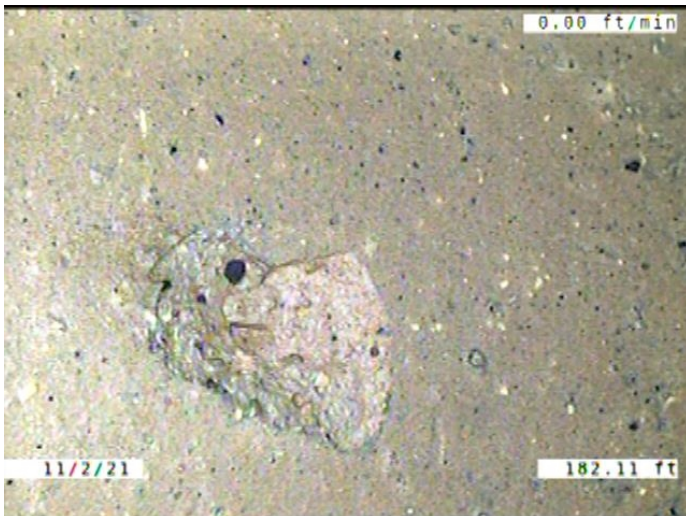
Code: **SSS**
 Description: **Surface Damage Surface Spalling**

Distance (ft): **182.1**
 Structural Grade: **2**
 O&M Grade: **0**
 Clock Start/From: **3**
 Clock To:
 1st Value:
 2nd Value:
 Value Percent:
 Continuous Index:
 Within 8" of Joint: **NO**
 Remarks:

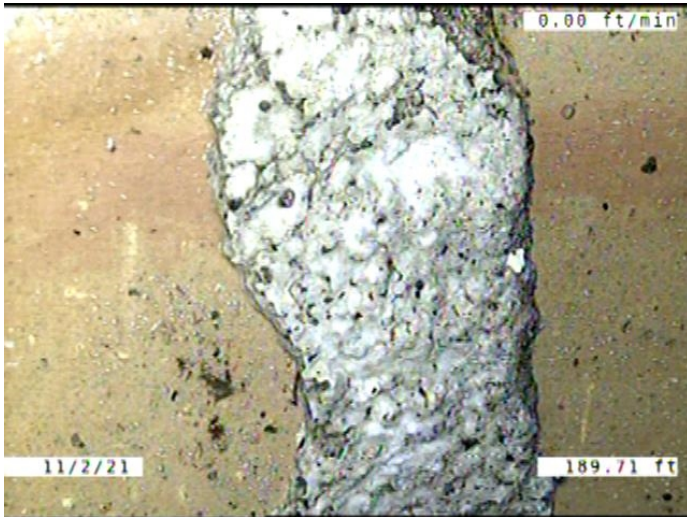
Code: **DAE**
 Description: **Deposits Attached Encrustation**

Distance (ft): **189.7**
 Structural Grade: **0**
 O&M Grade: **2**
 Clock Start/From: **8**
 Clock To: **9**
 1st Value:
 2nd Value:
 Value Percent: **5.000**
 Continuous Index:
 Within 8" of Joint: **YES**
 Remarks:

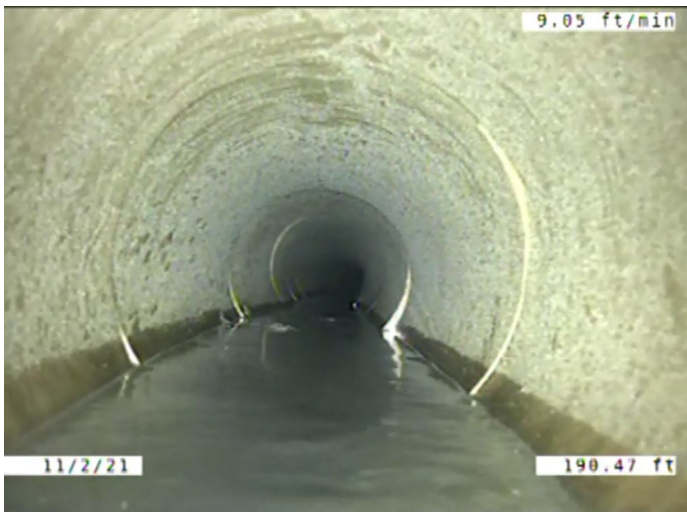
Code: **CM**
 Description: **Crack Multiple**

Distance (ft): **190.5**
 Structural Grade: **3**
 O&M Grade: **0**
 Clock Start/From: **10**
 Clock To: **2**
 1st Value:
 2nd Value:
 Value Percent:
 Continuous Index:
 Within 8" of Joint: **YES**
 Remarks:

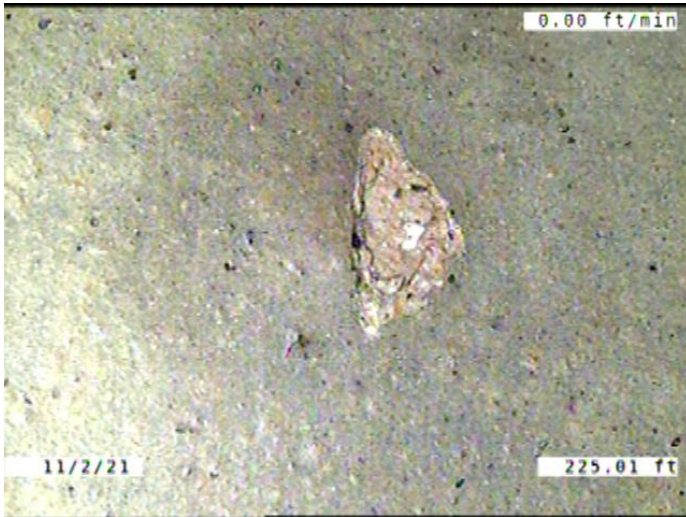
Code: **SSS**
 Description: **Surface Damage Surface Spalling**

Distance (ft): **225.0**
 Structural Grade: **2**
 O&M Grade: **0**
 Clock Start/From: **3**
 Clock To:
 1st Value:
 2nd Value:
 Value Percent:
 Continuous Index:
 Within 8" of Joint: **NO**
 Remarks:

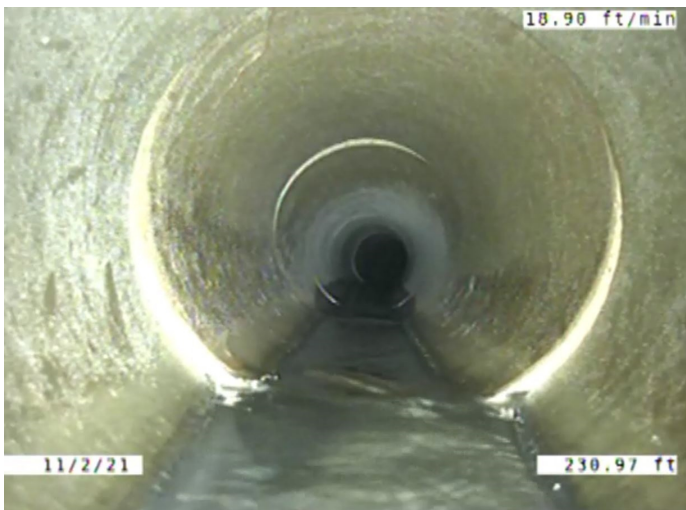
Code: **CS**
 Description: **Crack Spiral**

Distance (ft): **231.0**
 Structural Grade: **2**
 O&M Grade: **0**
 Clock Start/From: **10**
 Clock To: **11**
 1st Value:
 2nd Value:
 Value Percent:
 Continuous Index:
 Within 8" of Joint: **YES**
 Remarks:

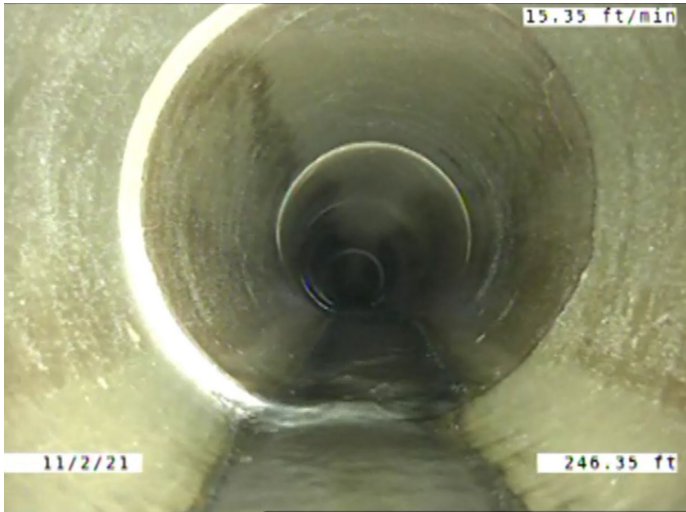
Code: **CM**
Description: **Crack Multiple**

Distance (ft): **246.4**
Structural Grade: **3**
O&M Grade: **0**
Clock Start/From: **7**
Clock To: **5**
1st Value:
2nd Value:
Value Percent:
Continuous Index: **S04**
Within 8" of Joint: **YES**
Remarks: **Wandering**

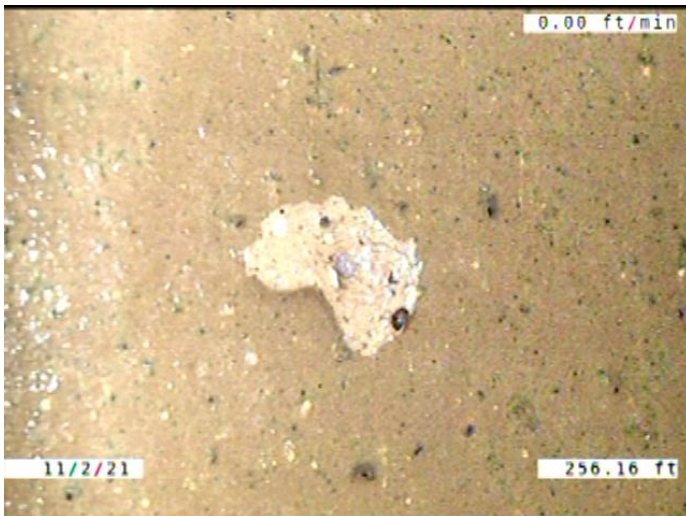
Code: **SSS**
Description: **Surface Damage Surface Spalling**

Distance (ft): **256.2**
Structural Grade: **2**
O&M Grade: **0**
Clock Start/From: **3**
Clock To:
1st Value:
2nd Value:
Value Percent:
Continuous Index:
Within 8" of Joint: **NO**
Remarks:

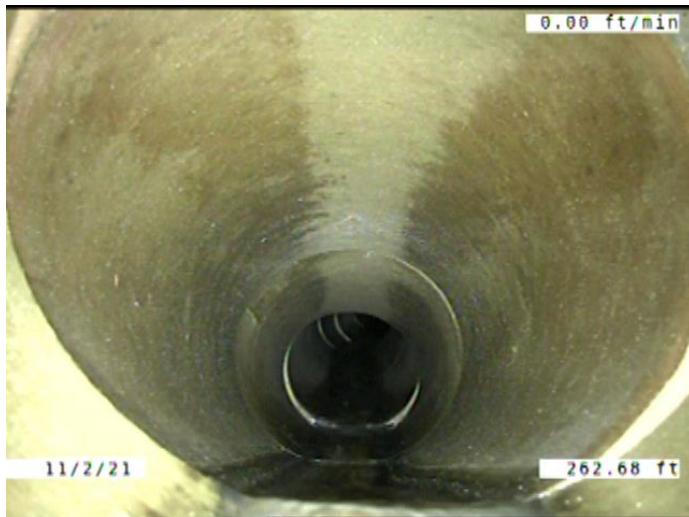
Code: **LD**
 Description: **Line Down**

Distance (ft): **262.7**
 Structural Grade: **0**
 O&M Grade: **2**
 Clock Start/From:
 Clock To:
 1st Value:
 2nd Value:
 Value Percent: **15.000**
 Continuous Index:
 Within 8" of Joint: **NO**
 Remarks:

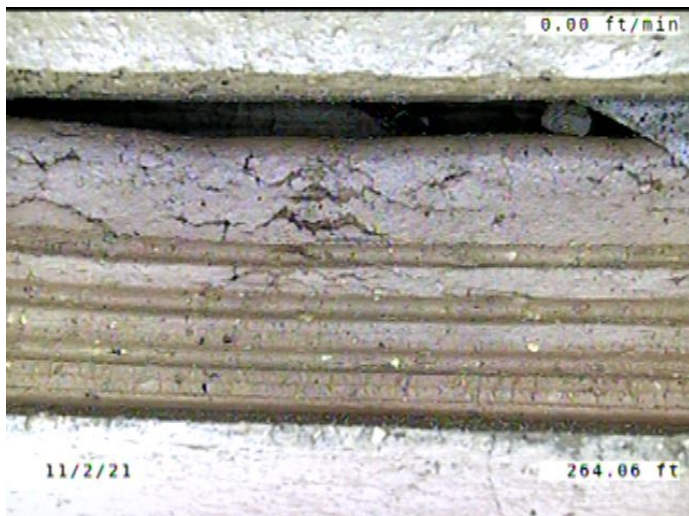
Code: **JAL**
 Description: **Joint Angular Large**

Distance (ft): **264.1**
 Structural Grade: **4**
 O&M Grade: **0**
 Clock Start/From:
 Clock To:
 1st Value:
 2nd Value:
 Value Percent:
 Continuous Index:
 Within 8" of Joint: **NO**
 Remarks: **SOIL VISIBLE**

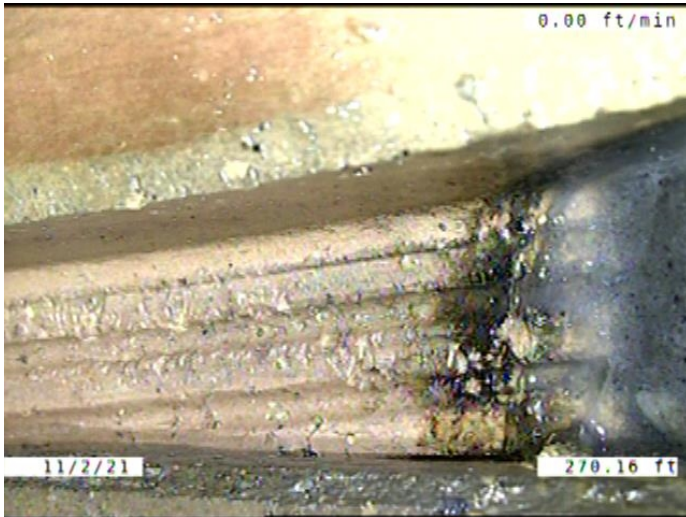
Code: **JAL**
Description: **Joint Angular Large**

Distance (ft): **270.2**
Structural Grade: **4**
O&M Grade: **0**
Clock Start/From:
Clock To:
1st Value:
2nd Value:
Value Percent:
Continuous Index:
Within 8" of Joint: **NO**
Remarks:

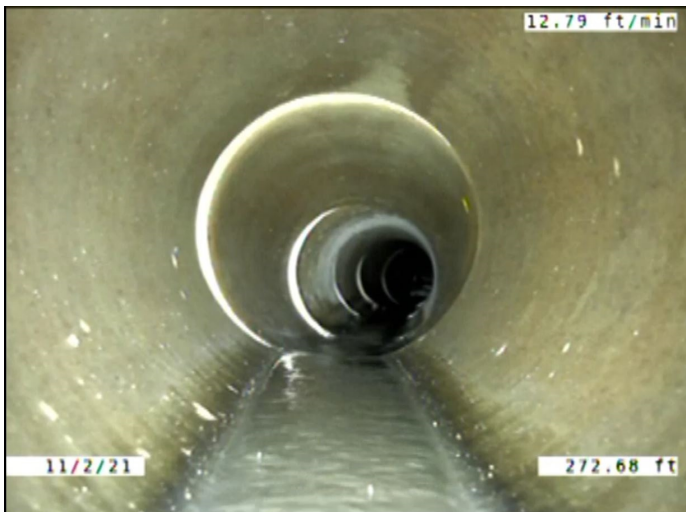
Code: **CM**
Description: **Crack Multiple**

Distance (ft): **272.7**
Structural Grade: **3**
O&M Grade: **0**
Clock Start/From: **7**
Clock To: **5**
1st Value:
2nd Value:
Value Percent:
Continuous Index: **F04**
Within 8" of Joint: **YES**
Remarks: **Wandering**
