| Profile/Photo Observation Report | | | | | |
| P.O.#: | 52-2 | Surveyor: | M. Pielacha | PSR: | M-505-055-M-505-054 |
| Street: | Colorado Street | | Flow Control: | Not Controlled | 1 |
| US MH: | M-505-055 | DS MH: | M-505-054 | Total Length Surveyed (ft |): 4.2 |

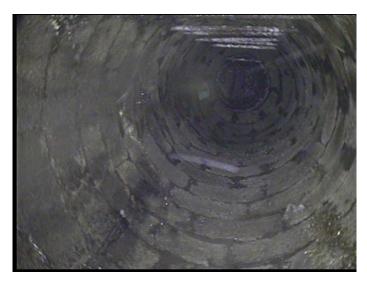
| Code: Description: | AMH Manhole |
| Remarks: | M-505-055 |

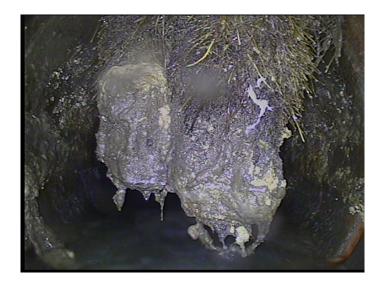
| Code: | MWL |
|---|---|
| Description: | Water Level |
| Value Percent: | 10.000 |

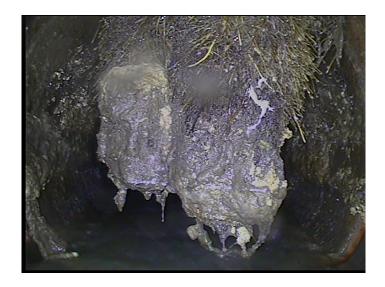
| Code: Description: | RMJ Roots Medium Joint |
| O&M Grade: | 3 |
| Value Percent: | 30.000 |

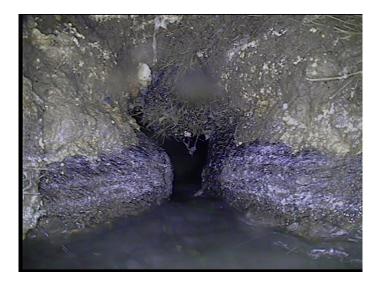
| Code: | RBJ |
|---|---|
| Description: | Roots Ball Joint |
| Distance (ft): | 2.6 |
| O&M Grade: | 4 |
| Value Percent: | 60.000 |

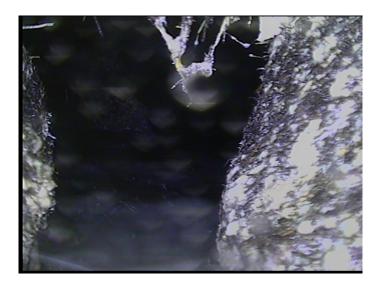
| Code: Description: | MSA Abandoned Survey |
| Distance (ft): | 4.2 |
| Remarks: | root ball |
