Profile/Photo Observation Report

Street:	Colorado Street	Flow Control:	Not Controlled
City:	Hobart, IN	Year Renewed:	
Location:	Light Highway	Tape/Media #:	DEP 53
Purpose:	Routine Assessment	Dia/Height:	18"
Use:	Sanitary	Material:	VCP
Drain Area:		Lining:	
Category:	NA		
Comment:			
Location Details:		Direction of Survey:	Upstream
US MH:	M-505-055	DS MH:	M-505-054
		Total Length Surveyed (ft):	86.7

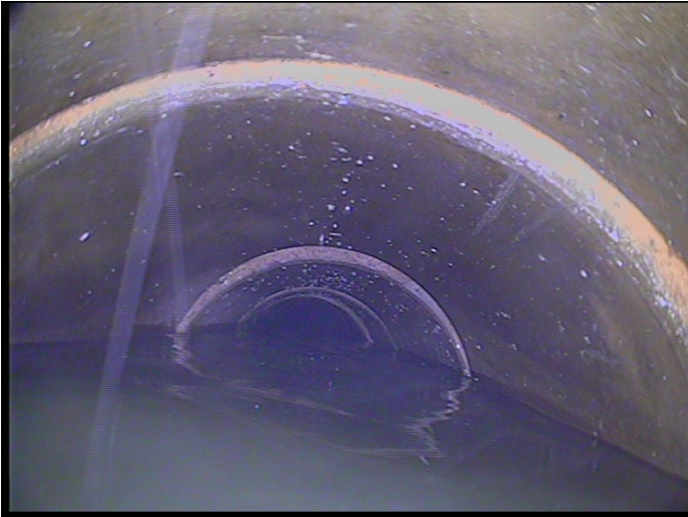
Code:	AMH
Description:	Manhole
Distance (ft):	.0
Structural Grade:	0
O&M Grade:	0
Clock Start/From:	
Clock To:	
1st Value:	
2nd Value:	
Value Percent:	
Continuous Index:	
Within 8" of Joint:	NO
Remarks:	M-505-054

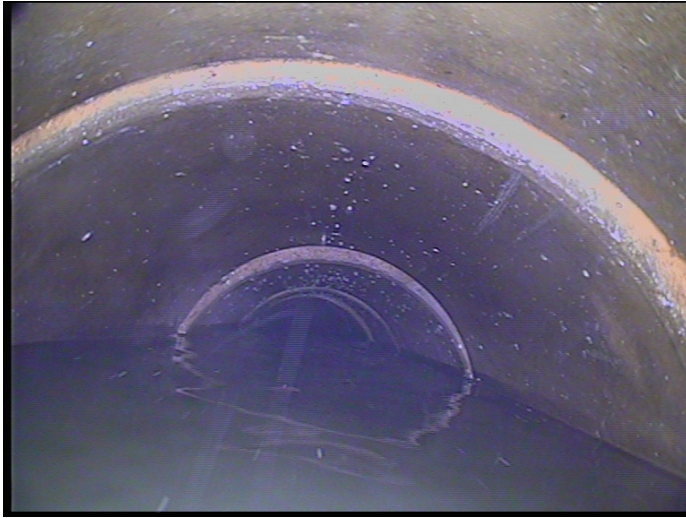
Code: **MWL**
Description: **Water Level**

Distance (ft): **.0**
Structural Grade: **0**
O&M Grade: **0**
Clock Start/From:
Clock To:
1st Value:
2nd Value:
Value Percent: **60.000**
Continuous Index:
Within 8" of Joint: **NO**
Remarks:

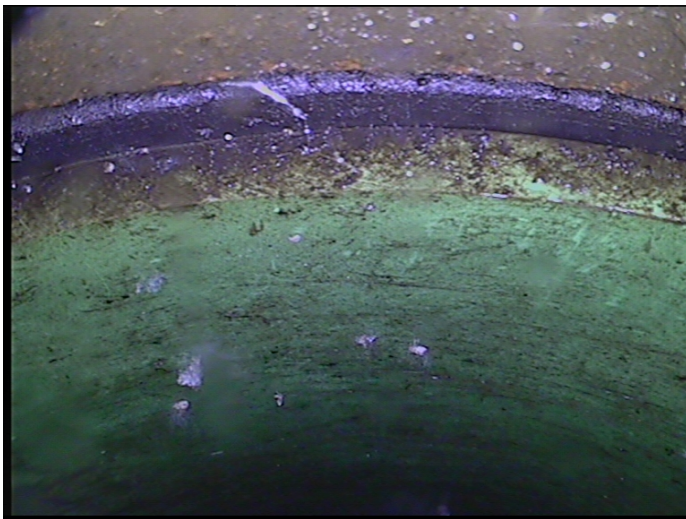
Code: **MMC**
Description: **Material Change**

Distance (ft): **26.4**
Structural Grade: **0**
O&M Grade: **0**
Clock Start/From:
Clock To:
1st Value:
2nd Value:
Value Percent:
Continuous Index:
Within 8" of Joint: **NO**
Remarks: **pvc**

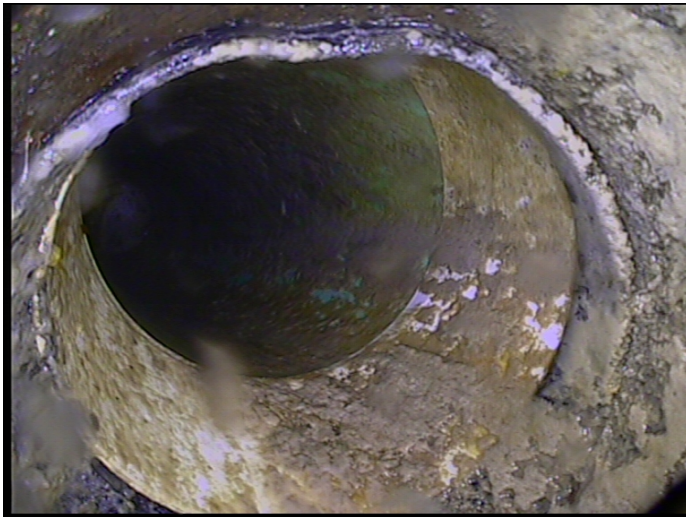
Code: **TB**
Description: **Tap Break-in**

Distance (ft): **45.6**
Structural Grade: **0**
O&M Grade: **0**
Clock Start/From: **2**
Clock To:
1st Value: **4.000**
2nd Value:
Value Percent:
Continuous Index:
Within 8" of Joint: **NO**
Remarks:

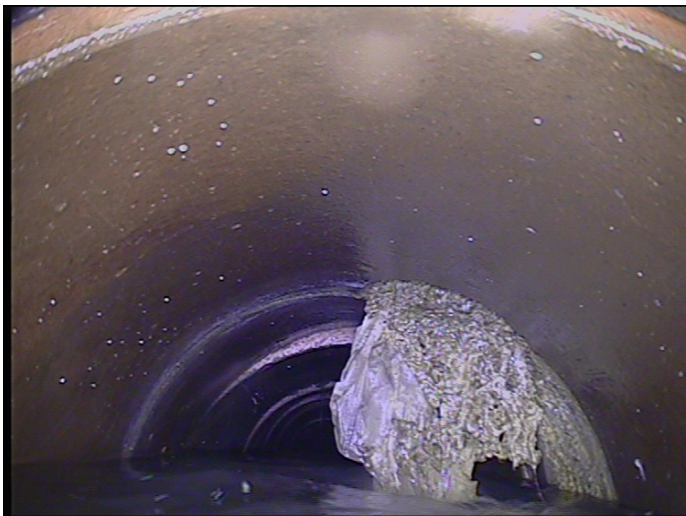
Code: **MSA**
Description: **Abandoned Survey**

Distance (ft): **86.7**
Structural Grade: **0**
O&M Grade: **0**
Clock Start/From:
Clock To:
1st Value:
2nd Value:
Value Percent:
Continuous Index:
Within 8" of Joint: **NO**
Remarks: **under water debris**
