## Profile/Photo Observation Report

Date:	<b>04/15/2018</b>	Weather:		Coding:	<b>PACP 6.0</b>
Pipe Length (ft):		Owner:	<b>City of Hobart</b>	Pre Clean:	<b>No Pre-Cleaning</b>
P.O.#:	<b>53-1</b>	Surveyor:	<b>M. Pielacha</b>	PSR:	<b>M-505-055-M-505-054</b>
Customer:	<b>City of Hobart</b>	Clean Date:		Shape:	<b>C</b>

Street:	<b>Colorado Street</b>	Flow Control:	<b>Not Controlled</b>
City:	<b>Hobart, IN</b>	Year Renewed:	
Location:	<b>Light Highway</b>	Tape/Media #:	<b>DEP 53</b>
Purpose:	<b>Routine Assessment</b>	Dia/Height:	<b>18"</b>
Use:	<b>Sanitary</b>	Material:	<b>VCP</b>
Drain Area:		Lining:

US MH: **M-505-055** DS MH: **M-505-054** Total Length Surveyed (ft): **86.7**

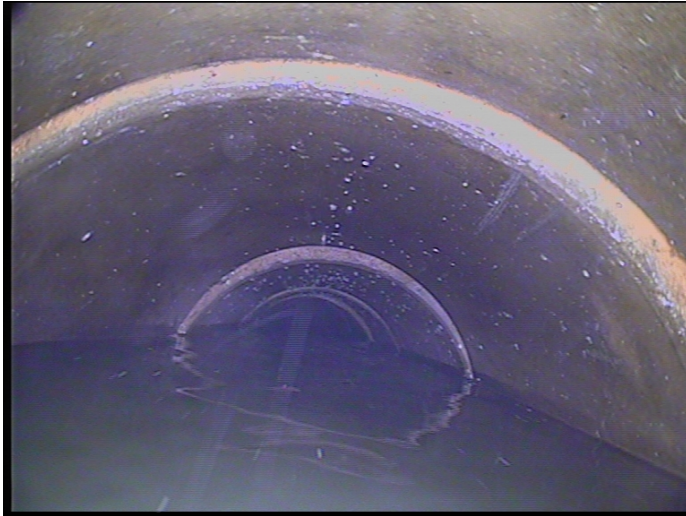
Code:	AMH
Description:	Manhole
Distance (ft):	.0
Structural Grade:	0
O&M Grade:	0
Clock Start/From:	
Clock To:	
1st Value:	
2nd Value:	
Value Percent:	
Continuous Index:	
Within 8" of Joint:	NO
Remarks:	M-505-054

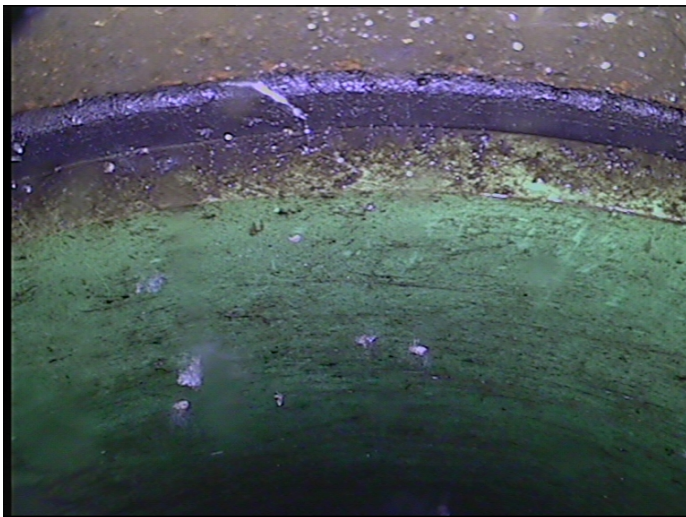
Code: **MWL**  
Description: **Water Level**

Distance (ft): **.0**  
Structural Grade: **0**  
O&M Grade: **0**  
Clock Start/From:  
Clock To:  
1st Value:  
2nd Value:  
Value Percent: **60.000**  
Continuous Index:  
Within 8" of Joint: **NO**  
Remarks:

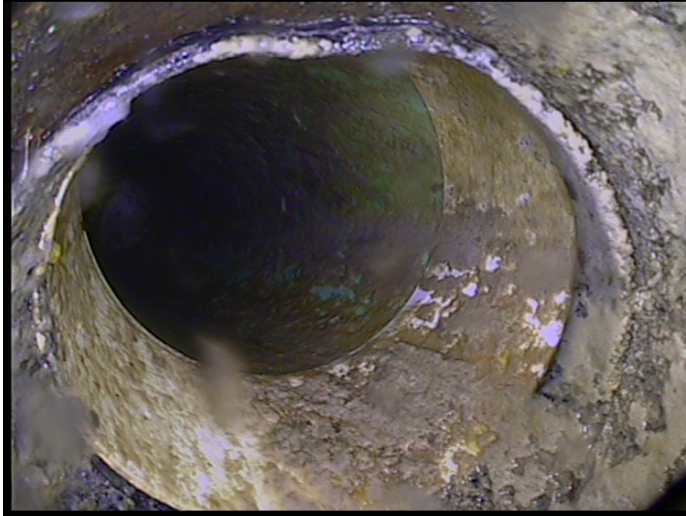
Code: **MMC**  
Description: **Material Change**

Distance (ft): **26.4**  
Structural Grade: **0**  
O&M Grade: **0**  
Clock Start/From:  
Clock To:  
1st Value:  
2nd Value:  
Value Percent:  
Continuous Index:  
Within 8" of Joint: **NO**  
Remarks: **pvc**

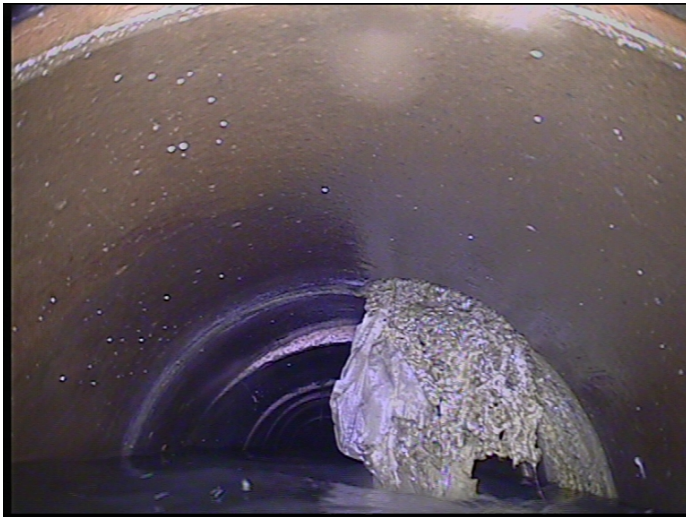
Code: **TB**  
Description: **Tap Break-in**

Distance (ft): **45.6**  
Structural Grade: **0**  
O&M Grade: **0**  
Clock Start/From: **2**  
Clock To:  
1st Value: **4.000**  
2nd Value:  
Value Percent:  
Continuous Index:  
Within 8" of Joint: **NO**  
Remarks:
