Profile/Photo Observation Report

| Street: | South Colorado Street | Flow Control: | Not Controlled |
| Purpose: | Sewer System Evaluation Survey (SS | Dia/Height: | 18" |
| US MH: | M-505-055 | DS MH: | M-505-054 |

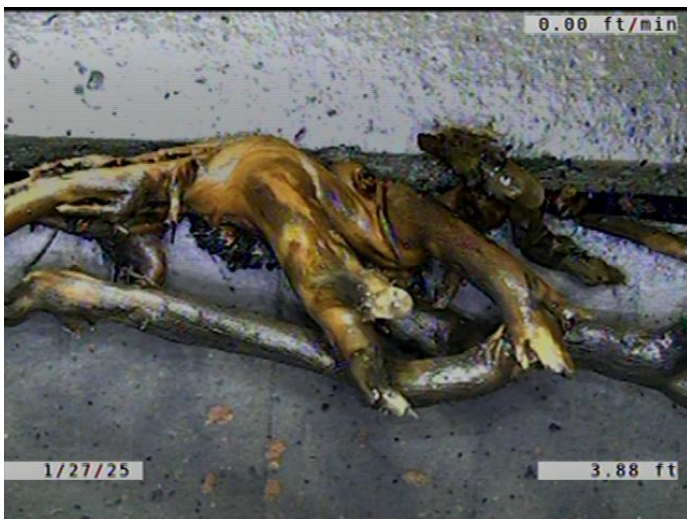
| Distance (ft): | 3.9 |

| | Position | Code | Observation | Video (sec) | Grade |
|--|---|---|---|---|---|
| | 3.9 | RTJ(S01) | Roots Tap Joint | 169 | M 2 |

| Description: | Roots Tap Joint |
| O&M Grade: | 2 |
| Value Percent: | 5.000 |

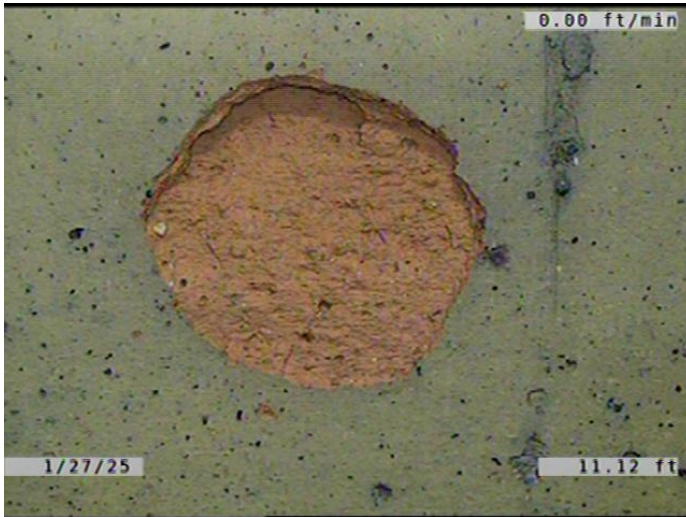
| Distance (ft): | 11.1 |

| | Position | Code | Observation | Video (sec) | Grade |
|--|---|---|---|---|---|
| | 11.1 | SSC | Surface Spalling of Damage Coating | 220 | S 1 |

| Description: | Surface Spalling of Damage Coating |
| Structural Grade: | 1 |

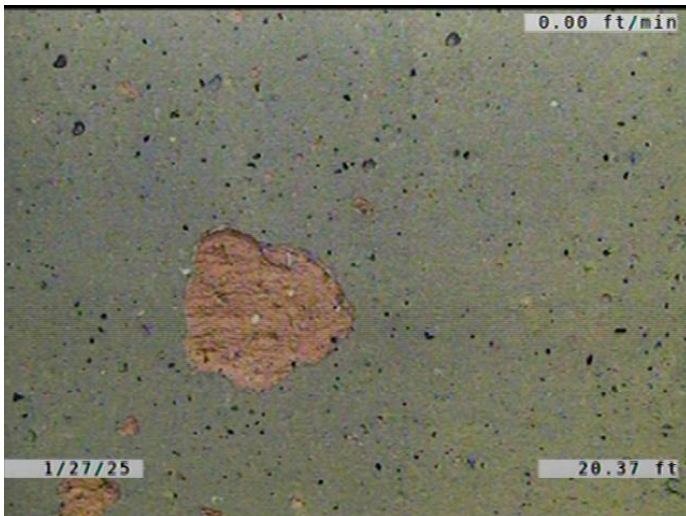
| Distance (ft): | 20.4 |

| | Position | Code | Observation | Video (sec) | Grade |
|--|---|---|---|---|---|
| | 20.4 | SSC | Surface Spalling of Damage Coating | 286 | S 1 |

| Description: | Surface Spalling of Damage Coating |
| Structural Grade: | 1 |

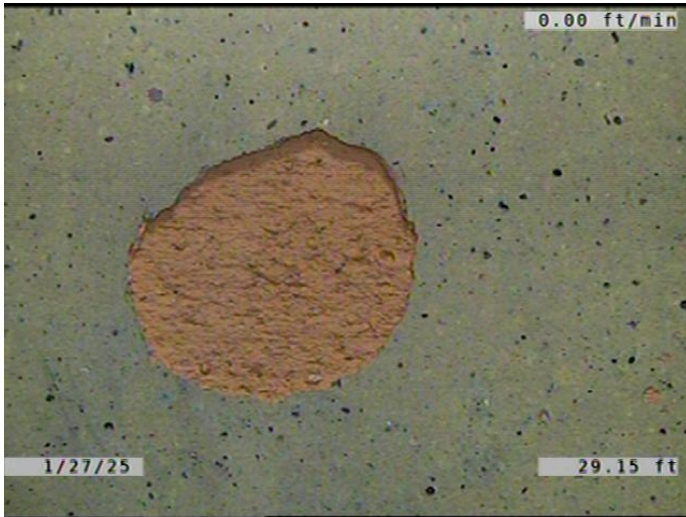
| | Position | Code | Observation | Video (sec) | Grade |
|--|---|---|---|---|---|
| | 29.2 | SSC | Surface Spalling of Damage Coating | 334 | S 1 |

Code: **SSC**
Description: **Surface Spalling of Damage Coating**

Distance (ft): **29.2**
Structural Grade: **1**
O&M Grade: **0**
Clock Start/From: **12**
Clock To:
1st Value:
2nd Value:
Value Percent:
Continuous Index:
Within 8" of Joint: **YES**
Remarks:

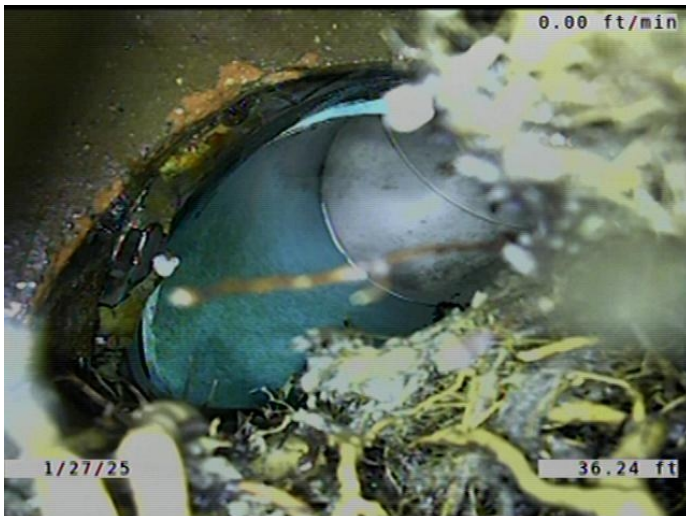
| | Position | Code | Observation | Video (sec) | Grade |
|--|---|---|---|---|---|
| | 36.2 | TFD | Tap Factory Defective | 506 | M 3 |
| | 36.2 | RML | Roots Medium Lateral | 550 | M 3 |

Code: **TFD**
Description: **Tap Factory Defective**

Distance (ft): **36.2**
Structural Grade: **0**
O&M Grade: **3**
Clock Start/From: **11**
Clock To:
1st Value: **6.000**
2nd Value:
Value Percent:
Continuous Index:
Within 8" of Joint: **YES**
Remarks: **SERVICE IS PVC. TAP IS VCP. ROOTS GROWING THROUGH THE SADDLE/**

| Description: | Roots Medium Lateral |
| O&M Grade: | 3 |
| Value Percent: | 25.000 |
| Remarks: | ROOTS GROWING THROUGH THE SADDLE/ FERNCO CONNECTION INT |

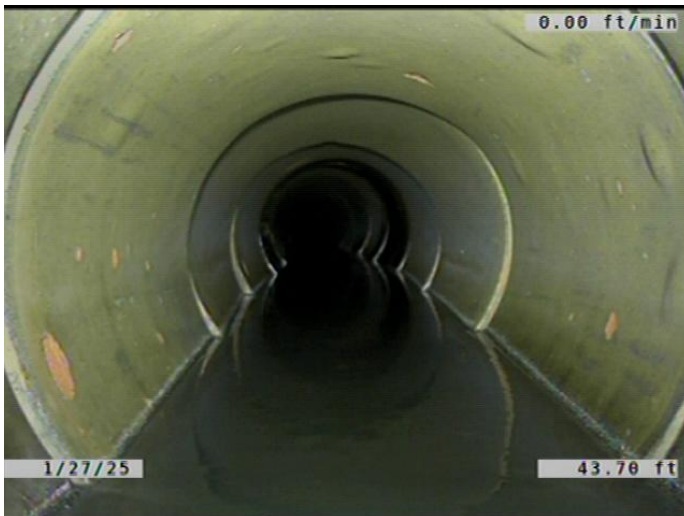
| Distance (ft): | 43.7 |

| | Position | Code | Observation | Video (sec) | Grade |
|--|---|---|---|---|---|
| | 43.7 | RTJ(F01) | Roots Tap Joint | 677 | M 2 |

| Description: | Roots Tap Joint |
| O&M Grade: | 2 |
| Value Percent: | 5.000 |

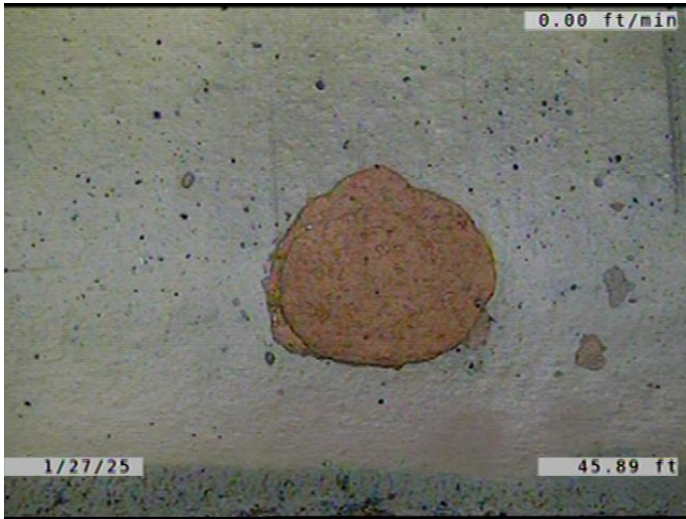
| | Position | Code | Observation | Video (sec) | Grade |
|--|---|---|---|---|---|
| | 45.9 | SSC | Surface Spalling of Damage Coating | 705 | S 1 |

Code: **SSC**
Description: **Surface Spalling of Damage Coating**

Distance (ft): **45.9**
Structural Grade: **1**
O&M Grade: **0**
Clock Start/From: **8**
Clock To:
1st Value:
2nd Value:
Value Percent:
Continuous Index:
Within 8" of Joint: **YES**
Remarks:

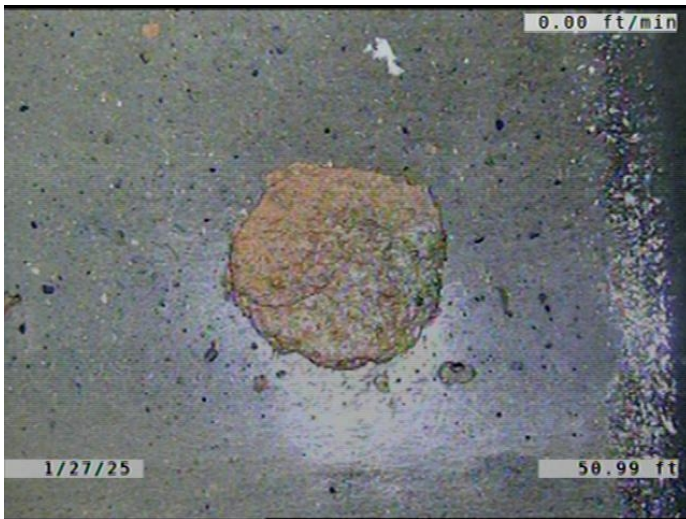
| | Position | Code | Observation | Video (sec) | Grade |
|--|---|---|---|---|---|
| | 51.0 | SSC | Surface Spalling of Damage Coating | 746 | S 1 |

Code: **SSC**
Description: **Surface Spalling of Damage Coating**

Distance (ft): **51.0**
Structural Grade: **1**
O&M Grade: **0**
Clock Start/From: **8**
Clock To:
1st Value:
2nd Value:
Value Percent:
Continuous Index:
Within 8" of Joint: **YES**
Remarks:

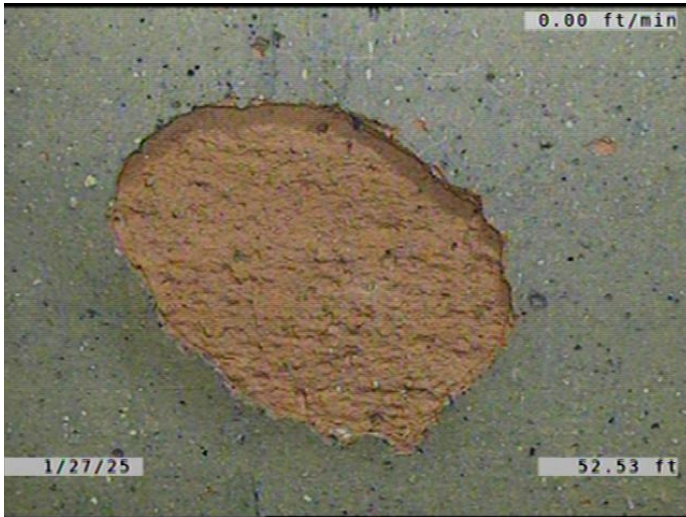
| Distance (ft): | 52.5 |

| | Position | Code | Observation | Video (sec) | Grade |
|--|---|---|---|---|---|
| | 52.5 | SSC | Surface Spalling of Damage Coating | 774 | S 1 |

| Description: | Surface Spalling of Damage Coating |
| Structural Grade: | 1 |

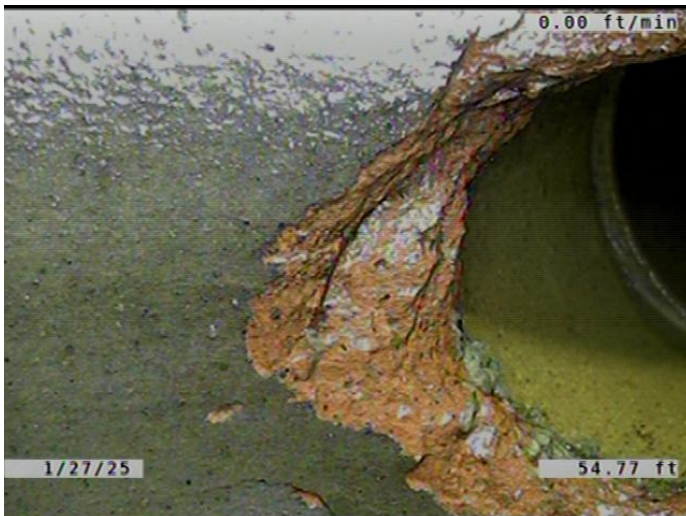
| Distance (ft): | 54.8 |

| | Position | Code | Observation | Video (sec) | Grade |
|--|---|---|---|---|---|
| | 54.8 | SSS | Surface Damage Surface Spalling | 821 | S 2 |

| Description: | Surface Damage Surface Spalling |
| Structural Grade: | 2 |

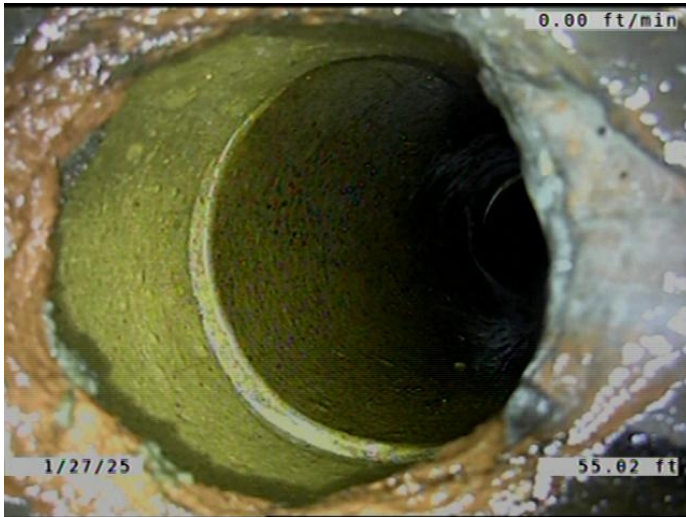
| Distance (ft): | 55.0 |

| | Position | Code | Observation | Video (sec) | Grade |
|--|---|---|---|---|---|
| | 55.0 | TBD | Tap Break-in/Hammer Defective | 835 | M 3 |

| Description: | Tap Break-in/Hammer Defective |
| O&M Grade: | 3 |
| Remarks: | CONSTANTLY RUNNING WATER. SERVICE COMES IN FROM THE RIGHT |

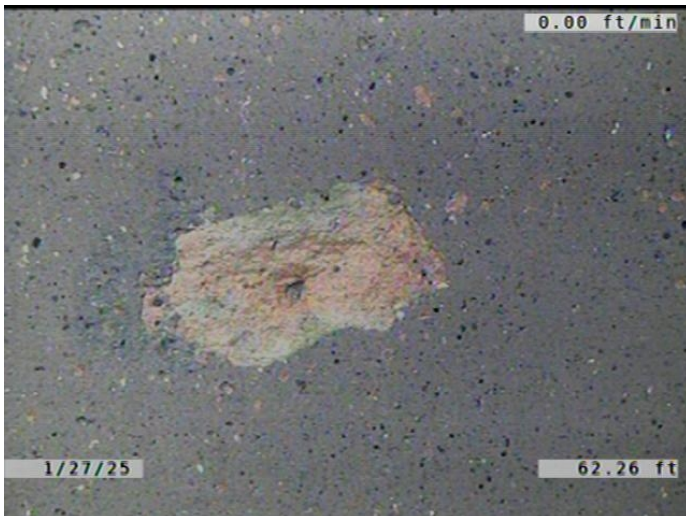
| Distance (ft): | 62.3 |

| | Position | Code | Observation | Video (sec) | Grade |
|--|---|---|---|---|---|
| | 62.3 | SSC | Surface Spalling of Damage Coating | 879 | S 1 |

| Description: | Surface Spalling of Damage Coating |
| Structural Grade: | 1 |

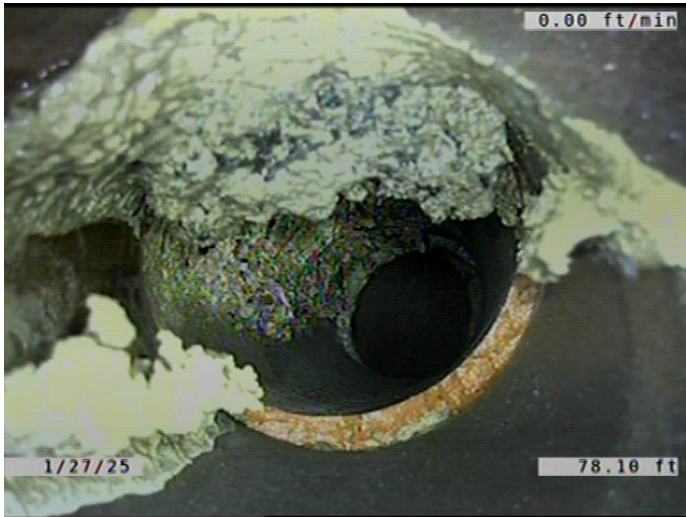
| Distance (ft): | 78.1 |

| | Position | Code | Observation | Video (sec) | Grade |
|--|---|---|---|---|---|
| | 78.1 | TFD | Tap Factory Defective | 958 | M 3 |

| Description: | Tap Factory Defective |
| O&M Grade: | 3 |
| Remarks: | CONSTANTLY DRIPPING WATER. ENCrustATION COMING DOWN THE |

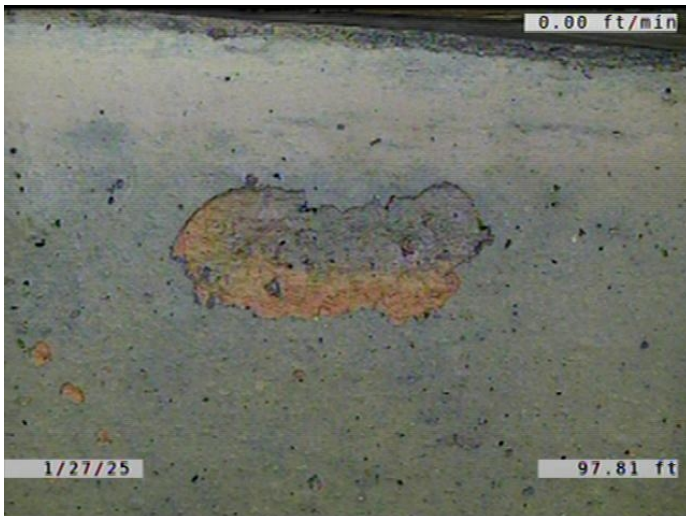
| Distance (ft): | 97.8 |

| | Position | Code | Observation | Video (sec) | Grade |
|--|---|---|---|---|---|
| | 97.8 | SSC | Surface Spalling of Damage Coating | 1066 | S 1 |

| Description: | Surface Spalling of Damage Coating |
| Structural Grade: | 1 |

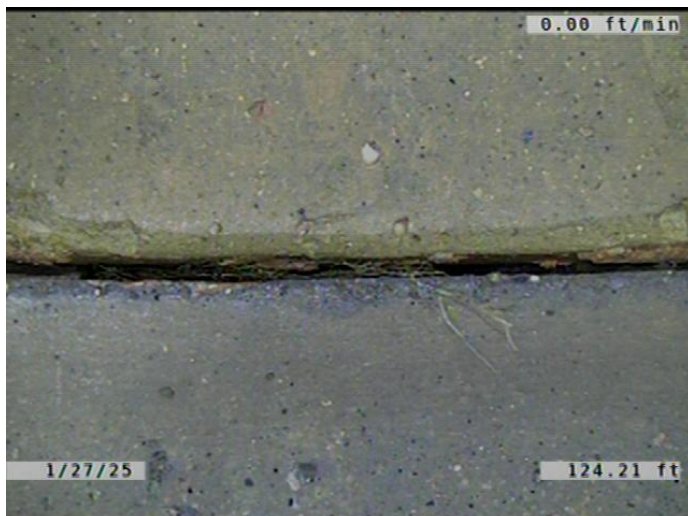
| | Position | Code | Observation | Video (sec) | Grade |
|--|---|---|---|---|---|
| | 124.2 | RFJ | Roots Fine Joint | 1238 | M 1 |

Code: **RFJ**
Description: **Roots Fine Joint**

Distance (ft): **124.2**
Structural Grade: **0**
O&M Grade: **1**
Clock Start/From: **8**
Clock To: **11**
1st Value:
2nd Value:
Value Percent:
Continuous Index:
Within 8" of Joint: **YES**
Remarks:

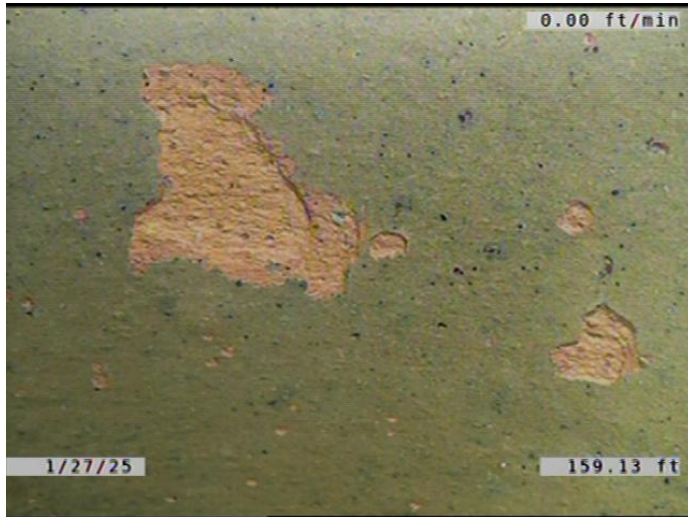
| Distance (ft): | 159.1 |

| | Position | Code | Observation | Video (sec) | Grade |
|--|---|---|---|---|---|
| | 159.1 | SSC | Surface Spalling of Damage Coating | 1515 | S 1 |

| Description: | Surface Spalling of Damage Coating |
| Structural Grade: | 1 |
