## Profile/Photo Observation Report

Street:	<b>S COLORADO ST &amp; W 1ST PL</b>	Flow Control:	<b>Not Controlled</b>
City:	<b>Hobart, IN</b>	Year Renewed:	
Location:	<b>Light Highway</b>	Tape/Media #:	
Purpose:	<b>Routine Assessment</b>	Dia/Height:	<b>12"</b>
Use:	<b>Sanitary</b>	Material:	<b>VCP</b>
Drain Area:	<b>NA</b>	Lining:	
Category:	<b>NA</b>		
Comment:	<b>MH_F at 262 ft false . Just about fell in to D_C . Flow direction wrong</b>		
Location Details:		Direction of Survey:	<b>Upstream</b>
US MH:	<b>M-505-056</b>	DS MH:	<b>M-505-063</b>
		Total Length Surveyed (ft):	<b>263.5</b>

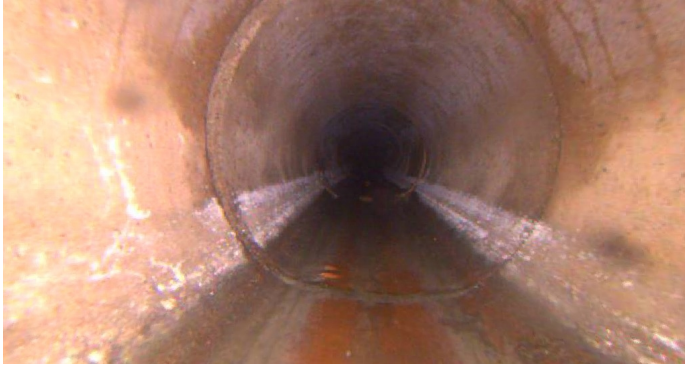
Code: **AMH**  
Description: **Manhole**

Distance (ft): **.0**  
Structural Grade: **0**  
O&M Grade: **0**  
Clock Start/From:  
Clock To:  
1st Value:  
2nd Value:  
Value Percent:  
Continuous Index:  
Within 8" of Joint: **NO**  
Remarks: **M-505-063**

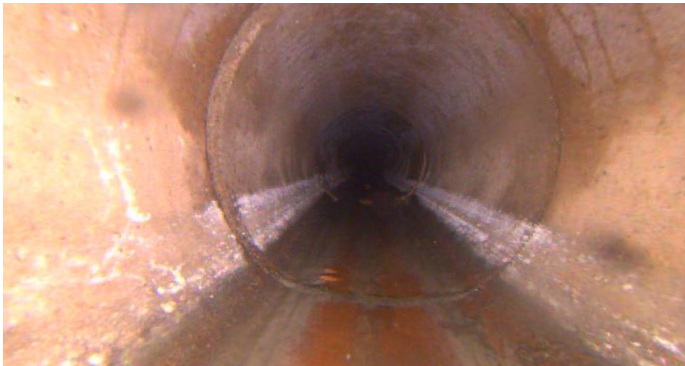
Code: **MWL**  
Description: **Water Level**

Distance (ft): **.0**  
Structural Grade: **0**  
O&M Grade: **0**  
Clock Start/From:  
Clock To:  
1st Value:  
2nd Value:  
Value Percent: **10.000**  
Continuous Index:  
Within 8" of Joint: **NO**  
Remarks:

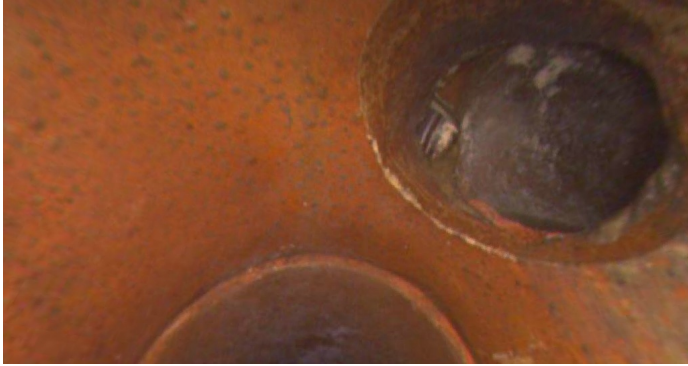
Code: **TF**  
Description: **Tap Factory**

Distance (ft): **23.0**  
Structural Grade: **0**  
O&M Grade: **0**  
Clock Start/From: **10**  
Clock To:  
1st Value: **4.000**  
2nd Value:  
Value Percent:  
Continuous Index:  
Within 8" of Joint:  
Remarks:

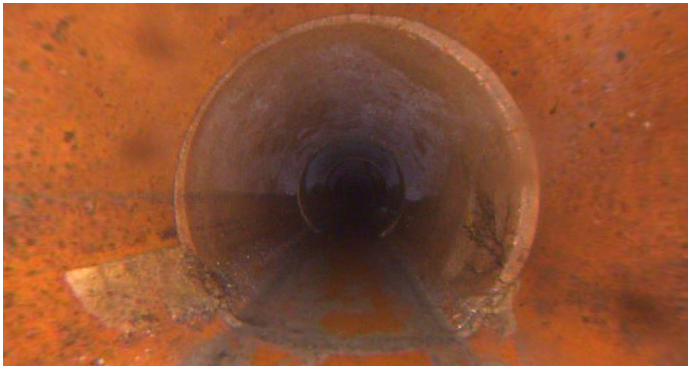
Code: **RFJ**  
Description: **Roots Fine Joint**

Distance (ft): **23.0**  
Structural Grade: **0**  
O&M Grade: **1**  
Clock Start/From: **7**  
Clock To: **5**  
1st Value:  
2nd Value:  
Value Percent:  
Continuous Index:  
Within 8" of Joint: **YES**  
Remarks:

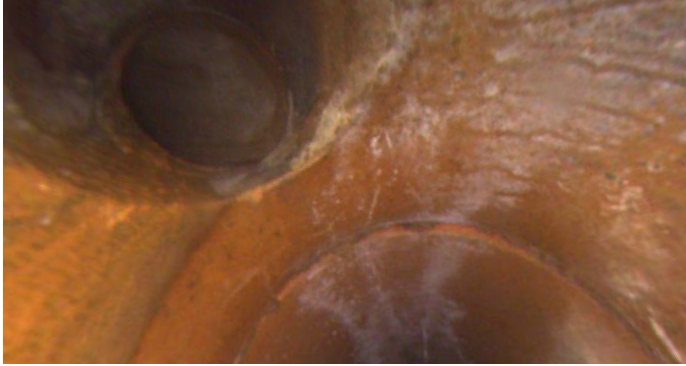
Code: **TF**  
Description: **Tap Factory**

Distance (ft): **36.9**  
Structural Grade: **0**  
O&M Grade: **0**  
Clock Start/From: **2**  
Clock To:  
1st Value: **4.000**  
2nd Value:  
Value Percent:  
Continuous Index:  
Within 8" of Joint:  
Remarks:

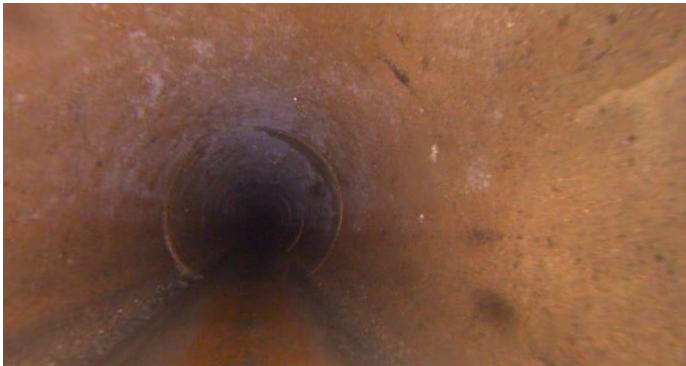
Code: **CL**  
Description: **Crack Longitudinal**

Distance (ft): **50.2**  
Structural Grade: **2**  
O&M Grade: **0**  
Clock Start/From: **3**  
Clock To:  
1st Value:  
2nd Value:  
Value Percent:  
Continuous Index:  
Within 8" of Joint: **YES**  
Remarks:

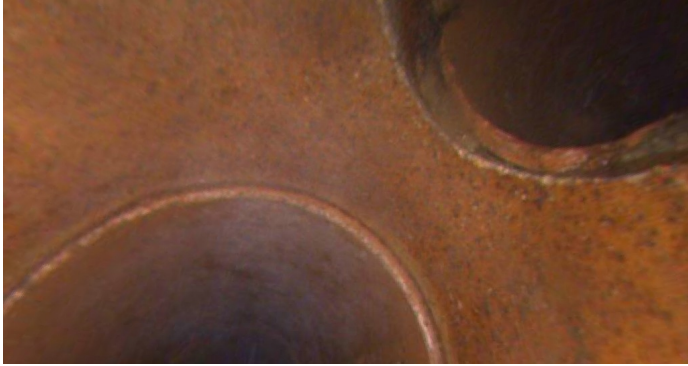
Code: **TF**  
Description: **Tap Factory**

Distance (ft): **71.1**  
Structural Grade: **0**  
O&M Grade: **0**  
Clock Start/From: **10**  
Clock To:  
1st Value: **4.000**  
2nd Value:  
Value Percent:  
Continuous Index:  
Within 8" of Joint:  
Remarks:

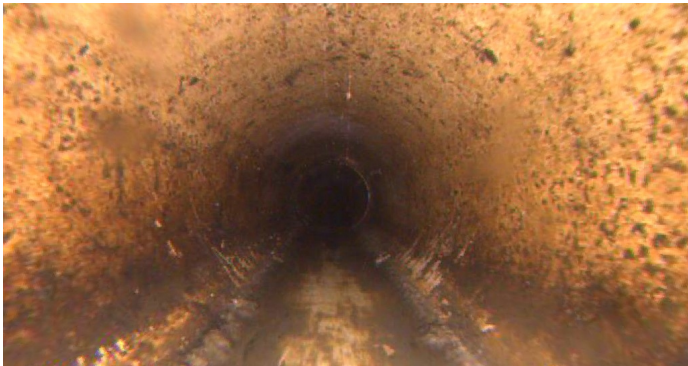
Code: **MMC**  
Description: **Material Change**

Distance (ft): **81.2**  
Structural Grade: **0**  
O&M Grade: **0**  
Clock Start/From:  
Clock To:  
1st Value:  
2nd Value:  
Value Percent:  
Continuous Index:  
Within 8" of Joint: **NO**  
Remarks: **PVC**

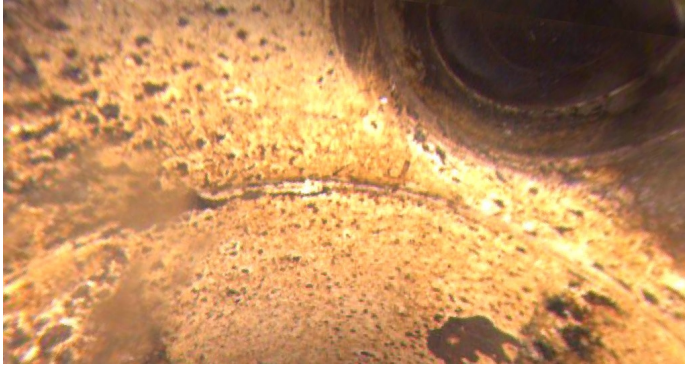
Code: **TF**  
Description: **Tap Factory**

Distance (ft): **85.0**  
Structural Grade: **0**  
O&M Grade: **0**  
Clock Start/From: **2**  
Clock To:  
1st Value: **4.000**  
2nd Value:  
Value Percent:  
Continuous Index:  
Within 8" of Joint:  
Remarks:

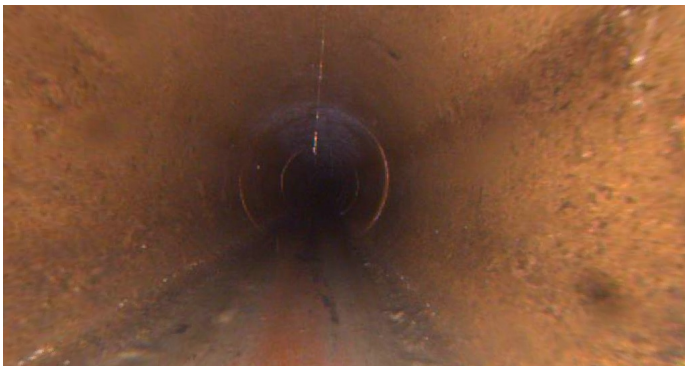
Code: **MMC**  
Description: **Material Change**

Distance (ft): **91.2**  
Structural Grade: **0**  
O&M Grade: **0**  
Clock Start/From:  
Clock To:  
1st Value:  
2nd Value:  
Value Percent:  
Continuous Index:  
Within 8" of Joint: **NO**  
Remarks: **VCP**

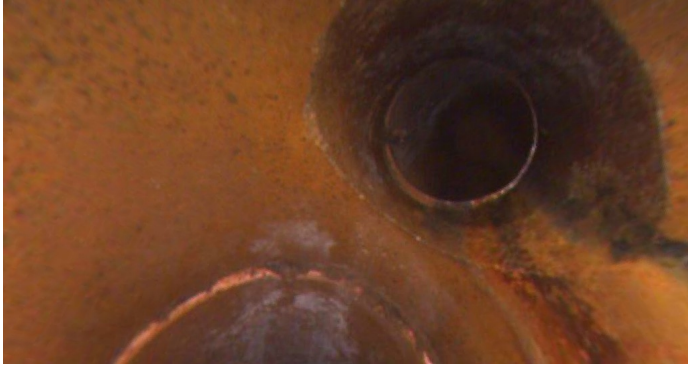
Code: **TF**  
Description: **Tap Factory**

Distance (ft): **114.7**  
Structural Grade: **0**  
O&M Grade: **0**  
Clock Start/From: **10**  
Clock To:  
1st Value: **4.000**  
2nd Value:  
Value Percent:  
Continuous Index:  
Within 8" of Joint:  
Remarks:

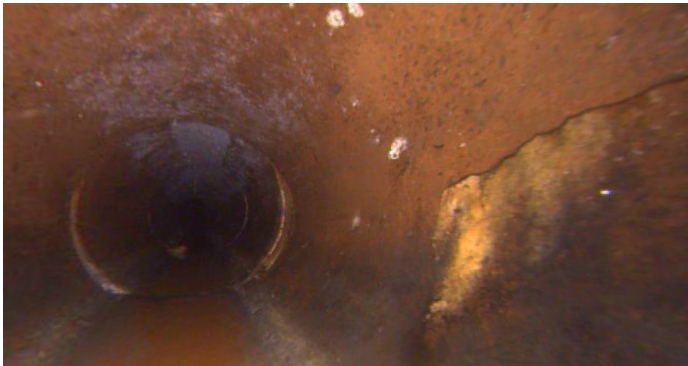
Code: **CL**  
Description: **Crack Longitudinal**

Distance (ft): **115.7**  
Structural Grade: **2**  
O&M Grade: **0**  
Clock Start/From: **3**  
Clock To:  
1st Value:  
2nd Value:  
Value Percent:  
Continuous Index:  
Within 8" of Joint: **YES**  
Remarks:

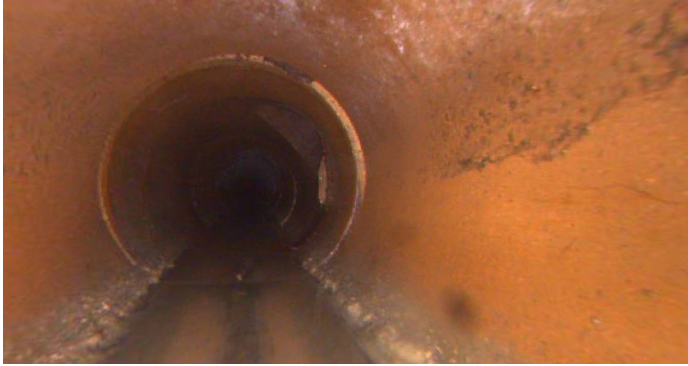
Code: **CL**  
Description: **Crack Longitudinal**

Distance (ft): **126.3**  
Structural Grade: **2**  
O&M Grade: **0**  
Clock Start/From: **4**  
Clock To:  
1st Value:  
2nd Value:  
Value Percent:  
Continuous Index:  
Within 8" of Joint: **YES**  
Remarks:

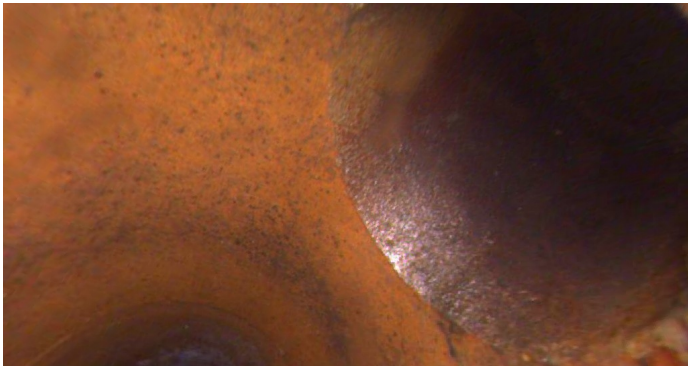
Code: **TF**  
Description: **Tap Factory**

Distance (ft): **128.2**  
Structural Grade: **0**  
O&M Grade: **0**  
Clock Start/From: **2**  
Clock To:  
1st Value: **4.000**  
2nd Value:  
Value Percent:  
Continuous Index:  
Within 8" of Joint:  
Remarks:

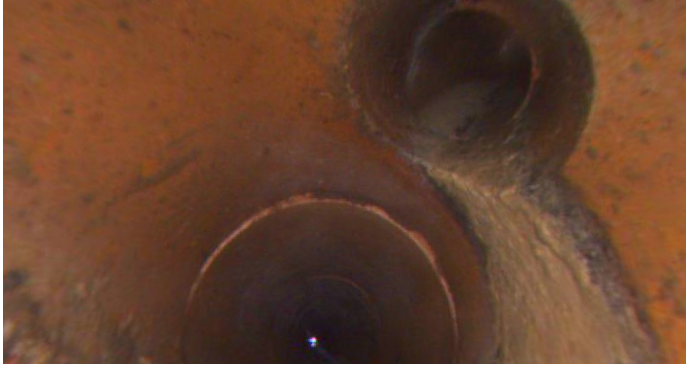
Code: **TF**  
Description: **Tap Factory**

Distance (ft): **147.1**  
Structural Grade: **0**  
O&M Grade: **0**  
Clock Start/From: **11**  
Clock To:  
1st Value: **4.000**  
2nd Value:  
Value Percent:  
Continuous Index:  
Within 8" of Joint:  
Remarks:

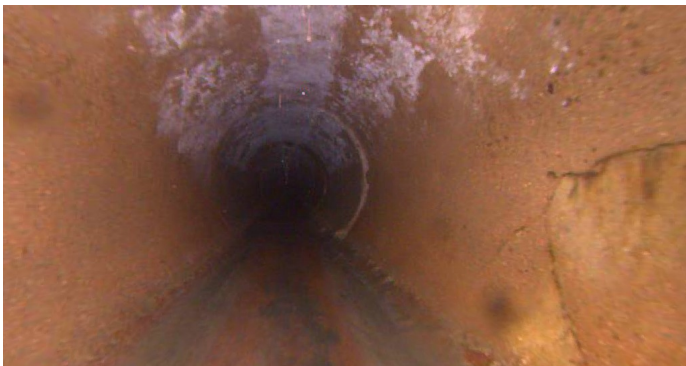
Code: **CM**  
Description: **Crack Multiple**

Distance (ft): **155.8**  
Structural Grade: **3**  
O&M Grade: **0**  
Clock Start/From: **4**  
Clock To: **5**  
1st Value:  
2nd Value:  
Value Percent:  
Continuous Index:  
Within 8" of Joint: **YES**  
Remarks:

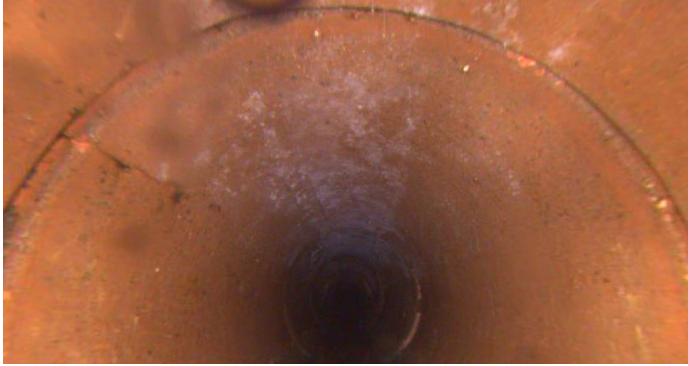
Code: **CL**  
Description: **Crack Longitudinal**

Distance (ft): **161.4**  
Structural Grade: **2**  
O&M Grade: **0**  
Clock Start/From: **10**  
Clock To:  
1st Value:  
2nd Value:  
Value Percent:  
Continuous Index:  
Within 8" of Joint: **YES**  
Remarks:

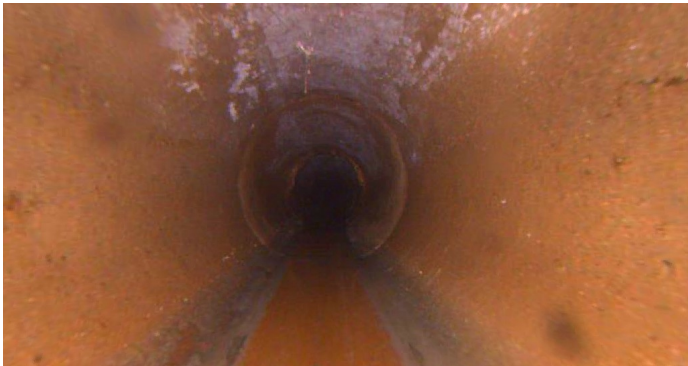
Code: **CL**  
Description: **Crack Longitudinal**

Distance (ft): **163.9**  
Structural Grade: **2**  
O&M Grade: **0**  
Clock Start/From: **3**  
Clock To:  
1st Value:  
2nd Value:  
Value Percent:  
Continuous Index:  
Within 8" of Joint: **YES**  
Remarks:

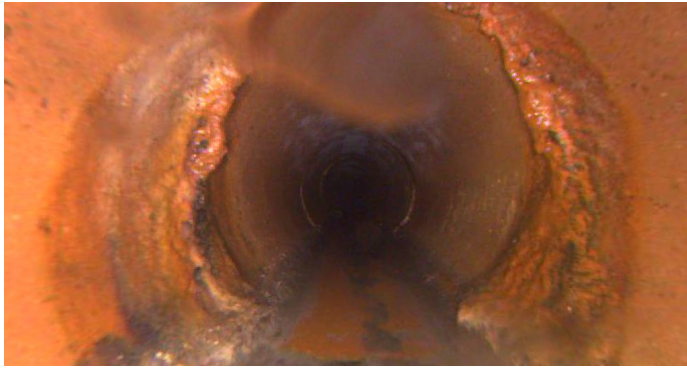
Code:	<b>DAZ</b>
Description:	<b>Deposits Attached Other</b>
Distance (ft):	<b>167.1</b>
Structural Grade:	<b>0</b>
O&M Grade:	<b>2</b>
Clock Start/From:	<b>7</b>
Clock To:	<b>5</b>
1st Value:	
2nd Value:	
Value Percent:	<b>5.000</b>
Continuous Index:	
Within 8" of Joint:	<b>YES</b>
Remarks:

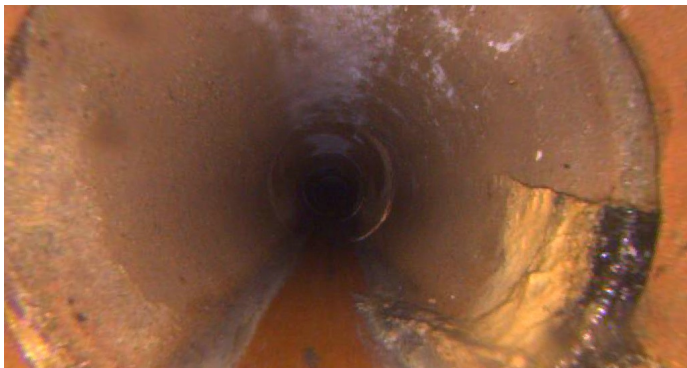
Code:	<b>CL</b>
Description:	<b>Crack Longitudinal</b>
Distance (ft):	<b>175.3</b>
Structural Grade:	<b>2</b>
O&M Grade:	<b>0</b>
Clock Start/From:	<b>4</b>
Clock To:	
1st Value:	
2nd Value:	
Value Percent:	
Continuous Index:	
Within 8" of Joint:	<b>YES</b>
Remarks:

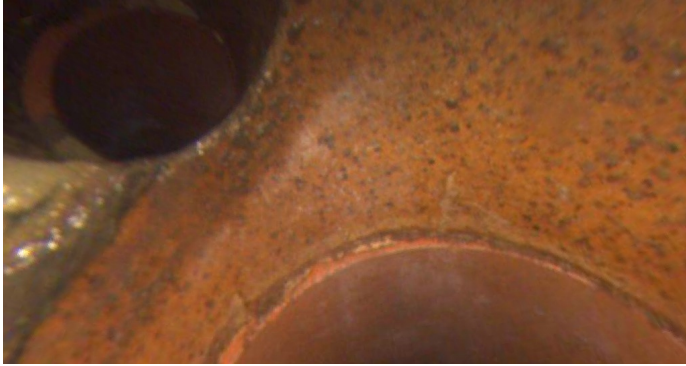
Code: **TF**  
Description: **Tap Factory**

Distance (ft): **182.4**  
Structural Grade: **0**  
O&M Grade: **0**  
Clock Start/From: **2**  
Clock To:  
1st Value: **4.000**  
2nd Value:  
Value Percent:  
Continuous Index:  
Within 8" of Joint:  
Remarks:

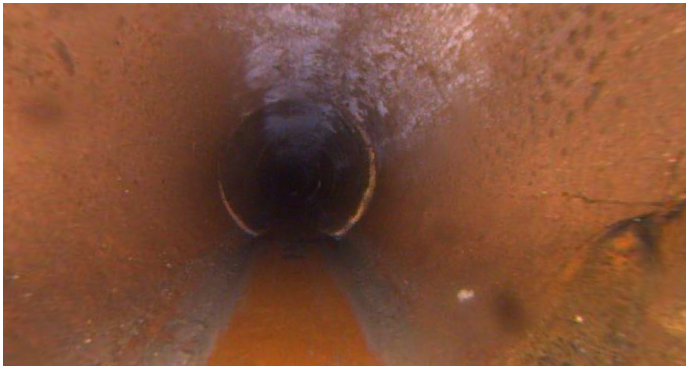
Code: **CL**  
Description: **Crack Longitudinal**

Distance (ft): **184.7**  
Structural Grade: **2**  
O&M Grade: **0**  
Clock Start/From: **4**  
Clock To:  
1st Value:  
2nd Value:  
Value Percent:  
Continuous Index:  
Within 8" of Joint: **YES**  
Remarks:

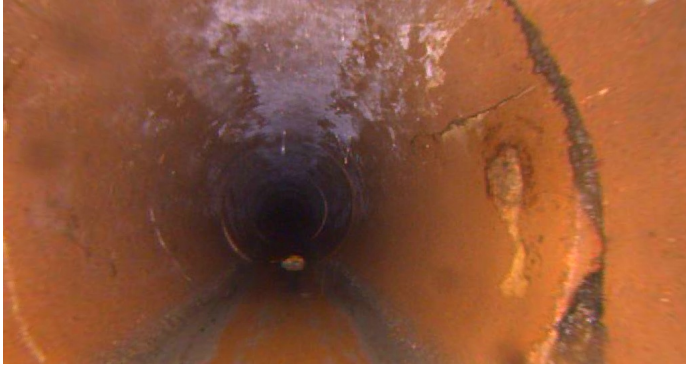
Code: **CL**  
Description: **Crack Longitudinal**

Distance (ft): **190.4**  
Structural Grade: **2**  
O&M Grade: **0**  
Clock Start/From: **3**  
Clock To:  
1st Value:  
2nd Value:  
Value Percent:  
Continuous Index:  
Within 8" of Joint: **YES**  
Remarks:

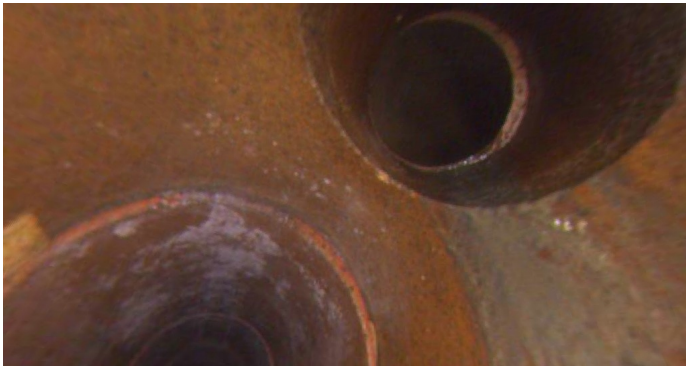
Code: **TF**  
Description: **Tap Factory**

Distance (ft): **201.8**  
Structural Grade: **0**  
O&M Grade: **0**  
Clock Start/From: **10**  
Clock To:  
1st Value: **4.000**  
2nd Value:  
Value Percent:  
Continuous Index:  
Within 8" of Joint:  
Remarks:

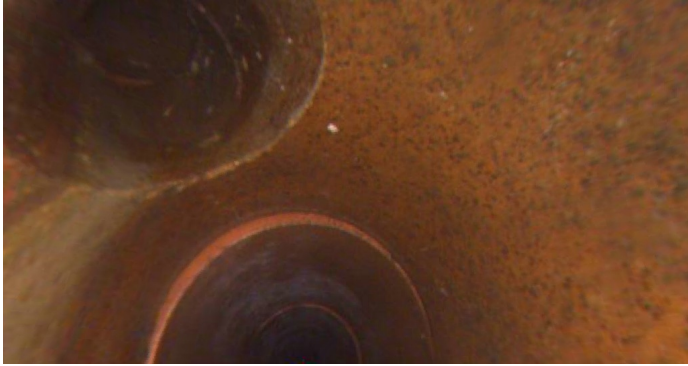
Code: **TF**  
Description: **Tap Factory**

Distance (ft): **218.9**  
Structural Grade: **0**  
O&M Grade: **0**  
Clock Start/From: **2**  
Clock To:  
1st Value: **4.000**  
2nd Value:  
Value Percent:  
Continuous Index:  
Within 8" of Joint:  
Remarks:

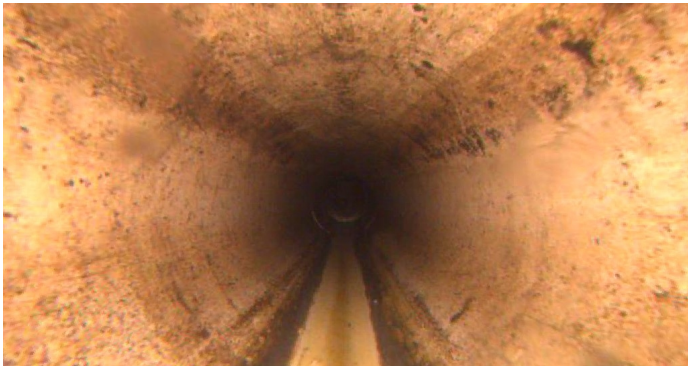
Code: **MMC**  
Description: **Material Change**

Distance (ft): **254.7**  
Structural Grade: **0**  
O&M Grade: **0**  
Clock Start/From:  
Clock To:  
1st Value:  
2nd Value:  
Value Percent:  
Continuous Index:  
Within 8" of Joint: **NO**  
Remarks: **PVC**

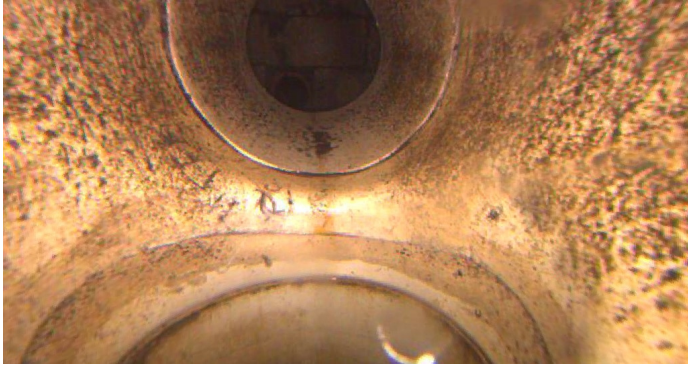
Code: **TF**  
Description: **Tap Factory**

Distance (ft): **261.2**  
Structural Grade: **0**  
O&M Grade: **0**  
Clock Start/From: **6**  
Clock To:  
1st Value: **4.000**  
2nd Value:  
Value Percent:  
Continuous Index:  
Within 8" of Joint:  
Remarks: **Drop connection**

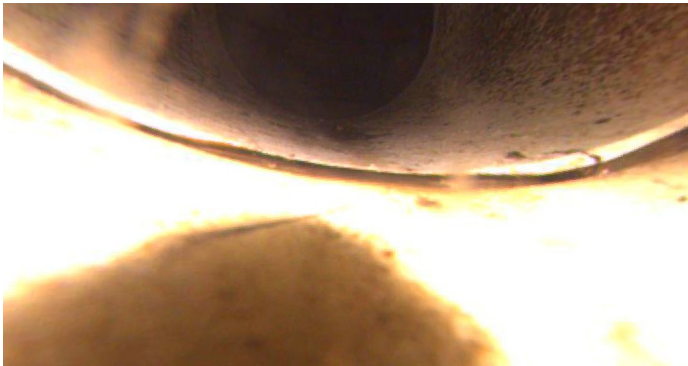
Code: **AMH**  
Description: **Manhole**

Distance (ft): **263.5**  
Structural Grade: **0**  
O&M Grade: **0**  
Clock Start/From:  
Clock To:  
1st Value:  
2nd Value:  
Value Percent:  
Continuous Index:  
Within 8" of Joint: **NO**  
Remarks: **M-505-056**
