## Profile/Photo Observation Report

Date:	<b>01/27/2025</b>	Weather:		Coding:	<b>PACP 7.0</b>
Pipe Length (ft):	<b>169.0</b>	Owner:	<b>City of Hobart</b>	Pre Clean:	<b>Heavy Cleaning</b>
P.O.#:	<b>YES502259</b>	Surveyor:	<b>S. Bucklin</b>	PSR:	<b>P-505-057-056</b>
Customer:	<b>City of Hobart</b>	Clean Date:	<b>12/27/2024</b>	Shape:	<b>C</b>

Street:	<b>South Colorado Street</b>	Flow Control:	<b>Not Controlled</b>
City:	<b>Hobart, IN</b>	Year Renewed:	
Location:	<b>Local rural streets with light traffic, t</b>	Tape/Media #:	
Purpose:	<b>Sewer System Evaluation Survey (SS</b>	Dia/Height:	<b>18"</b>
Use:	<b>Sanitary Sewage Pipe</b>	Material:	<b>VCP</b>
Drain Area:		Lining:	<b>None</b>
Category:	<b>NA</b>		
Comment:			
Location Details:		Direction of Survey:	<b>Downstream</b>
US MH:	<b>M-505-057</b>	DS MH:	<b>M-505-056</b>
		Total Length Surveyed (ft):	<b>165.2</b>

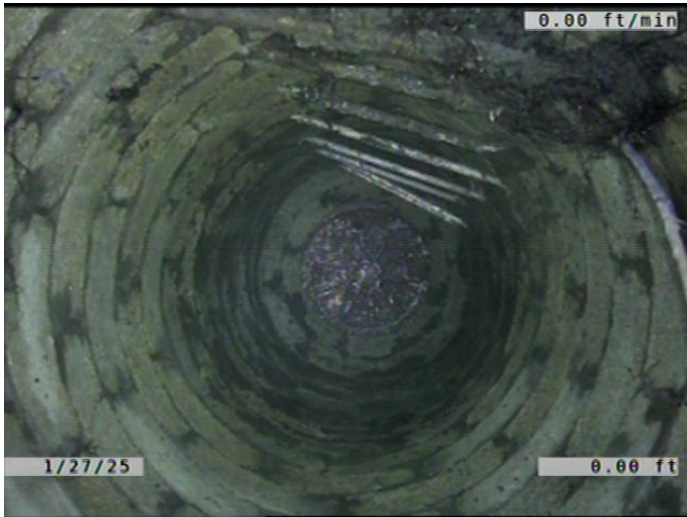
Code: **AMH**  
Description: **Manhole**

Distance (ft): **.0**  
Structural Grade: **0**  
O&M Grade: **0**  
Clock Start/From:  
Clock To:  
1st Value:  
2nd Value:  
Value Percent:  
Continuous Index:  
Within 8" of Joint: **NO**  
Remarks: **M-505-057**

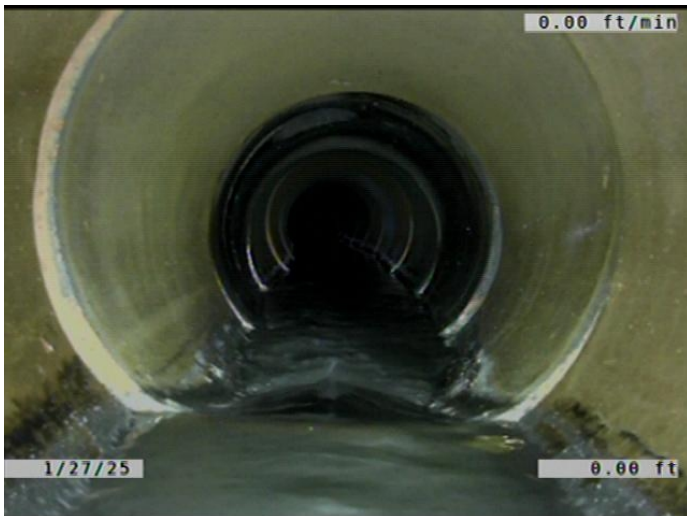
Code: **MWL**  
Description: **Miscellaneous Water Level**

Distance (ft): **.0**  
Structural Grade: **0**  
O&M Grade: **0**  
Clock Start/From:  
Clock To:  
1st Value:  
2nd Value:  
Value Percent: **15.000**  
Continuous Index:  
Within 8" of Joint: **NO**  
Remarks:

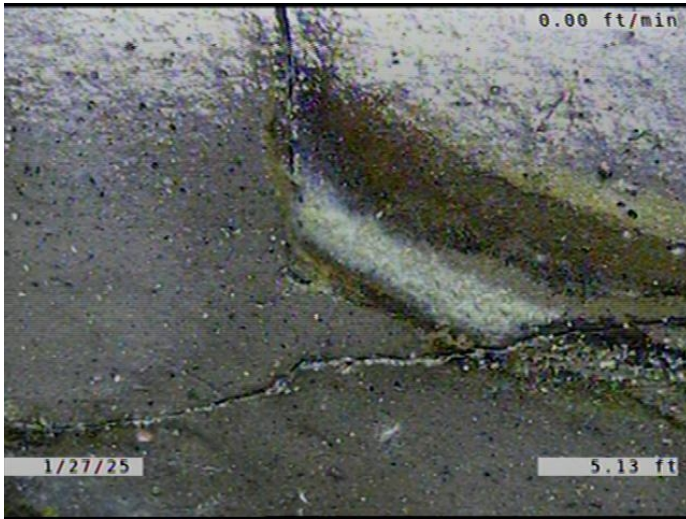
Code: **FM**  
Description: **Fracture Multiple**

Distance (ft): **5.1**  
Structural Grade: **4**  
O&M Grade: **0**  
Clock Start/From: **9**  
Clock To: **3**  
1st Value:  
2nd Value:  
Value Percent:  
Continuous Index:  
Within 8" of Joint: **YES**  
Remarks:

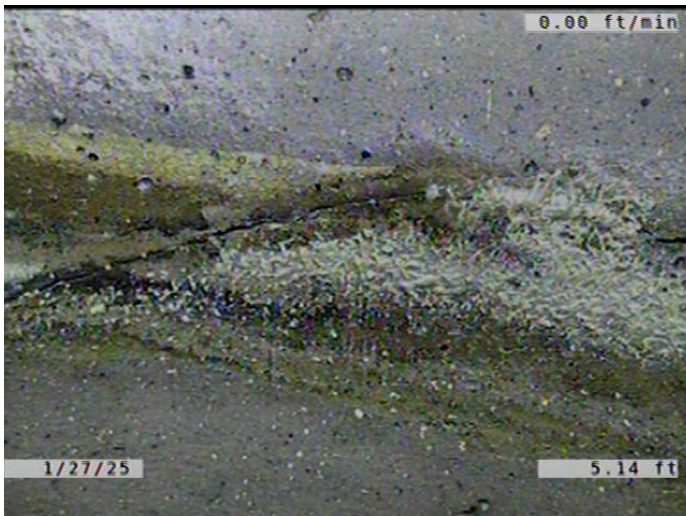
Code: **DAE**  
Description: **Deposits Attached Encrustation**

Distance (ft): **5.1**  
Structural Grade: **0**  
O&M Grade: **2**  
Clock Start/From: **12**  
Clock To: **4**  
1st Value:  
2nd Value:  
Value Percent: **5.000**  
Continuous Index:  
Within 8" of Joint: **YES**  
Remarks:

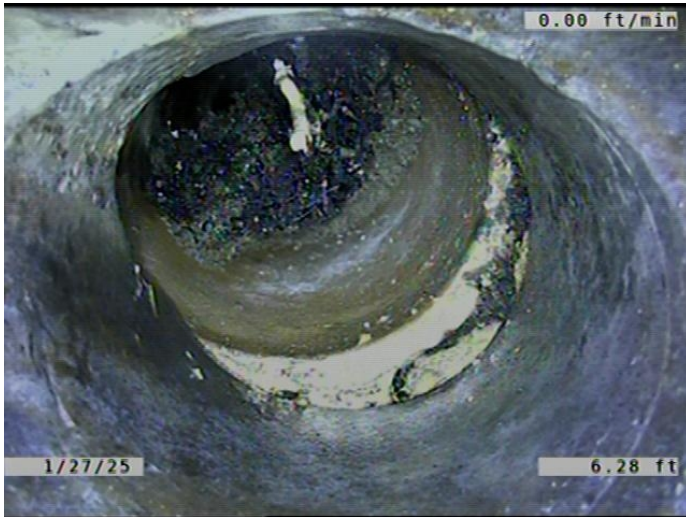
Code:	<b>TFD</b>
Description:	<b>Tap Factory Defective</b>
Distance (ft):	<b>6.3</b>
Structural Grade:	<b>0</b>
O&M Grade:	<b>3</b>
Clock Start/From:	<b>11</b>
Clock To:	
1st Value:	<b>6.000</b>
2nd Value:	
Value Percent:	
Continuous Index:	
Within 8" of Joint:	<b>YES</b>
Remarks:	<b>SERVICE OFFSET. ROOTS GROWING FROM THE SERVICE. 95% PLUGGED</b>

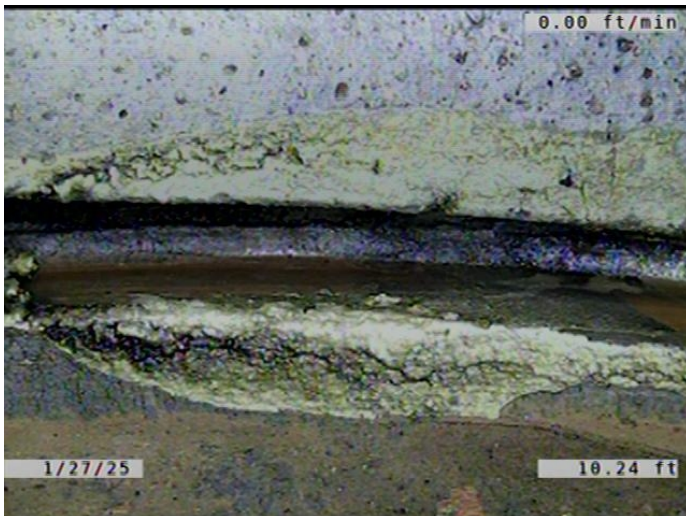
Code:	<b>DAE</b>
Description:	<b>Deposits Attached Encrustation</b>
Distance (ft):	<b>10.2</b>
Structural Grade:	<b>0</b>
O&M Grade:	<b>2</b>
Clock Start/From:	<b>12</b>
Clock To:	<b>4</b>
1st Value:	
2nd Value:	
Value Percent:	<b>5.000</b>
Continuous Index:	
Within 8" of Joint:	<b>YES</b>
Remarks:

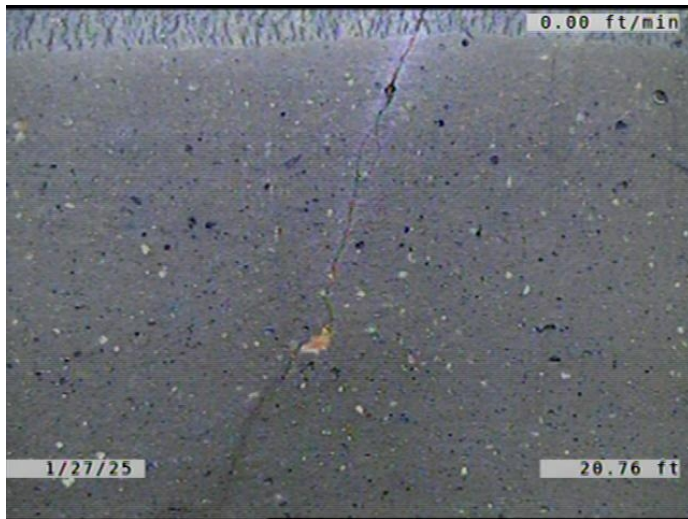
Code: **CS**  
Description: **Crack Spiral**

Distance (ft): **20.8**  
Structural Grade: **2**  
O&M Grade: **0**  
Clock Start/From: **9**  
Clock To: **10**  
1st Value:  
2nd Value:  
Value Percent:  
Continuous Index:  
Within 8" of Joint: **YES**  
Remarks:

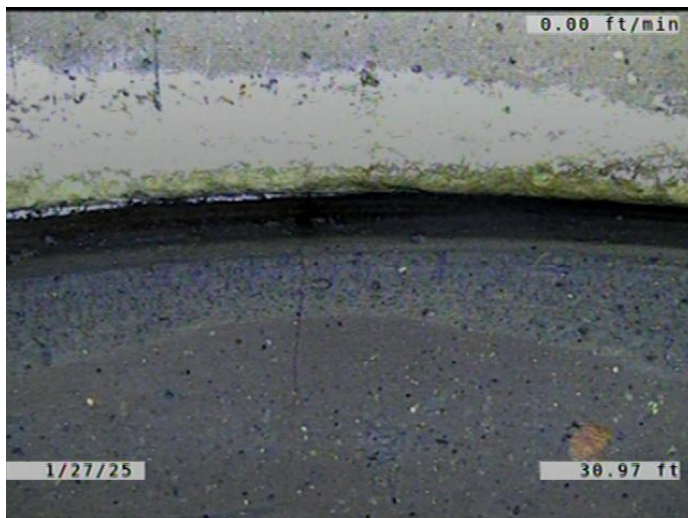
Code: **DAE**  
Description: **Deposits Attached Encrustation**

Distance (ft): **31.0**  
Structural Grade: **0**  
O&M Grade: **2**  
Clock Start/From: **8**  
Clock To: **12**  
1st Value:  
2nd Value:  
Value Percent: **5.000**  
Continuous Index:  
Within 8" of Joint: **YES**  
Remarks:

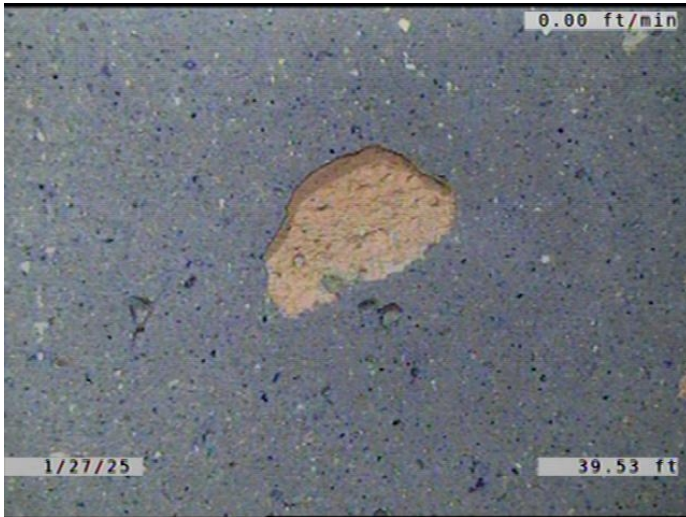
Code: **SSC**  
Description: **Surface Spalling of Damage Coating**

Distance (ft): **39.5**  
Structural Grade: **1**  
O&M Grade: **0**  
Clock Start/From: **2**  
Clock To:  
1st Value:  
2nd Value:  
Value Percent:  
Continuous Index:  
Within 8" of Joint: **YES**  
Remarks:

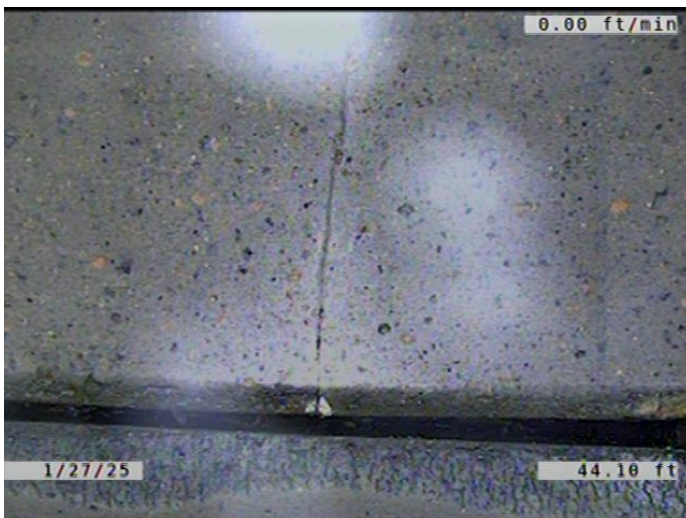
Code: **CL**  
Description: **Crack Longitudinal**

Distance (ft): **44.1**  
Structural Grade: **2**  
O&M Grade: **0**  
Clock Start/From: **12**  
Clock To:  
1st Value:  
2nd Value:  
Value Percent:  
Continuous Index:  
Within 8" of Joint: **YES**  
Remarks:

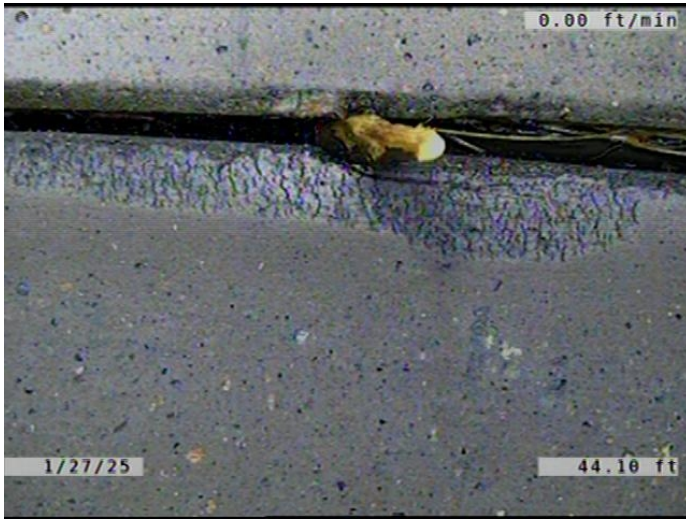
Code: **RFJ**  
 Description: **Roots Fine Joint**

Distance (ft): **44.1**  
 Structural Grade: **0**  
 O&M Grade: **1**  
 Clock Start/From: **10**  
 Clock To: **2**  
 1st Value:  
 2nd Value:  
 Value Percent:  
 Continuous Index:  
 Within 8" of Joint: **YES**  
 Remarks:

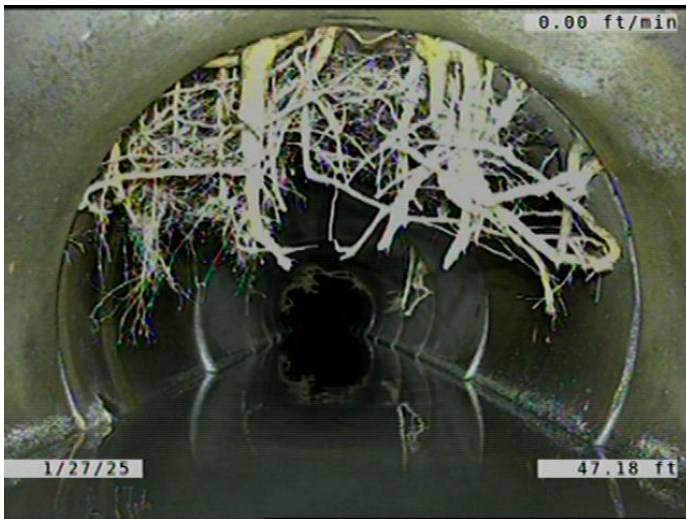
Code: **RTJ**  
 Description: **Roots Tap Joint**

Distance (ft): **47.2**  
 Structural Grade: **0**  
 O&M Grade: **2**  
 Clock Start/From: **8**  
 Clock To: **4**  
 1st Value:  
 2nd Value:  
 Value Percent: **25.000**  
 Continuous Index:  
 Within 8" of Joint: **YES**  
 Remarks:

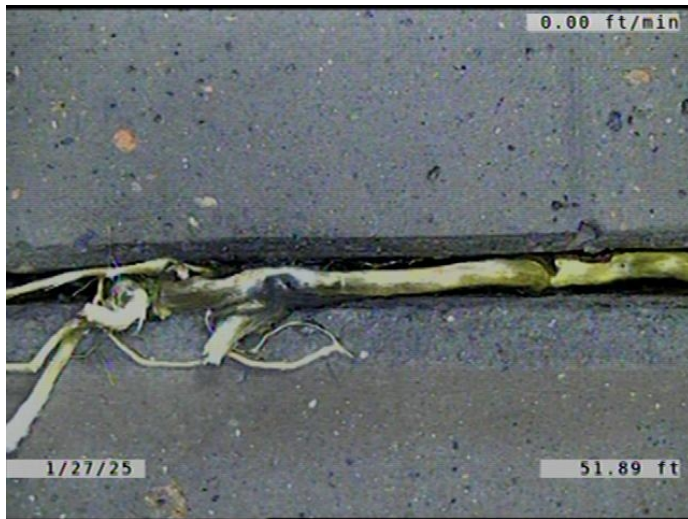
Code: **RFJ**  
 Description: **Roots Fine Joint**

Distance (ft): **51.9**  
 Structural Grade: **0**  
 O&M Grade: **1**  
 Clock Start/From: **8**  
 Clock To: **4**  
 1st Value:  
 2nd Value:  
 Value Percent:  
 Continuous Index: **S01**  
 Within 8" of Joint: **YES**  
 Remarks:

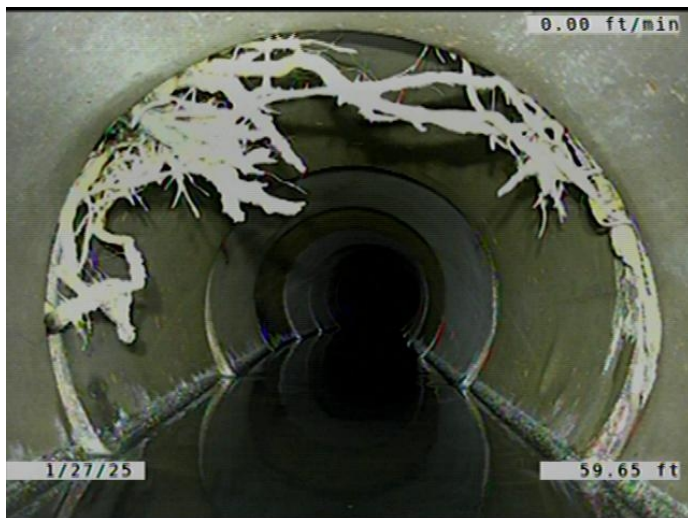
Code: **RTJ**  
 Description: **Roots Tap Joint**

Distance (ft): **59.6**  
 Structural Grade: **0**  
 O&M Grade: **2**  
 Clock Start/From: **8**  
 Clock To: **4**  
 1st Value:  
 2nd Value:  
 Value Percent: **5.000**  
 Continuous Index:  
 Within 8" of Joint: **YES**  
 Remarks:

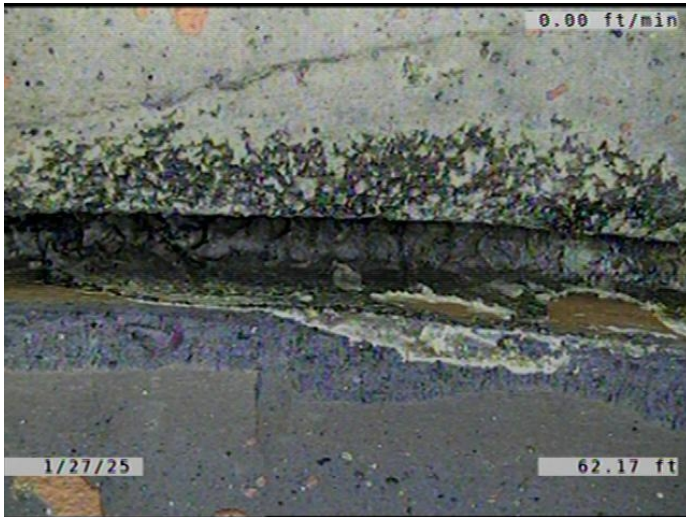
Code: **DAE**  
 Description: **Deposits Attached Encrustation**

Distance (ft): **62.2**  
 Structural Grade: **0**  
 O&M Grade: **2**  
 Clock Start/From: **12**  
 Clock To: **4**  
 1st Value:  
 2nd Value:  
 Value Percent: **5.000**  
 Continuous Index:  
 Within 8" of Joint: **YES**  
 Remarks:

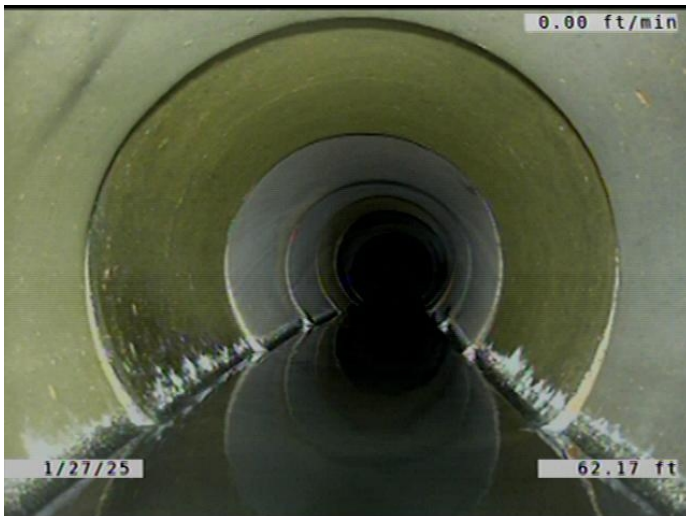
Code: **RFJ**  
 Description: **Roots Fine Joint**

Distance (ft): **62.2**  
 Structural Grade: **0**  
 O&M Grade: **1**  
 Clock Start/From: **8**  
 Clock To: **4**  
 1st Value:  
 2nd Value:  
 Value Percent:  
 Continuous Index: **F01**  
 Within 8" of Joint: **YES**  
 Remarks:

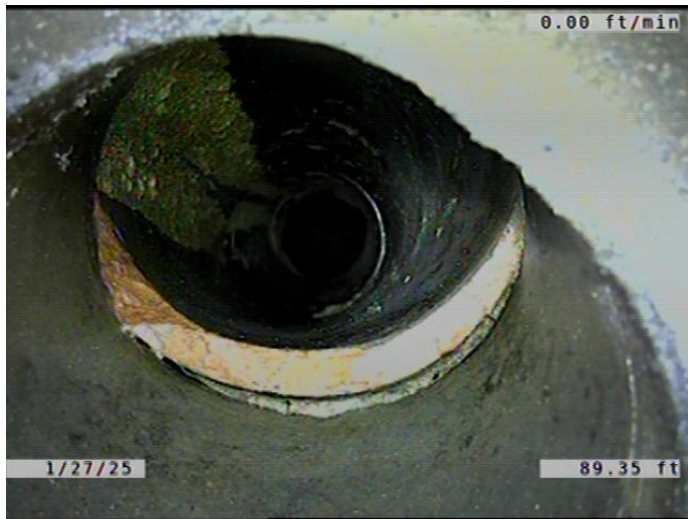
Code:	<b>TFD</b>
Description:	<b>Tap Factory Defective</b>
Distance (ft):	<b>89.4</b>
Structural Grade:	<b>0</b>
O&M Grade:	<b>3</b>
Clock Start/From:	<b>11</b>
Clock To:	
1st Value:	<b>6.000</b>
2nd Value:	
Value Percent:	
Continuous Index:	
Within 8" of Joint:	<b>YES</b>
Remarks:	<b>SERVICE OFFSET. SOIL VISIBLE. ENCrustation COMING DOWN THE</b>

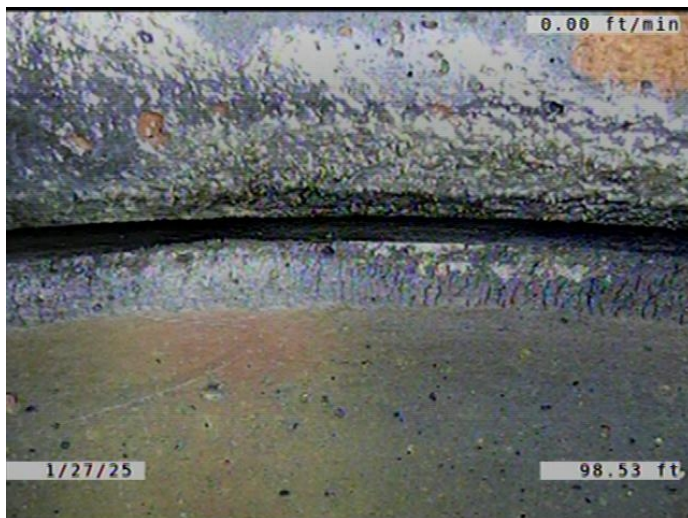
Code:	<b>DAE</b>
Description:	<b>Deposits Attached Encrustation</b>
Distance (ft):	<b>98.5</b>
Structural Grade:	<b>0</b>
O&M Grade:	<b>2</b>
Clock Start/From:	<b>8</b>
Clock To:	<b>10</b>
1st Value:	
2nd Value:	
Value Percent:	<b>5.000</b>
Continuous Index:	
Within 8" of Joint:	<b>YES</b>
Remarks:

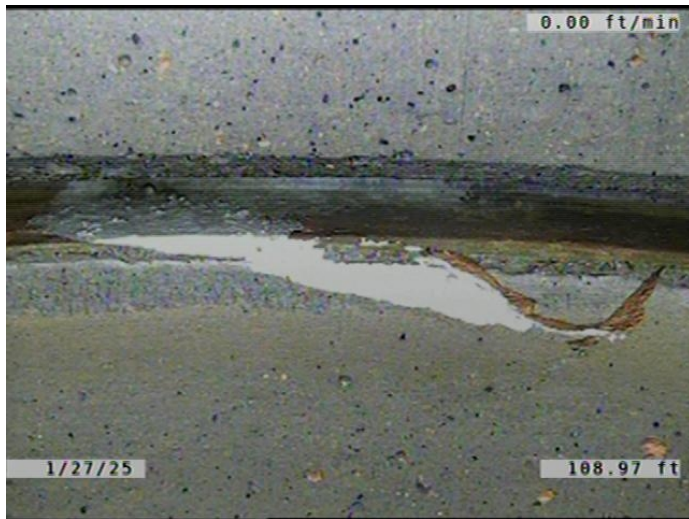
Code: **DAE**  
Description: **Deposits Attached Encrustation**

Distance (ft): **109.0**  
Structural Grade: **0**  
O&M Grade: **2**  
Clock Start/From: **12**  
Clock To: **4**  
1st Value:  
2nd Value:  
Value Percent: **5.000**  
Continuous Index:  
Within 8" of Joint: **YES**  
Remarks:

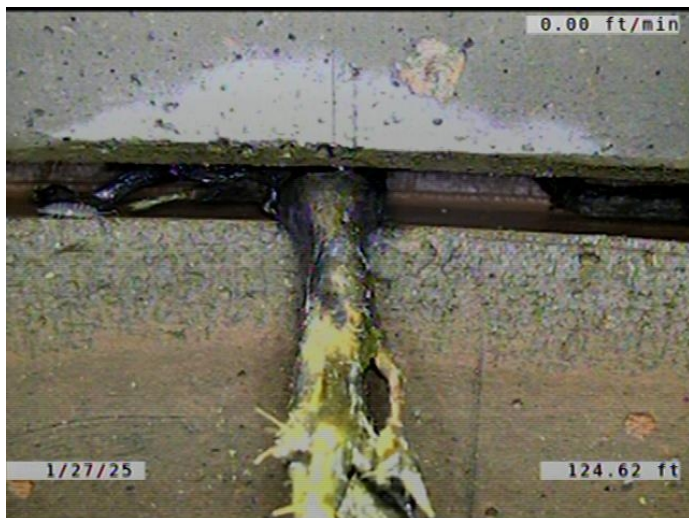
Code: **RFJ**  
Description: **Roots Fine Joint**

Distance (ft): **124.6**  
Structural Grade: **0**  
O&M Grade: **1**  
Clock Start/From: **8**  
Clock To: **4**  
1st Value:  
2nd Value:  
Value Percent:  
Continuous Index:  
Within 8" of Joint: **YES**  
Remarks:

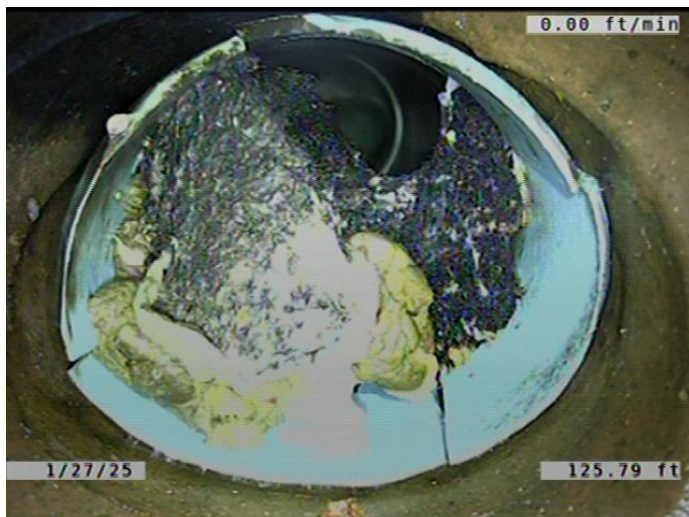
Code: **TFD**  
 Description: **Tap Factory Defective**

Distance (ft): **125.8**  
 Structural Grade: **0**  
 O&M Grade: **3**  
 Clock Start/From: **11**  
 Clock To:  
 1st Value: **6.000**  
 2nd Value:  
 Value Percent:  
 Continuous Index:  
 Within 8" of Joint: **YES**  
 Remarks: **PVC SERVICE. TAPBROKEN. ROOTS GROWING IN THE SERVICE INTO THE**

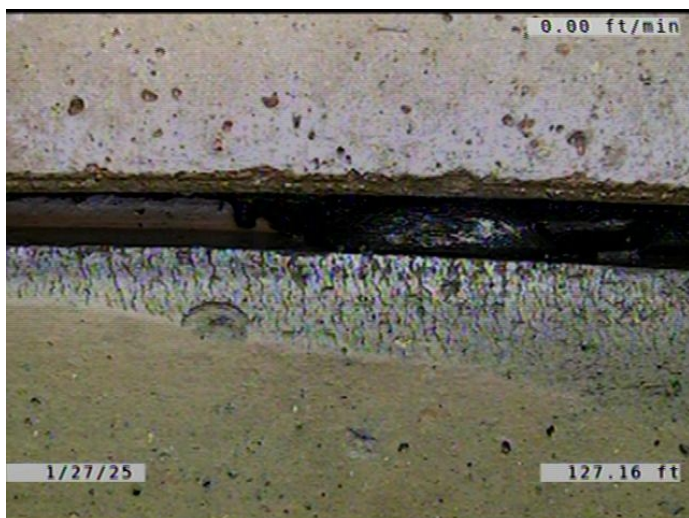
Code: **IWJ**  
 Description: **Infiltration Weeper Joint**

Distance (ft): **127.2**  
 Structural Grade: **0**  
 O&M Grade: **2**  
 Clock Start/From: **12**  
 Clock To:  
 1st Value:  
 2nd Value:  
 Value Percent:  
 Continuous Index:  
 Within 8" of Joint: **YES**  
 Remarks:

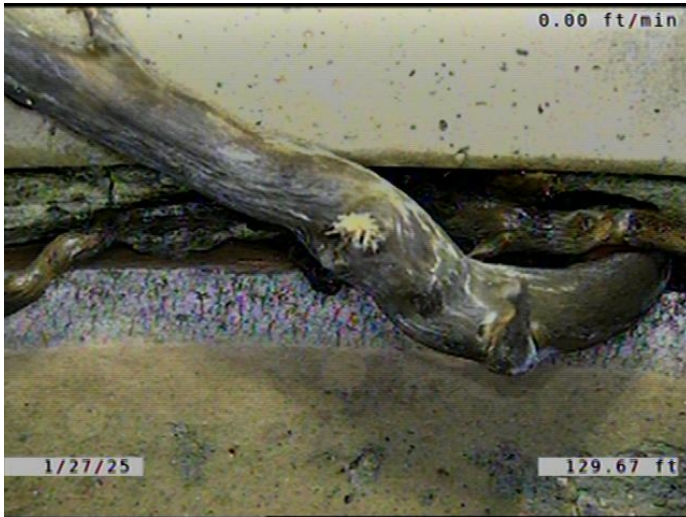
Code: **RTJ**  
Description: **Roots Tap Joint**

Distance (ft): **129.7**  
Structural Grade: **0**  
O&M Grade: **2**  
Clock Start/From: **8**  
Clock To: **4**  
1st Value:  
2nd Value:  
Value Percent: **5.000**  
Continuous Index:  
Within 8" of Joint: **YES**  
Remarks:

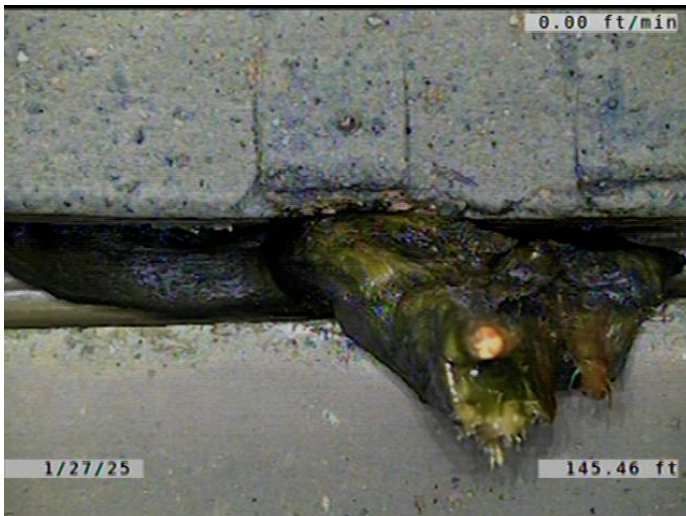
Code: **RTJ**  
Description: **Roots Tap Joint**

Distance (ft): **145.5**  
Structural Grade: **0**  
O&M Grade: **2**  
Clock Start/From: **8**  
Clock To: **4**  
1st Value:  
2nd Value:  
Value Percent: **5.000**  
Continuous Index:  
Within 8" of Joint: **YES**  
Remarks:

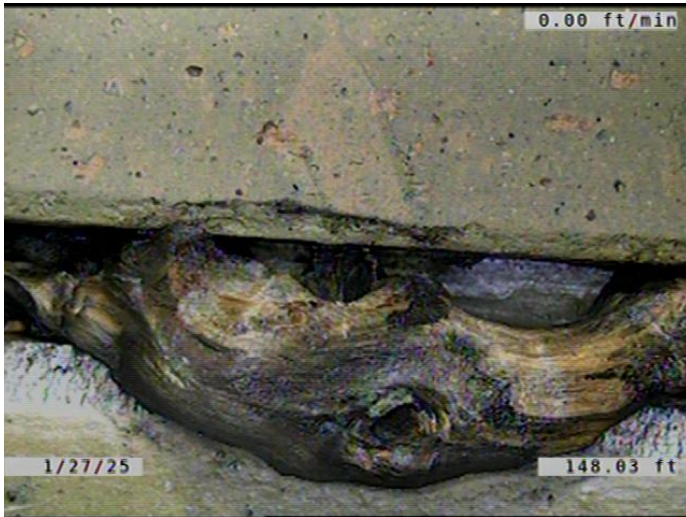
Code: **RTJ**  
Description: **Roots Tap Joint**

Distance (ft): **148.0**  
Structural Grade: **0**  
O&M Grade: **2**  
Clock Start/From: **11**  
Clock To: **4**  
1st Value:  
2nd Value:  
Value Percent: **40.000**  
Continuous Index:  
Within 8" of Joint: **YES**  
Remarks:

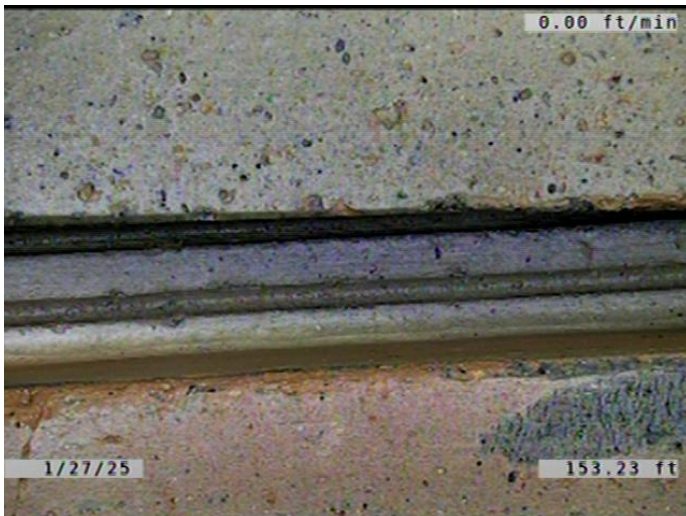
Code: **JAM**  
Description: **Joint Angular Medium**

Distance (ft): **153.2**  
Structural Grade: **3**  
O&M Grade: **0**  
Clock Start/From:  
Clock To:  
1st Value:  
2nd Value:  
Value Percent:  
Continuous Index:  
Within 8" of Joint: **NO**  
Remarks:
