## Profile/Photo Observation Report

Street:	<b>W 2ND ST</b>	Flow Control:	<b>Not Controlled</b>
City:	<b>Hobart, IN</b>	Year Renewed:	
Location:	<b>Light Highway</b>	Tape/Media #:	
Purpose:	<b>Routine Assessment</b>	Dia/Height:	<b>12"</b>
Use:	<b>Sanitary</b>	Material:	<b>VCP</b>
Drain Area:	<b>NA</b>	Lining:	
Category:	<b>NA</b>		
Comment:	<b>P_C at 19 ft debris . Flow direction wrong</b>

Location Details:		Direction of Survey:	<b>Downstream</b>
US MH:	<b>M-505-059</b>	DS MH:	<b>M-505-060</b>
		Total Length Surveyed (ft):	<b>20.1</b>

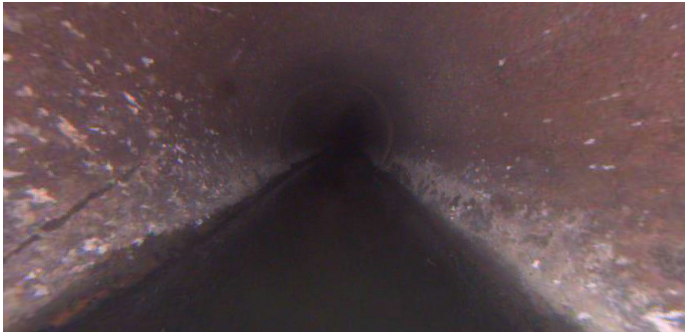
Code:	<b>MWL</b>
Description:	<b>Water Level</b>

Distance (ft):	<b>.0</b>
Structural Grade:	<b>0</b>
O&M Grade:	<b>0</b>
Clock Start/From:	
Clock To:	
1st Value:	
2nd Value:	
Value Percent:	<b>10.000</b>
Continuous Index:	
Within 8" of Joint:	<b>NO</b>
Remarks:

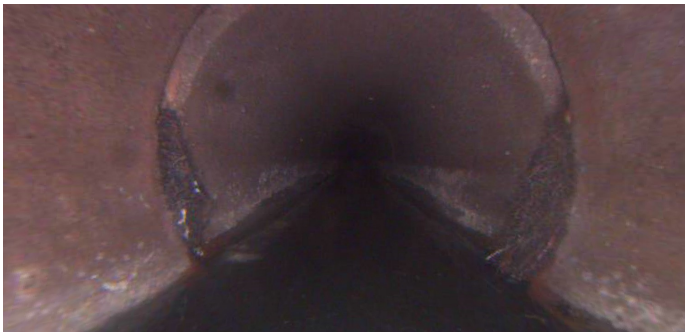
Code:	<b>RMJ</b>
Description:	<b>Roots Medium Joint</b>

Distance (ft):	<b>5.9</b>
Structural Grade:	<b>0</b>
O&M Grade:	<b>3</b>
Clock Start/From:	<b>8</b>
Clock To:	<b>4</b>
1st Value:	
2nd Value:	
Value Percent:	<b>5.000</b>
Continuous Index:	
Within 8" of Joint:	<b>YES</b>
Remarks:

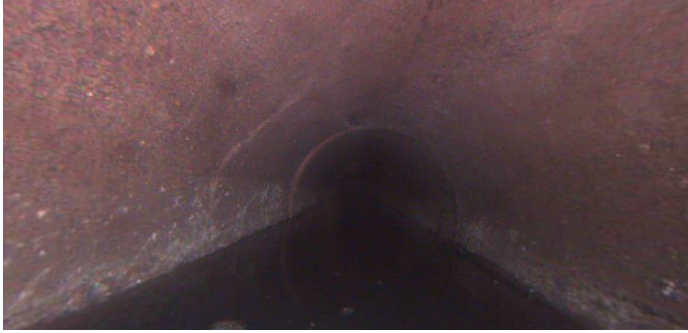
Code:	<b>MSA</b>
Description:	<b>Abandoned Survey</b>
Distance (ft):	<b>20.1</b>
Structural Grade:	<b>0</b>
O&M Grade:	<b>0</b>
Clock Start/From:	
Clock To:	
1st Value:	
2nd Value:	
Value Percent:	
Continuous Index:	
Within 8" of Joint:	<b>NO</b>
Remarks:	<b>DEBRIS UNDER WATER</b>
