Profile/Photo Observation Report

Street:	FOXCROFT STREET	Flow Control:	Not Controlled
City:	Hobart, IN	Year Renewed:	
Location:	Light Highway	Tape/Media #:	
Purpose:	Routine Assessment	Dia/Height:	12"
Use:	Sanitary	Material:	VCP
Drain Area:	NA	Lining:	
Category:	NA		
Comment:	P_C at 19 ft debris . Flow direction wrong		
Location Details:		Direction of Survey:	Downstream
US MH:	M-505-059	DS MH:	M-505-060
		Total Length Surveyed (ft):	20.1

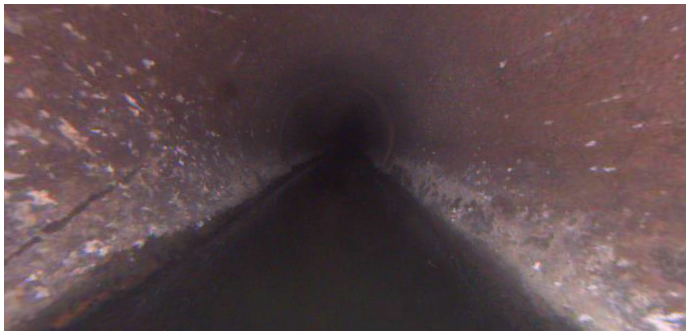
Code: **AMH**
Description: **Manhole**

Distance (ft): **.0**
Structural Grade: **0**
O&M Grade: **0**
Clock Start/From:
Clock To:
1st Value:
2nd Value:
Value Percent:
Continuous Index:
Within 8" of Joint: **NO**
Remarks: **M-505-059**

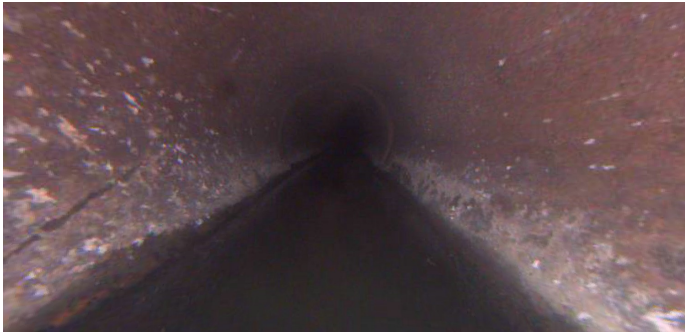
Code:	MWL
Description:	Water Level

Distance (ft):	.0
Structural Grade:	0
O&M Grade:	0
Clock Start/From:	
Clock To:	
1st Value:	
2nd Value:	
Value Percent:	10.000
Continuous Index:	
Within 8" of Joint:	NO
Remarks:

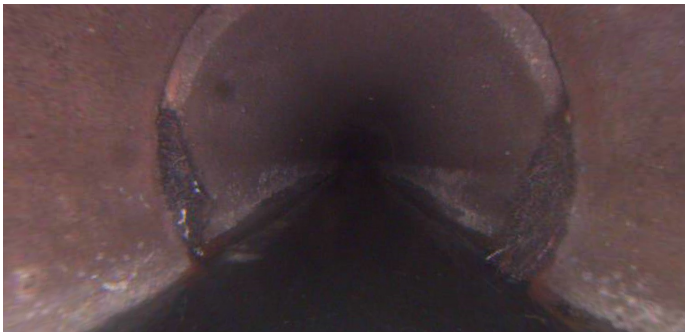
Code:	RMJ
Description:	Roots Medium Joint

Distance (ft):	5.9
Structural Grade:	0
O&M Grade:	3
Clock Start/From:	8
Clock To:	4
1st Value:	
2nd Value:	
Value Percent:	5.000
Continuous Index:	
Within 8" of Joint:	YES
Remarks:

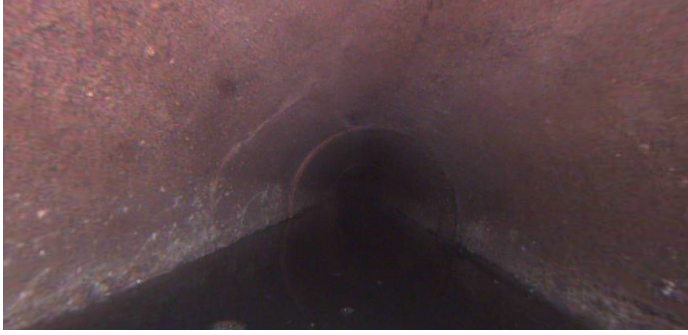
Code:	MSA
Description:	Abandoned Survey
Distance (ft):	20.1
Structural Grade:	0
O&M Grade:	0
Clock Start/From:	
Clock To:	
1st Value:	
2nd Value:	
Value Percent:	
Continuous Index:	
Within 8" of Joint:	NO
Remarks:	DEBRIS UNDER WATER
