Profile/Photo Observation Report

Date:	04/21/2018	Weather:		Coding:	PACP 6.0
Pipe Length (ft):	248.2	Owner:	NA	Pre Clean:	No Pre-Cleaning
P.O.#:		Surveyor:	Mark Ruby	PSR:	P-505-060-059
Customer:		Clean Date:	01/01/1900	Shape:	C

Street:	W 2ND ST	Flow Control:	Not Controlled
City:	Hobart, IN	Year Renewed:	
Location:	Light Highway	Tape/Media #:	
Purpose:	Routine Assessment	Dia/Height:	12"
Use:	Sanitary	Material:	VCP
Drain Area:	NA	Lining:	
Category:	NA		
Comment:	P_C at 94 ft debris . Flow direction wrong		
Location Details:		Direction of Survey:	Upstream
US MH:	M-505-059	DS MH:	M-505-060
		Total Length Surveyed (ft):	95.5

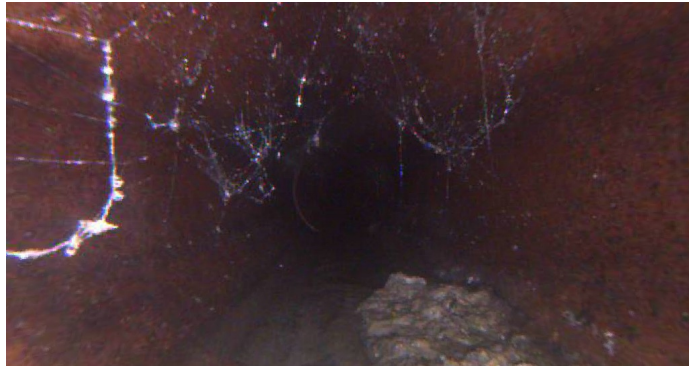
Code:	MWL
Description:	Water Level
Distance (ft):	.0
Structural Grade:	0
O&M Grade:	0
Clock Start/From:	
Clock To:	
1st Value:	
2nd Value:	
Value Percent:	10.000
Continuous Index:	
Within 8" of Joint:	NO
Remarks:

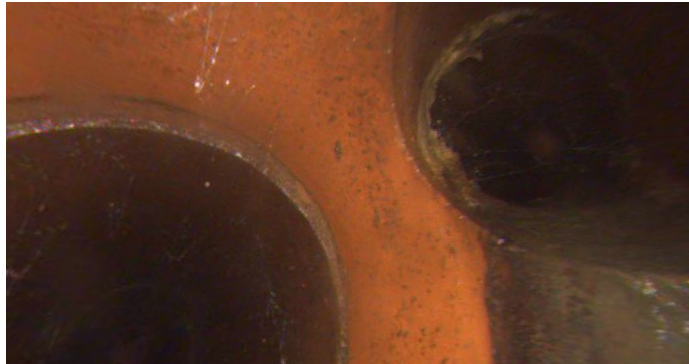
Code:	TF
Description:	Tap Factory
Distance (ft):	10.8
Structural Grade:	0
O&M Grade:	0
Clock Start/From:	10
Clock To:	
1st Value:	4.000
2nd Value:	
Value Percent:	
Continuous Index:	
Within 8" of Joint:	
Remarks:

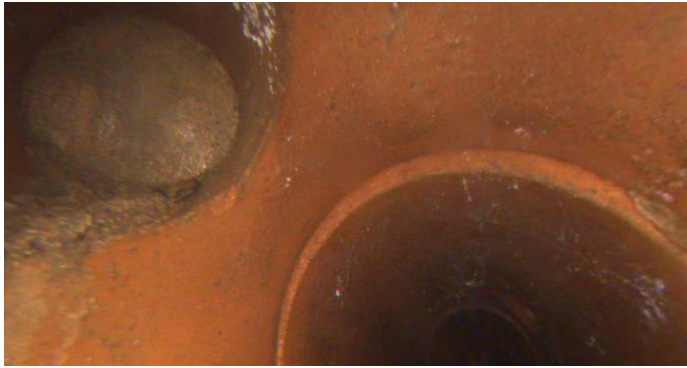
Code: **TFC**
Description: **Tap Factory Capped**

Distance (ft): **14.0**
Structural Grade: **0**
O&M Grade: **0**
Clock Start/From: **2**
Clock To:
1st Value: **4.000**
2nd Value:
Value Percent:
Continuous Index:
Within 8" of Joint:
Remarks:

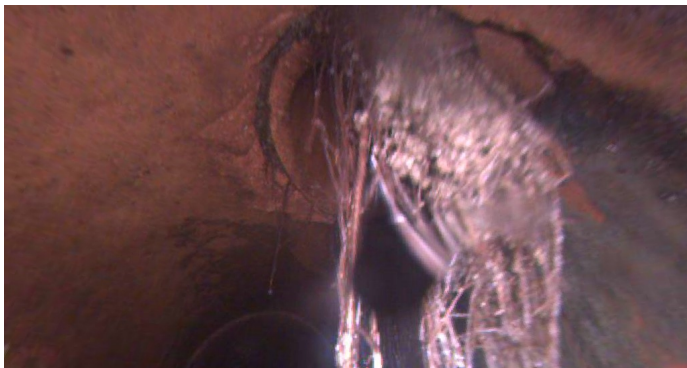
Code: **TBD**
Description: **Tap Break-in Defective**

Distance (ft): **50.1**
Structural Grade: **0**
O&M Grade: **3**
Clock Start/From: **1**
Clock To:
1st Value: **4.000**
2nd Value:
Value Percent:
Continuous Index:
Within 8" of Joint:
Remarks: **ROOTS**

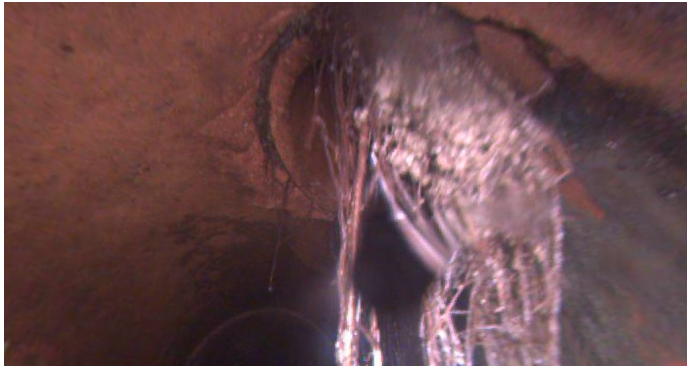
Code: **RFL**
Description: **Roots Fine Lateral**

Distance (ft): **50.1**
Structural Grade: **0**
O&M Grade: **1**
Clock Start/From: **1**
Clock To:
1st Value:
2nd Value:
Value Percent:
Continuous Index:
Within 8" of Joint: **NO**
Remarks:

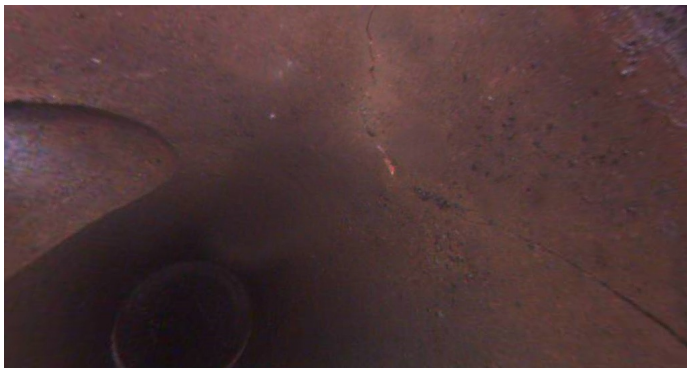
Code: **CS**
Description: **Crack Spiral**

Distance (ft): **58.6**
Structural Grade: **2**
O&M Grade: **0**
Clock Start/From: **1**
Clock To: **5**
1st Value:
2nd Value:
Value Percent:
Continuous Index:
Within 8" of Joint: **YES**
Remarks:

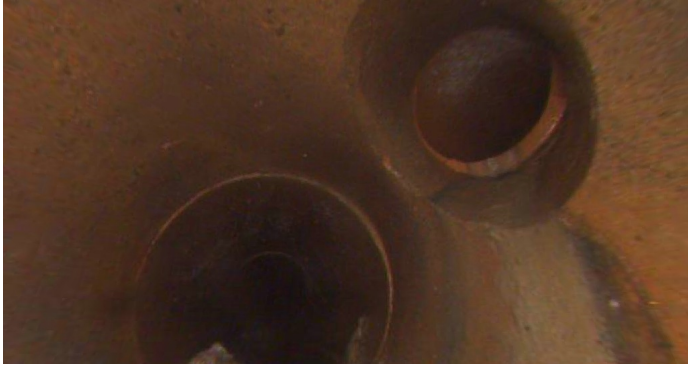
Code: **TF**
Description: **Tap Factory**

Distance (ft): **60.0**
Structural Grade: **0**
O&M Grade: **0**
Clock Start/From: **10**
Clock To:
1st Value: **4.000**
2nd Value:
Value Percent:
Continuous Index:
Within 8" of Joint:
Remarks:

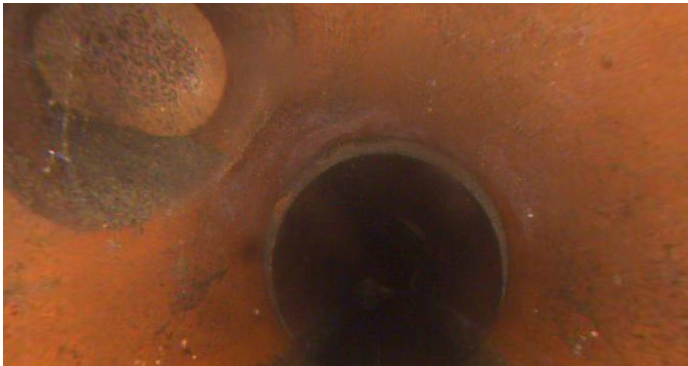
Code: **TFC**
Description: **Tap Factory Capped**

Distance (ft): **63.0**
Structural Grade: **0**
O&M Grade: **0**
Clock Start/From: **2**
Clock To:
1st Value: **4.000**
2nd Value:
Value Percent:
Continuous Index:
Within 8" of Joint:
Remarks:

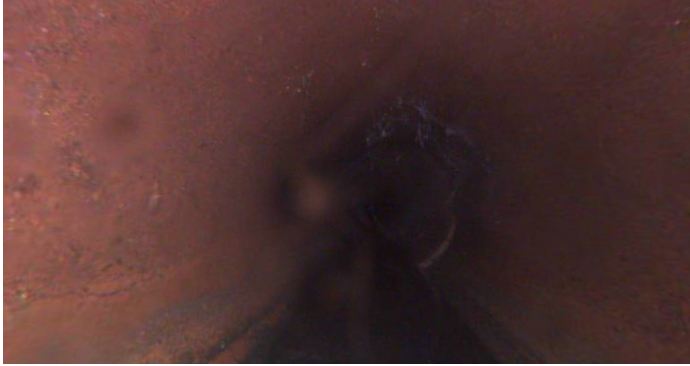
Code:	MSA
Description:	Abandoned Survey
Distance (ft):	95.5
Structural Grade:	0
O&M Grade:	0
Clock Start/From:	
Clock To:	
1st Value:	
2nd Value:	
Value Percent:	
Continuous Index:	
Within 8" of Joint:	NO
Remarks:	No blockage
