Profile/Photo Observation Report

Date:	04/21/2018	Weather:		Coding:	PACP 6.0
Pipe Length (ft):	248.2	Owner:	NA	Pre Clean:	No Pre-Cleaning
P.O.#:		Surveyor:	Mark Ruby	PSR:	P-505-060-059
Customer:		Clean Date:	01/01/1900	Shape:	C

Street:	FOXCROFT STREET	Flow Control:	Not Controlled
City:	Hobart, IN	Year Renewed:	
Location:	Light Highway	Tape/Media #:	
Purpose:	Routine Assessment	Dia/Height:	12"
Use:	Sanitary	Material:	VCP
Drain Area:	NA	Lining:	
Category:	NA		
Comment:	P_C at 94 ft debris . Flow direction wrong		
Location Details:		Direction of Survey:	Upstream
US MH:	M-505-059	DS MH:	M-505-060
		Total Length Surveyed (ft):	95.5

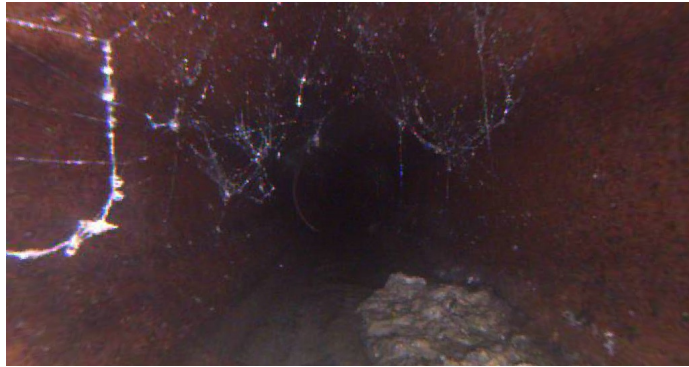
Code:	MWL
Description:	Water Level
Distance (ft):	.0
Structural Grade:	0
O&M Grade:	0
Clock Start/From:	
Clock To:	
1st Value:	
2nd Value:	
Value Percent:	10.000
Continuous Index:	
Within 8" of Joint:	NO
Remarks:

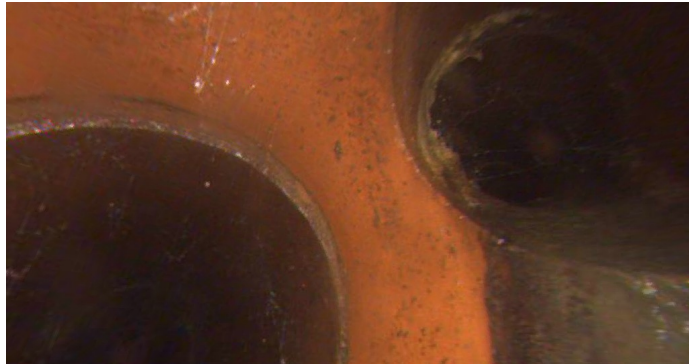
Code:	TF
Description:	Tap Factory
Distance (ft):	10.8
Structural Grade:	0
O&M Grade:	0
Clock Start/From:	10
Clock To:	
1st Value:	4.000
2nd Value:	
Value Percent:	
Continuous Index:	
Within 8" of Joint:	
Remarks:

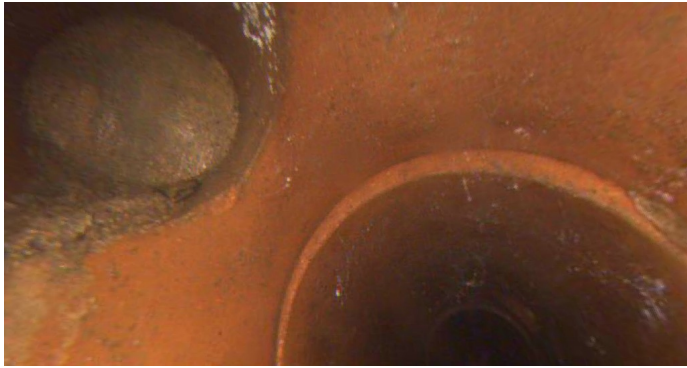
Code: **TFC**
Description: **Tap Factory Capped**

Distance (ft): **14.0**
Structural Grade: **0**
O&M Grade: **0**
Clock Start/From: **2**
Clock To:
1st Value: **4.000**
2nd Value:
Value Percent:
Continuous Index:
Within 8" of Joint:
Remarks:

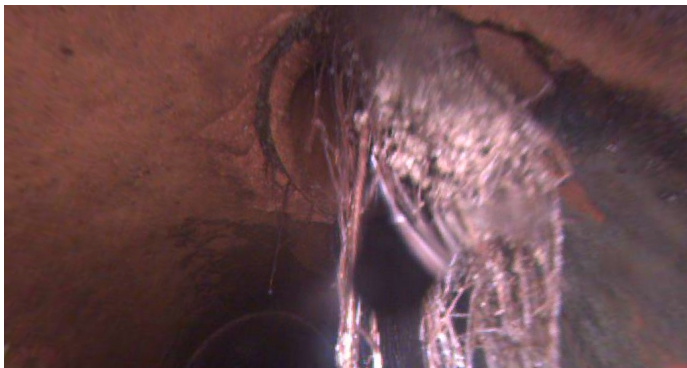
Code: **TBD**
Description: **Tap Break-in Defective**

Distance (ft): **50.1**
Structural Grade: **0**
O&M Grade: **3**
Clock Start/From: **1**
Clock To:
1st Value: **4.000**
2nd Value:
Value Percent:
Continuous Index:
Within 8" of Joint:
Remarks: **ROOTS**

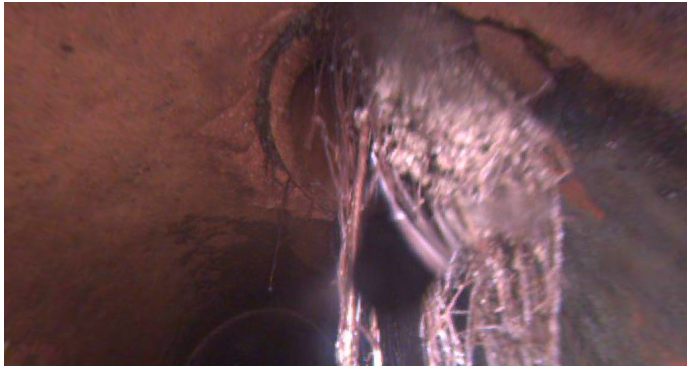
Code: **RFL**
Description: **Roots Fine Lateral**

Distance (ft): **50.1**
Structural Grade: **0**
O&M Grade: **1**
Clock Start/From: **1**
Clock To:
1st Value:
2nd Value:
Value Percent:
Continuous Index:
Within 8" of Joint: **NO**
Remarks:

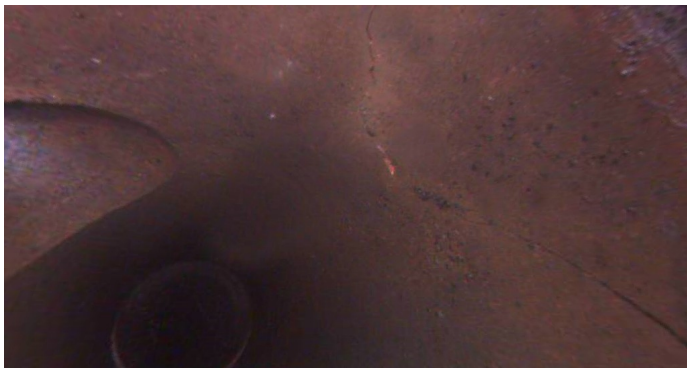
Code: **CS**
Description: **Crack Spiral**

Distance (ft): **58.6**
Structural Grade: **2**
O&M Grade: **0**
Clock Start/From: **1**
Clock To: **5**
1st Value:
2nd Value:
Value Percent:
Continuous Index:
Within 8" of Joint: **YES**
Remarks:

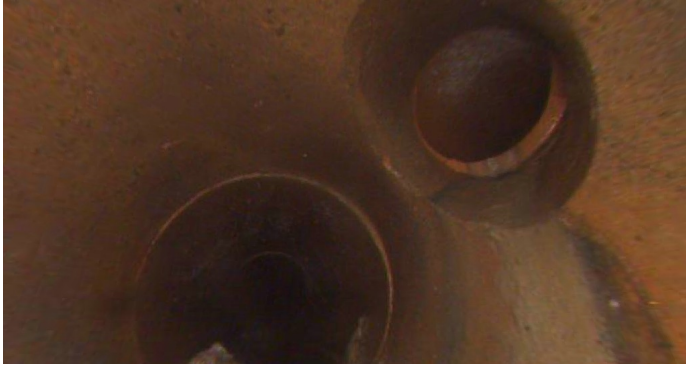
Code: **TF**
Description: **Tap Factory**

Distance (ft): **60.0**
Structural Grade: **0**
O&M Grade: **0**
Clock Start/From: **10**
Clock To:
1st Value: **4.000**
2nd Value:
Value Percent:
Continuous Index:
Within 8" of Joint:
Remarks:

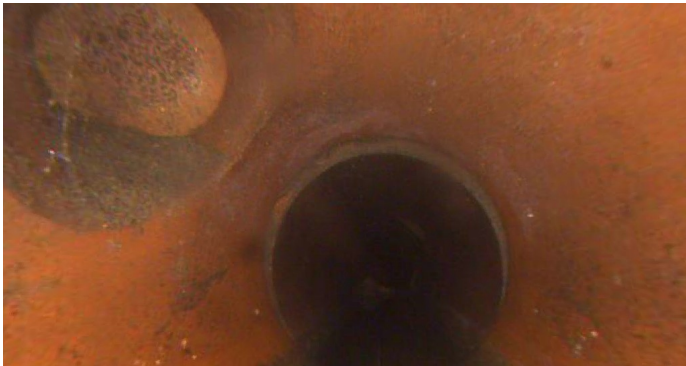
Code: **TFC**
Description: **Tap Factory Capped**

Distance (ft): **63.0**
Structural Grade: **0**
O&M Grade: **0**
Clock Start/From: **2**
Clock To:
1st Value: **4.000**
2nd Value:
Value Percent:
Continuous Index:
Within 8" of Joint:
Remarks:

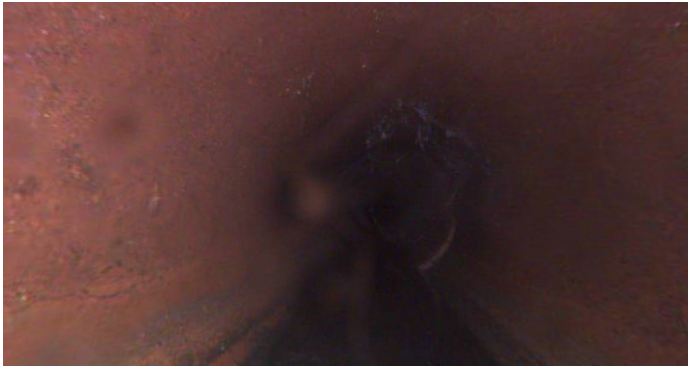
Code:	MSA
Description:	Abandoned Survey
Distance (ft):	95.5
Structural Grade:	0
O&M Grade:	0
Clock Start/From:	
Clock To:	
1st Value:	
2nd Value:	
Value Percent:	
Continuous Index:	
Within 8" of Joint:	NO
Remarks:	No blockage
