# Profile/Photo Observation Report

Date:	<b>11/02/2021</b>	Weather:		Coding:	<b>PACP 7.0</b>
Pipe Length (ft):	<b>247.1</b>	Owner:	<b>City of Hobart</b>	Pre Clean:	<b>Heavy Cleaning</b>
P.O.#:	<b>YES502259</b>	Surveyor:	<b>S. Bucklin</b>	PSR:	<b>P-505-060-059</b>
Customer:	<b>City of Hobart</b>	Clean Date:	<b>10/28/2021</b>	Shape:	<b>C</b>

Street:	<b>West 2nd Street</b>	Flow Control:	<b>Not Controlled</b>
City:	<b>Hobart, IN</b>	Year Renewed:	
Location:	<b>Local rural streets with light traffic, t</b>	Tape/Media #:	
Purpose:	<b>Routine Assessment</b>	Dia/Height:	<b>10"</b>
Use:	<b>Sanitary Sewage Pipe</b>	Material:	<b>VCP</b>
Drain Area:		Lining:	<b>None</b>
Category:	<b>NA</b>		
Comment:			
Location Details:		Direction of Survey:	<b>Downstream</b>
US MH:	<b>M-505-059</b>	DS MH:	<b>M-505-060</b>
		Total Length Surveyed (ft):	<b>247.1</b>

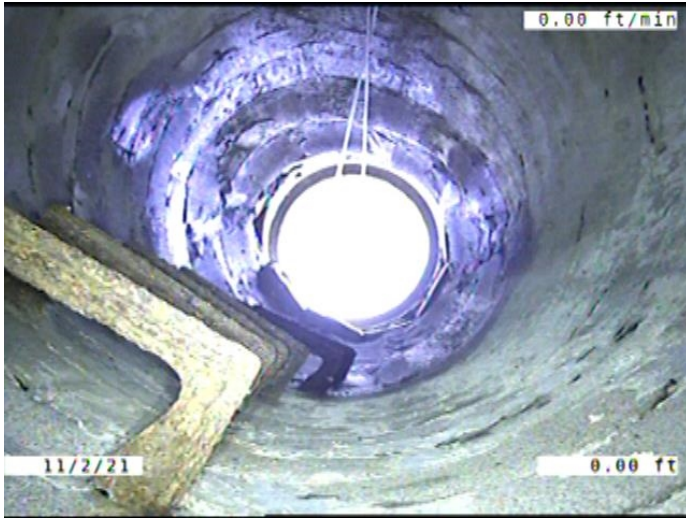
Code: **AMH**  
 Description: **Manhole**

Distance (ft): **.0**  
 Structural Grade: **0**  
 O&M Grade: **0**  
 Clock Start/From:  
 Clock To:  
 1st Value:  
 2nd Value:  
 Value Percent:  
 Continuous Index:  
 Within 8" of Joint: **NO**  
 Remarks: **M-505-059**

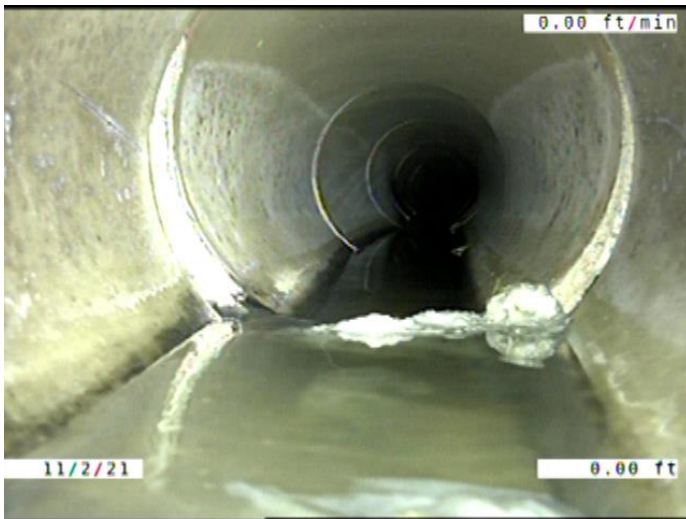
Code: **MWL**  
 Description: **Miscellaneous Water Level**

Distance (ft): **.0**  
 Structural Grade: **0**  
 O&M Grade: **0**  
 Clock Start/From:  
 Clock To:  
 1st Value:  
 2nd Value:  
 Value Percent: **5.000**  
 Continuous Index:  
 Within 8" of Joint: **NO**  
 Remarks:

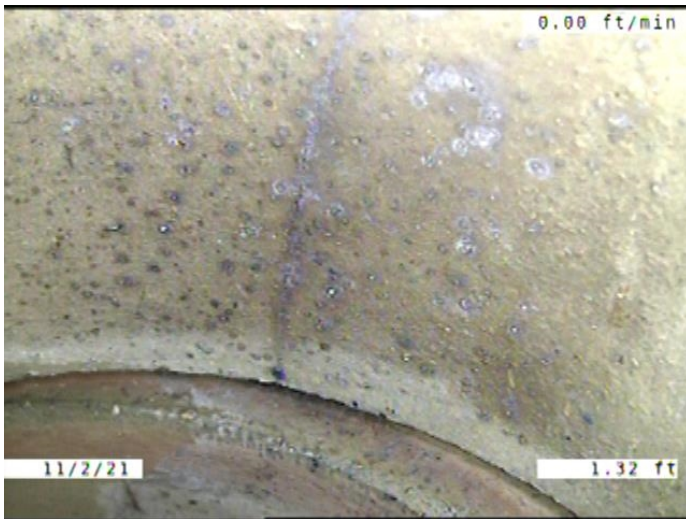
Code:	<b>CS</b>
Description:	<b>Crack Spiral</b>
Distance (ft):	<b>1.3</b>
Structural Grade:	<b>2</b>
O&M Grade:	<b>0</b>
Clock Start/From:	<b>2</b>
Clock To:	<b>3</b>
1st Value:	
2nd Value:	
Value Percent:	
Continuous Index:	
Within 8" of Joint:	<b>YES</b>
Remarks:

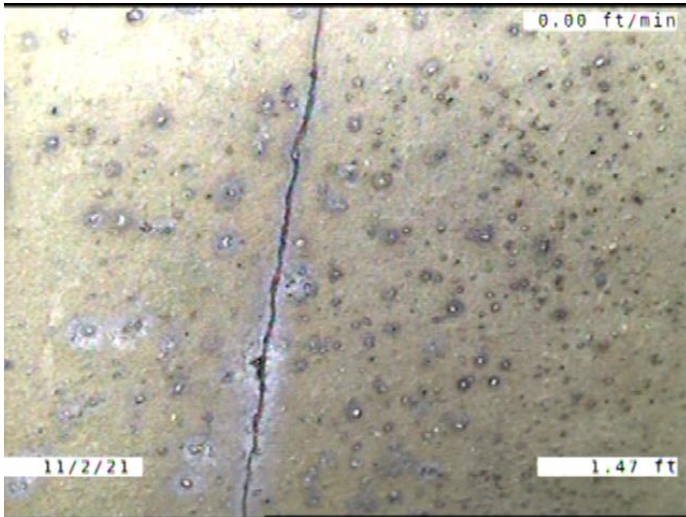
Code: **FL**  
 Description: **Fracture Longitudinal**

Distance (ft): **1.5**  
 Structural Grade: **3**  
 O&M Grade: **0**  
 Clock Start/From: **10**  
 Clock To:  
 1st Value:  
 2nd Value:  
 Value Percent:  
 Continuous Index:  
 Within 8" of Joint: **YES**  
 Remarks:

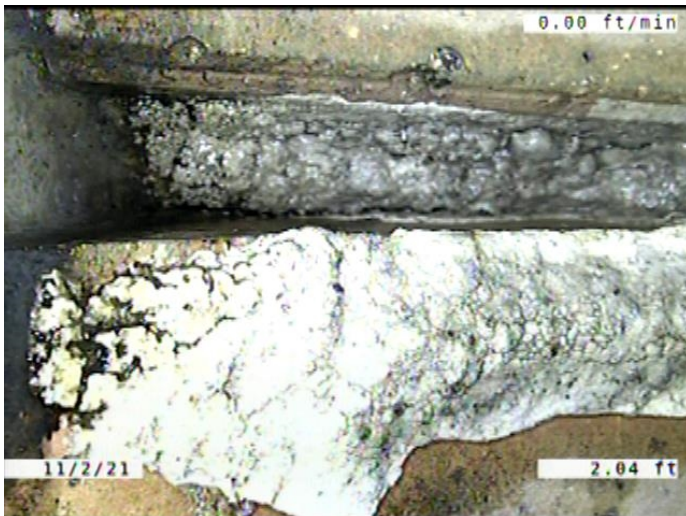
Code: **DAE**  
 Description: **Deposits Attached Encrustation**

Distance (ft): **2.0**  
 Structural Grade: **0**  
 O&M Grade: **2**  
 Clock Start/From: **8**  
 Clock To: **4**  
 1st Value:  
 2nd Value:  
 Value Percent: **5.000**  
 Continuous Index:  
 Within 8" of Joint: **YES**  
 Remarks:

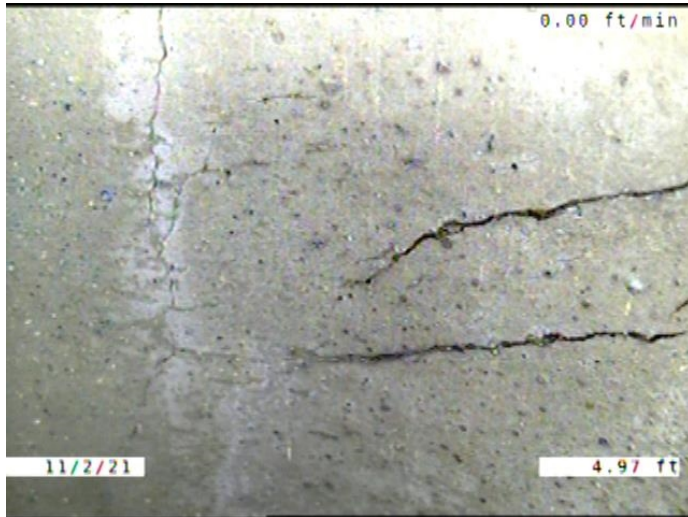
Code: **CM**  
Description: **Crack Multiple**

Distance (ft): **5.0**  
Structural Grade: **3**  
O&M Grade: **0**  
Clock Start/From: **2**  
Clock To: **3**  
1st Value:  
2nd Value:  
Value Percent:  
Continuous Index:  
Within 8" of Joint: **YES**  
Remarks:

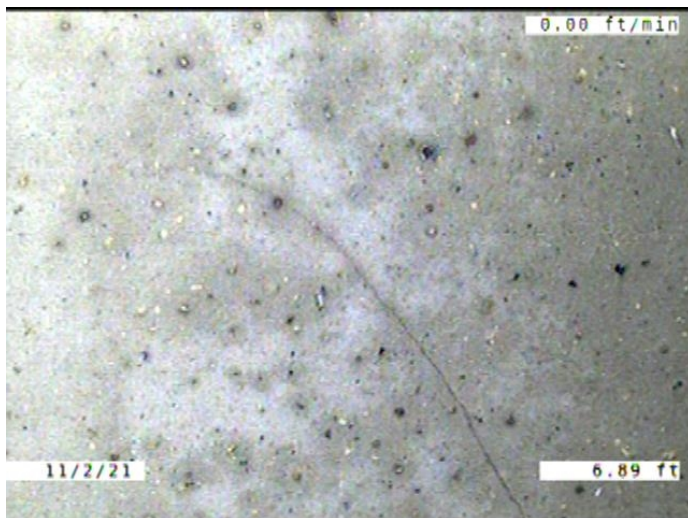
Code: **CM**  
Description: **Crack Multiple**

Distance (ft): **6.9**  
Structural Grade: **3**  
O&M Grade: **0**  
Clock Start/From: **8**  
Clock To: **10**  
1st Value:  
2nd Value:  
Value Percent:  
Continuous Index: **S02**  
Within 8" of Joint: **YES**  
Remarks:

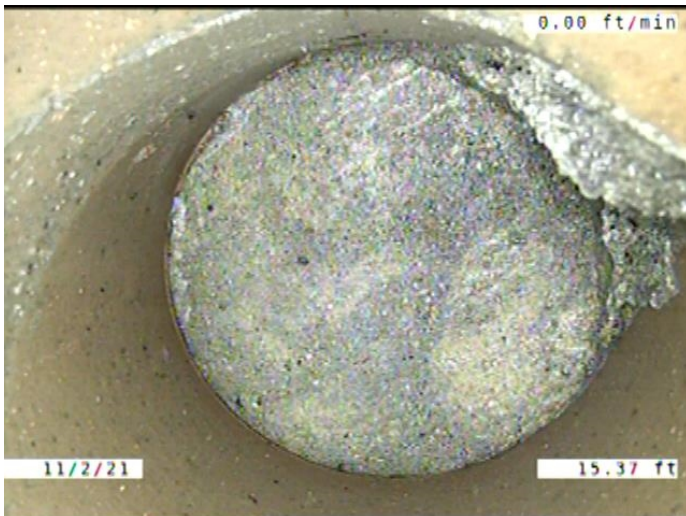
Code: **TFC**  
 Description: **Tap Factory Capped**

Distance (ft): **15.4**  
 Structural Grade: **0**  
 O&M Grade: **0**  
 Clock Start/From: **2**  
 Clock To:  
 1st Value: **4.000**  
 2nd Value:  
 Value Percent:  
 Continuous Index:  
 Within 8" of Joint: **YES**  
 Remarks:

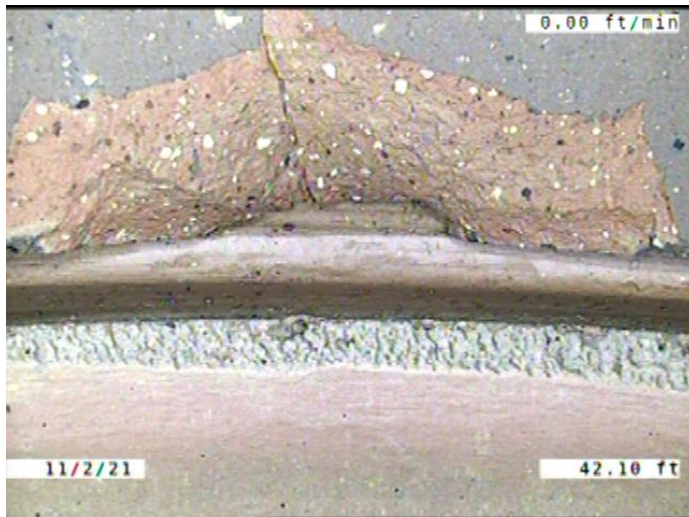
Code: **SMW**  
 Description: **Surface Damage Missing Wall**

Distance (ft): **42.1**  
 Structural Grade: **5**  
 O&M Grade: **0**  
 Clock Start/From: **11**  
 Clock To: **12**  
 1st Value:  
 2nd Value:  
 Value Percent:  
 Continuous Index:  
 Within 8" of Joint: **YES**  
 Remarks: **INSIDE OF THE JOINT**

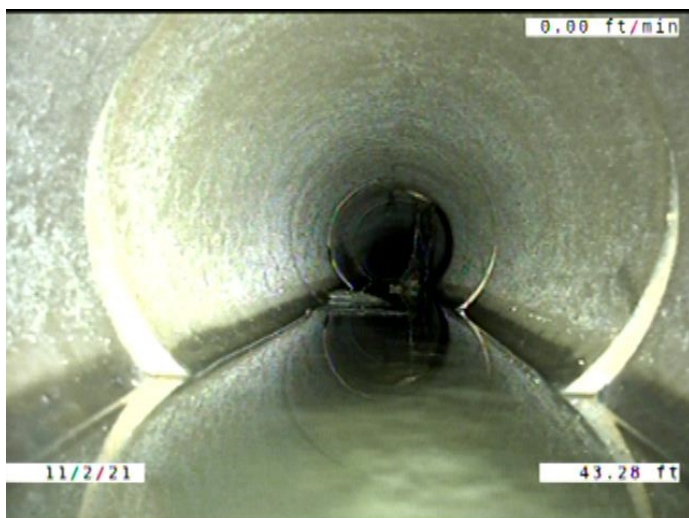
Code: **DSF**  
 Description: **Deposits Settled Fine**

Distance (ft): **43.3**  
 Structural Grade: **0**  
 O&M Grade: **2**  
 Clock Start/From: **5**  
 Clock To: **7**  
 1st Value:  
 2nd Value:  
 Value Percent: **5.000**  
 Continuous Index: **S03**  
 Within 8" of Joint: **YES**  
 Remarks:

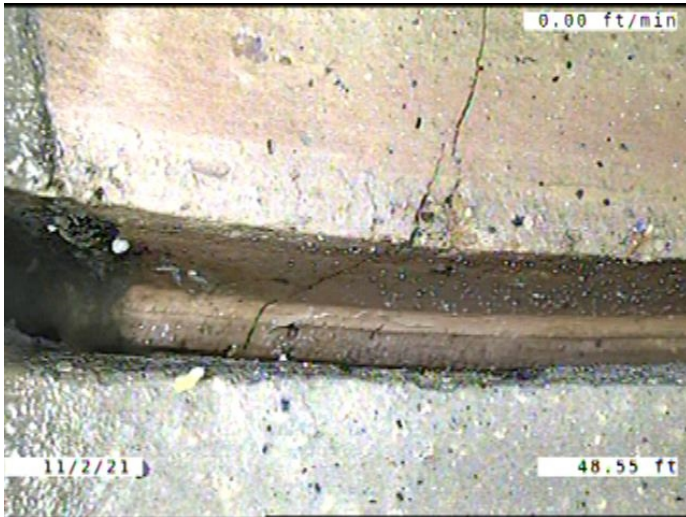
Code: **CM**  
 Description: **Crack Multiple**

Distance (ft): **48.6**  
 Structural Grade: **3**  
 O&M Grade: **0**  
 Clock Start/From: **2**  
 Clock To: **3**  
 1st Value:  
 2nd Value:  
 Value Percent:  
 Continuous Index:  
 Within 8" of Joint: **YES**  
 Remarks:

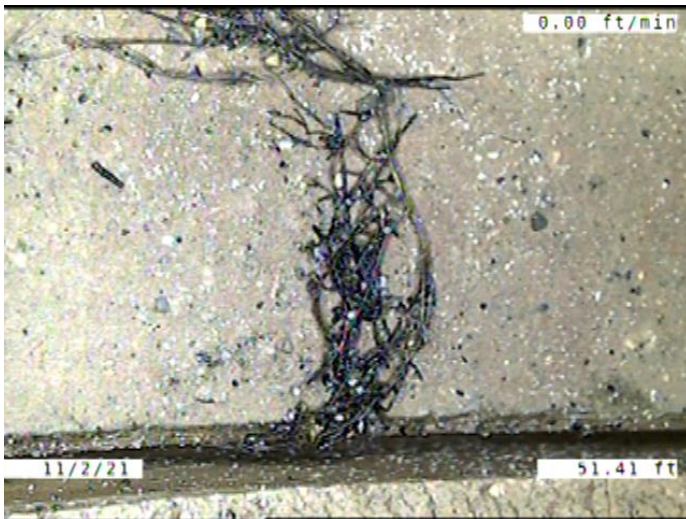
Code: **RFJ**  
 Description: **Roots Fine Joint**

Distance (ft): **51.4**  
 Structural Grade: **0**  
 O&M Grade: **1**  
 Clock Start/From: **9**  
 Clock To:  
 1st Value:  
 2nd Value:  
 Value Percent:  
 Continuous Index:  
 Within 8" of Joint: **YES**  
 Remarks:

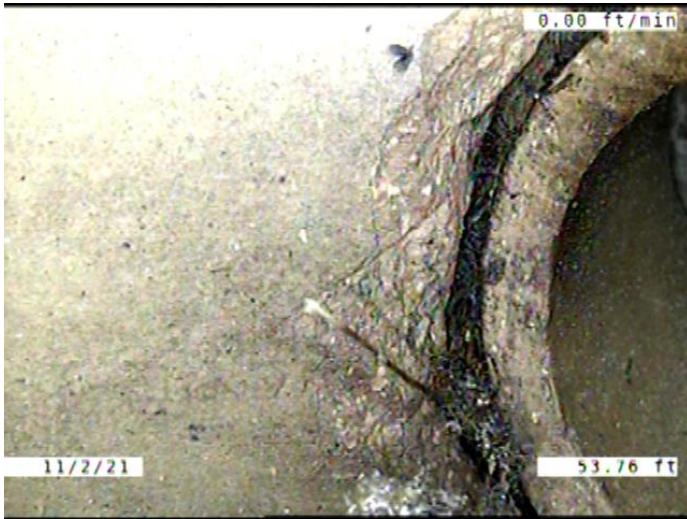
Code: **SSS**  
 Description: **Surface Damage Surface Spalling**

Distance (ft): **53.8**  
 Structural Grade: **2**  
 O&M Grade: **0**  
 Clock Start/From: **11**  
 Clock To: **1**  
 1st Value:  
 2nd Value:  
 Value Percent:  
 Continuous Index:  
 Within 8" of Joint: **YES**  
 Remarks:

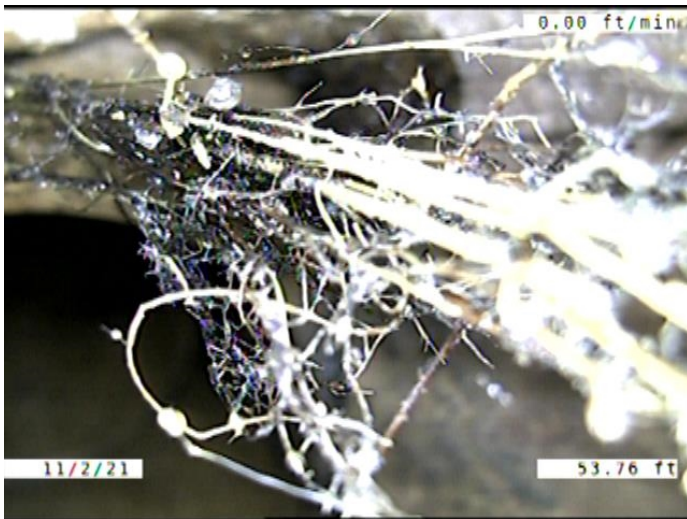
Code: **RMC**  
 Description: **Roots Medium Connection**

Distance (ft): **53.8**  
 Structural Grade: **0**  
 O&M Grade: **3**  
 Clock Start/From: **11**  
 Clock To: **1**  
 1st Value:  
 2nd Value:  
 Value Percent: **5.000**  
 Continuous Index:  
 Within 8" of Joint: **NO**  
 Remarks:

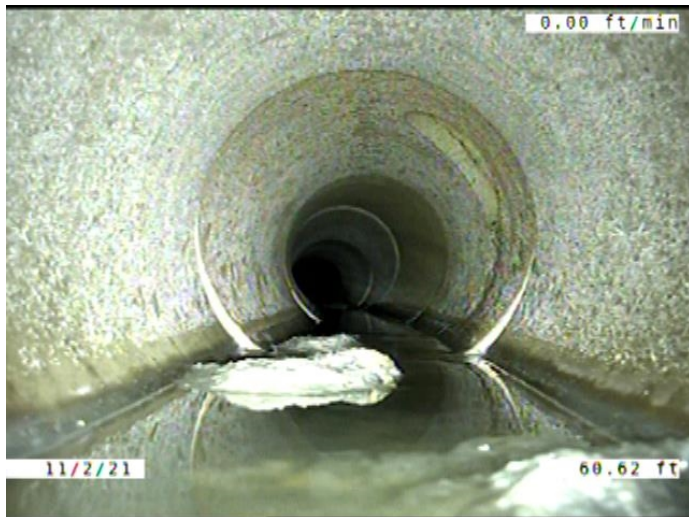
Code: **DAE**  
 Description: **Deposits Attached Encrustation**

Distance (ft): **60.6**  
 Structural Grade: **0**  
 O&M Grade: **2**  
 Clock Start/From: **4**  
 Clock To: **8**  
 1st Value:  
 2nd Value:  
 Value Percent: **5.000**  
 Continuous Index: **F01**  
 Within 8" of Joint: **YES**  
 Remarks:

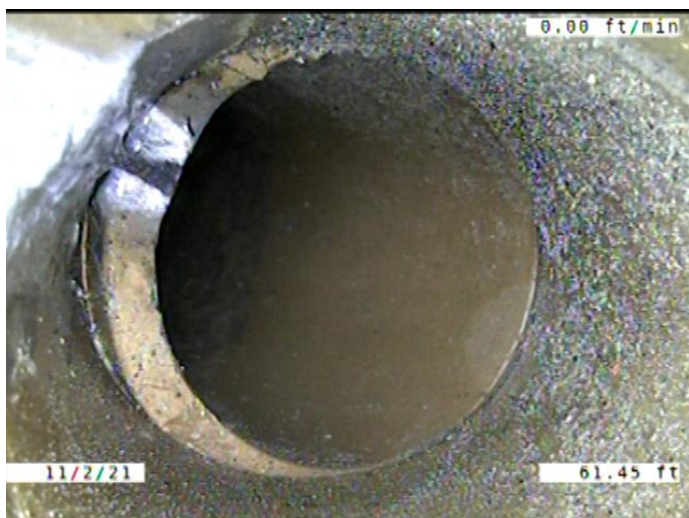
Code: **TF**  
 Description: **Tap Factory**

Distance (ft): **61.4**  
 Structural Grade: **0**  
 O&M Grade: **0**  
 Clock Start/From: **11**  
 Clock To:  
 1st Value: **4.000**  
 2nd Value:  
 Value Percent:  
 Continuous Index:  
 Within 8" of Joint: **YES**  
 Remarks:

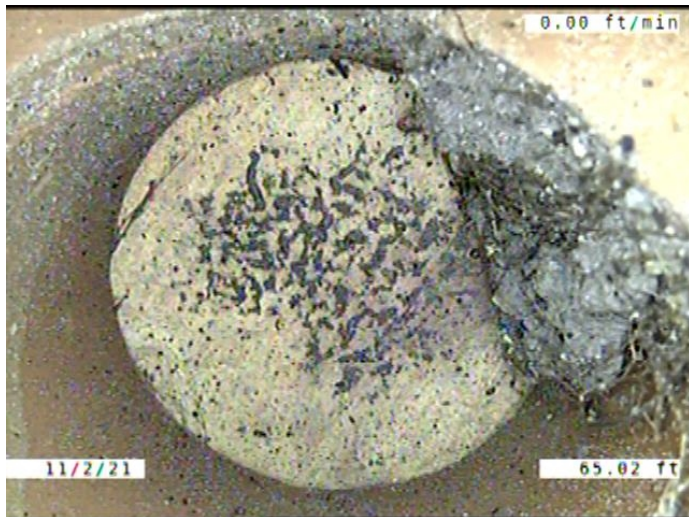
Code: **TFD**  
Description: **Tap Factory Defective**

Distance (ft): **65.0**  
Structural Grade: **0**  
O&M Grade: **3**  
Clock Start/From: **1**  
Clock To:  
1st Value: **4.000**  
2nd Value:  
Value Percent:  
Continuous Index:  
Within 8" of Joint: **YES**  
Remarks: **BROKEN. CAPPED. ROOTS GROWING IN THE BREAK AND AROUND THE CA**

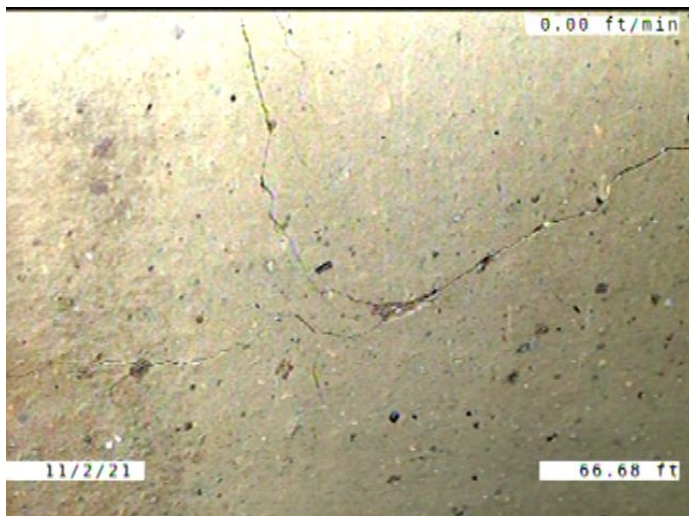
Code: **CM**  
Description: **Crack Multiple**

Distance (ft): **66.7**  
Structural Grade: **3**  
O&M Grade: **0**  
Clock Start/From: **7**  
Clock To: **11**  
1st Value:  
2nd Value:  
Value Percent:  
Continuous Index:  
Within 8" of Joint: **YES**  
Remarks:

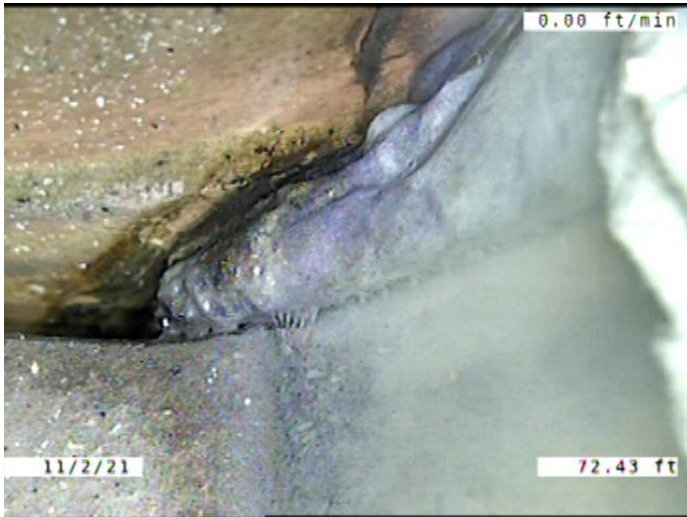
Code: **DAE**  
 Description: **Deposits Attached Encrustation**

Distance (ft): **72.4**  
 Structural Grade: **0**  
 O&M Grade: **2**  
 Clock Start/From: **4**  
 Clock To: **8**  
 1st Value:  
 2nd Value:  
 Value Percent: **5.000**  
 Continuous Index:  
 Within 8" of Joint: **YES**  
 Remarks:

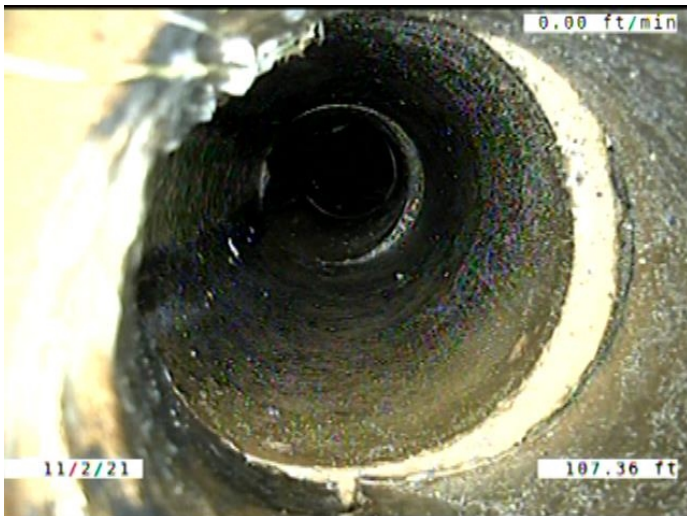
Code: **TFD**  
 Description: **Tap Factory Defective**

Distance (ft): **107.4**  
 Structural Grade: **0**  
 O&M Grade: **3**  
 Clock Start/From: **10**  
 Clock To:  
 1st Value: **4.000**  
 2nd Value:  
 Value Percent:  
 Continuous Index:  
 Within 8" of Joint: **YES**  
 Remarks: **BROKEN. ROOTS GROWING OUT OF THE JOINT**

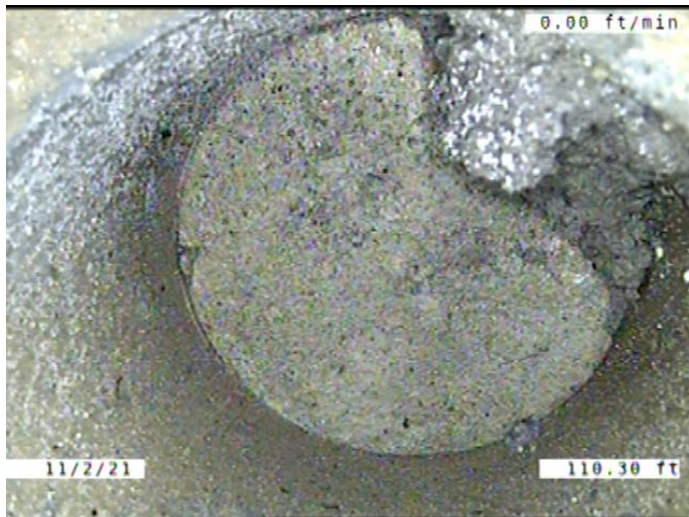
Code: **TFC**  
 Description: **Tap Factory Capped**

Distance (ft): **110.3**  
 Structural Grade: **0**  
 O&M Grade: **0**  
 Clock Start/From: **2**  
 Clock To:  
 1st Value: **4.000**  
 2nd Value:  
 Value Percent:  
 Continuous Index:  
 Within 8" of Joint: **YES**  
 Remarks:

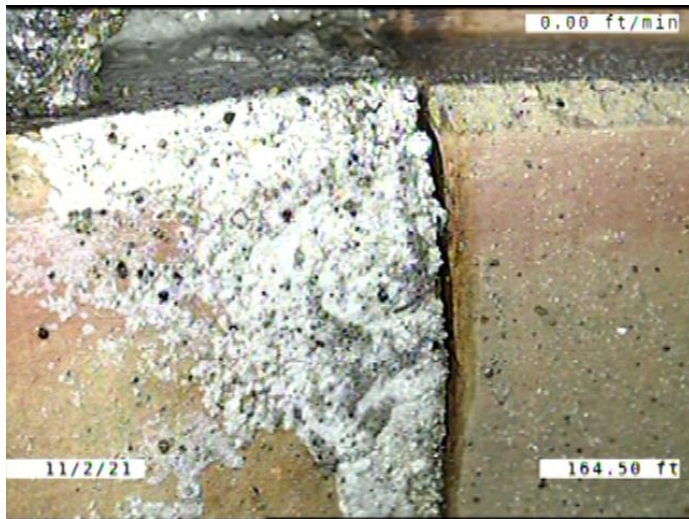
Code: **DAE**  
Description: **Deposits Attached Encrustation**

Distance (ft): **164.5**  
Structural Grade: **0**  
O&M Grade: **2**  
Clock Start/From: **8**  
Clock To: **9**  
1st Value:  
2nd Value:  
Value Percent: **5.000**  
Continuous Index:  
Within 8" of Joint: **YES**  
Remarks:

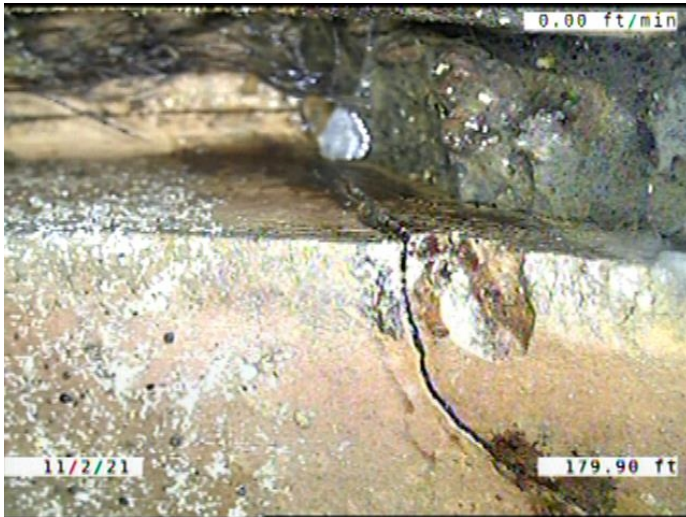
Code: **FM**  
 Description: **Fracture Multiple**

Distance (ft): **179.9**  
 Structural Grade: **4**  
 O&M Grade: **0**  
 Clock Start/From: **4**  
 Clock To: **11**  
 1st Value:  
 2nd Value:  
 Value Percent:  
 Continuous Index:  
 Within 8" of Joint: **YES**  
 Remarks:

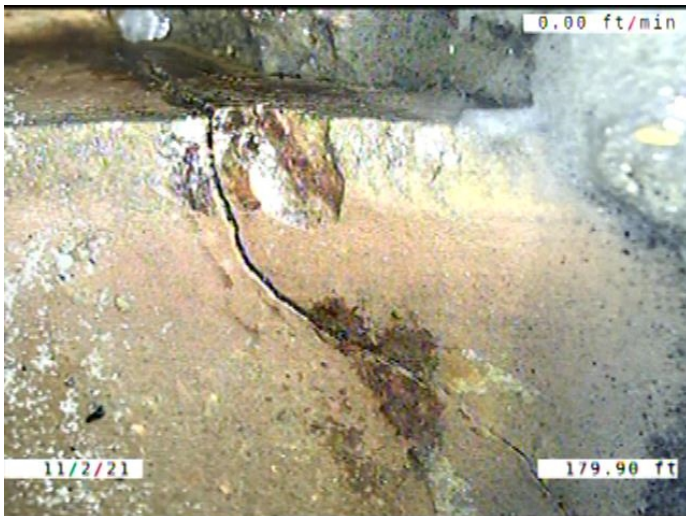
Code: **ISB**  
 Description: **Infiltration Stain Barrel**

Distance (ft): **179.9**  
 Structural Grade: **0**  
 O&M Grade: **1**  
 Clock Start/From: **4**  
 Clock To: **5**  
 1st Value:  
 2nd Value:  
 Value Percent:  
 Continuous Index:  
 Within 8" of Joint: **YES**  
 Remarks:

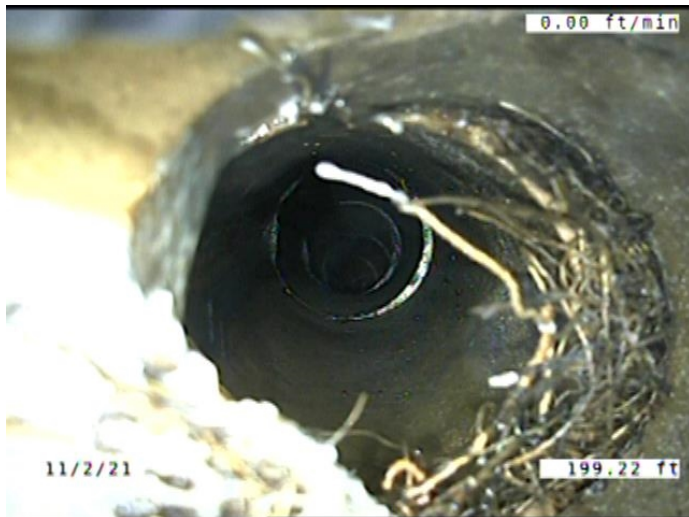
Code:	<b>TFD</b>
Description:	<b>Tap Factory Defective</b>
Distance (ft):	<b>199.2</b>
Structural Grade:	<b>0</b>
O&M Grade:	<b>3</b>
Clock Start/From:	<b>10</b>
Clock To:	
1st Value:	<b>4.000</b>
2nd Value:	
Value Percent:	
Continuous Index:	
Within 8" of Joint:	<b>YES</b>
Remarks:	<b>OFFSET. ROOTS GROWING OUT OF THE JOINT AND INTO THE MAIN</b>

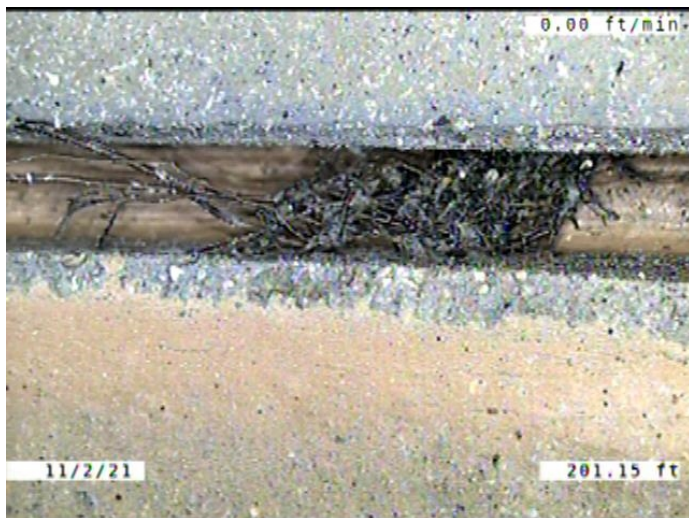
Code:	<b>RFJ</b>
Description:	<b>Roots Fine Joint</b>
Distance (ft):	<b>201.1</b>
Structural Grade:	<b>0</b>
O&M Grade:	<b>1</b>
Clock Start/From:	<b>1</b>
Clock To:	<b>3</b>
1st Value:	
2nd Value:	
Value Percent:	
Continuous Index:	
Within 8" of Joint:	<b>YES</b>
Remarks:

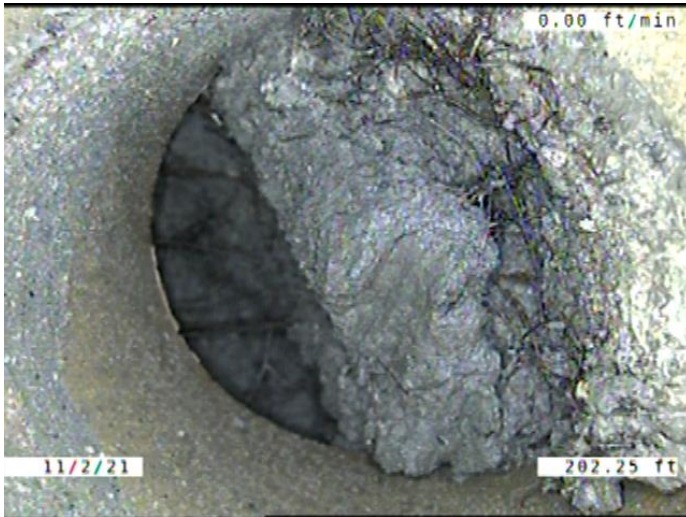
Code:	<b>TFD</b>
Description:	<b>Tap Factory Defective</b>
Distance (ft):	<b>202.2</b>
Structural Grade:	<b>0</b>
O&M Grade:	<b>3</b>
Clock Start/From:	<b>2</b>
Clock To:	
1st Value:	<b>4.000</b>
2nd Value:	
Value Percent:	
Continuous Index:	
Within 8" of Joint:	<b>YES</b>
Remarks:	<b>SOIL VISIBLE. ROOTS GROWING IN THE TAP. LOOKS TO BE 85% PLUGGED</b>

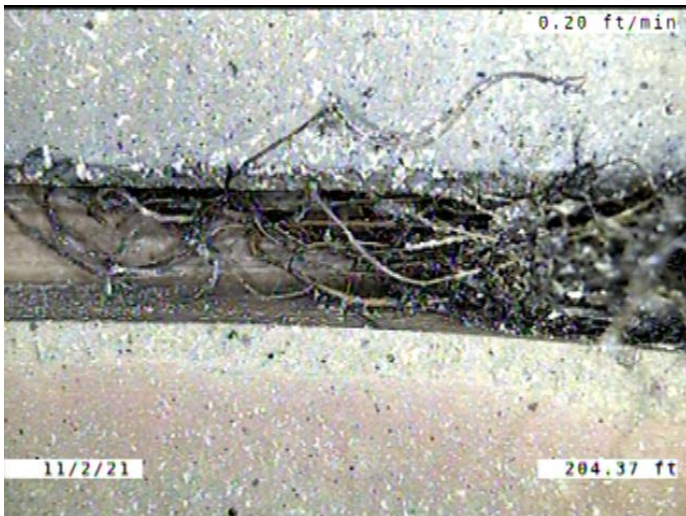
Code:	<b>RFJ</b>
Description:	<b>Roots Fine Joint</b>
Distance (ft):	<b>204.3</b>
Structural Grade:	<b>0</b>
O&M Grade:	<b>1</b>
Clock Start/From:	<b>1</b>
Clock To:	<b>3</b>
1st Value:	
2nd Value:	
Value Percent:	
Continuous Index:	
Within 8" of Joint:	<b>YES</b>
Remarks:

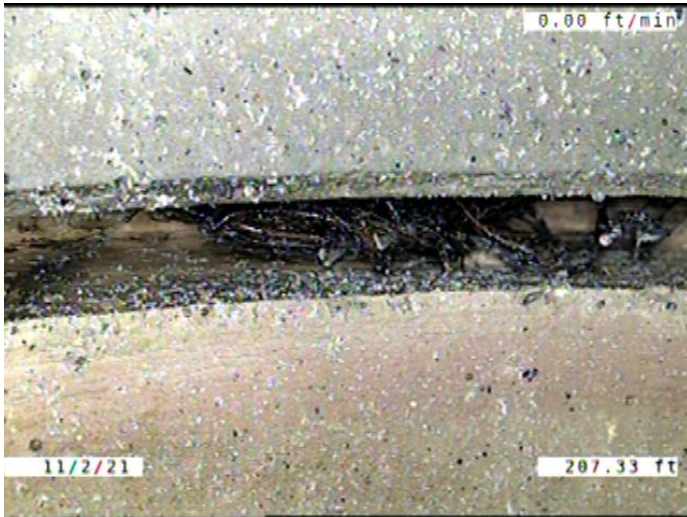
Code: **RFJ**  
Description: **Roots Fine Joint**

Distance (ft): **207.3**  
Structural Grade: **0**  
O&M Grade: **1**  
Clock Start/From: **9**  
Clock To: **10**  
1st Value:  
2nd Value:  
Value Percent:  
Continuous Index:  
Within 8" of Joint: **YES**  
Remarks:

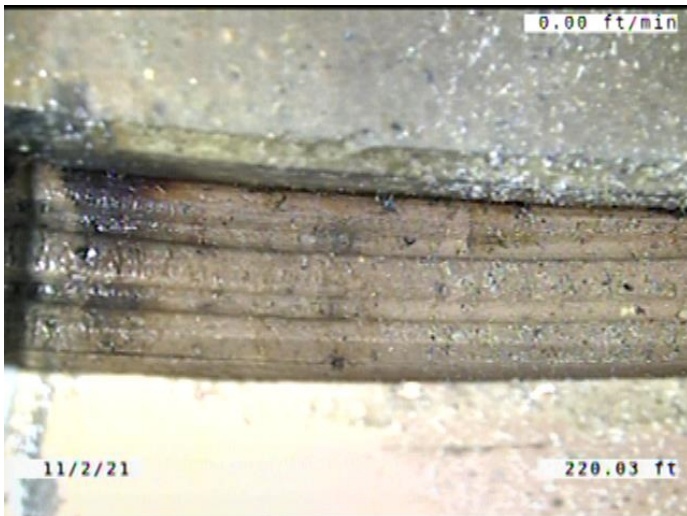
Code: **JAL**  
Description: **Joint Angular Large**

Distance (ft): **220.0**  
Structural Grade: **4**  
O&M Grade: **0**  
Clock Start/From:  
Clock To:  
1st Value:  
2nd Value:  
Value Percent:  
Continuous Index:  
Within 8" of Joint: **NO**  
Remarks:

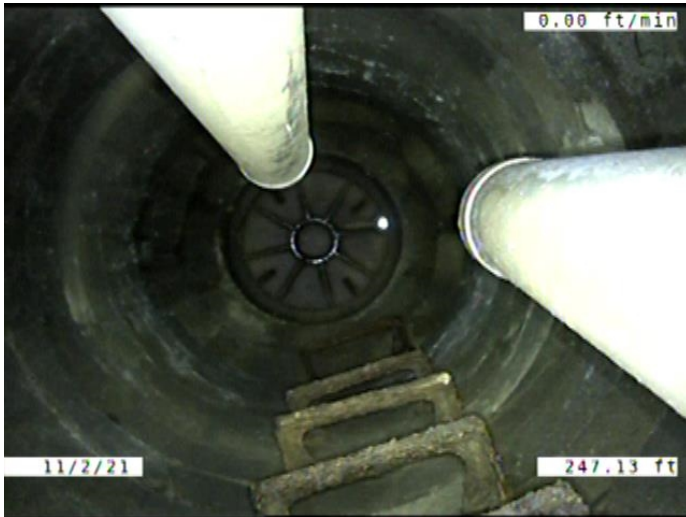
Code:	AMH
Description:	Manhole
Distance (ft):	247.1
Structural Grade:	0
O&M Grade:	0
Clock Start/From:	
Clock To:	
1st Value:	
2nd Value:	
Value Percent:	
Continuous Index:	
Within 8" of Joint:	NO
Remarks:	M-505-060
