Profile/Photo Observation Report

Date:	11/02/2021	Weather:		Coding:	PACP 7.0
Pipe Length (ft):	247.1	Owner:	City of Hobart	Pre Clean:	Heavy Cleaning
P.O.#:	YES502259	Surveyor:	S. Bucklin	PSR:	P-505-060-059
Customer:	City of Hobart	Clean Date:	10/28/2021	Shape:	C

Street:	West 2nd Street	Flow Control:	Not Controlled
City:	Hobart, IN	Year Renewed:	
Location:	Local rural streets with light traffic, t	Tape/Media #:	
Purpose:	Routine Assessment	Dia/Height:	10"
Use:	Sanitary Sewage Pipe	Material:	VCP
Drain Area:		Lining:	None
Category:	NA		
Comment:			
Location Details:		Direction of Survey:	Downstream
US MH:	M-505-059	DS MH:	M-505-060
		Total Length Surveyed (ft):	247.1

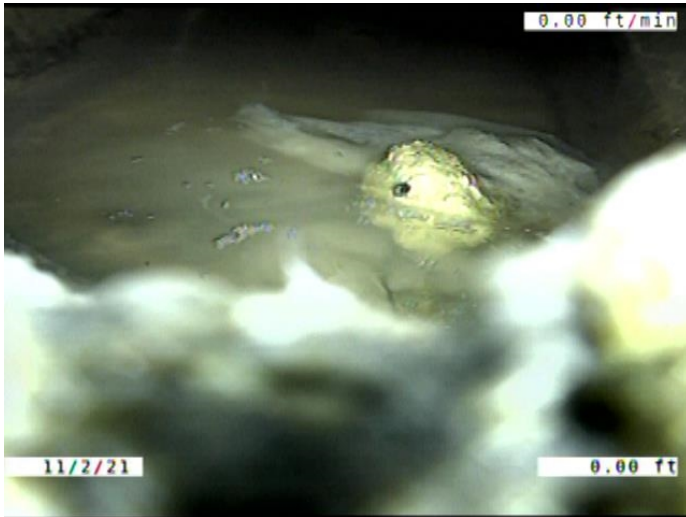
Code: **DAR**
 Description: **Deposits Attached Ragging**

Distance (ft): **.0**
 Structural Grade: **0**
 O&M Grade: **2**
 Clock Start/From: **5**
 Clock To: **7**
 1st Value:
 2nd Value:
 Value Percent: **5.000**
 Continuous Index:
 Within 8" of Joint: **YES**
 Remarks:

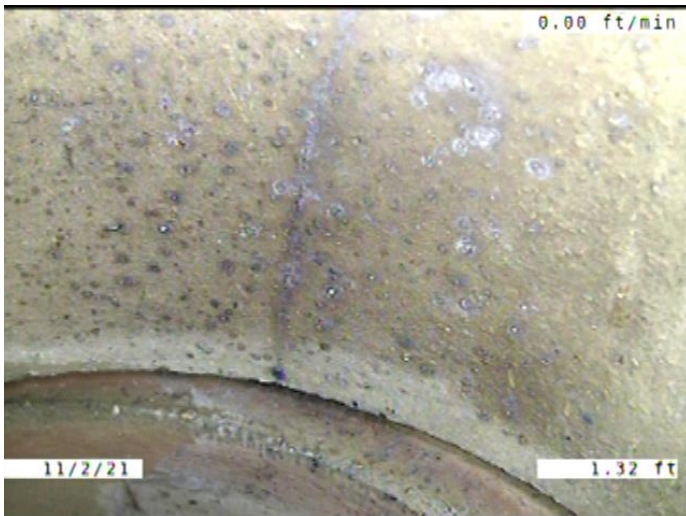
Code: **CS**
 Description: **Crack Spiral**

Distance (ft): **1.3**
 Structural Grade: **2**
 O&M Grade: **0**
 Clock Start/From: **2**
 Clock To: **3**
 1st Value:
 2nd Value:
 Value Percent:
 Continuous Index:
 Within 8" of Joint: **YES**
 Remarks:

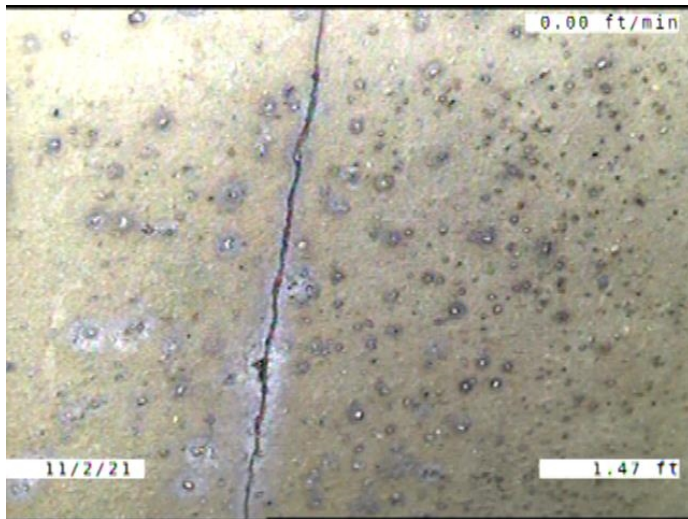
Code: **FL**
Description: **Fracture Longitudinal**

Distance (ft): **1.5**
Structural Grade: **3**
O&M Grade: **0**
Clock Start/From: **10**
Clock To:
1st Value:
2nd Value:
Value Percent:
Continuous Index:
Within 8" of Joint: **YES**
Remarks:

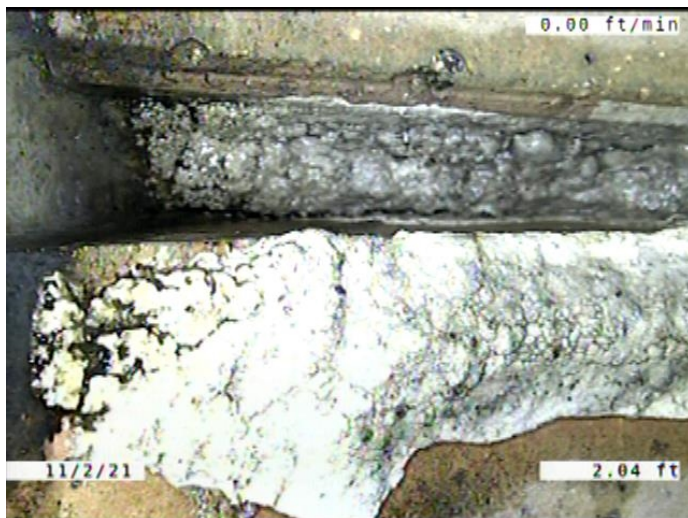
Code: **DAE**
Description: **Deposits Attached Encrustation**

Distance (ft): **2.0**
Structural Grade: **0**
O&M Grade: **2**
Clock Start/From: **8**
Clock To: **4**
1st Value:
2nd Value:
Value Percent: **5.000**
Continuous Index:
Within 8" of Joint: **YES**
Remarks:

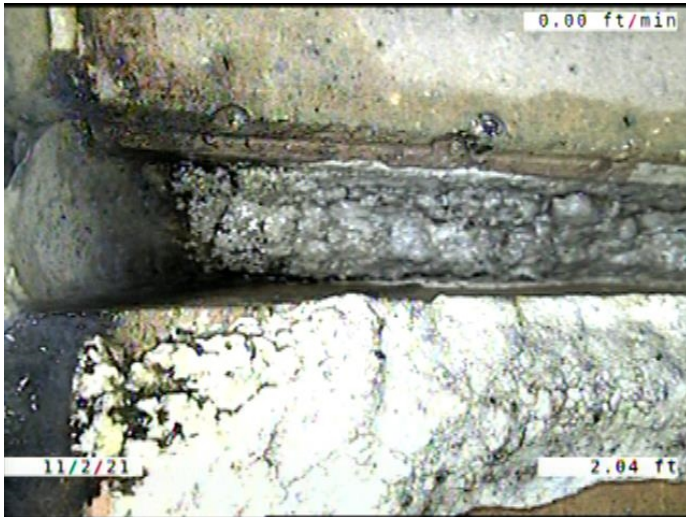
Code: **JAM**
 Description: **Joint Angular Medium**

Distance (ft): **2.0**
 Structural Grade: **3**
 O&M Grade: **0**
 Clock Start/From:
 Clock To:
 1st Value:
 2nd Value:
 Value Percent:
 Continuous Index:
 Within 8" of Joint: **NO**
 Remarks:

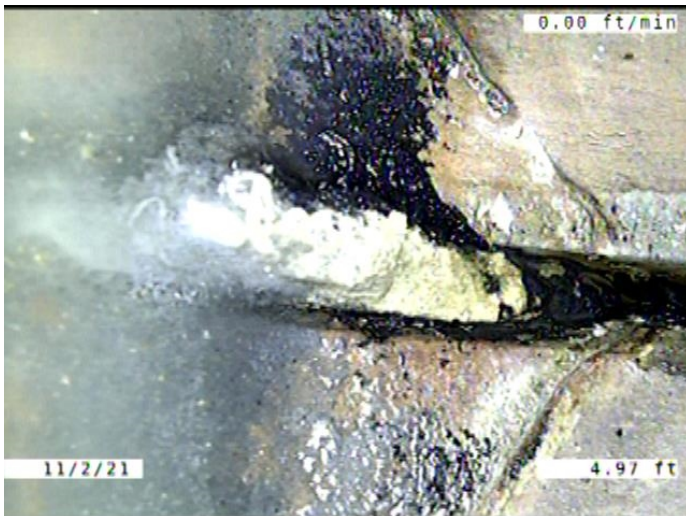
Code: **DAE**
 Description: **Deposits Attached Encrustation**

Distance (ft): **5.0**
 Structural Grade: **0**
 O&M Grade: **2**
 Clock Start/From: **4**
 Clock To: **8**
 1st Value:
 2nd Value:
 Value Percent: **5.000**
 Continuous Index: **S01**
 Within 8" of Joint: **YES**
 Remarks:

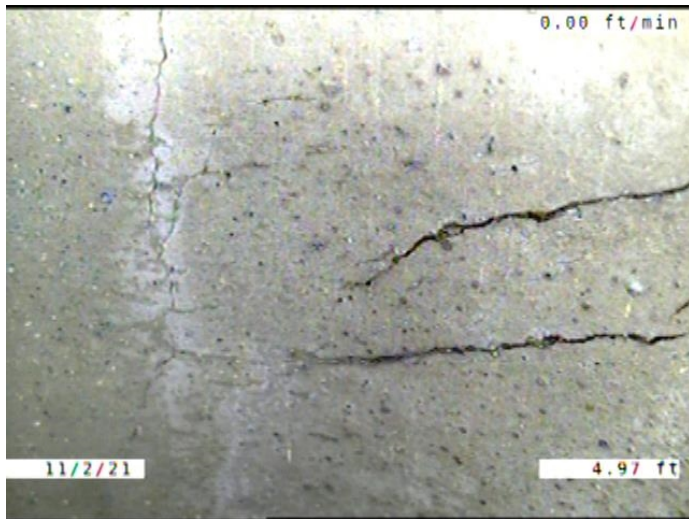
Code: **CM**
 Description: **Crack Multiple**

Distance (ft): **5.0**
 Structural Grade: **3**
 O&M Grade: **0**
 Clock Start/From: **2**
 Clock To: **3**
 1st Value:
 2nd Value:
 Value Percent:
 Continuous Index:
 Within 8" of Joint: **YES**
 Remarks:

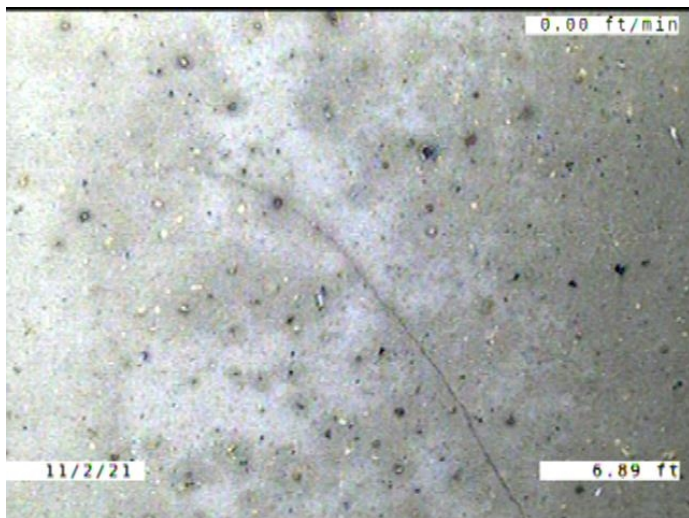
Code: **CM**
 Description: **Crack Multiple**

Distance (ft): **6.9**
 Structural Grade: **3**
 O&M Grade: **0**
 Clock Start/From: **8**
 Clock To: **10**
 1st Value:
 2nd Value:
 Value Percent:
 Continuous Index: **S02**
 Within 8" of Joint: **YES**
 Remarks:

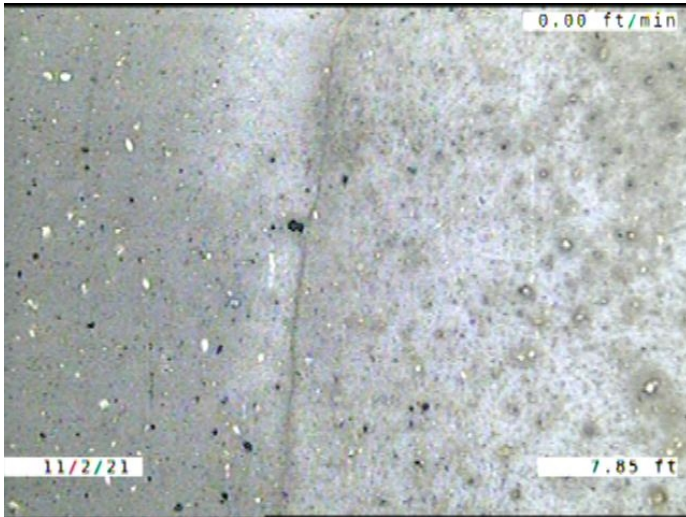
Code: **CL**
Description: **Crack Longitudinal**

Distance (ft): **7.9**
Structural Grade: **2**
O&M Grade: **0**
Clock Start/From: **2**
Clock To:
1st Value:
2nd Value:
Value Percent:
Continuous Index:
Within 8" of Joint: **YES**
Remarks:

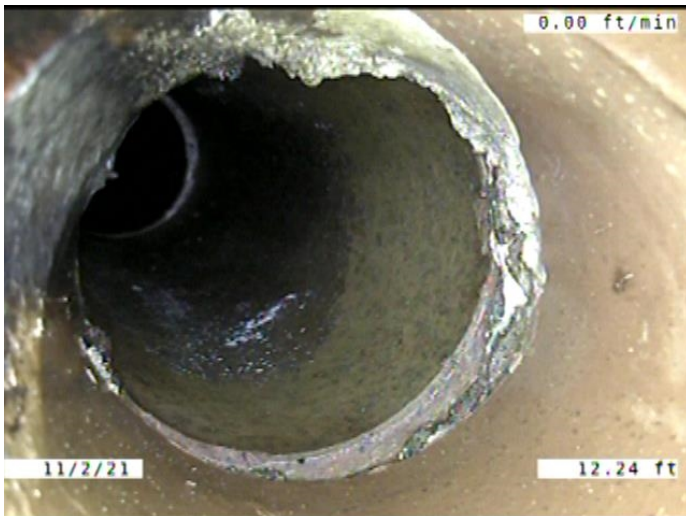
Code: **TF**
Description: **Tap Factory**

Distance (ft): **12.2**
Structural Grade: **0**
O&M Grade: **0**
Clock Start/From: **10**
Clock To:
1st Value: **4.000**
2nd Value:
Value Percent:
Continuous Index:
Within 8" of Joint: **YES**
Remarks: **CONSTANTLY RUNNING WATER.
ENCRUSTATION COMING FROM AR**

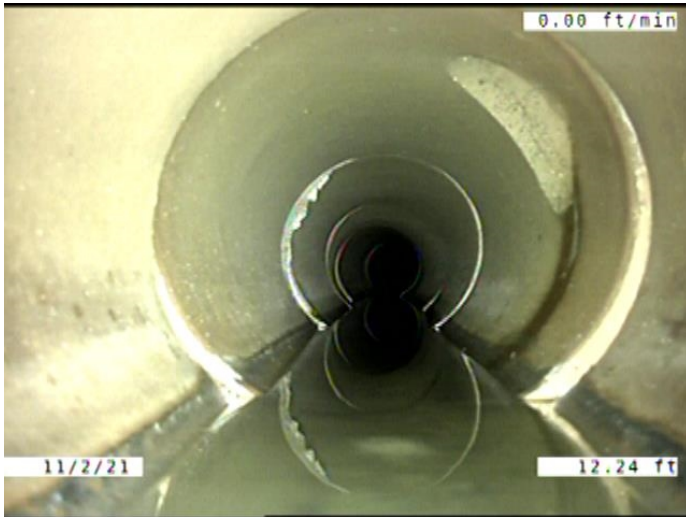
Code: **CM**
 Description: **Crack Multiple**

Distance (ft): **12.2**
 Structural Grade: **3**
 O&M Grade: **0**
 Clock Start/From: **8**
 Clock To: **10**
 1st Value:
 2nd Value:
 Value Percent:
 Continuous Index: **F02**
 Within 8" of Joint: **YES**
 Remarks:

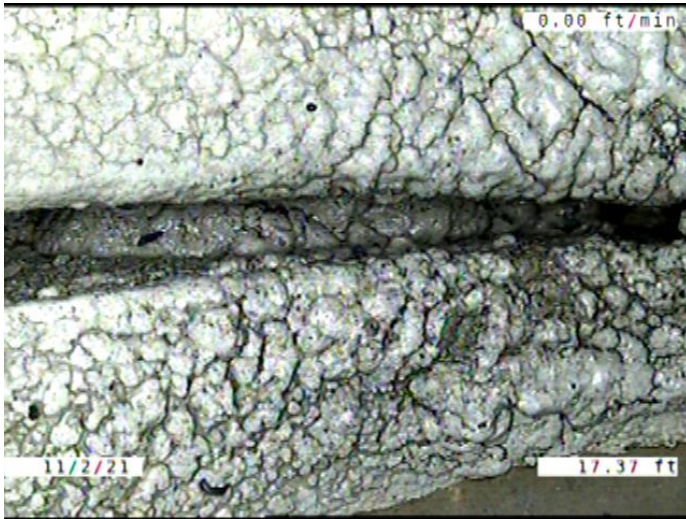
Code: **DAE**
 Description: **Deposits Attached Encrustation**

Distance (ft): **17.4**
 Structural Grade: **0**
 O&M Grade: **2**
 Clock Start/From: **8**
 Clock To: **12**
 1st Value:
 2nd Value:
 Value Percent: **5.000**
 Continuous Index:
 Within 8" of Joint: **YES**
 Remarks:

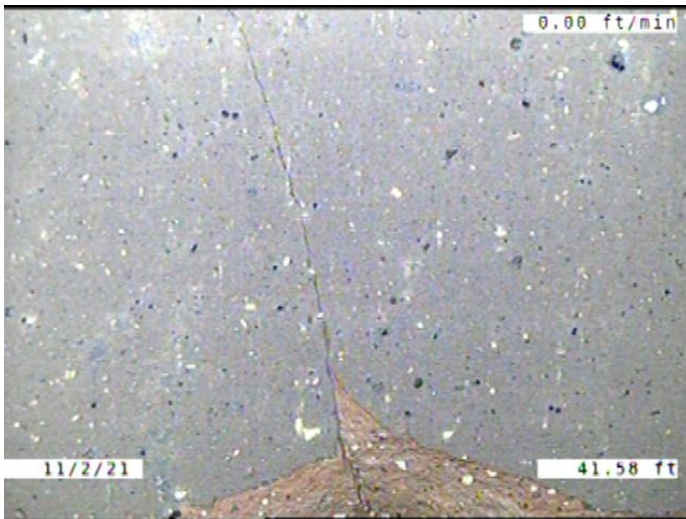
Code: **CS**
 Description: **Crack Spiral**

Distance (ft): **41.6**
 Structural Grade: **2**
 O&M Grade: **0**
 Clock Start/From: **11**
 Clock To: **12**
 1st Value:
 2nd Value:
 Value Percent:
 Continuous Index:
 Within 8" of Joint: **YES**
 Remarks:

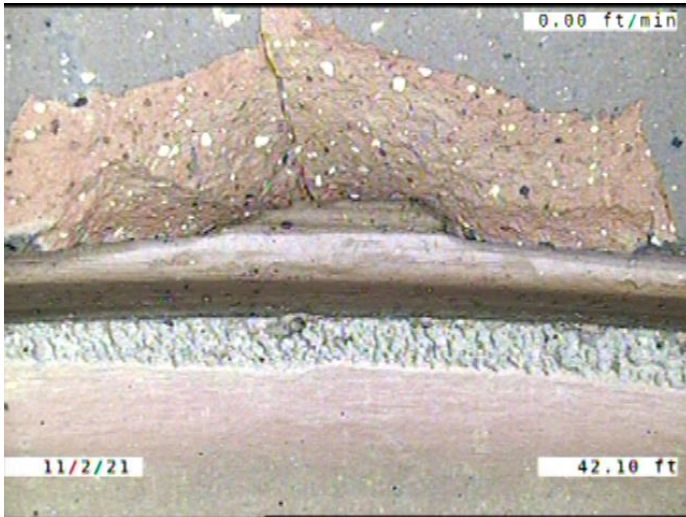
Code: **SMW**
 Description: **Surface Damage Missing Wall**

Distance (ft): **42.1**
 Structural Grade: **5**
 O&M Grade: **0**
 Clock Start/From: **11**
 Clock To: **12**
 1st Value:
 2nd Value:
 Value Percent:
 Continuous Index:
 Within 8" of Joint: **YES**
 Remarks: **INSIDE OF THE JOINT**

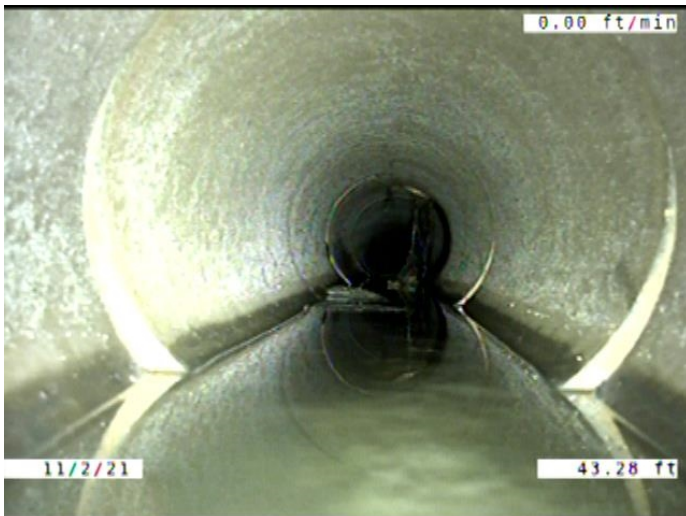
Code: **DSF**
 Description: **Deposits Settled Fine**

Distance (ft): **43.3**
 Structural Grade: **0**
 O&M Grade: **2**
 Clock Start/From: **5**
 Clock To: **7**
 1st Value:
 2nd Value:
 Value Percent: **5.000**
 Continuous Index: **S03**
 Within 8" of Joint: **YES**
 Remarks:

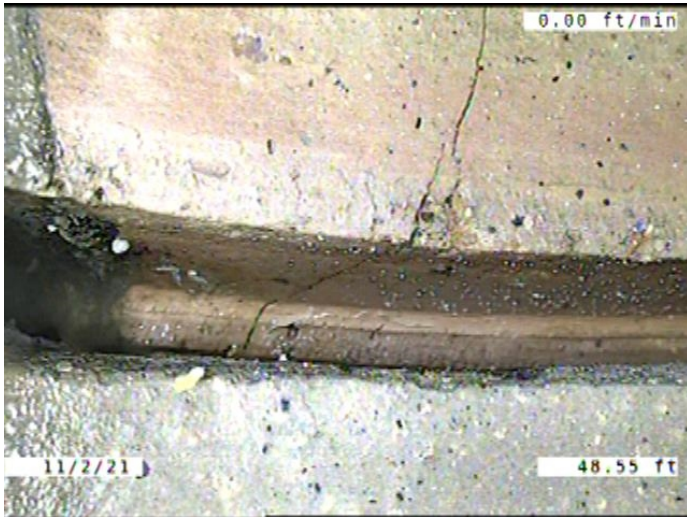
Code: **CM**
 Description: **Crack Multiple**

Distance (ft): **48.6**
 Structural Grade: **3**
 O&M Grade: **0**
 Clock Start/From: **2**
 Clock To: **3**
 1st Value:
 2nd Value:
 Value Percent:
 Continuous Index:
 Within 8" of Joint: **YES**
 Remarks:

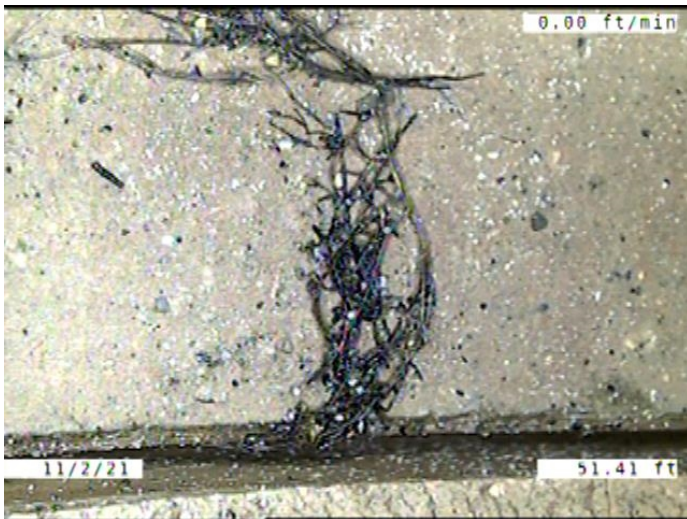
Code: **RFJ**
 Description: **Roots Fine Joint**

Distance (ft): **51.4**
 Structural Grade: **0**
 O&M Grade: **1**
 Clock Start/From: **9**
 Clock To:
 1st Value:
 2nd Value:
 Value Percent:
 Continuous Index:
 Within 8" of Joint: **YES**
 Remarks:

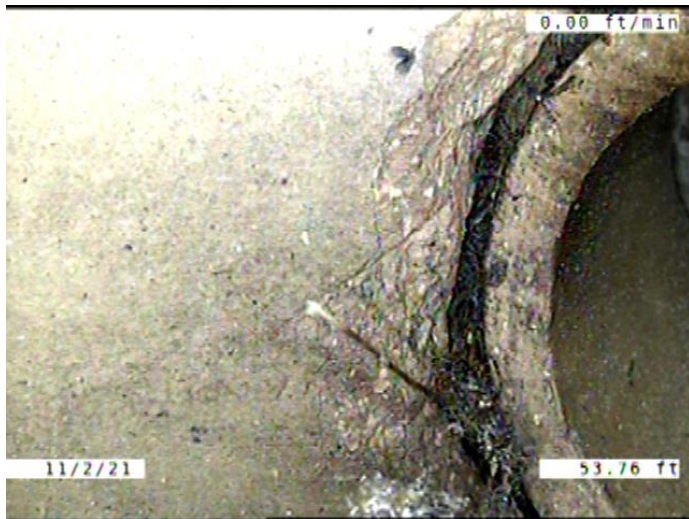
Code: **SSS**
 Description: **Surface Damage Surface Spalling**

Distance (ft): **53.8**
 Structural Grade: **2**
 O&M Grade: **0**
 Clock Start/From: **11**
 Clock To: **1**
 1st Value:
 2nd Value:
 Value Percent:
 Continuous Index:
 Within 8" of Joint: **YES**
 Remarks:

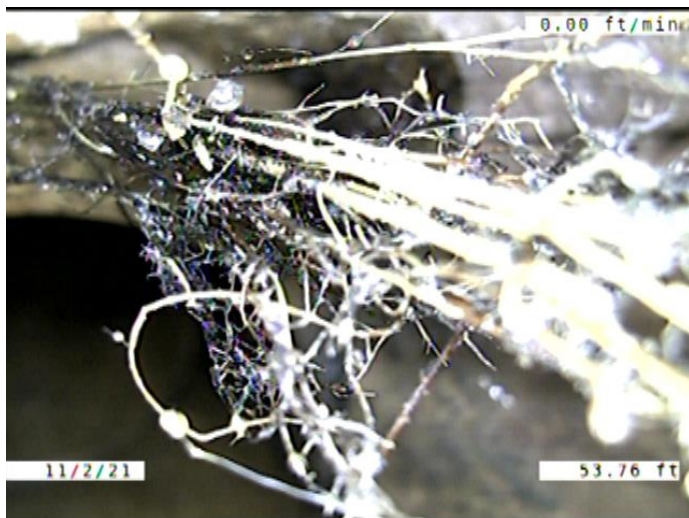
Code: **RMC**
 Description: **Roots Medium Connection**

Distance (ft): **53.8**
 Structural Grade: **0**
 O&M Grade: **3**
 Clock Start/From: **11**
 Clock To: **1**
 1st Value:
 2nd Value:
 Value Percent: **5.000**
 Continuous Index:
 Within 8" of Joint: **NO**
 Remarks:

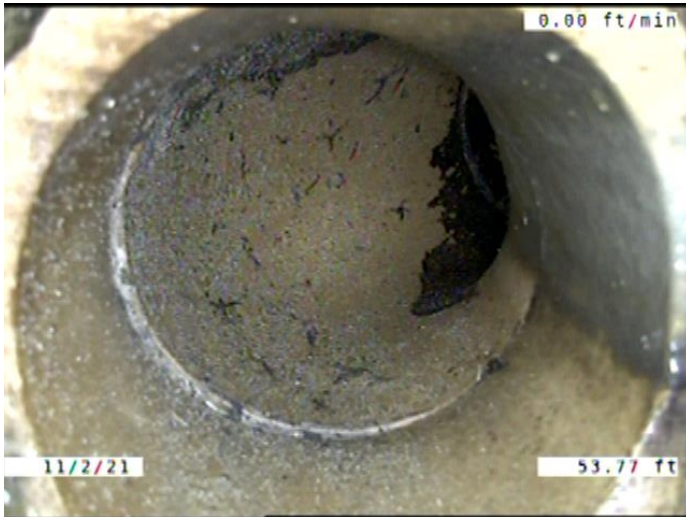
Code: **TBD**
 Description: **Tap Break-in/Hammer Defective**

Distance (ft): **53.8**
 Structural Grade: **0**
 O&M Grade: **3**
 Clock Start/From: **1**
 Clock To:
 1st Value: **4.000**
 2nd Value:
 Value Percent:
 Continuous Index:
 Within 8" of Joint: **YES**
 Remarks: **CONSTANTLY RUNNING WATER.**

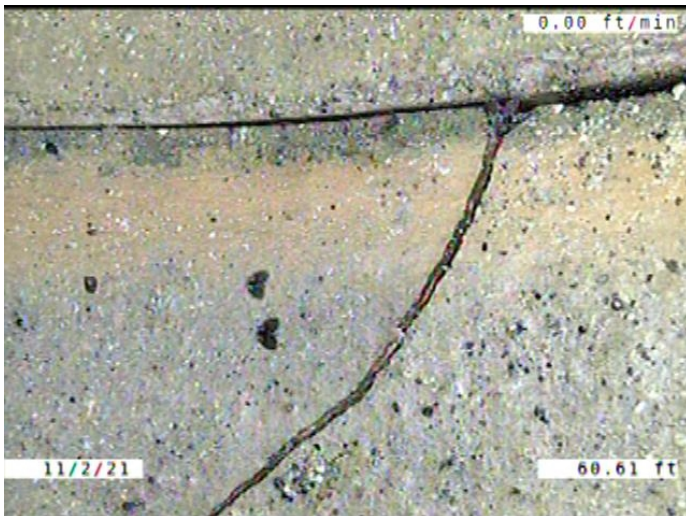
Code: **B**
 Description: **Broken**

Distance (ft): **60.6**
 Structural Grade: **4**
 O&M Grade: **0**
 Clock Start/From: **12**
 Clock To: **3**
 1st Value:
 2nd Value:
 Value Percent:
 Continuous Index:
 Within 8" of Joint: **YES**
 Remarks:

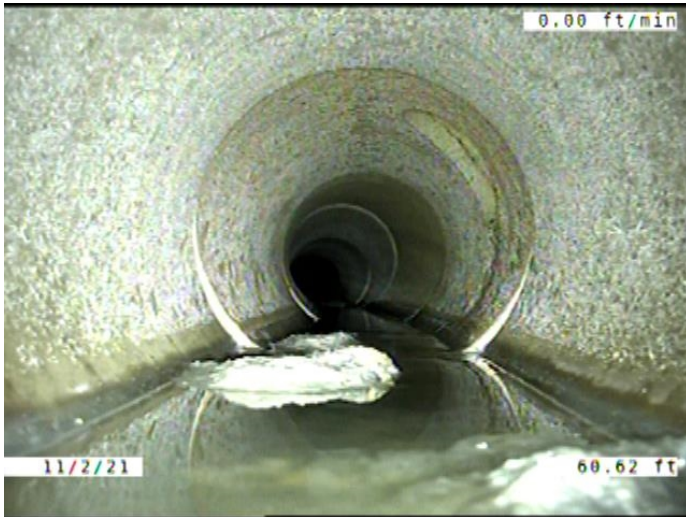
Code: **DAE**
Description: **Deposits Attached Encrustation**

Distance (ft): **60.6**
Structural Grade: **0**
O&M Grade: **2**
Clock Start/From: **4**
Clock To: **8**
1st Value:
2nd Value:
Value Percent: **5.000**
Continuous Index: **F01**
Within 8" of Joint: **YES**
Remarks:

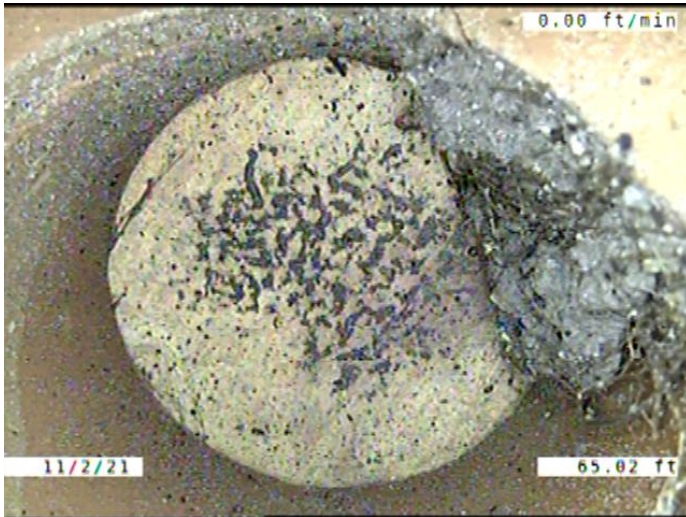
Code: **TFD**
Description: **Tap Factory Defective**

Distance (ft): **65.0**
Structural Grade: **0**
O&M Grade: **3**
Clock Start/From: **1**
Clock To:
1st Value: **4.000**
2nd Value:
Value Percent:
Continuous Index:
Within 8" of Joint: **YES**
Remarks: **BROKEN. CAPPED. ROOTS GROWING IN THE BREAK AND AROUND THE CA**

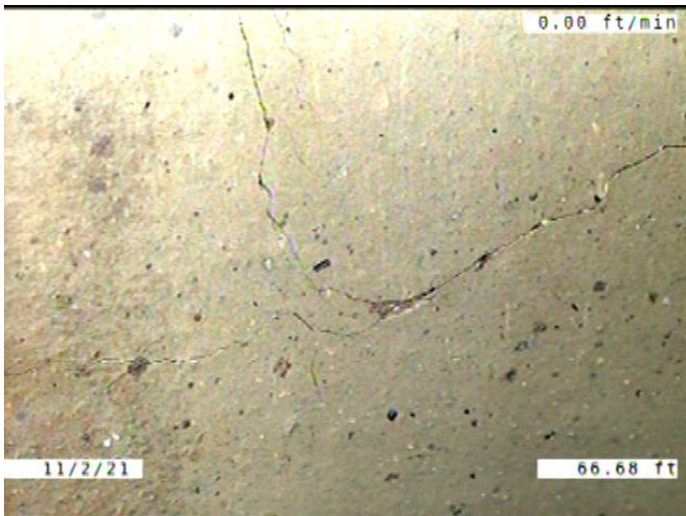
Code: **CM**
Description: **Crack Multiple**

Distance (ft): **66.7**
Structural Grade: **3**
O&M Grade: **0**
Clock Start/From: **7**
Clock To: **11**
1st Value:
2nd Value:
Value Percent:
Continuous Index:
Within 8" of Joint: **YES**
Remarks:

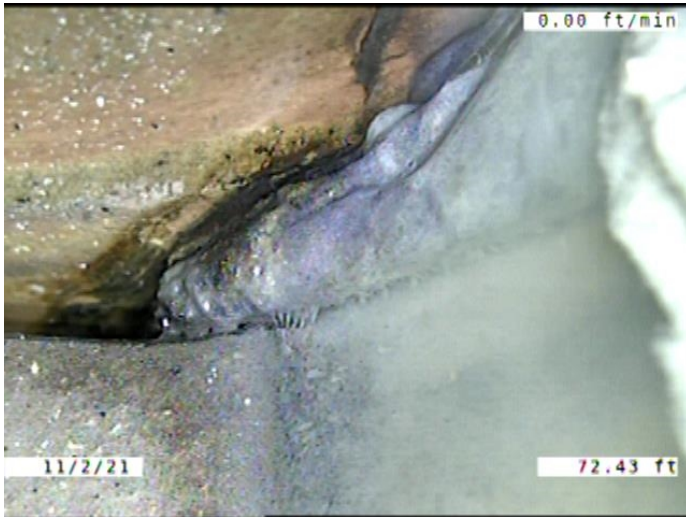
Code: **DAE**
Description: **Deposits Attached Encrustation**

Distance (ft): **72.4**
Structural Grade: **0**
O&M Grade: **2**
Clock Start/From: **4**
Clock To: **8**
1st Value:
2nd Value:
Value Percent: **5.000**
Continuous Index:
Within 8" of Joint: **YES**
Remarks:

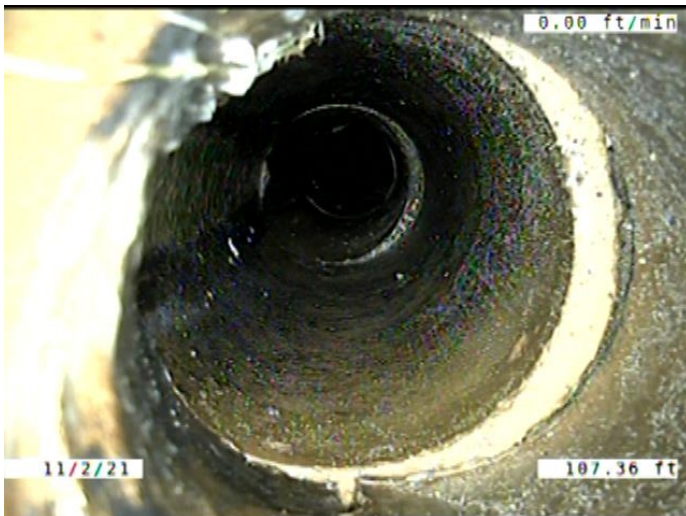
Code: **TFD**
Description: **Tap Factory Defective**

Distance (ft): **107.4**
Structural Grade: **0**
O&M Grade: **3**
Clock Start/From: **10**
Clock To:
1st Value: **4.000**
2nd Value:
Value Percent:
Continuous Index:
Within 8" of Joint: **YES**
Remarks: **BROKEN. ROOTS GROWING OUT OF THE JOINT**

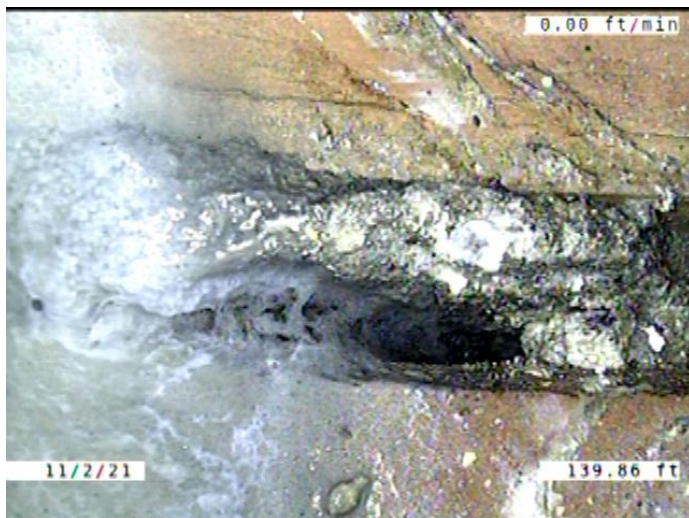
Code: **DAE**
 Description: **Deposits Attached Encrustation**

Distance (ft): **139.9**
 Structural Grade: **0**
 O&M Grade: **2**
 Clock Start/From: **3**
 Clock To: **8**
 1st Value:
 2nd Value:
 Value Percent: **5.000**
 Continuous Index:
 Within 8" of Joint: **YES**
 Remarks:

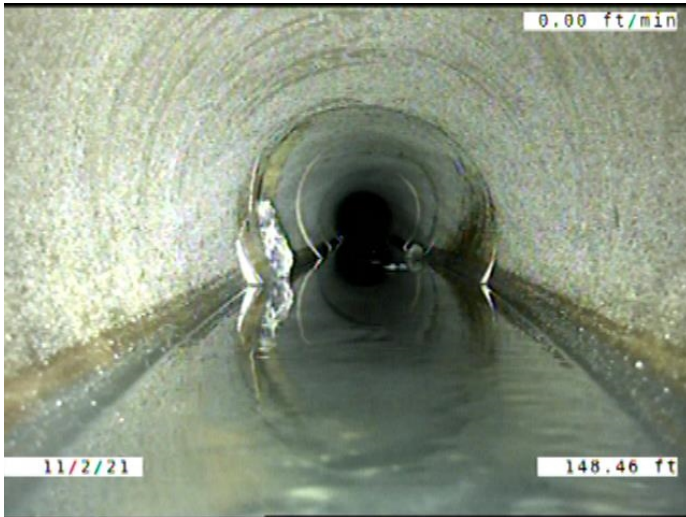
Code: **MWLS**
Description: **Miscellaneous Water Level Sag**

Distance (ft): **148.5**
Structural Grade: **2**
O&M Grade: **0**
Clock Start/From:
Clock To:
1st Value:
2nd Value:
Value Percent: **5.000**
Continuous Index: **S04**
Within 8" of Joint: **NO**
Remarks:

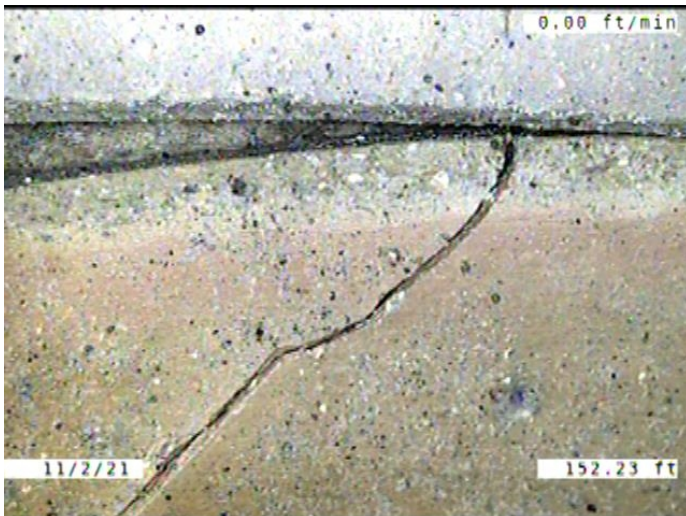
Code: **B**
Description: **Broken**

Distance (ft): **152.2**
Structural Grade: **4**
O&M Grade: **0**
Clock Start/From: **9**
Clock To: **11**
1st Value:
2nd Value:
Value Percent:
Continuous Index:
Within 8" of Joint: **YES**
Remarks:

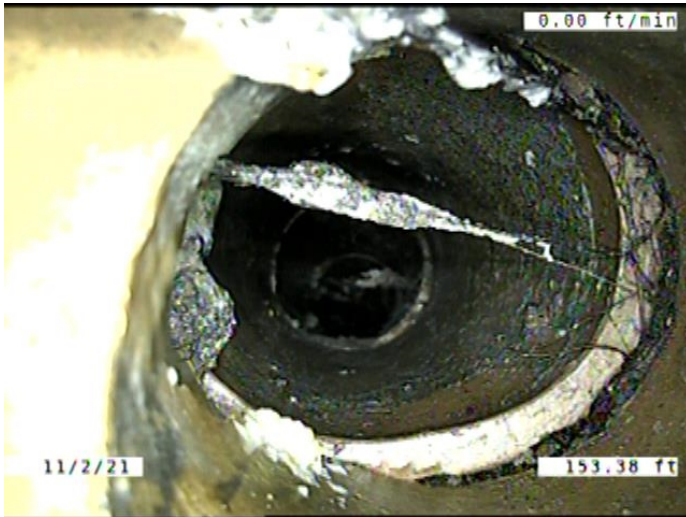
Code: **TFD**
 Description: **Tap Factory Defective**

Distance (ft): **153.4**
 Structural Grade: **0**
 O&M Grade: **3**
 Clock Start/From: **10**
 Clock To:
 1st Value: **4.000**
 2nd Value:
 Value Percent:
 Continuous Index:
 Within 8" of Joint: **YES**
 Remarks: **OFFSET. SOIL VISIBLE. ROOTS GROWING FROM THE JOINTS**

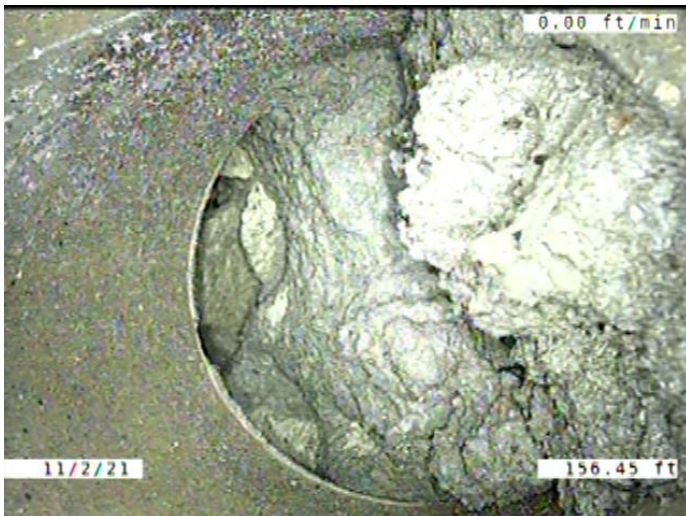
Code: **TFD**
 Description: **Tap Factory Defective**

Distance (ft): **156.4**
 Structural Grade: **0**
 O&M Grade: **3**
 Clock Start/From: **2**
 Clock To:
 1st Value: **4.000**
 2nd Value:
 Value Percent:
 Continuous Index:
 Within 8" of Joint: **YES**
 Remarks: **95% PLUGGED. SOIL AND ROCKS VISIBLE**

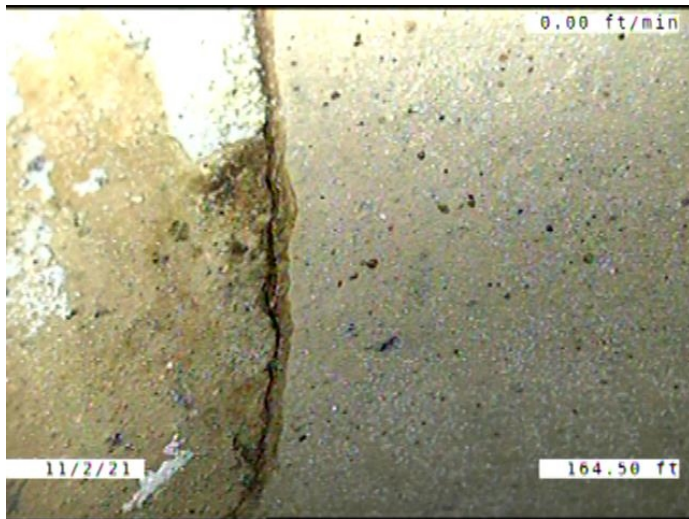
Code: **FM**
 Description: **Fracture Multiple**

Distance (ft): **164.5**
 Structural Grade: **4**
 O&M Grade: **0**
 Clock Start/From: **8**
 Clock To: **10**
 1st Value:
 2nd Value:
 Value Percent:
 Continuous Index:
 Within 8" of Joint: **YES**
 Remarks:

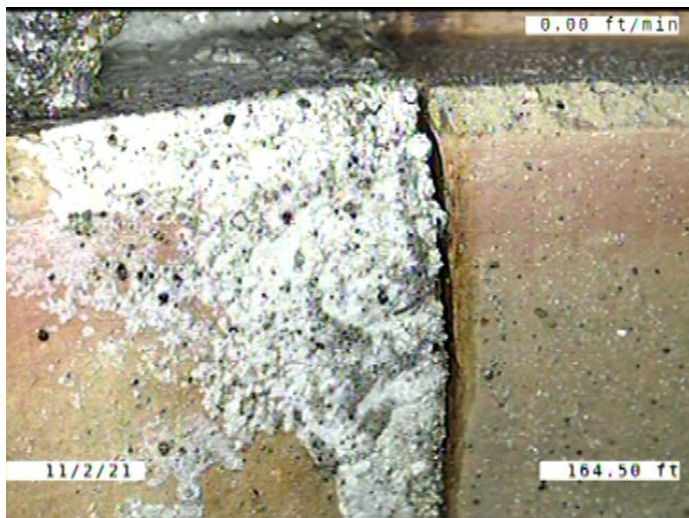
Code: **DAE**
 Description: **Deposits Attached Encrustation**

Distance (ft): **164.5**
 Structural Grade: **0**
 O&M Grade: **2**
 Clock Start/From: **8**
 Clock To: **9**
 1st Value:
 2nd Value:
 Value Percent: **5.000**
 Continuous Index:
 Within 8" of Joint: **YES**
 Remarks:

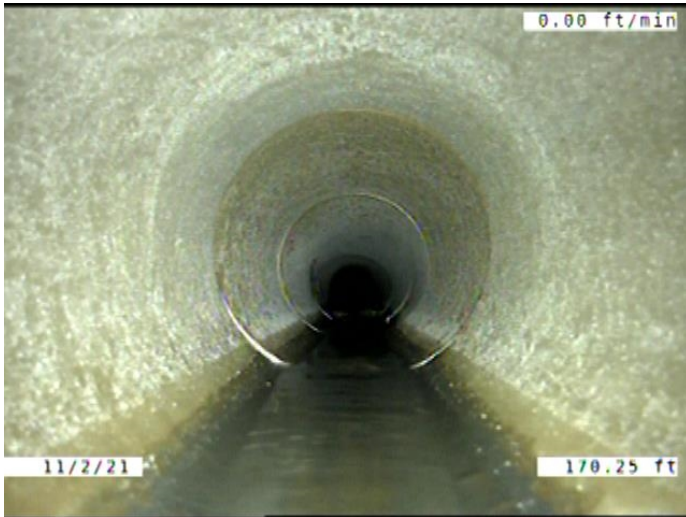
Code: **MWLS**
 Description: **Miscellaneous Water Level Sag**

Distance (ft): **170.2**
 Structural Grade: **2**
 O&M Grade: **0**
 Clock Start/From:
 Clock To:
 1st Value:
 2nd Value:
 Value Percent: **5.000**
 Continuous Index: **F04**
 Within 8" of Joint: **NO**
 Remarks:

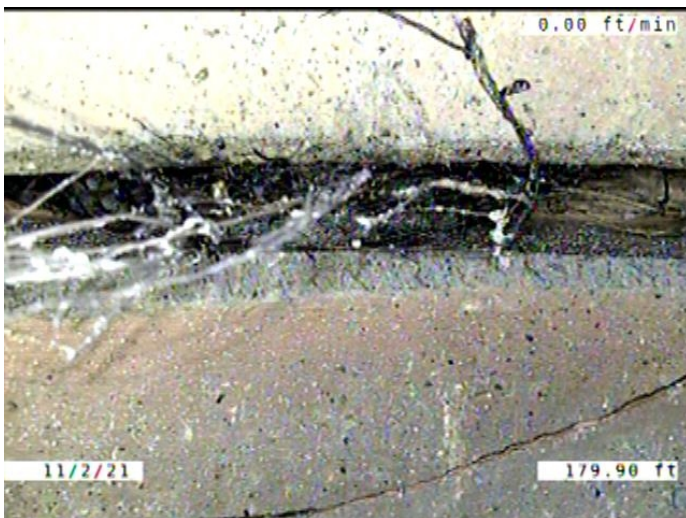
Code: **RFJ**
 Description: **Roots Fine Joint**

Distance (ft): **179.9**
 Structural Grade: **0**
 O&M Grade: **1**
 Clock Start/From: **9**
 Clock To: **10**
 1st Value:
 2nd Value:
 Value Percent:
 Continuous Index:
 Within 8" of Joint: **YES**
 Remarks:

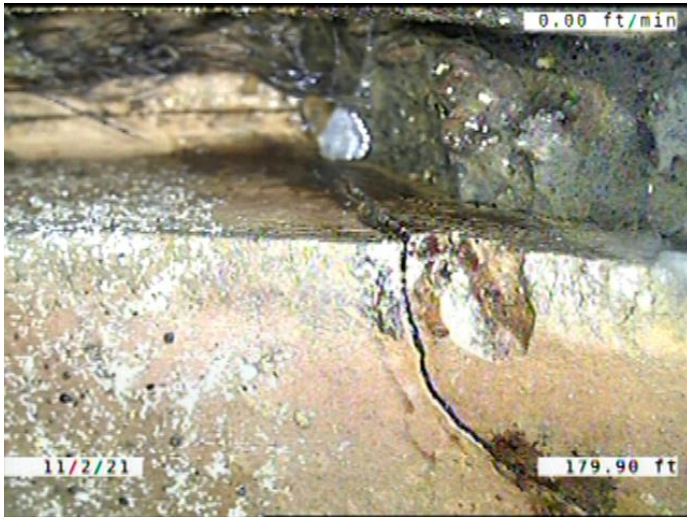
Code: **FM**
 Description: **Fracture Multiple**

Distance (ft): **179.9**
 Structural Grade: **4**
 O&M Grade: **0**
 Clock Start/From: **4**
 Clock To: **11**
 1st Value:
 2nd Value:
 Value Percent:
 Continuous Index:
 Within 8" of Joint: **YES**
 Remarks:

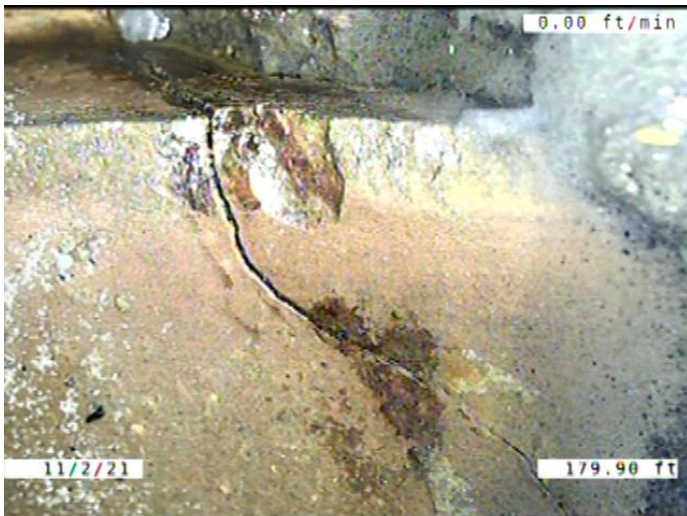
Code: **ISB**
 Description: **Infiltration Stain Barrel**

Distance (ft): **179.9**
 Structural Grade: **0**
 O&M Grade: **1**
 Clock Start/From: **4**
 Clock To: **5**
 1st Value:
 2nd Value:
 Value Percent:
 Continuous Index:
 Within 8" of Joint: **YES**
 Remarks:

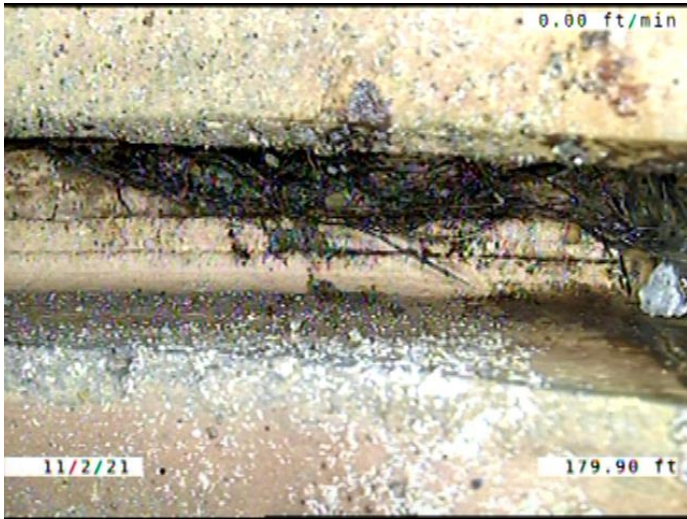
Code: **RFJ**
 Description: **Roots Fine Joint**

Distance (ft): **179.9**
 Structural Grade: **0**
 O&M Grade: **1**
 Clock Start/From: **2**
 Clock To: **4**
 1st Value:
 2nd Value:
 Value Percent:
 Continuous Index:
 Within 8" of Joint: **YES**
 Remarks:

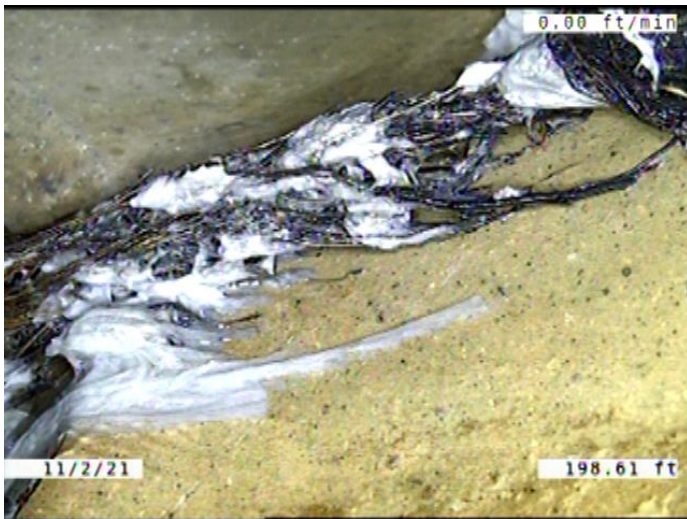
Code: **RFL**
 Description: **Roots Fine Lateral**

Distance (ft): **198.6**
 Structural Grade: **0**
 O&M Grade: **1**
 Clock Start/From: **9**
 Clock To:
 1st Value:
 2nd Value:
 Value Percent:
 Continuous Index:
 Within 8" of Joint: **NO**
 Remarks:

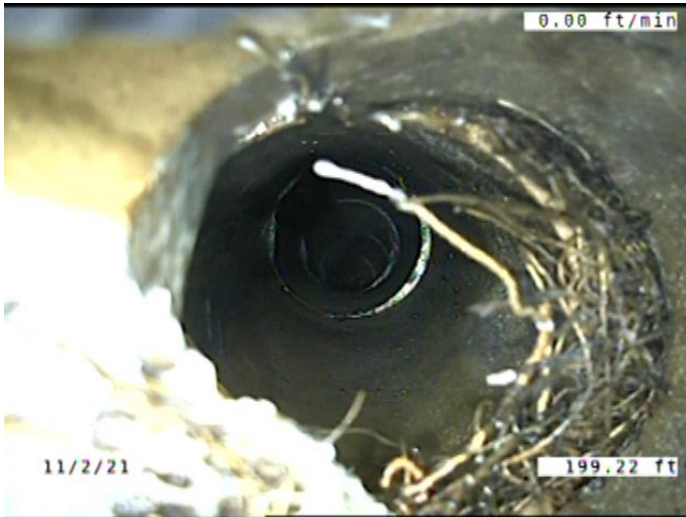
Code:	TFD
Description:	Tap Factory Defective
Distance (ft):	199.2
Structural Grade:	0
O&M Grade:	3
Clock Start/From:	10
Clock To:	
1st Value:	4.000
2nd Value:	
Value Percent:	
Continuous Index:	
Within 8" of Joint:	YES
Remarks:	OFFSET. ROOTS GROWING OUT OF THE JOINT AND INTO THE MAIN

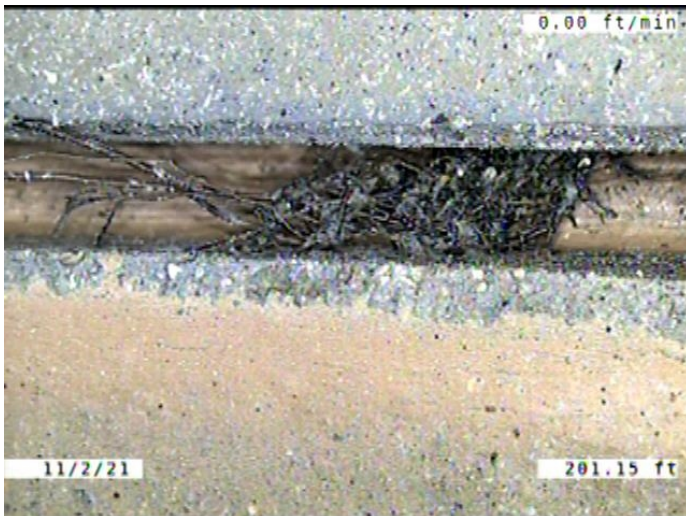
Code:	RFJ
Description:	Roots Fine Joint
Distance (ft):	201.1
Structural Grade:	0
O&M Grade:	1
Clock Start/From:	1
Clock To:	3
1st Value:	
2nd Value:	
Value Percent:	
Continuous Index:	
Within 8" of Joint:	YES
Remarks:

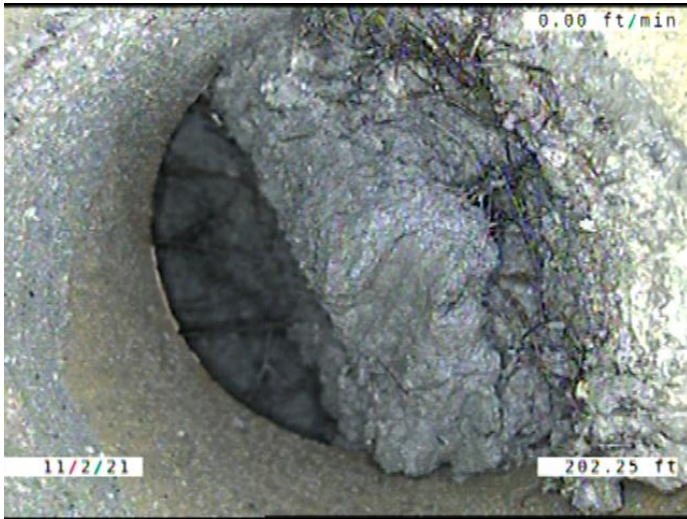
Code:	TFD
Description:	Tap Factory Defective
Distance (ft):	202.2
Structural Grade:	0
O&M Grade:	3
Clock Start/From:	2
Clock To:	
1st Value:	4.000
2nd Value:	
Value Percent:	
Continuous Index:	
Within 8" of Joint:	YES
Remarks:	SOIL VISIBLE. ROOTS GROWING IN THE TAP. LOOKS TO BE 85% PLUGGED

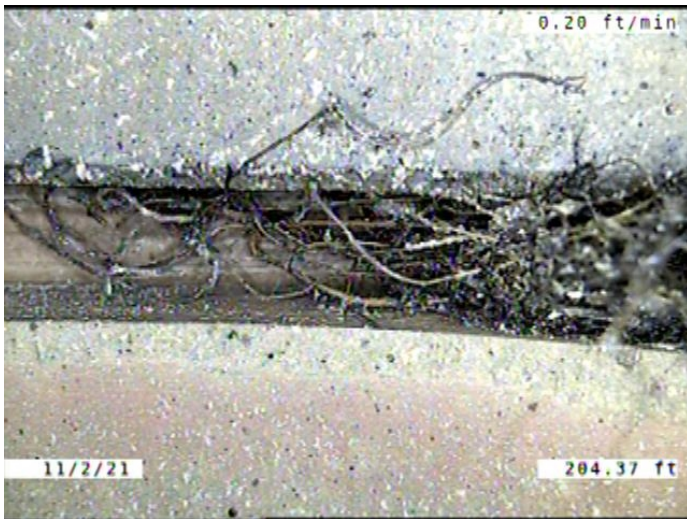
Code:	RFJ
Description:	Roots Fine Joint
Distance (ft):	204.3
Structural Grade:	0
O&M Grade:	1
Clock Start/From:	1
Clock To:	3
1st Value:	
2nd Value:	
Value Percent:	
Continuous Index:	
Within 8" of Joint:	YES
Remarks:

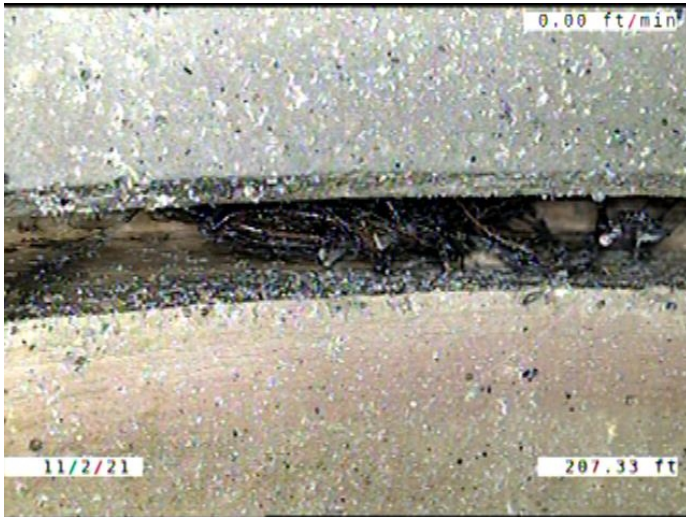
Code: **RFJ**
Description: **Roots Fine Joint**

Distance (ft): **207.3**
Structural Grade: **0**
O&M Grade: **1**
Clock Start/From: **9**
Clock To: **10**
1st Value:
2nd Value:
Value Percent:
Continuous Index:
Within 8" of Joint: **YES**
Remarks:

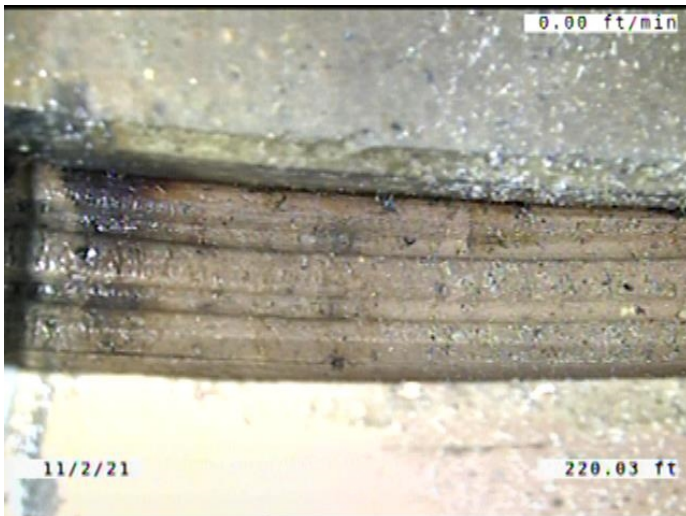
Code: **JAL**
Description: **Joint Angular Large**

Distance (ft): **220.0**
Structural Grade: **4**
O&M Grade: **0**
Clock Start/From:
Clock To:
1st Value:
2nd Value:
Value Percent:
Continuous Index:
Within 8" of Joint: **NO**
Remarks:

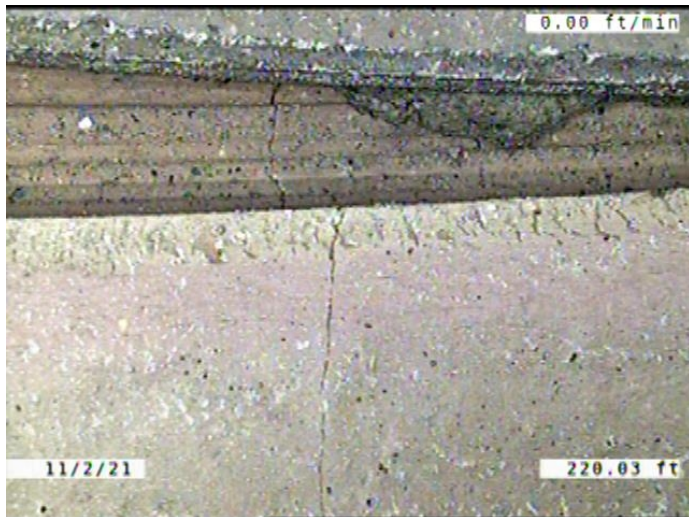
Code: **CM**
 Description: **Crack Multiple**

Distance (ft): **220.0**
 Structural Grade: **3**
 O&M Grade: **0**
 Clock Start/From: **10**
 Clock To: **12**
 1st Value:
 2nd Value:
 Value Percent:
 Continuous Index:
 Within 8" of Joint: **YES**
 Remarks:

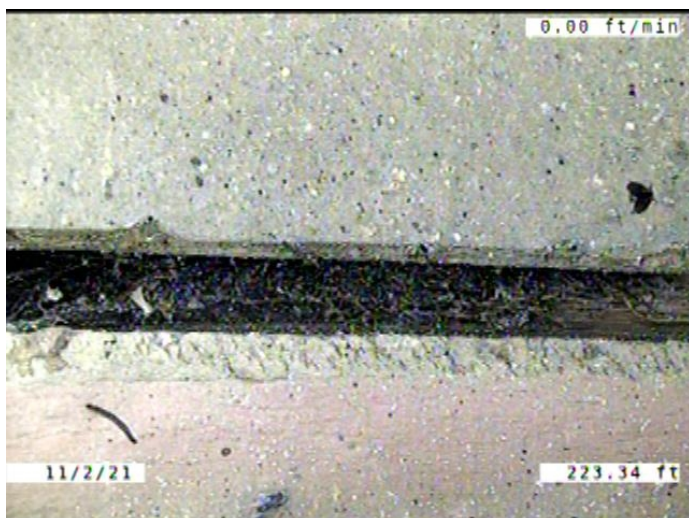
Code: **RFJ**
 Description: **Roots Fine Joint**

Distance (ft): **223.3**
 Structural Grade: **0**
 O&M Grade: **1**
 Clock Start/From: **9**
 Clock To: **11**
 1st Value:
 2nd Value:
 Value Percent:
 Continuous Index:
 Within 8" of Joint: **YES**
 Remarks:

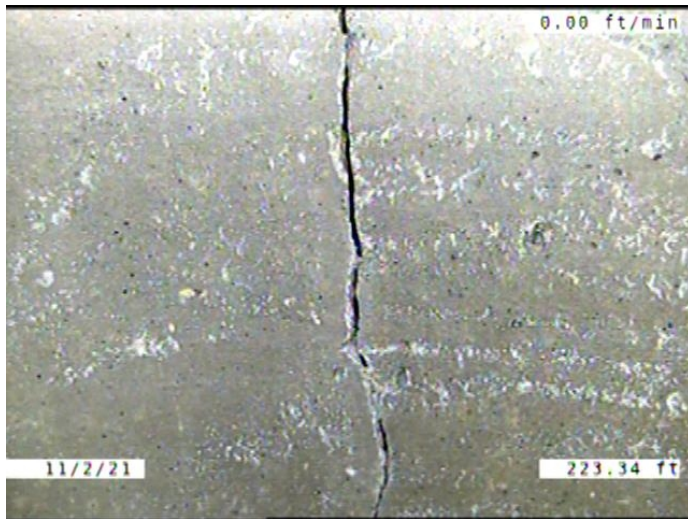
Code: **FS**
 Description: **Fracture Spiral**

Distance (ft): **223.3**
 Structural Grade: **3**
 O&M Grade: **0**
 Clock Start/From: **1**
 Clock To: **4**
 1st Value:
 2nd Value:
 Value Percent:
 Continuous Index:
 Within 8" of Joint: **NO**
 Remarks:

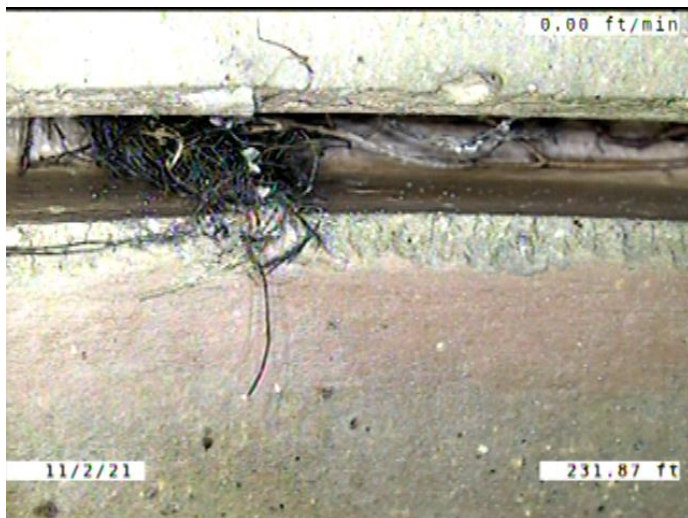
Code: **RFJ**
 Description: **Roots Fine Joint**

Distance (ft): **231.9**
 Structural Grade: **0**
 O&M Grade: **1**
 Clock Start/From: **9**
 Clock To: **10**
 1st Value:
 2nd Value:
 Value Percent:
 Continuous Index:
 Within 8" of Joint: **YES**
 Remarks:

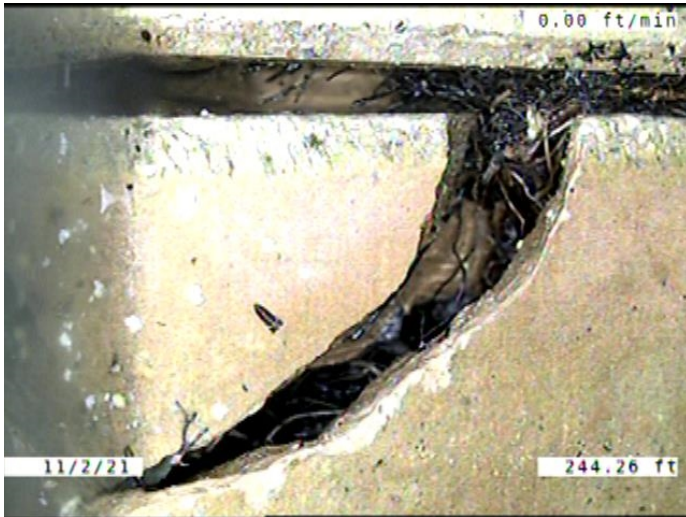
Code: **BSV**
 Description: **Broken Soil Visible**

Distance (ft): **244.3**
 Structural Grade: **5**
 O&M Grade: **0**
 Clock Start/From: **8**
 Clock To: **9**
 1st Value:
 2nd Value:
 Value Percent:
 Continuous Index:
 Within 8" of Joint: **YES**
 Remarks:

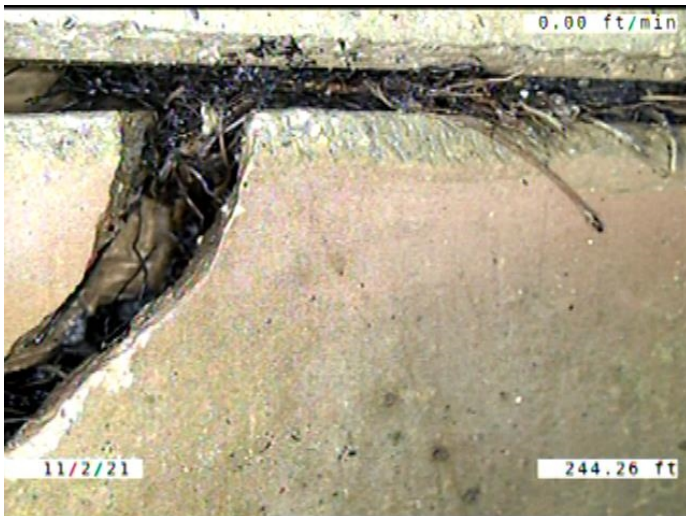
Code: **RFJ**
 Description: **Roots Fine Joint**

Distance (ft): **244.3**
 Structural Grade: **0**
 O&M Grade: **1**
 Clock Start/From: **9**
 Clock To: **3**
 1st Value:
 2nd Value:
 Value Percent:
 Continuous Index:
 Within 8" of Joint: **YES**
 Remarks:

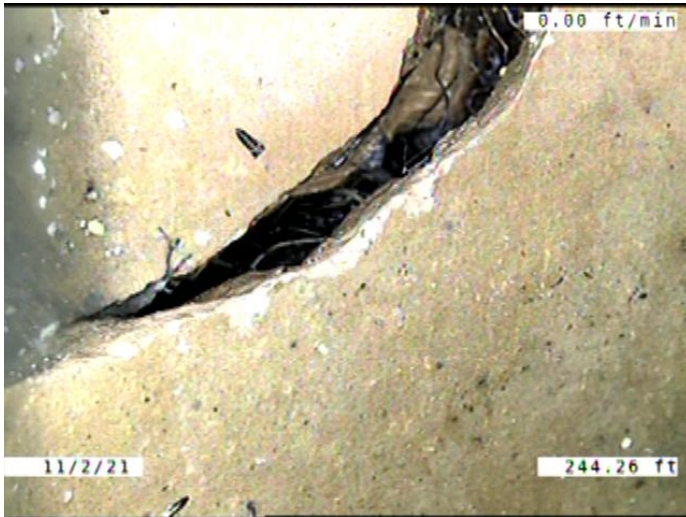
Code: **RFB**
 Description: **Roots Fine Barrel**

Distance (ft): **244.3**
 Structural Grade: **0**
 O&M Grade: **2**
 Clock Start/From: **8**
 Clock To: **9**
 1st Value:
 2nd Value:
 Value Percent:
 Continuous Index:
 Within 8" of Joint: **NO**
 Remarks:

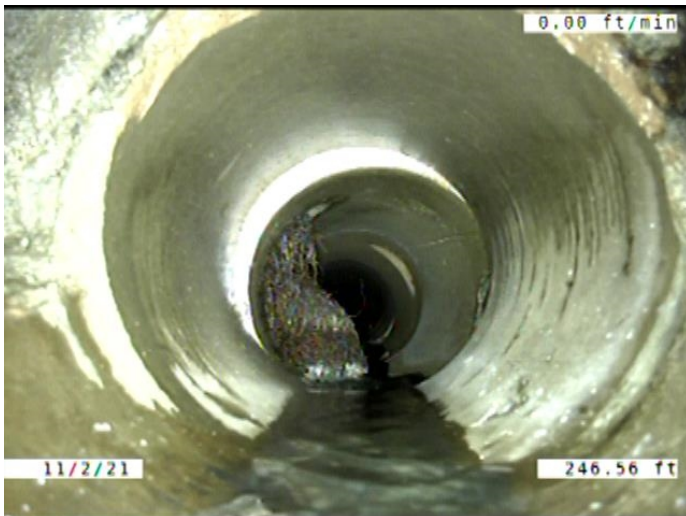
Code: **DSF**
 Description: **Deposits Settled Fine**

Distance (ft): **246.6**
 Structural Grade: **0**
 O&M Grade: **2**
 Clock Start/From: **5**
 Clock To: **7**
 1st Value:
 2nd Value:
 Value Percent: **5.000**
 Continuous Index: **F03**
 Within 8" of Joint: **YES**
 Remarks:
