Profile/Photo Observation Report

| Street: | S COLORADO ST & W 2ND ST | Flow Control: | Not Controlled |
| City: | Hobart, IN | Year Renewed: | |
| Purpose: | Routine Assessment | Dia/Height: | 10" |

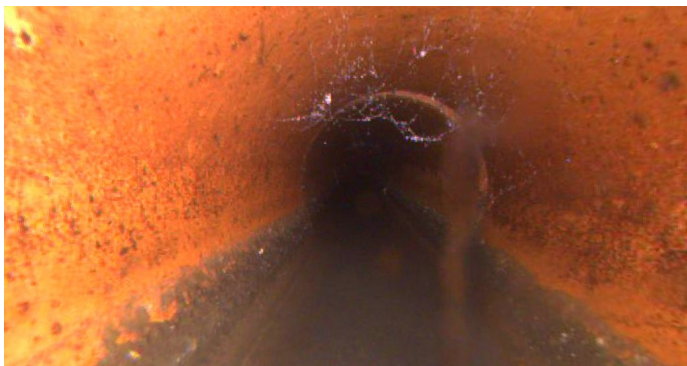
Code: **AMH**
 Description: **Manhole**

Distance (ft): **.0**
 Structural Grade: **0**
 O&M Grade: **0**
 Clock Start/From:
 Clock To:
 1st Value:
 2nd Value:
 Value Percent:
 Continuous Index:
 Within 8" of Joint: **NO**
 Remarks: **M-505-061**

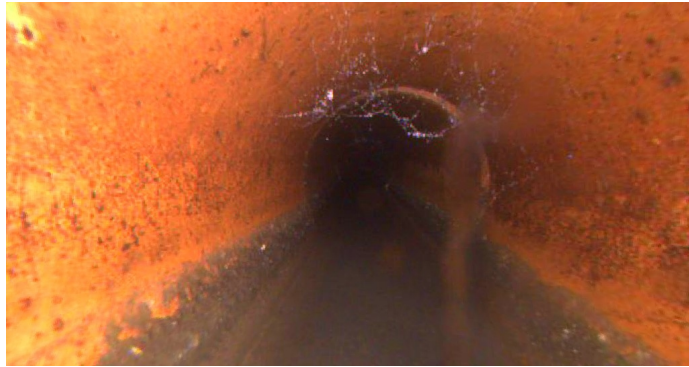
Code: **MWL**
Description: **Water Level**

Distance (ft): **.0**
Structural Grade: **0**
O&M Grade: **0**
Clock Start/From:
Clock To:
1st Value:
2nd Value:
Value Percent: **10.000**
Continuous Index:
Within 8" of Joint: **NO**
Remarks:

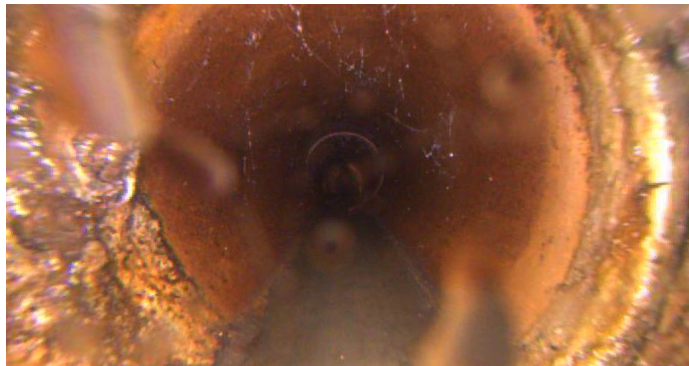
Code: **DAZ**
Description: **Deposits Attached Other**

Distance (ft): **29.3**
Structural Grade: **0**
O&M Grade: **2**
Clock Start/From: **7**
Clock To: **5**
1st Value:
2nd Value:
Value Percent: **5.000**
Continuous Index:
Within 8" of Joint: **YES**
Remarks:

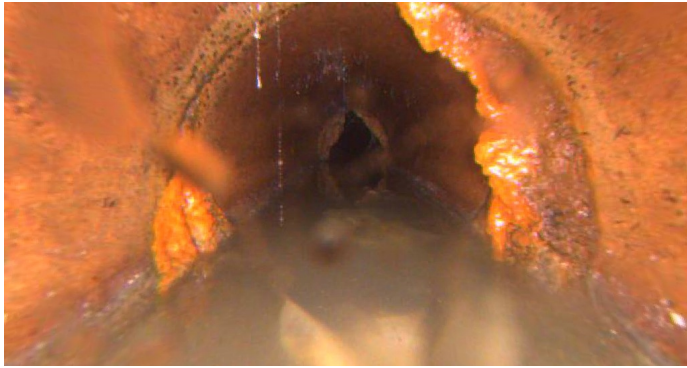
Code: **DAZ**
Description: **Deposits Attached Other**

Distance (ft): **35.0**
Structural Grade: **0**
O&M Grade: **2**
Clock Start/From: **7**
Clock To: **5**
1st Value:
2nd Value:
Value Percent: **5.000**
Continuous Index: **S01**
Within 8" of Joint: **NO**
Remarks:

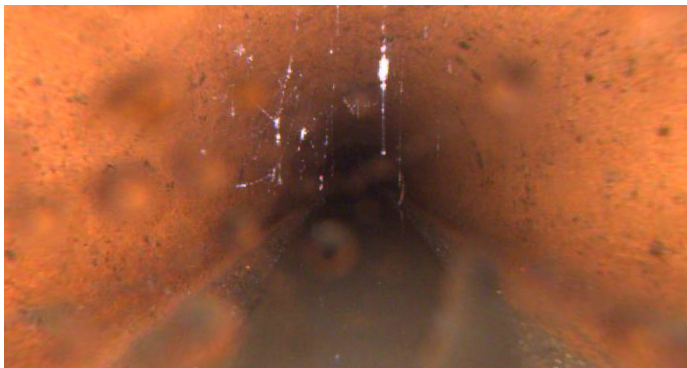
Code: **DAZ**
Description: **Deposits Attached Other**

Distance (ft): **69.1**
Structural Grade: **0**
O&M Grade: **2**
Clock Start/From: **7**
Clock To: **5**
1st Value:
2nd Value:
Value Percent: **5.000**
Continuous Index: **F01**
Within 8" of Joint: **NO**
Remarks:

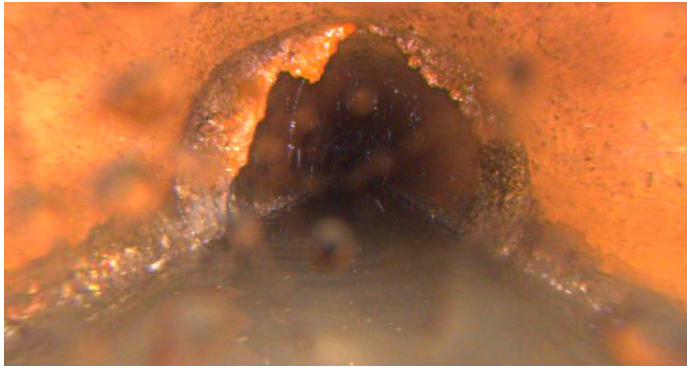
| Code: | DAZ |
| Description: | Deposits Attached Other |
| Distance (ft): | 83.2 |
| O&M Grade: | 2 |
| Clock Start/From: | 7 |
| Clock To: | 5 |
| Value Percent: | 5.000 |
| Within 8" of Joint: | YES |

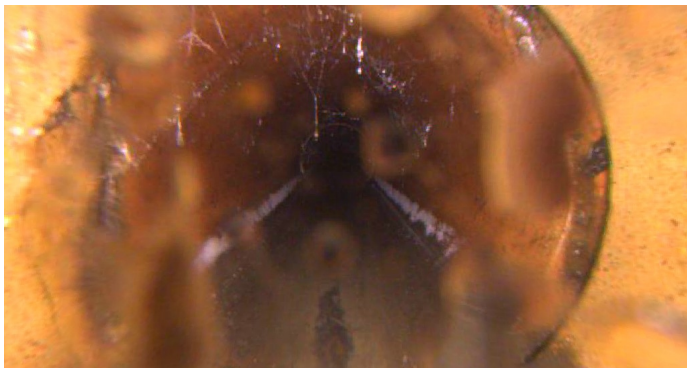
| Code: | DAZ |
| Description: | Deposits Attached Other |
| Distance (ft): | 114.7 |
| O&M Grade: | 2 |
| Clock Start/From: | 7 |
| Clock To: | 5 |
| Value Percent: | 5.000 |
| Within 8" of Joint: | YES |

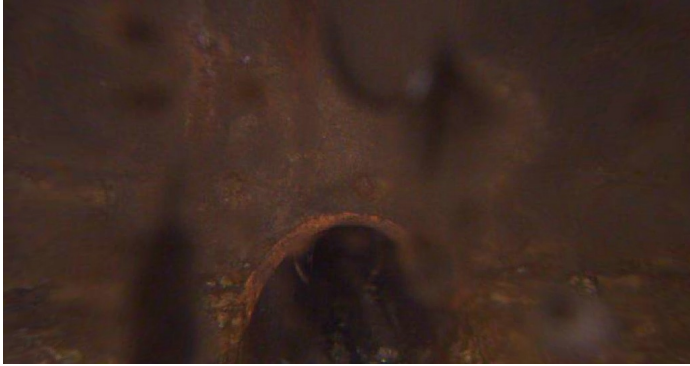
| Code: | AMH |
| Description: | Manhole |
| Distance (ft): | 149.6 |
| Remarks: | M-505-060 |
