## Profile/Photo Observation Report

Street:	<b>FOXCROFT STREET</b>	Flow Control:	<b>Not Controlled</b>
City:	<b>Hobart, IN</b>	Year Renewed:	
Location:	<b>Light Highway</b>	Tape/Media #:	
Purpose:	<b>Routine Assessment</b>	Dia/Height:	<b>10"</b>
Use:	<b>Sanitary</b>	Material:	<b>VCP</b>
Drain Area:	<b>NA</b>	Lining:	
Category:	<b>NA</b>		
Comment:	<b>Flow direction wrong</b>

Location Details:		Direction of Survey:	<b>Upstream</b>
US MH:	<b>M-505-060</b>	DS MH:	<b>M-505-061</b>
		Total Length Surveyed (ft):	<b>149.6</b>

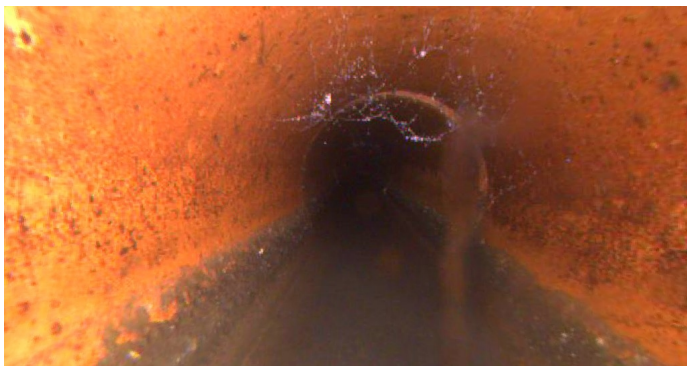
Code: **AMH**  
 Description: **Manhole**

Distance (ft): **.0**  
 Structural Grade: **0**  
 O&M Grade: **0**  
 Clock Start/From:  
 Clock To:  
 1st Value:  
 2nd Value:  
 Value Percent:  
 Continuous Index:  
 Within 8" of Joint: **NO**  
 Remarks: **M-505-061**

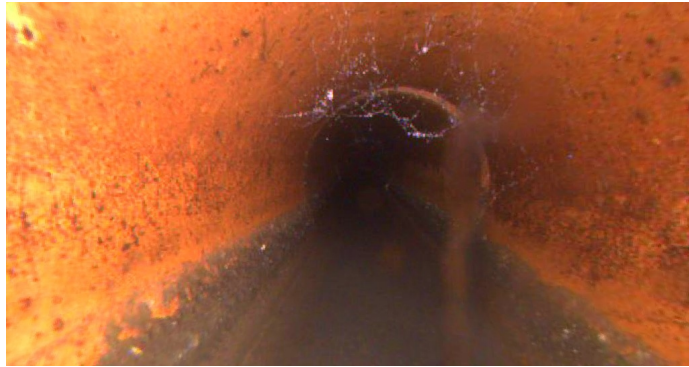
Code: **MWL**  
Description: **Water Level**

Distance (ft): **.0**  
Structural Grade: **0**  
O&M Grade: **0**  
Clock Start/From:  
Clock To:  
1st Value:  
2nd Value:  
Value Percent: **10.000**  
Continuous Index:  
Within 8" of Joint: **NO**  
Remarks:

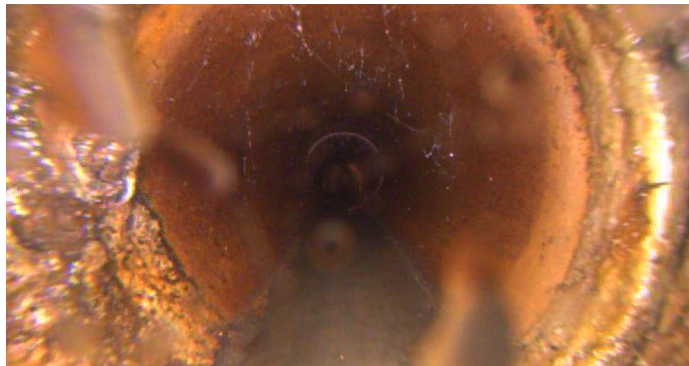
Code: **DAZ**  
Description: **Deposits Attached Other**

Distance (ft): **29.3**  
Structural Grade: **0**  
O&M Grade: **2**  
Clock Start/From: **7**  
Clock To: **5**  
1st Value:  
2nd Value:  
Value Percent: **5.000**  
Continuous Index:  
Within 8" of Joint: **YES**  
Remarks:

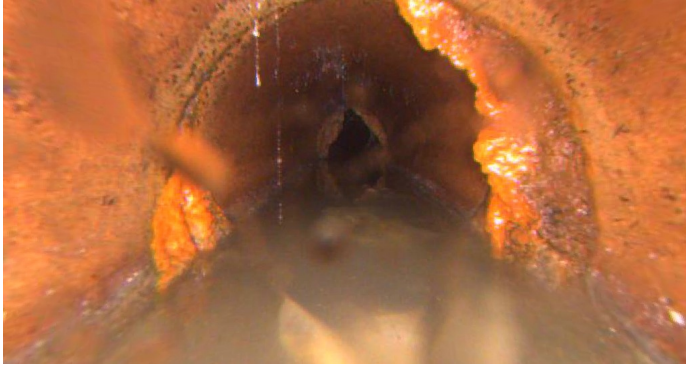
Code: **DAZ**  
Description: **Deposits Attached Other**

Distance (ft): **35.0**  
Structural Grade: **0**  
O&M Grade: **2**  
Clock Start/From: **7**  
Clock To: **5**  
1st Value:  
2nd Value:  
Value Percent: **5.000**  
Continuous Index: **S01**  
Within 8" of Joint: **NO**  
Remarks:

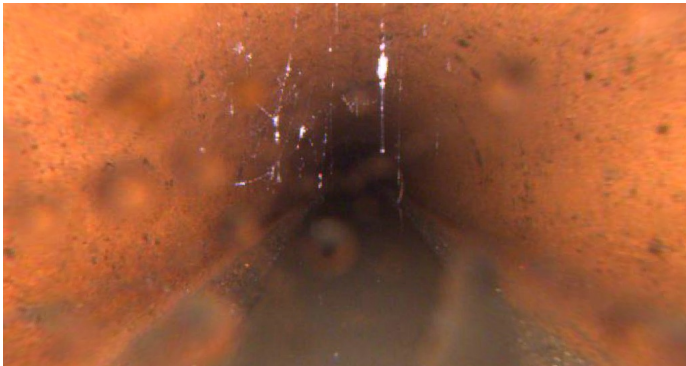
Code: **DAZ**  
Description: **Deposits Attached Other**

Distance (ft): **69.1**  
Structural Grade: **0**  
O&M Grade: **2**  
Clock Start/From: **7**  
Clock To: **5**  
1st Value:  
2nd Value:  
Value Percent: **5.000**  
Continuous Index: **F01**  
Within 8" of Joint: **NO**  
Remarks:

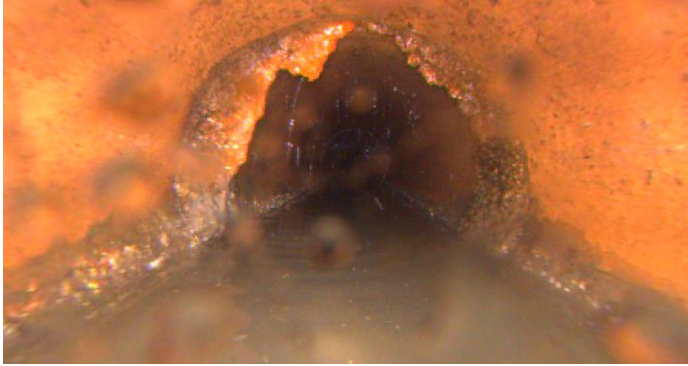
Code: **DAZ**  
Description: **Deposits Attached Other**

Distance (ft): **83.2**  
Structural Grade: **0**  
O&M Grade: **2**  
Clock Start/From: **7**  
Clock To: **5**  
1st Value:  
2nd Value:  
Value Percent: **5.000**  
Continuous Index: **S02**  
Within 8" of Joint: **YES**  
Remarks:

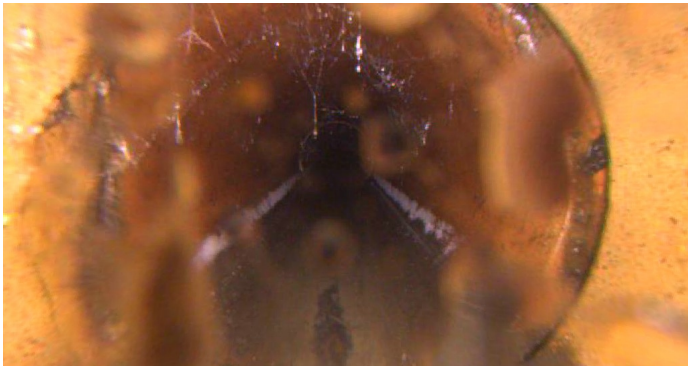
Code: **DAZ**  
Description: **Deposits Attached Other**

Distance (ft): **114.7**  
Structural Grade: **0**  
O&M Grade: **2**  
Clock Start/From: **7**  
Clock To: **5**  
1st Value:  
2nd Value:  
Value Percent: **5.000**  
Continuous Index: **F02**  
Within 8" of Joint: **YES**  
Remarks:

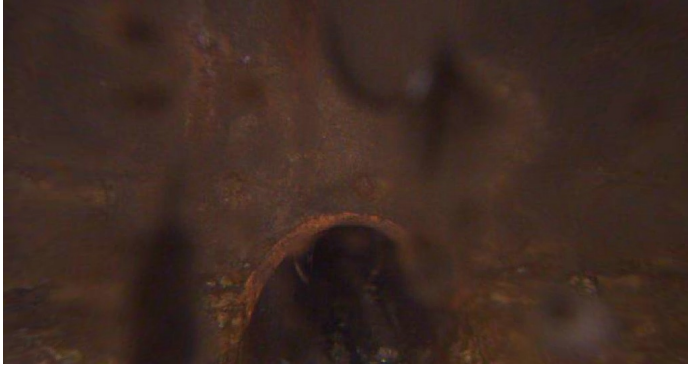
Code:	<b>AMH</b>
Description:	<b>Manhole</b>
Distance (ft):	<b>149.6</b>
Structural Grade:	<b>0</b>
O&M Grade:	<b>0</b>
Clock Start/From:	
Clock To:	
1st Value:	
2nd Value:	
Value Percent:	
Continuous Index:	
Within 8" of Joint:	<b>NO</b>
Remarks:	<b>M-505-060</b>
