Profile/Photo Observation Report

Street:	2ND CT	Flow Control:	Not Controlled
City:	Hobart, IN	Year Renewed:	
Location:	Light Highway	Tape/Media #:	
Purpose:	Routine Assessment	Dia/Height:	8"
Use:	Sanitary	Material:	VCP
Drain Area:	NA	Lining:	
Category:	NA		
Comment:	R_M at 27 ft debris

Location Details:		Direction of Survey:	Downstream
US MH:	M-505-061	DS MH:	M-505-062
		Total Length Surveyed (ft):	28.8

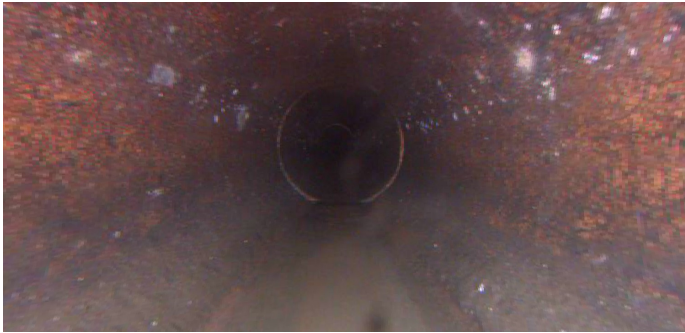
Code:	MWL
Description:	Water Level

Distance (ft):	.0
Structural Grade:	0
O&M Grade:	0
Clock Start/From:	
Clock To:	
1st Value:	
2nd Value:	
Value Percent:	5.000
Continuous Index:	
Within 8" of Joint:	NO
Remarks:

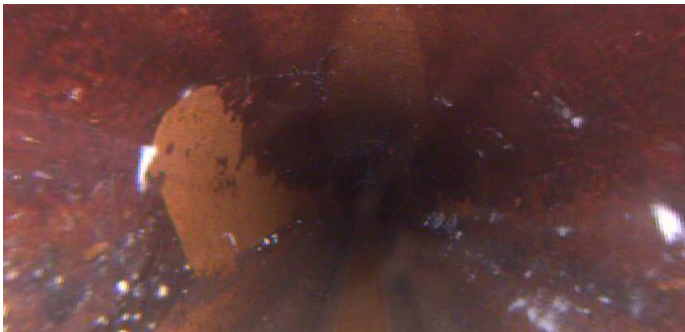
Code:	CC
Description:	Crack Circumferential

Distance (ft):	8.1
Structural Grade:	1
O&M Grade:	0
Clock Start/From:	7
Clock To:	12
1st Value:	
2nd Value:	
Value Percent:	
Continuous Index:	
Within 8" of Joint:	
Remarks:

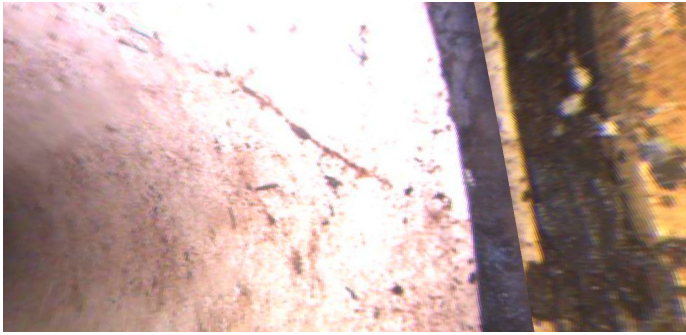
Code: **MMC**
Description: **Material Change**

Distance (ft): **18.4**
Structural Grade: **0**
O&M Grade: **0**
Clock Start/From:
Clock To:
1st Value:
2nd Value:
Value Percent:
Continuous Index:
Within 8" of Joint: **NO**
Remarks: **pvc**

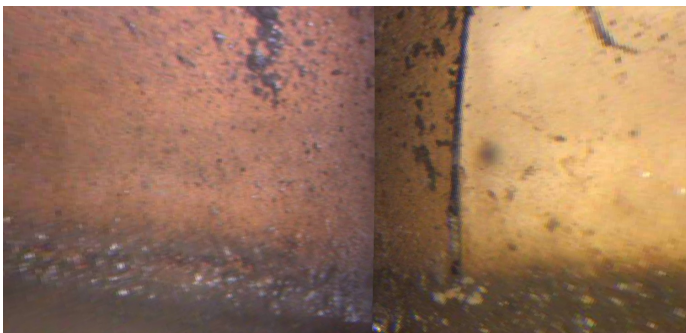
Code: **MMC**
Description: **Material Change**

Distance (ft): **22.8**
Structural Grade: **0**
O&M Grade: **0**
Clock Start/From:
Clock To:
1st Value:
2nd Value:
Value Percent:
Continuous Index:
Within 8" of Joint: **NO**
Remarks: **vcp**

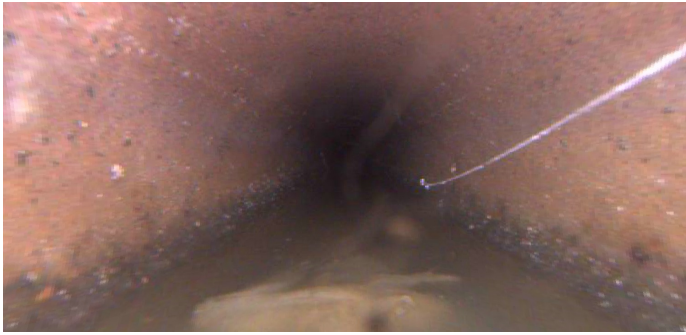
Code: **DSZ**
Description: **Deposits Settled Other**

Distance (ft): **27.4**
Structural Grade: **0**
O&M Grade: **2**
Clock Start/From: **6**
Clock To:
1st Value:
2nd Value:
Value Percent: **5.000**
Continuous Index:
Within 8" of Joint: **NO**
Remarks: **tissue**

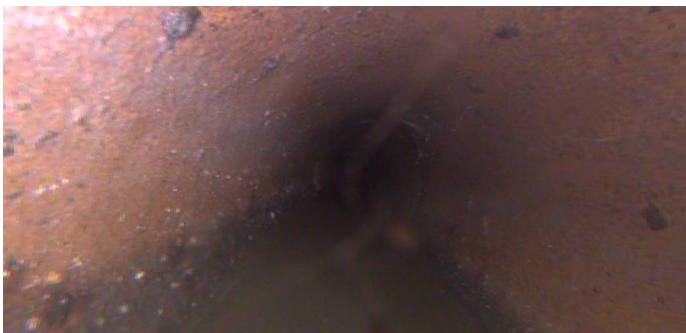
Code: **MSA**
Description: **Abandoned Survey**

Distance (ft): **28.8**
Structural Grade: **0**
O&M Grade: **0**
Clock Start/From:
Clock To:
1st Value:
2nd Value:
Value Percent:
Continuous Index:
Within 8" of Joint: **NO**
Remarks: **no blockage**
