## Profile/Photo Observation Report

Street:	<b>FOXCROFT STREET</b>	Flow Control:	<b>Not Controlled</b>
City:	<b>Hobart, IN</b>	Year Renewed:	
Location:	<b>Light Highway</b>	Tape/Media #:	
Purpose:	<b>Routine Assessment</b>	Dia/Height:	<b>8"</b>
Use:	<b>Sanitary</b>	Material:	<b>VCP</b>
Drain Area:	<b>NA</b>	Lining:	
Category:	<b>NA</b>		
Comment:	<b>R_M at 27 ft debris</b>

Location Details:		Direction of Survey:	<b>Downstream</b>
US MH:	<b>M-505-061</b>	DS MH:	<b>M-505-062</b>
		Total Length Surveyed (ft):	<b>28.8</b>

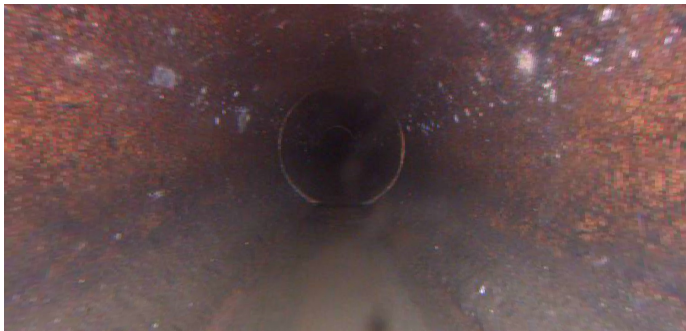
Code: **AMH**  
Description: **Manhole**

Distance (ft): **.0**  
Structural Grade: **0**  
O&M Grade: **0**  
Clock Start/From:  
Clock To:  
1st Value:  
2nd Value:  
Value Percent:  
Continuous Index:  
Within 8" of Joint: **NO**  
Remarks: **M-505-061**

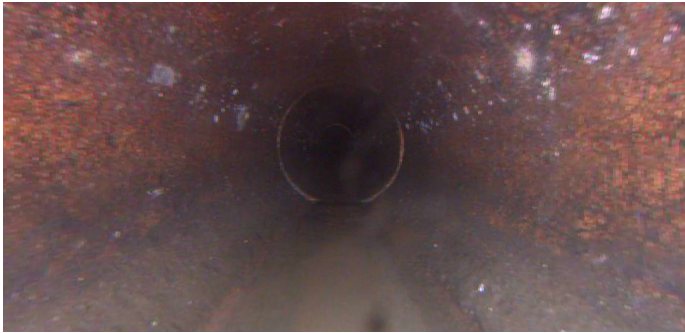
Code:	<b>MWL</b>
Description:	<b>Water Level</b>

Distance (ft):	<b>.0</b>
Structural Grade:	<b>0</b>
O&M Grade:	<b>0</b>
Clock Start/From:	
Clock To:	
1st Value:	
2nd Value:	
Value Percent:	<b>5.000</b>
Continuous Index:	
Within 8" of Joint:	<b>NO</b>
Remarks:

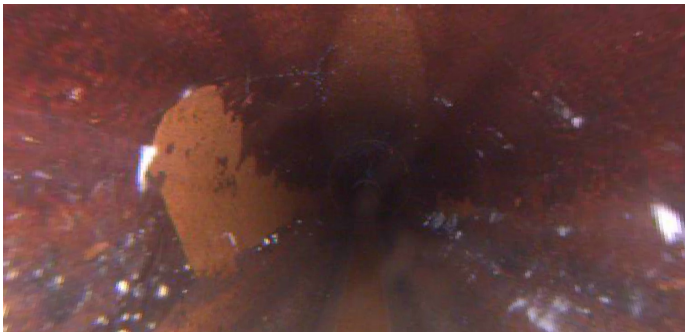
Code:	<b>CC</b>
Description:	<b>Crack Circumferential</b>

Distance (ft):	<b>8.1</b>
Structural Grade:	<b>1</b>
O&M Grade:	<b>0</b>
Clock Start/From:	<b>7</b>
Clock To:	<b>12</b>
1st Value:	
2nd Value:	
Value Percent:	
Continuous Index:	
Within 8" of Joint:	
Remarks:

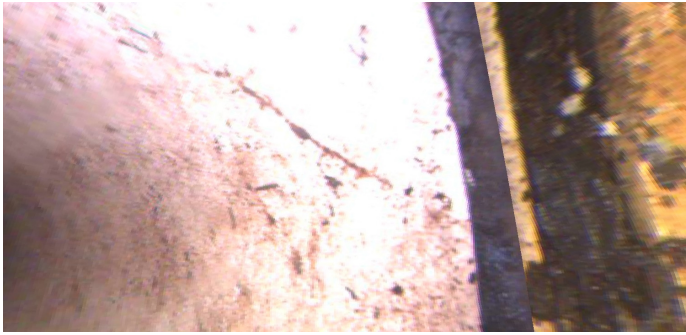
Code: **MMC**  
Description: **Material Change**

Distance (ft): **18.4**  
Structural Grade: **0**  
O&M Grade: **0**  
Clock Start/From:  
Clock To:  
1st Value:  
2nd Value:  
Value Percent:  
Continuous Index:  
Within 8" of Joint: **NO**  
Remarks: **pvc**

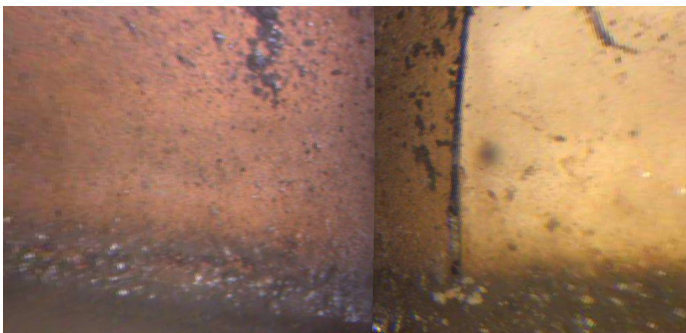
Code: **MMC**  
Description: **Material Change**

Distance (ft): **22.8**  
Structural Grade: **0**  
O&M Grade: **0**  
Clock Start/From:  
Clock To:  
1st Value:  
2nd Value:  
Value Percent:  
Continuous Index:  
Within 8" of Joint: **NO**  
Remarks: **vcp**

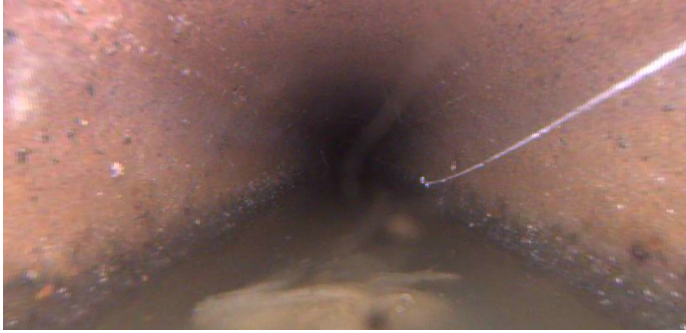
Code: **DSZ**  
Description: **Deposits Settled Other**

Distance (ft): **27.4**  
Structural Grade: **0**  
O&M Grade: **2**  
Clock Start/From: **6**  
Clock To:  
1st Value:  
2nd Value:  
Value Percent: **5.000**  
Continuous Index:  
Within 8" of Joint: **NO**  
Remarks: **tissue**

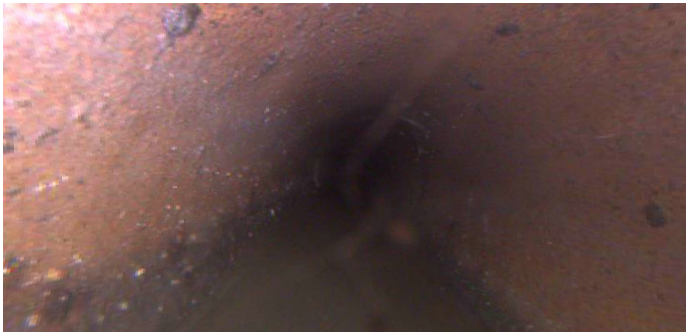
Code: **MSA**  
Description: **Abandoned Survey**

Distance (ft): **28.8**  
Structural Grade: **0**  
O&M Grade: **0**  
Clock Start/From:  
Clock To:  
1st Value:  
2nd Value:  
Value Percent:  
Continuous Index:  
Within 8" of Joint: **NO**  
Remarks: **no blockage**
