Profile/Photo Observation Report

Street:	FOXCROFT STREET	Flow Control:	Not Controlled
City:	Hobart, IN	Year Renewed:	
Location:	Light Highway	Tape/Media #:	
Purpose:	Routine Assessment	Dia/Height:	8"
Use:	Sanitary	Material:	VCP
Drain Area:	NA	Lining:	
Category:	NA		
Comment:	P_C at 27 ft debris		
Location Details:		Direction of Survey:	Upstream
US MH:	M-505-061	DS MH:	M-505-062
		Total Length Surveyed (ft):	28.3

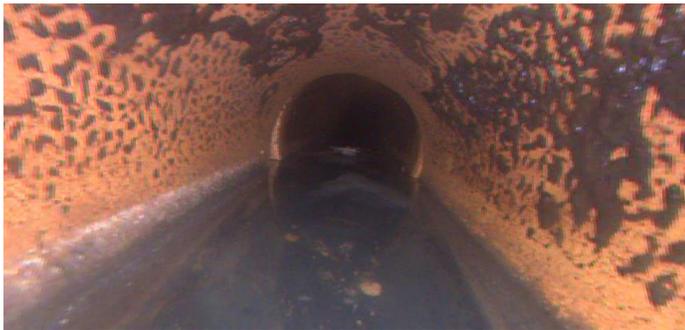
Code: **AMH**
Description: **Manhole**
Distance (ft): **.0**
Structural Grade: **0**
O&M Grade: **0**
Clock Start/From:
Clock To:
1st Value:
2nd Value:
Value Percent:
Continuous Index:
Within 8" of Joint: **NO**
Remarks: **M-505-062**

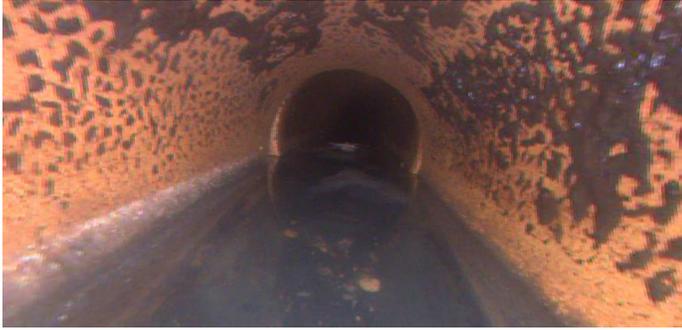
Code: **MWL**
Description: **Water Level**

Distance (ft): **.0**
Structural Grade: **0**
O&M Grade: **0**
Clock Start/From:
Clock To:
1st Value:
2nd Value:
Value Percent: **5.000**
Continuous Index:
Within 8" of Joint: **NO**
Remarks:

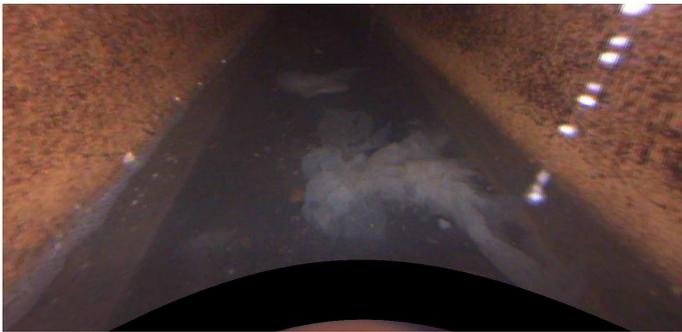
Code: **DSZ**
Description: **Deposits Settled Other**

Distance (ft): **4.3**
Structural Grade: **0**
O&M Grade: **2**
Clock Start/From: **6**
Clock To:
1st Value:
2nd Value:
Value Percent: **5.000**
Continuous Index: **S01**
Within 8" of Joint: **NO**
Remarks: **tissue**

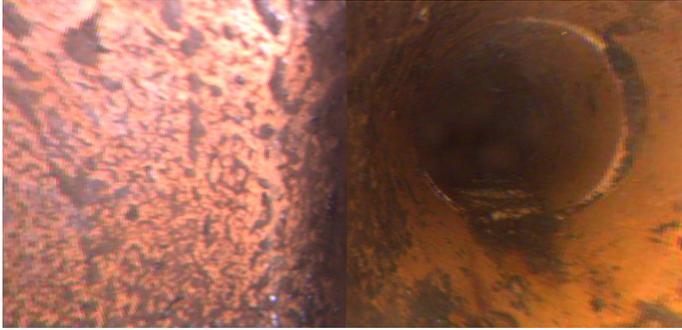
Code: **TF**
Description: **Tap Factory**

Distance (ft): **15.2**
Structural Grade: **0**
O&M Grade: **0**
Clock Start/From: **2**
Clock To:
1st Value: **4.000**
2nd Value:
Value Percent:
Continuous Index:
Within 8" of Joint: **YES**
Remarks:

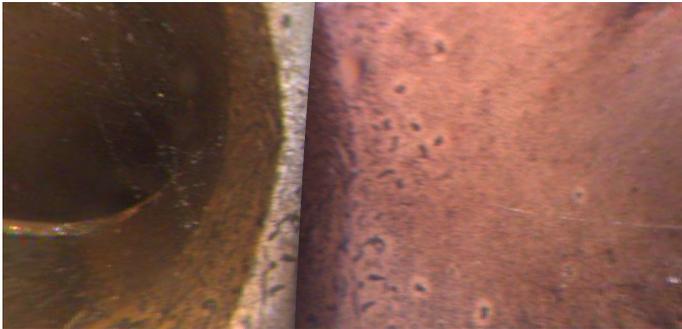
Code: **TF**
Description: **Tap Factory**

Distance (ft): **18.3**
Structural Grade: **0**
O&M Grade: **0**
Clock Start/From: **10**
Clock To:
1st Value: **4.000**
2nd Value:
Value Percent:
Continuous Index:
Within 8" of Joint: **YES**
Remarks:

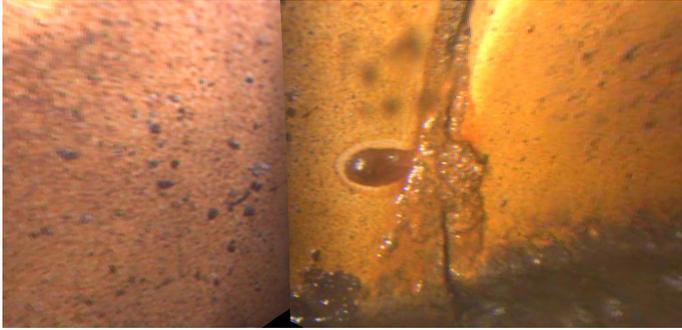
Code: **DAE**
Description: **Deposits Attached Encrustation**

Distance (ft): **24.5**
Structural Grade: **0**
O&M Grade: **2**
Clock Start/From: **4**
Clock To:
1st Value:
2nd Value:
Value Percent: **5.000**
Continuous Index:
Within 8" of Joint: **YES**
Remarks:

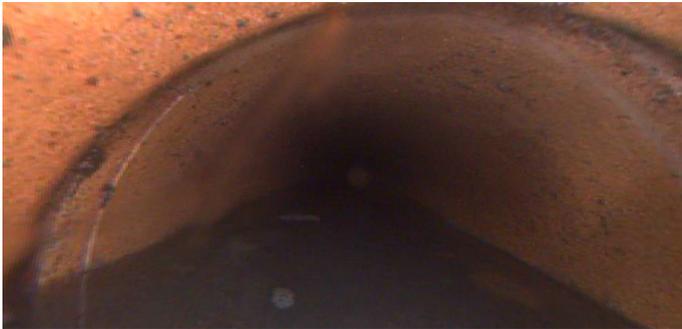
Code: **MWL**
Description: **Water Level**

Distance (ft): **28.3**
Structural Grade: **0**
O&M Grade: **0**
Clock Start/From:
Clock To:
1st Value:
2nd Value:
Value Percent: **50.000**
Continuous Index:
Within 8" of Joint: **NO**
Remarks:

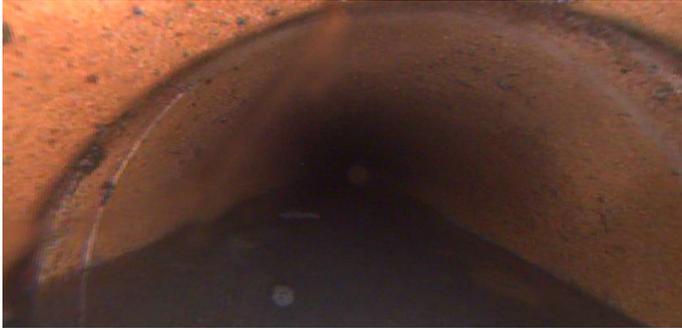
Code: **MSA**
Description: **Abandoned Survey**

Distance (ft): **28.3**
Structural Grade: **0**
O&M Grade: **0**
Clock Start/From:
Clock To:
1st Value:
2nd Value:
Value Percent:
Continuous Index:
Within 8" of Joint: **NO**
Remarks: **no blockage**

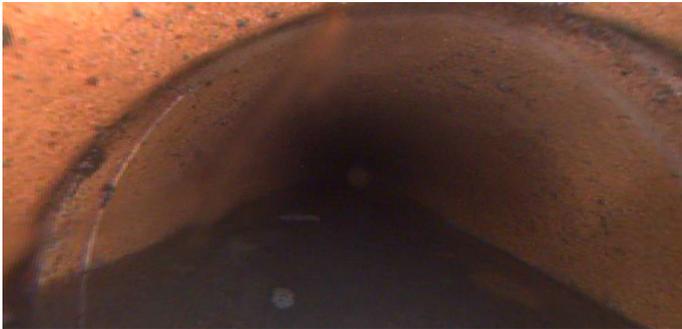
Code: **DSZ**
Description: **Deposits Settled Other**

Distance (ft): **28.3**
Structural Grade: **0**
O&M Grade: **2**
Clock Start/From: **6**
Clock To:
1st Value:
2nd Value:
Value Percent: **5.000**
Continuous Index: **F01**
Within 8" of Joint: **NO**
Remarks: **tissue**
