Profile/Photo Observation Report

Date:	11/03/2021	Weather:		Coding:	PACP 7.0
Pipe Length (ft):	166.0	Owner:	City of Hobart	Pre Clean:	Heavy Cleaning
P.O.#:	YES502259	Surveyor:	S. Bucklin	PSR:	P-505-062-061
Customer:	City of Hobart	Clean Date:	10/28/2021	Shape:	C

Street:	2nd Court	Flow Control:	Not Controlled
City:	Hobart, IN	Year Renewed:	
Location:	Local rural streets with light traffic, t	Tape/Media #:	
Purpose:	Routine Assessment	Dia/Height:	8"
Use:	Sanitary Sewage Pipe	Material:	CT
Drain Area:		Lining:	None
Category:	NA		
Comment:			
Location Details:		Direction of Survey:	Downstream
US MH:	M-505-061	DS MH:	M-505-062
		Total Length Surveyed (ft):	64.4

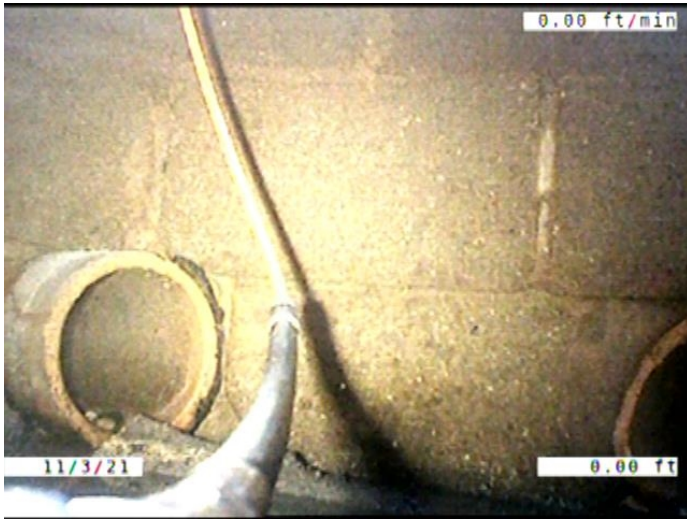
Code: **AMH**
Description: **Manhole**

Distance (ft): **.0**
Structural Grade: **0**
O&M Grade: **0**
Clock Start/From:
Clock To:
1st Value:
2nd Value:
Value Percent:
Continuous Index:
Within 8" of Joint: **NO**
Remarks: **M-505-061**

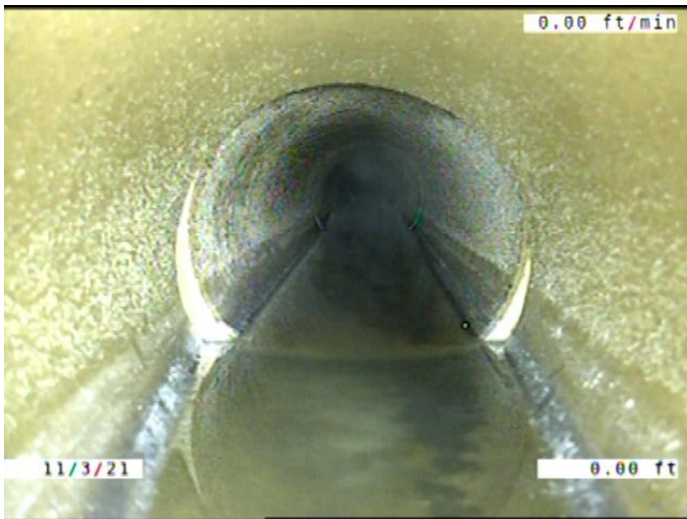
Code: **MWL**
Description: **Miscellaneous Water Level**

Distance (ft): **.0**
Structural Grade: **0**
O&M Grade: **0**
Clock Start/From:
Clock To:
1st Value:
2nd Value:
Value Percent: **5.000**
Continuous Index:
Within 8" of Joint: **NO**
Remarks:

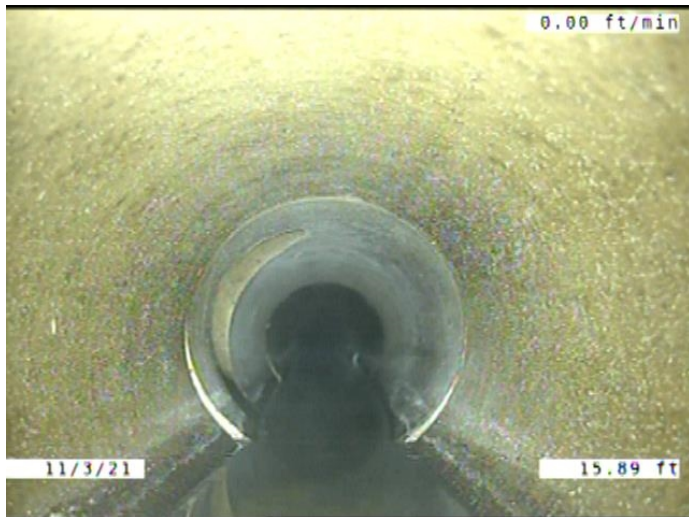
Code: **MWLS**
 Description: **Miscellaneous Water Level Sag**

Distance (ft): **15.9**
 Structural Grade: **2**
 O&M Grade: **0**
 Clock Start/From:
 Clock To:
 1st Value:
 2nd Value:
 Value Percent: **5.000**
 Continuous Index: **F01**
 Within 8" of Joint: **NO**
 Remarks:

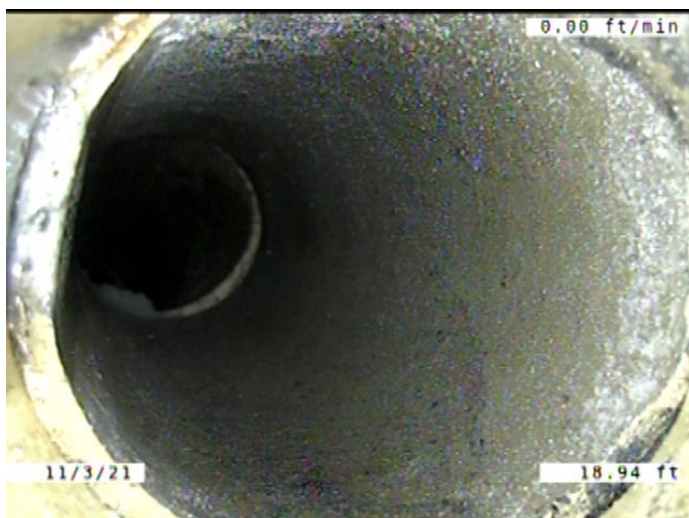
Code: **TF**
 Description: **Tap Factory**

Distance (ft): **18.9**
 Structural Grade: **0**
 O&M Grade: **0**
 Clock Start/From: **10**
 Clock To:
 1st Value: **4.000**
 2nd Value:
 Value Percent:
 Continuous Index:
 Within 8" of Joint: **YES**
 Remarks:

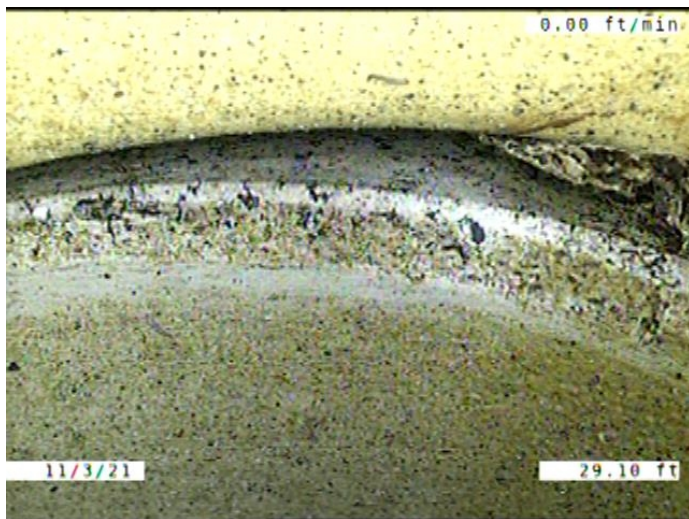
Code: **DAE**
 Description: **Deposits Attached Encrustation**

Distance (ft): **29.1**
 Structural Grade: **0**
 O&M Grade: **2**
 Clock Start/From: **1**
 Clock To: **2**
 1st Value:
 2nd Value:
 Value Percent: **5.000**
 Continuous Index:
 Within 8" of Joint: **YES**
 Remarks:

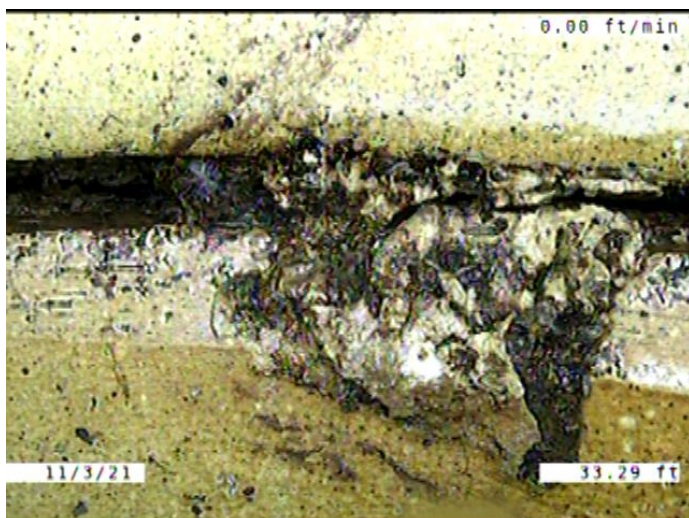
Code: **DAE**
 Description: **Deposits Attached Encrustation**

Distance (ft): **33.3**
 Structural Grade: **0**
 O&M Grade: **2**
 Clock Start/From: **2**
 Clock To: **3**
 1st Value:
 2nd Value:
 Value Percent: **5.000**
 Continuous Index:
 Within 8" of Joint: **YES**
 Remarks:

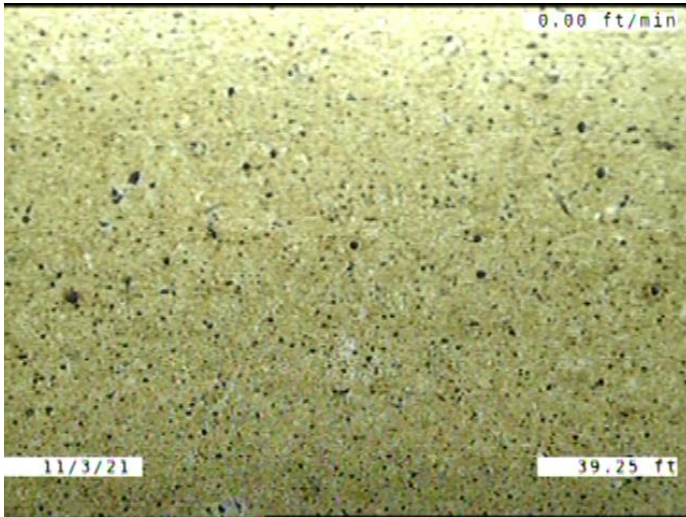
Code: **MWL**
Description: **Miscellaneous Water Level**

Distance (ft): **39.2**
Structural Grade: **0**
O&M Grade: **0**
Clock Start/From:
Clock To:
1st Value:
2nd Value:
Value Percent: **30.000**
Continuous Index:
Within 8" of Joint: **NO**
Remarks:

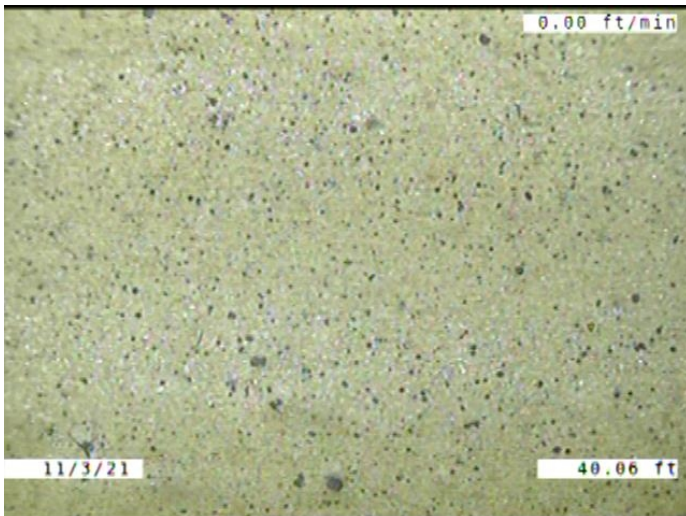
Code: **MCU**
Description: **Miscellaneous Camera Underwater**

Distance (ft): **40.1**
Structural Grade: **0**
O&M Grade: **4**
Clock Start/From:
Clock To:
1st Value:
2nd Value:
Value Percent:
Continuous Index: **S04**
Within 8" of Joint: **NO**
Remarks:

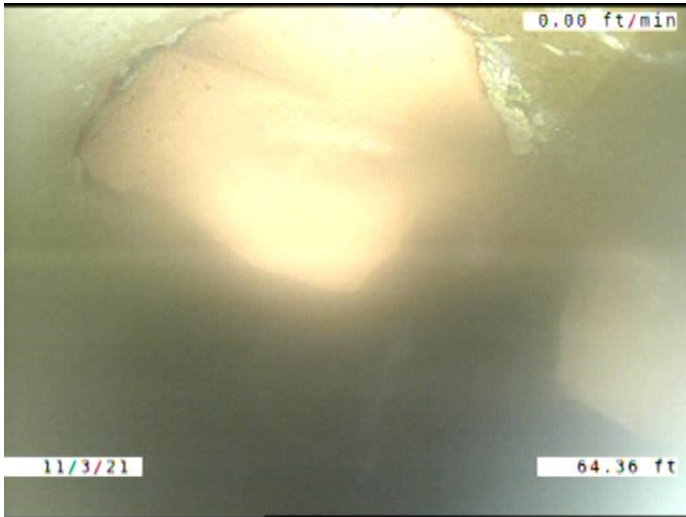
Code: **TBI**
 Description: **Tap Break-in Intruding**

Distance (ft): **64.4**
 Structural Grade: **0**
 O&M Grade: **2**
 Clock Start/From: **2**
 Clock To:
 1st Value: **4.000**
 2nd Value: **3.000**
 Value Percent:
 Continuous Index:
 Within 8" of Joint: **YES**
 Remarks:

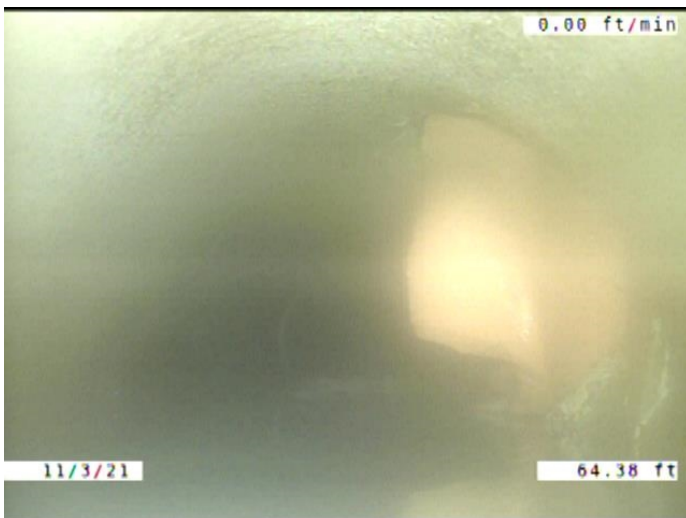
Code: **MSA**
 Description: **Miscellaneous Survey Abandoned**

Distance (ft): **64.4**
 Structural Grade: **0**
 O&M Grade: **0**
 Clock Start/From:
 Clock To:
 1st Value:
 2nd Value:
 Value Percent:
 Continuous Index:
 Within 8" of Joint: **NO**
 Remarks: **CAMERA CANT MAKE IT PAST
 PROTUDING TAP**
