## Profile/Photo Observation Report

Date:	<b>11/03/2021</b>	Weather:		Coding:	<b>PACP 7.0</b>
Pipe Length (ft):	<b>166.0</b>	Owner:	<b>City of Hobart</b>	Pre Clean:	<b>Heavy Cleaning</b>
P.O.#:	<b>YES502259</b>	Surveyor:	<b>S. Bucklin</b>	PSR:	<b>P-505-062-061</b>
Customer:	<b>City of Hobart</b>	Clean Date:	<b>10/28/2021</b>	Shape:	<b>C</b>

Street:	<b>2nd Court</b>	Flow Control:	<b>Not Controlled</b>
City:	<b>Hobart, IN</b>	Year Renewed:	
Location:	<b>Local rural streets with light traffic, t</b>	Tape/Media #:	
Purpose:	<b>Routine Assessment</b>	Dia/Height:	<b>8"</b>
Use:	<b>Sanitary Sewage Pipe</b>	Material:	<b>CT</b>
Drain Area:		Lining:	<b>None</b>
Category:	<b>NA</b>		
Comment:			
Location Details:		Direction of Survey:	<b>Downstream</b>
US MH:	<b>M-505-061</b>	DS MH:	<b>M-505-062</b>
		Total Length Surveyed (ft):	<b>64.4</b>

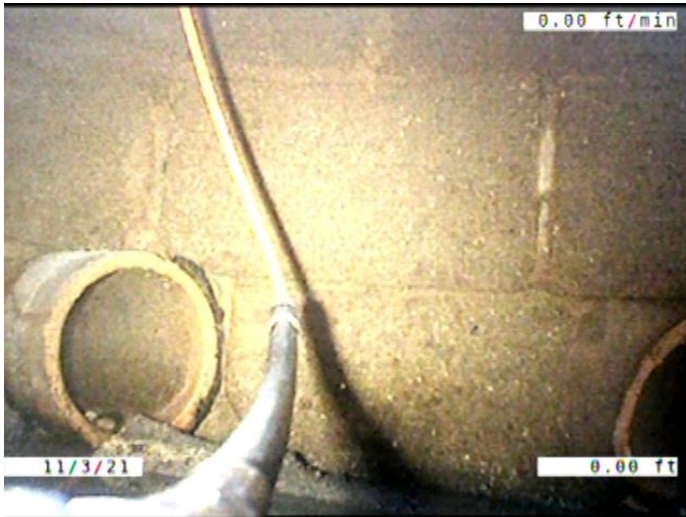
Code: **AMH**  
 Description: **Manhole**

Distance (ft): **.0**  
 Structural Grade: **0**  
 O&M Grade: **0**  
 Clock Start/From:  
 Clock To:  
 1st Value:  
 2nd Value:  
 Value Percent:  
 Continuous Index:  
 Within 8" of Joint: **NO**  
 Remarks: **M-505-061**

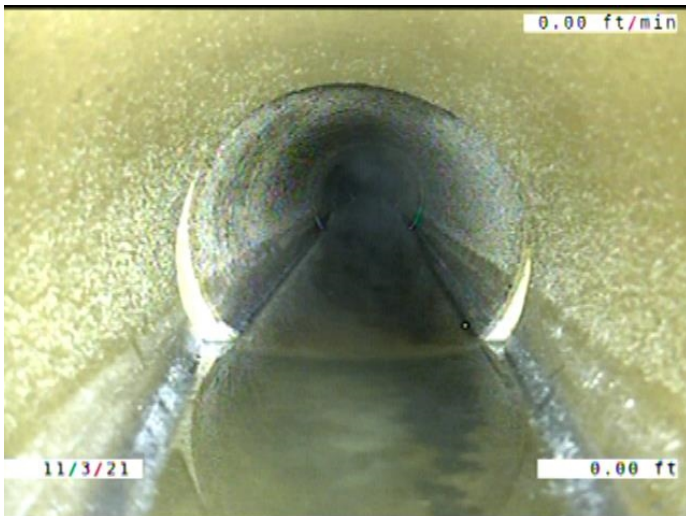
Code: **MWL**  
 Description: **Miscellaneous Water Level**

Distance (ft): **.0**  
 Structural Grade: **0**  
 O&M Grade: **0**  
 Clock Start/From:  
 Clock To:  
 1st Value:  
 2nd Value:  
 Value Percent: **5.000**  
 Continuous Index:  
 Within 8" of Joint: **NO**  
 Remarks:

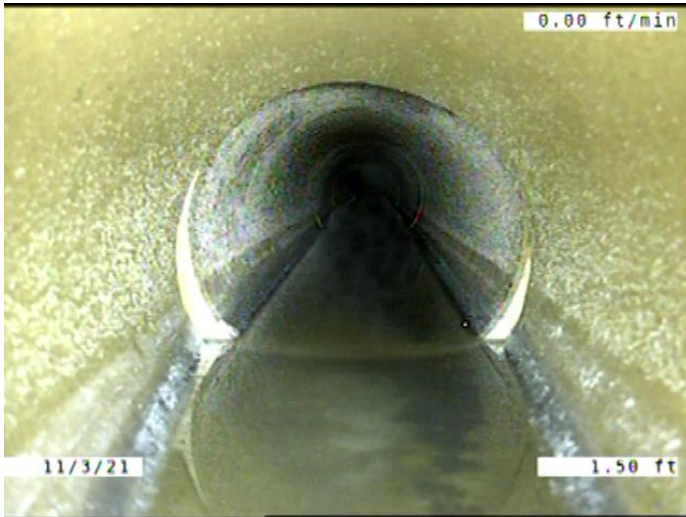
Code:	<b>MGO</b>
Description:	<b>Miscellaneous General Observation</b>
Distance (ft):	<b>1.5</b>
Structural Grade:	<b>0</b>
O&M Grade:	<b>0</b>
Clock Start/From:	
Clock To:	
1st Value:	
2nd Value:	
Value Percent:	
Continuous Index:	
Within 8" of Joint:	<b>NO</b>
Remarks:	<b>PIPE ANGLED INTO THE MANHOLE. HAD TO START IN THE PIPE.</b>

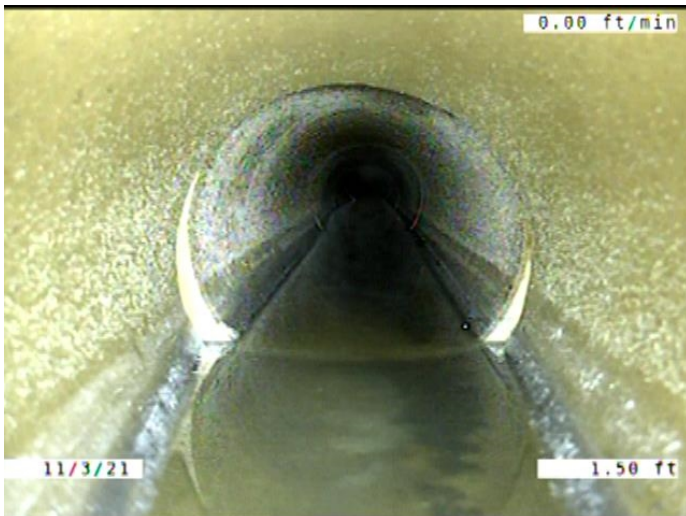
Code:	<b>MWLS</b>
Description:	<b>Miscellaneous Water Level Sag</b>
Distance (ft):	<b>1.5</b>
Structural Grade:	<b>2</b>
O&M Grade:	<b>0</b>
Clock Start/From:	
Clock To:	
1st Value:	
2nd Value:	
Value Percent:	<b>5.000</b>
Continuous Index:	<b>S01</b>
Within 8" of Joint:	<b>NO</b>
Remarks:

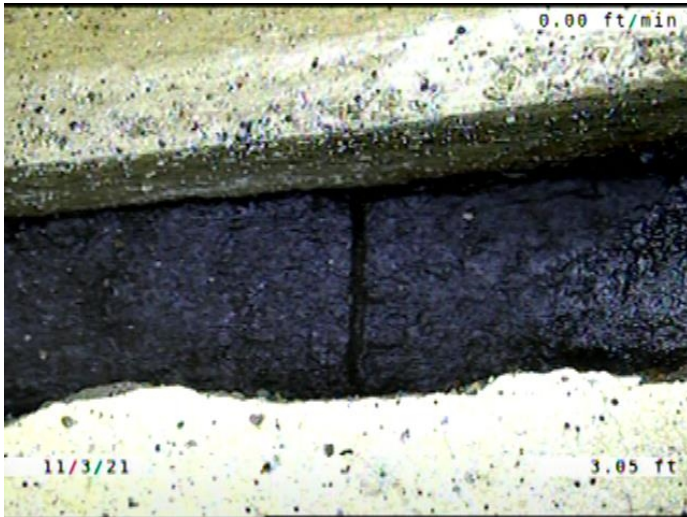
Code: **JAM**  
Description: **Joint Angular Medium**

Distance (ft): **3.0**  
Structural Grade: **3**  
O&M Grade: **0**  
Clock Start/From:  
Clock To:  
1st Value:  
2nd Value:  
Value Percent:  
Continuous Index:  
Within 8" of Joint: **NO**  
Remarks:

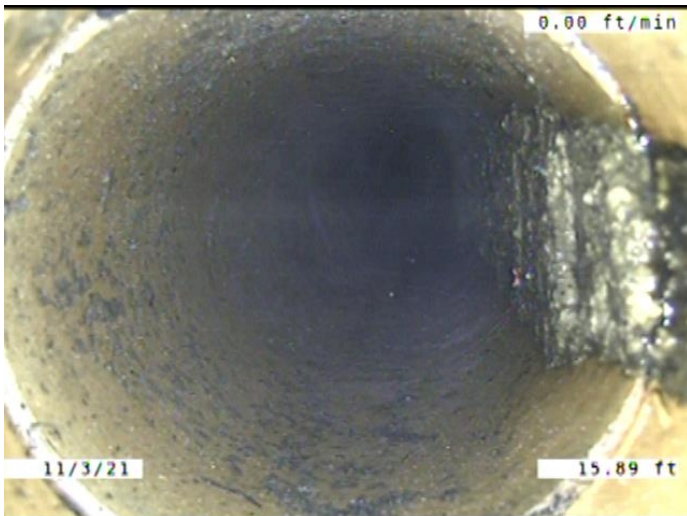
Code: **TF**  
Description: **Tap Factory**

Distance (ft): **15.9**  
Structural Grade: **0**  
O&M Grade: **0**  
Clock Start/From: **3**  
Clock To:  
1st Value: **4.000**  
2nd Value:  
Value Percent:  
Continuous Index:  
Within 8" of Joint: **YES**  
Remarks:

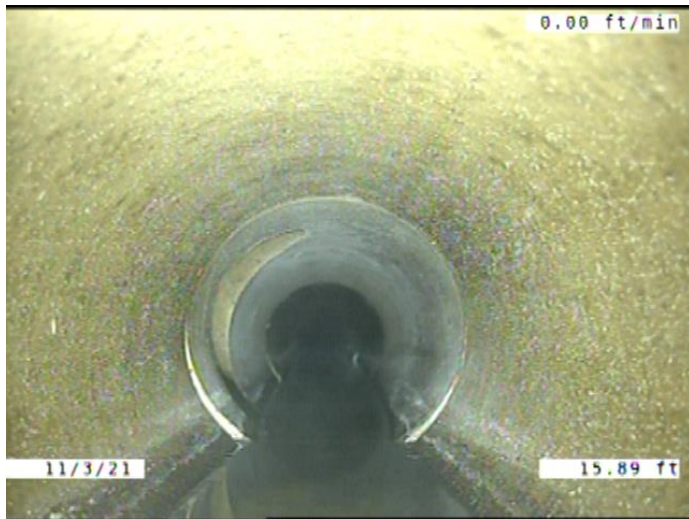
Code: **MWLS**  
 Description: **Miscellaneous Water Level Sag**

Distance (ft): **15.9**  
 Structural Grade: **2**  
 O&M Grade: **0**  
 Clock Start/From:  
 Clock To:  
 1st Value:  
 2nd Value:  
 Value Percent: **5.000**  
 Continuous Index: **F01**  
 Within 8" of Joint: **NO**  
 Remarks:

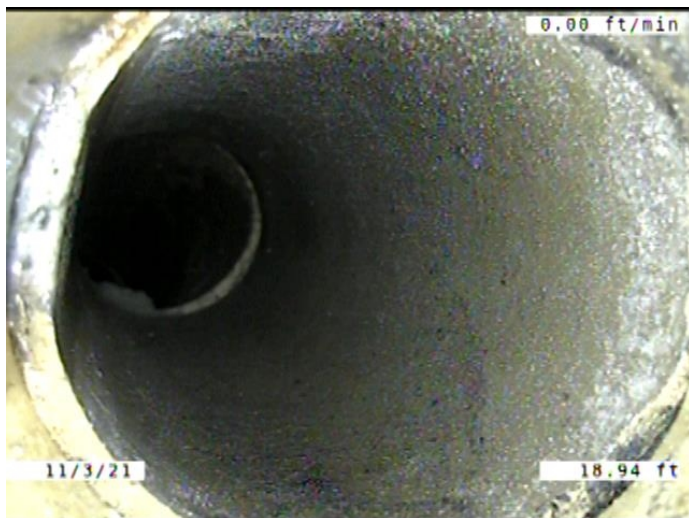
Code: **TF**  
 Description: **Tap Factory**

Distance (ft): **18.9**  
 Structural Grade: **0**  
 O&M Grade: **0**  
 Clock Start/From: **10**  
 Clock To:  
 1st Value: **4.000**  
 2nd Value:  
 Value Percent:  
 Continuous Index:  
 Within 8" of Joint: **YES**  
 Remarks:

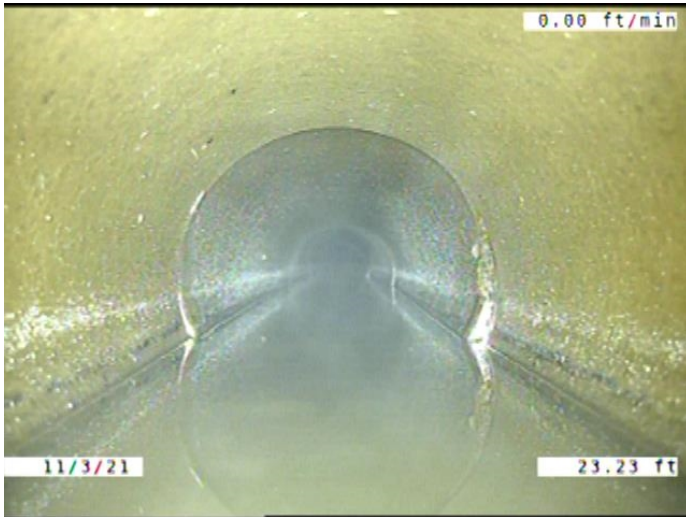
Code: **MWLS**  
 Description: **Miscellaneous Water Level Sag**

Distance (ft): **23.2**  
 Structural Grade: **2**  
 O&M Grade: **0**  
 Clock Start/From:  
 Clock To:  
 1st Value:  
 2nd Value:  
 Value Percent: **15.000**  
 Continuous Index: **S02**  
 Within 8" of Joint: **NO**  
 Remarks:

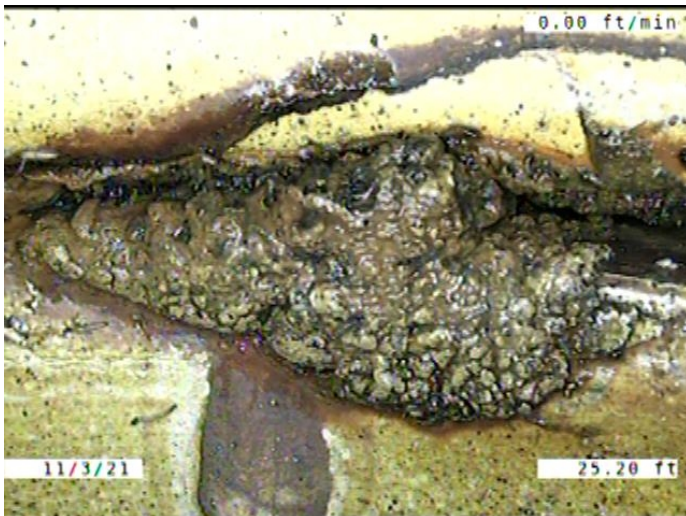
Code: **DAE**  
 Description: **Deposits Attached Encrustation**

Distance (ft): **25.2**  
 Structural Grade: **0**  
 O&M Grade: **2**  
 Clock Start/From: **1**  
 Clock To: **3**  
 1st Value:  
 2nd Value:  
 Value Percent: **5.000**  
 Continuous Index:  
 Within 8" of Joint: **YES**  
 Remarks:

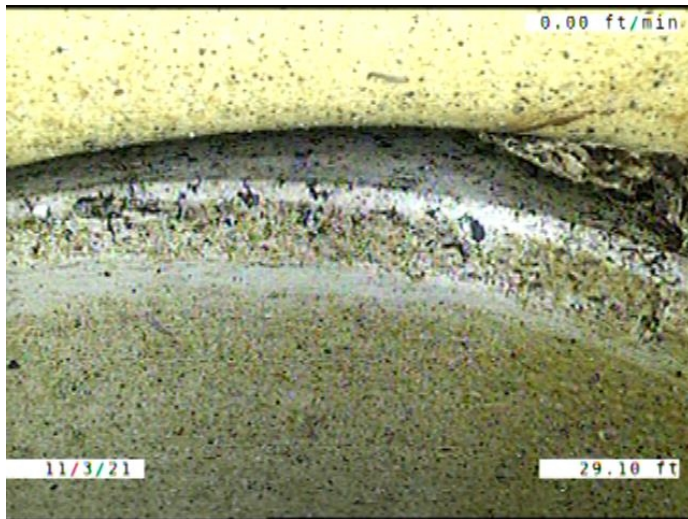
Code: **DAE**  
 Description: **Deposits Attached Encrustation**

Distance (ft): **29.1**  
 Structural Grade: **0**  
 O&M Grade: **2**  
 Clock Start/From: **1**  
 Clock To: **2**  
 1st Value:  
 2nd Value:  
 Value Percent: **5.000**  
 Continuous Index:  
 Within 8" of Joint: **YES**  
 Remarks:

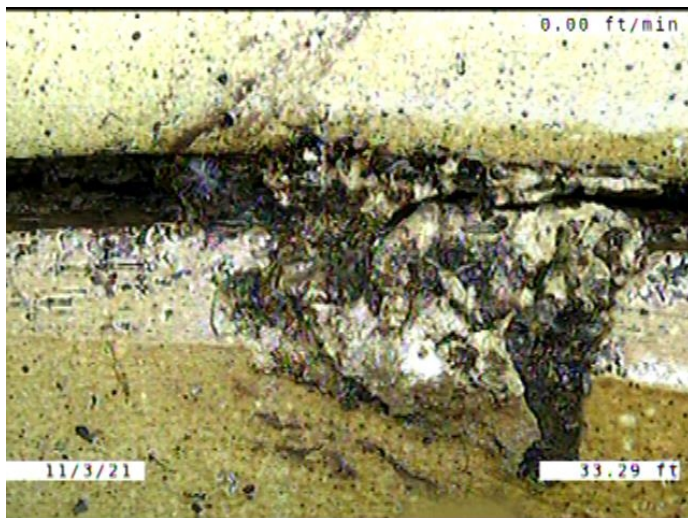
Code: **DAE**  
 Description: **Deposits Attached Encrustation**

Distance (ft): **33.3**  
 Structural Grade: **0**  
 O&M Grade: **2**  
 Clock Start/From: **2**  
 Clock To: **3**  
 1st Value:  
 2nd Value:  
 Value Percent: **5.000**  
 Continuous Index:  
 Within 8" of Joint: **YES**  
 Remarks:

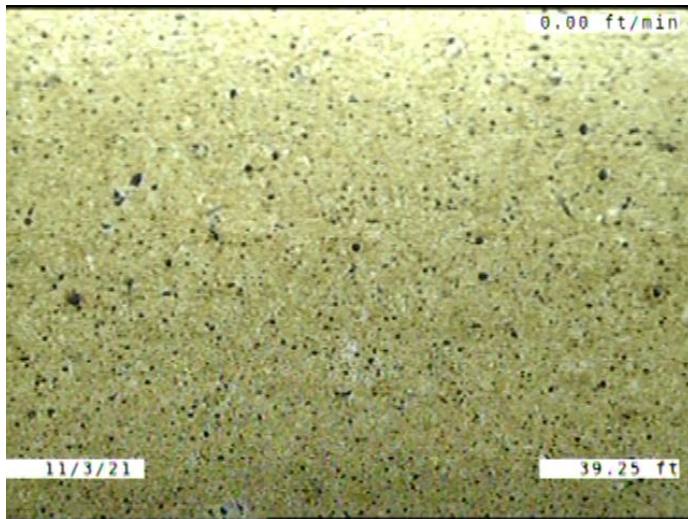
Code: **MWL**  
Description: **Miscellaneous Water Level**

Distance (ft): **39.2**  
Structural Grade: **0**  
O&M Grade: **0**  
Clock Start/From:  
Clock To:  
1st Value:  
2nd Value:  
Value Percent: **30.000**  
Continuous Index:  
Within 8" of Joint: **NO**  
Remarks:

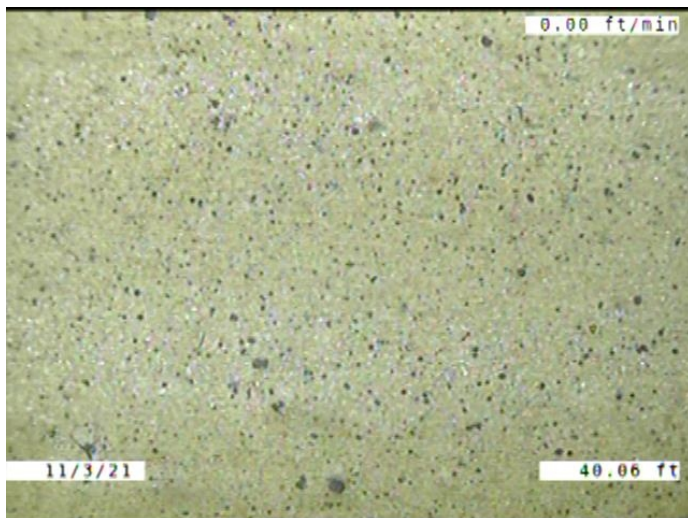
Code: **MCU**  
Description: **Miscellaneous Camera Underwater**

Distance (ft): **40.1**  
Structural Grade: **0**  
O&M Grade: **4**  
Clock Start/From:  
Clock To:  
1st Value:  
2nd Value:  
Value Percent:  
Continuous Index: **S04**  
Within 8" of Joint: **NO**  
Remarks:

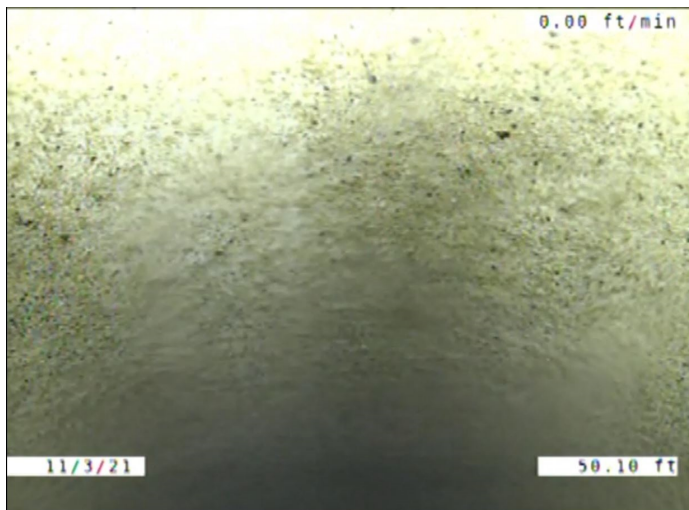
Code: **MCU**  
Description: **Miscellaneous Camera Underwater**

Distance (ft): **50.1**  
Structural Grade: **0**  
O&M Grade: **4**  
Clock Start/From:  
Clock To:  
1st Value:  
2nd Value:  
Value Percent:  
Continuous Index: **F04**  
Within 8" of Joint: **NO**  
Remarks:

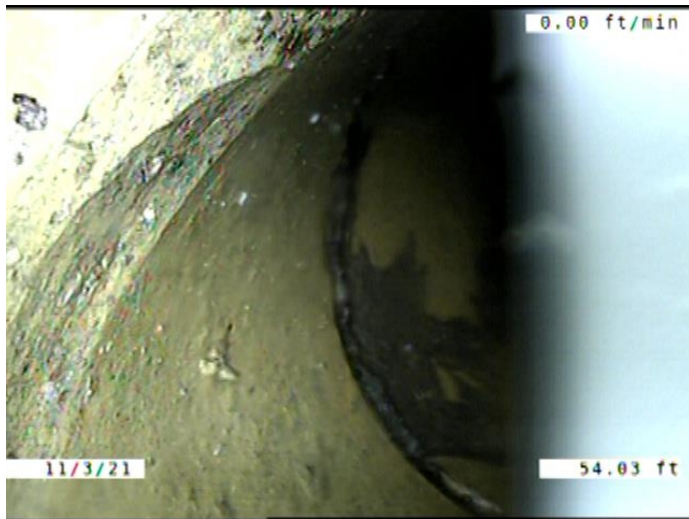
Code: **TF**  
 Description: **Tap Factory**

Distance (ft): **54.0**  
 Structural Grade: **0**  
 O&M Grade: **0**  
 Clock Start/From: **3**  
 Clock To:  
 1st Value: **4.000**  
 2nd Value:  
 Value Percent:  
 Continuous Index:  
 Within 8" of Joint: **YES**  
 Remarks:

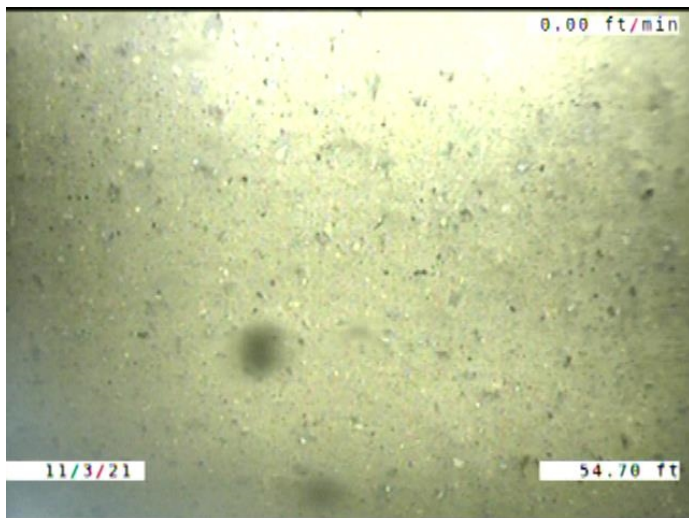
Code: **MCU**  
 Description: **Miscellaneous Camera Underwater**

Distance (ft): **54.7**  
 Structural Grade: **0**  
 O&M Grade: **4**  
 Clock Start/From:  
 Clock To:  
 1st Value:  
 2nd Value:  
 Value Percent:  
 Continuous Index:  
 Within 8" of Joint: **NO**  
 Remarks: **Out at 55**

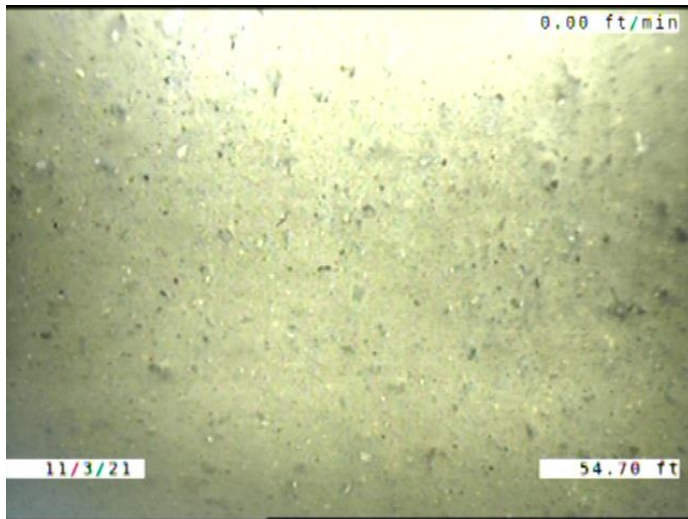
Code: **MWLS**  
 Description: **Miscellaneous Water Level Sag**

Distance (ft): **54.7**  
 Structural Grade: **3**  
 O&M Grade: **0**  
 Clock Start/From:  
 Clock To:  
 1st Value:  
 2nd Value:  
 Value Percent: **35.000**  
 Continuous Index: **S03**  
 Within 8" of Joint: **NO**  
 Remarks:

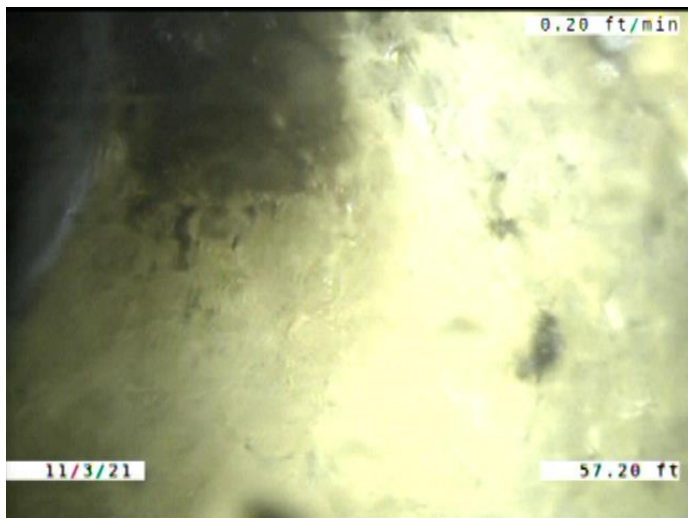
Code: **TF**  
 Description: **Tap Factory**

Distance (ft): **57.2**  
 Structural Grade: **0**  
 O&M Grade: **0**  
 Clock Start/From: **10**  
 Clock To:  
 1st Value: **4.000**  
 2nd Value:  
 Value Percent:  
 Continuous Index:  
 Within 8" of Joint: **YES**  
 Remarks:

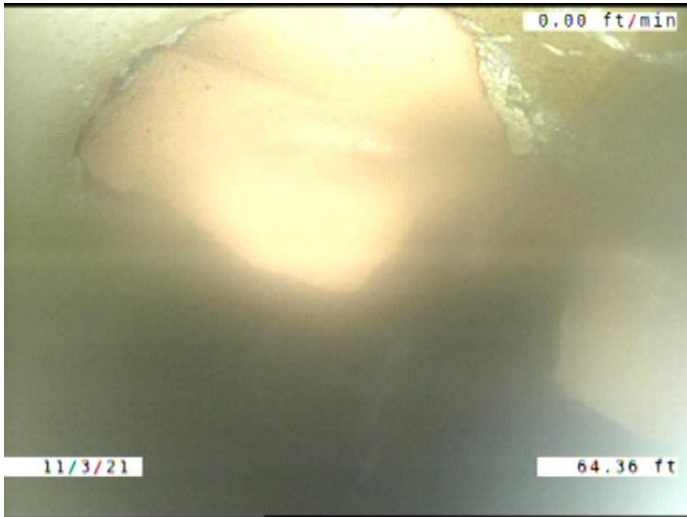
Code: **TBI**  
 Description: **Tap Break-in Intruding**

Distance (ft): **64.4**  
 Structural Grade: **0**  
 O&M Grade: **2**  
 Clock Start/From: **2**  
 Clock To:  
 1st Value: **4.000**  
 2nd Value: **3.000**  
 Value Percent:  
 Continuous Index:  
 Within 8" of Joint: **YES**  
 Remarks:

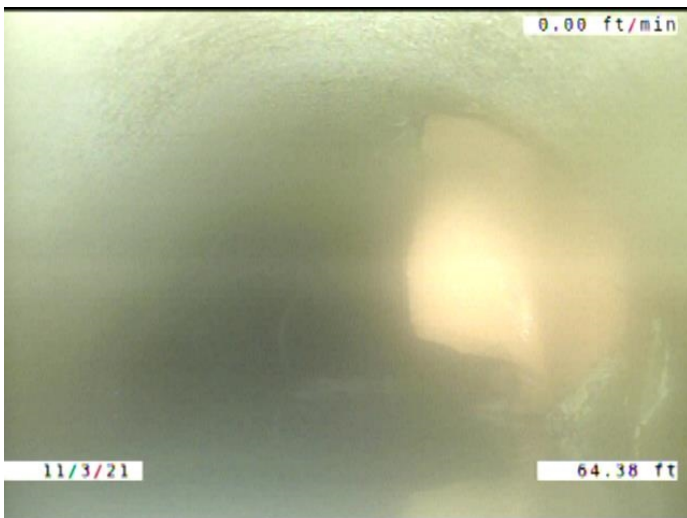
Code: **MSA**  
 Description: **Miscellaneous Survey Abandoned**

Distance (ft): **64.4**  
 Structural Grade: **0**  
 O&M Grade: **0**  
 Clock Start/From:  
 Clock To:  
 1st Value:  
 2nd Value:  
 Value Percent:  
 Continuous Index:  
 Within 8" of Joint: **NO**  
 Remarks: **CAMERA CANT MAKE IT PAST  
 PROTUDING TAP**
