## Profile/Photo Observation Report

Date:	<b>11/03/2021</b>	Weather:		Coding:	<b>PACP 7.0</b>
Pipe Length (ft):	<b>166.0</b>	Owner:	<b>City of Hobart</b>	Pre Clean:	<b>Heavy Cleaning</b>
P.O.#:	<b>YES502259</b>	Surveyor:	<b>S. Bucklin</b>	PSR:	<b>P-505-062-061</b>
Customer:	<b>City of Hobart</b>	Clean Date:	<b>10/28/2021</b>	Shape:	<b>C</b>

Street:	<b>2nd Court</b>	Flow Control:	<b>Not Controlled</b>
City:	<b>Hobart, IN</b>	Year Renewed:	
Location:	<b>Local rural streets with light traffic, t</b>	Tape/Media #:	
Purpose:	<b>Routine Assessment</b>	Dia/Height:	<b>8"</b>
Use:	<b>Sanitary Sewage Pipe</b>	Material:	<b>CT</b>
Drain Area:		Lining:	<b>None</b>
Category:	<b>NA</b>		
Comment:			
Location Details:		Direction of Survey:	<b>Upstream</b>
US MH:	<b>M-505-061</b>	DS MH:	<b>M-505-062</b>
		Total Length Surveyed (ft):	<b>106.6</b>

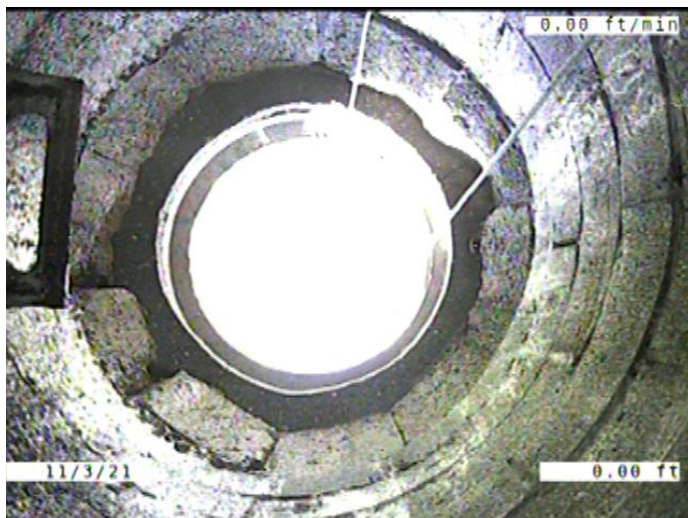
Code: **AMH**  
Description: **Manhole**

Distance (ft): **.0**  
Structural Grade: **0**  
O&M Grade: **0**  
Clock Start/From:  
Clock To:  
1st Value:  
2nd Value:  
Value Percent:  
Continuous Index:  
Within 8" of Joint: **NO**  
Remarks: **M-505-062**

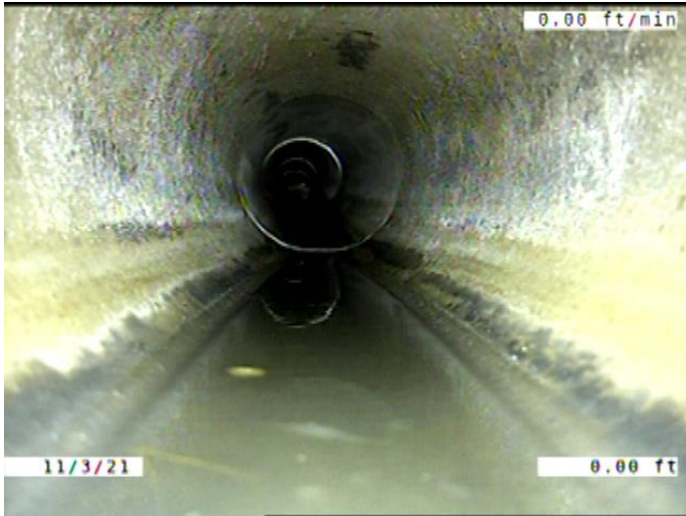
Code:	<b>MWL</b>
Description:	<b>Miscellaneous Water Level</b>
Distance (ft):	<b>.0</b>
Structural Grade:	<b>0</b>
O&M Grade:	<b>0</b>
Clock Start/From:	
Clock To:	
1st Value:	
2nd Value:	
Value Percent:	<b>5.000</b>
Continuous Index:	
Within 8" of Joint:	<b>NO</b>
Remarks:

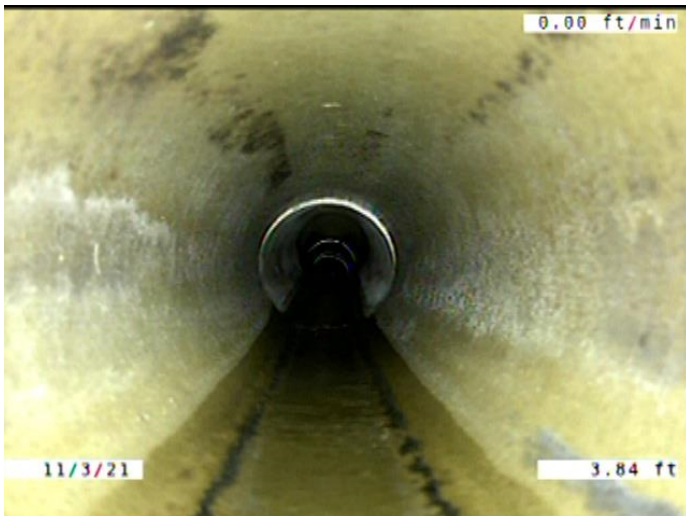
Code:	<b>LU</b>
Description:	<b>Line Up</b>
Distance (ft):	<b>3.8</b>
Structural Grade:	<b>0</b>
O&M Grade:	<b>1</b>
Clock Start/From:	
Clock To:	
1st Value:	
2nd Value:	
Value Percent:	<b>10.000</b>
Continuous Index:	
Within 8" of Joint:	<b>NO</b>
Remarks:

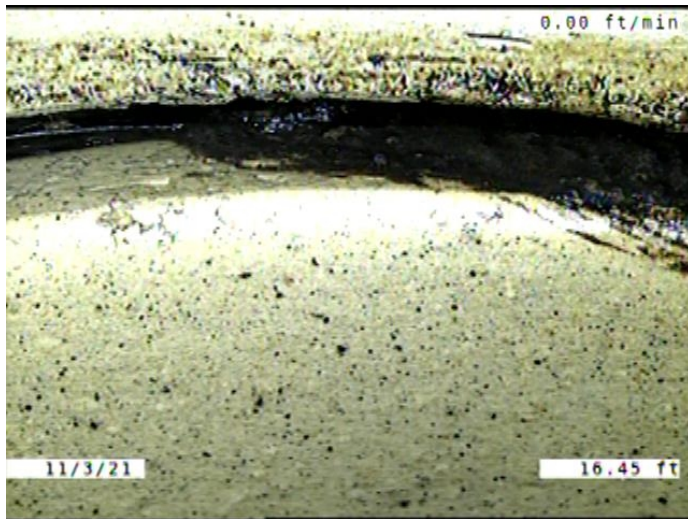
Code: **ISJ**  
 Description: **Infiltration Stain Joint**

Distance (ft): **16.5**  
 Structural Grade: **0**  
 O&M Grade: **1**  
 Clock Start/From: **1**  
 Clock To: **3**  
 1st Value:  
 2nd Value:  
 Value Percent:  
 Continuous Index:  
 Within 8" of Joint: **YES**  
 Remarks:

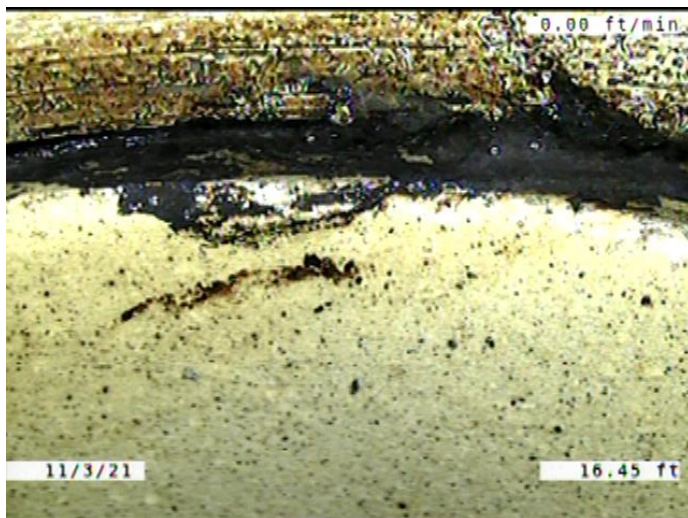
Code: **ISJ**  
 Description: **Infiltration Stain Joint**

Distance (ft): **16.5**  
 Structural Grade: **0**  
 O&M Grade: **1**  
 Clock Start/From: **8**  
 Clock To: **10**  
 1st Value:  
 2nd Value:  
 Value Percent:  
 Continuous Index:  
 Within 8" of Joint: **YES**  
 Remarks:

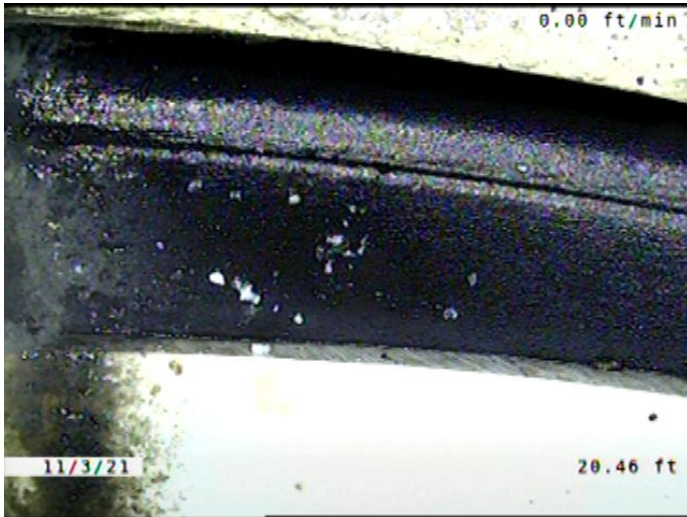
Code: **MMC**  
 Description: **Miscellaneous Material Change**

Distance (ft): **20.5**  
 Structural Grade: **0**  
 O&M Grade: **0**  
 Clock Start/From:  
 Clock To:  
 1st Value:  
 2nd Value:  
 Value Percent:  
 Continuous Index:  
 Within 8" of Joint: **NO**  
 Remarks: **VCP TO PVC**

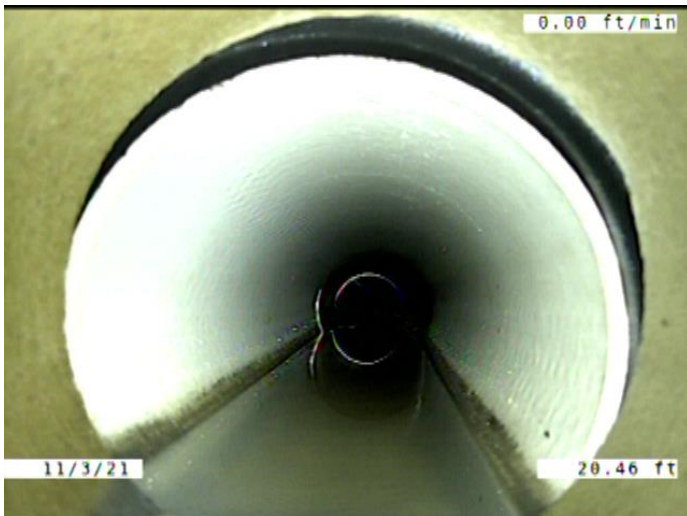
Code: **JOLD**  
 Description: **Joint Offset Large Defective**

Distance (ft): **20.5**  
 Structural Grade: **4**  
 O&M Grade: **0**  
 Clock Start/From:  
 Clock To:  
 1st Value:  
 2nd Value:  
 Value Percent:  
 Continuous Index:  
 Within 8" of Joint: **NO**  
 Remarks:

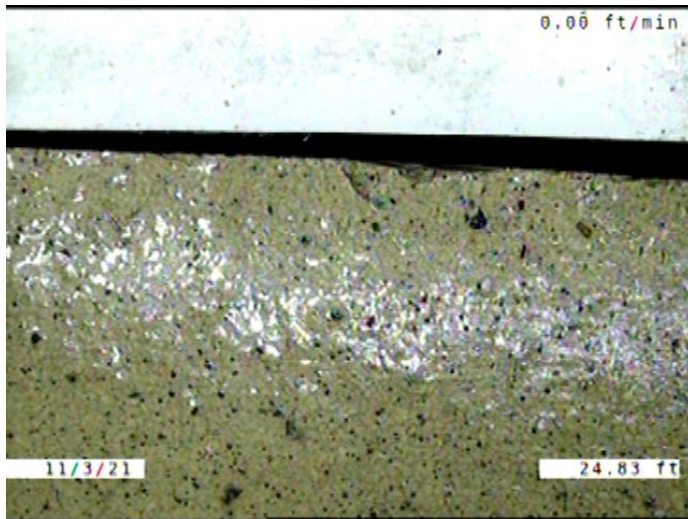
Code: **MMC**  
 Description: **Miscellaneous Material Change**

Distance (ft): **24.8**  
 Structural Grade: **0**  
 O&M Grade: **0**  
 Clock Start/From:  
 Clock To:  
 1st Value:  
 2nd Value:  
 Value Percent:  
 Continuous Index:  
 Within 8" of Joint: **NO**  
 Remarks: **PVC TO VCP**

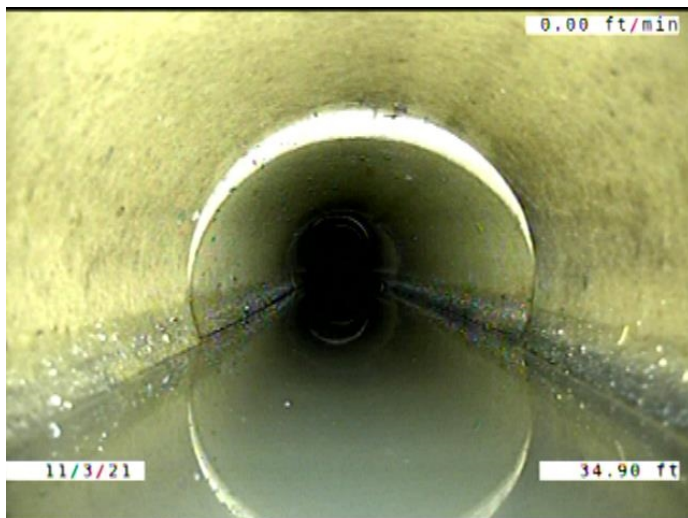
Code: **MWLS**  
 Description: **Miscellaneous Water Level Sag**

Distance (ft): **34.9**  
 Structural Grade: **2**  
 O&M Grade: **0**  
 Clock Start/From:  
 Clock To:  
 1st Value:  
 2nd Value:  
 Value Percent: **10.000**  
 Continuous Index: **S01**  
 Within 8" of Joint: **NO**  
 Remarks:

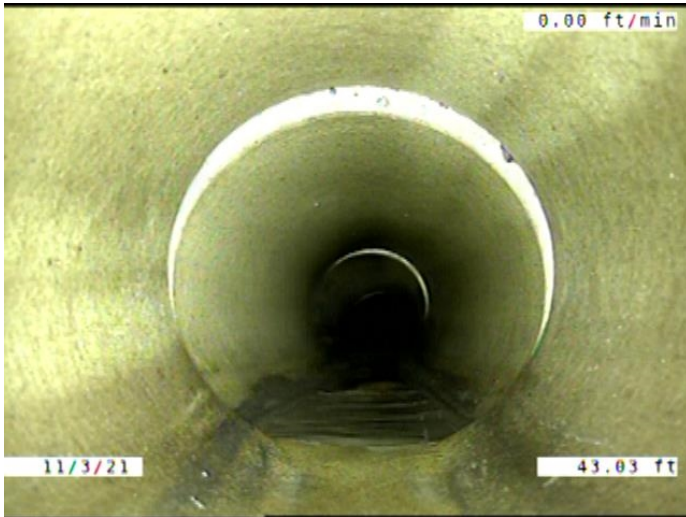
Code: **MWLS**  
Description: **Miscellaneous Water Level Sag**

Distance (ft): **43.0**  
Structural Grade: **2**  
O&M Grade: **0**  
Clock Start/From:  
Clock To:  
1st Value:  
2nd Value:  
Value Percent: **10.000**  
Continuous Index: **F01**  
Within 8" of Joint: **NO**  
Remarks:

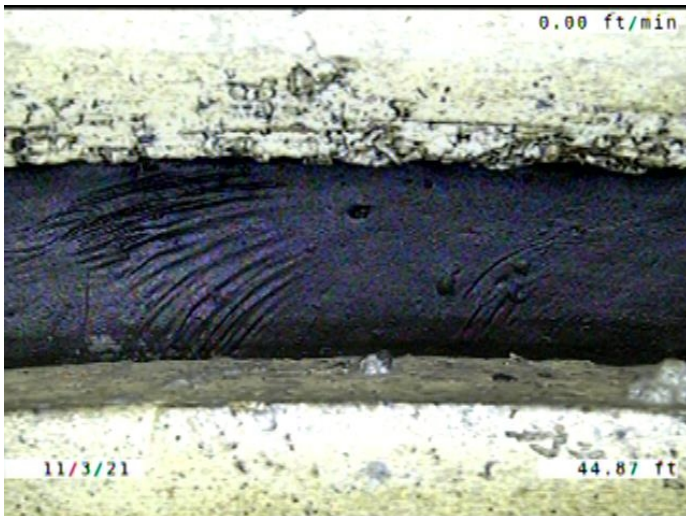
Code: **JAM**  
Description: **Joint Angular Medium**

Distance (ft): **44.9**  
Structural Grade: **3**  
O&M Grade: **0**  
Clock Start/From:  
Clock To:  
1st Value:  
2nd Value:  
Value Percent:  
Continuous Index:  
Within 8" of Joint: **NO**  
Remarks:

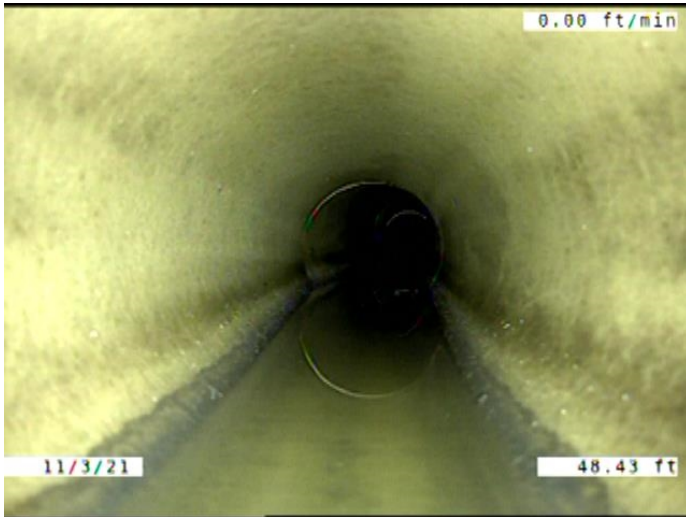
Code: **MWLS**  
Description: **Miscellaneous Water Level Sag**

Distance (ft): **48.4**  
Structural Grade: **2**  
O&M Grade: **0**  
Clock Start/From:  
Clock To:  
1st Value:  
2nd Value:  
Value Percent: **10.000**  
Continuous Index: **S02**  
Within 8" of Joint: **NO**  
Remarks:

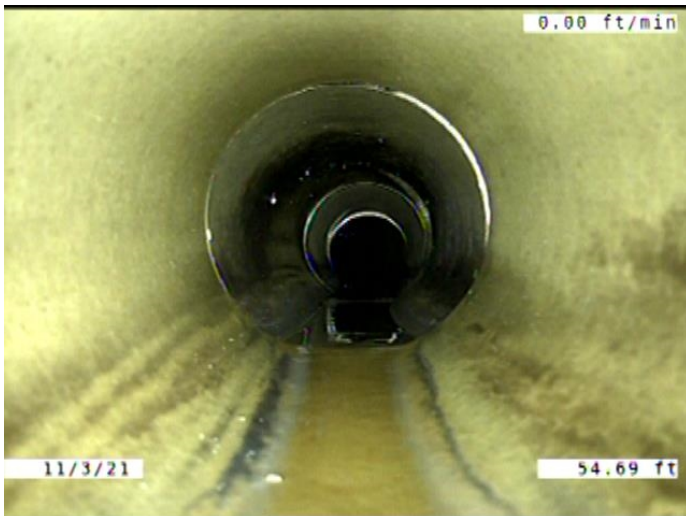
Code: **MWLS**  
Description: **Miscellaneous Water Level Sag**

Distance (ft): **54.7**  
Structural Grade: **2**  
O&M Grade: **0**  
Clock Start/From:  
Clock To:  
1st Value:  
2nd Value:  
Value Percent: **10.000**  
Continuous Index: **F02**  
Within 8" of Joint: **NO**  
Remarks:

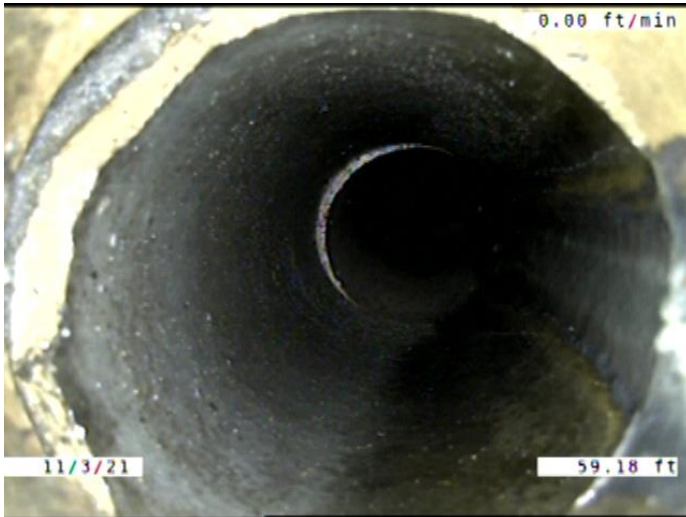
Code: **TF**  
Description: **Tap Factory**

Distance (ft): **59.2**  
Structural Grade: **0**  
O&M Grade: **0**  
Clock Start/From: **2**  
Clock To:  
1st Value: **4.000**  
2nd Value:  
Value Percent:  
Continuous Index:  
Within 8" of Joint: **YES**  
Remarks: **CONSTANTLY RUNNING WATER**

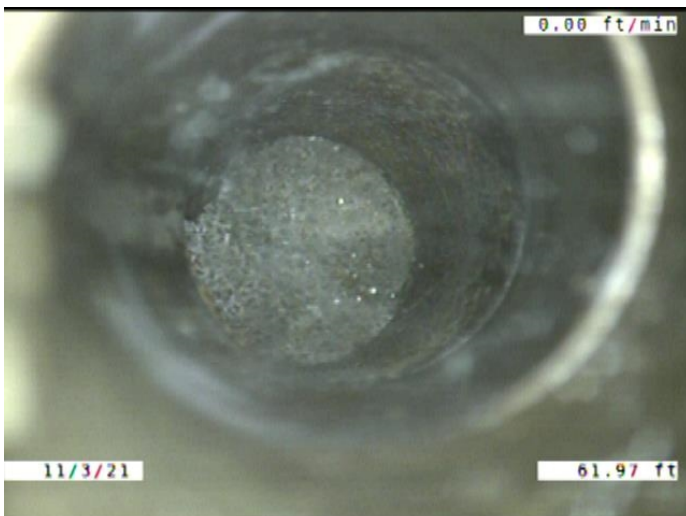
Code: **TFC**  
Description: **Tap Factory Capped**

Distance (ft): **62.0**  
Structural Grade: **0**  
O&M Grade: **0**  
Clock Start/From: **9**  
Clock To:  
1st Value: **4.000**  
2nd Value:  
Value Percent:  
Continuous Index:  
Within 8" of Joint: **YES**  
Remarks: **CONNECTION TO THE MAIN HAS  
ENCUSTATION ON THE JOINT**

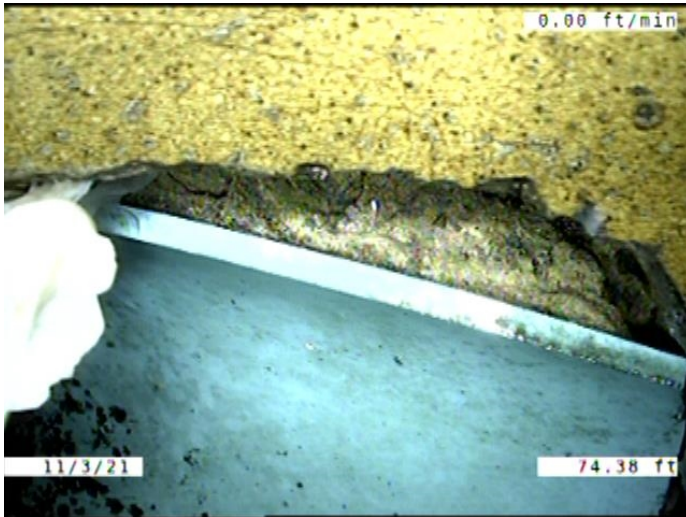
Code: **BSV**  
 Description: **Broken Soil Visible**

Distance (ft): **74.4**  
 Structural Grade: **5**  
 O&M Grade: **0**  
 Clock Start/From: **9**  
 Clock To: **3**  
 1st Value:  
 2nd Value:  
 Value Percent:  
 Continuous Index:  
 Within 8" of Joint: **YES**  
 Remarks:

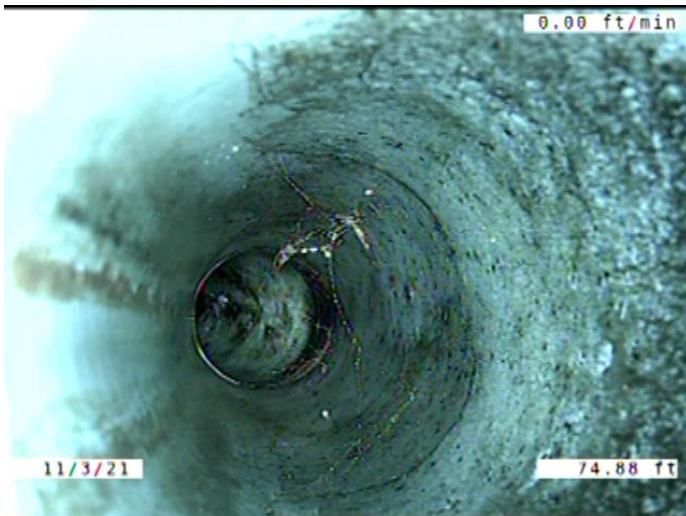
Code: **TBI**  
 Description: **Tap Break-in Intruding**

Distance (ft): **74.9**  
 Structural Grade: **0**  
 O&M Grade: **2**  
 Clock Start/From: **10**  
 Clock To:  
 1st Value: **4.000**  
 2nd Value: **1.000**  
 Value Percent:  
 Continuous Index:  
 Within 8" of Joint: **YES**  
 Remarks:

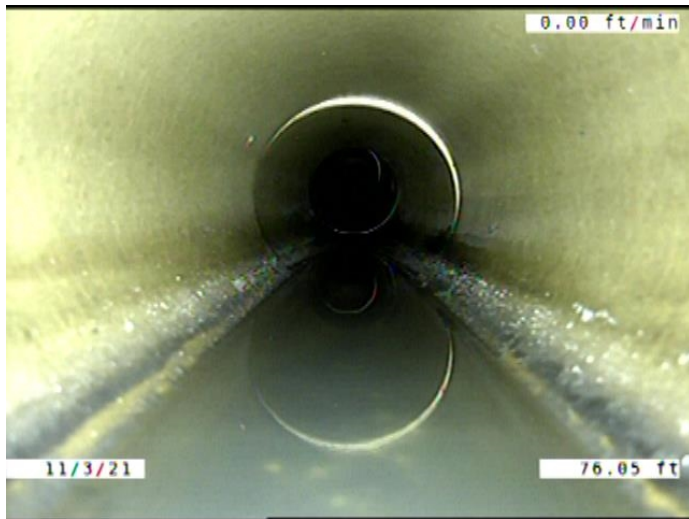
Code: **MWLS**  
 Description: **Miscellaneous Water Level Sag**

Distance (ft): **76.0**  
 Structural Grade: **2**  
 O&M Grade: **0**  
 Clock Start/From:  
 Clock To:  
 1st Value:  
 2nd Value:  
 Value Percent: **5.000**  
 Continuous Index: **S03**  
 Within 8" of Joint: **NO**  
 Remarks:

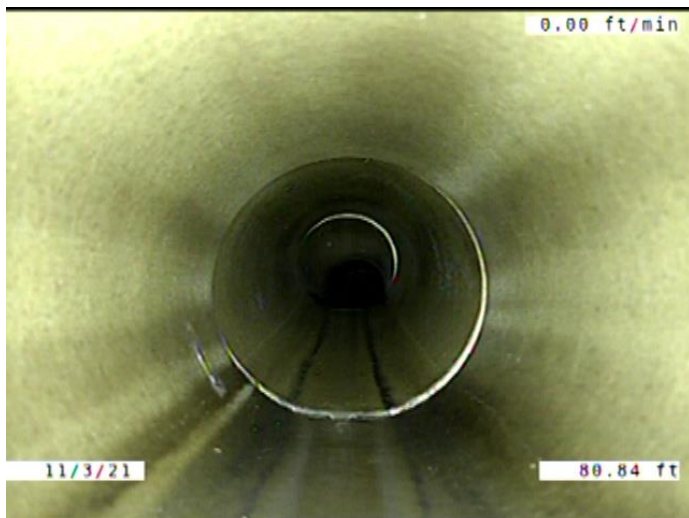
Code: **MWLS**  
 Description: **Miscellaneous Water Level Sag**

Distance (ft): **80.8**  
 Structural Grade: **2**  
 O&M Grade: **0**  
 Clock Start/From:  
 Clock To:  
 1st Value:  
 2nd Value:  
 Value Percent: **5.000**  
 Continuous Index: **F03**  
 Within 8" of Joint: **NO**  
 Remarks:

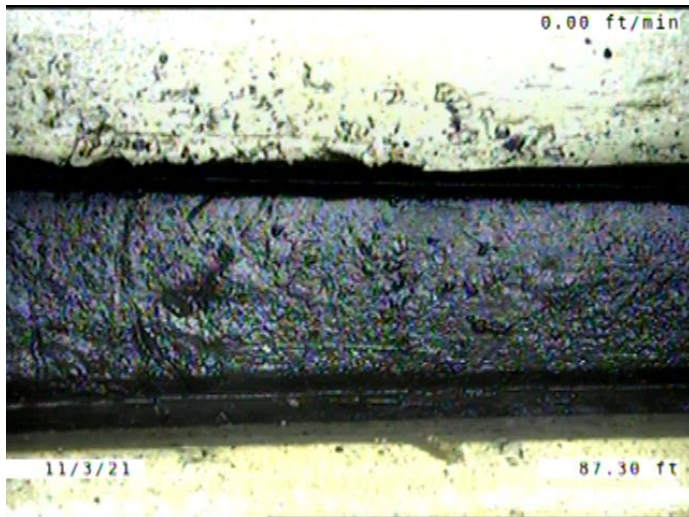
Code: **JAM**  
 Description: **Joint Angular Medium**

Distance (ft): **87.3**  
 Structural Grade: **3**  
 O&M Grade: **0**  
 Clock Start/From:  
 Clock To:  
 1st Value:  
 2nd Value:  
 Value Percent:  
 Continuous Index:  
 Within 8" of Joint: **NO**  
 Remarks:

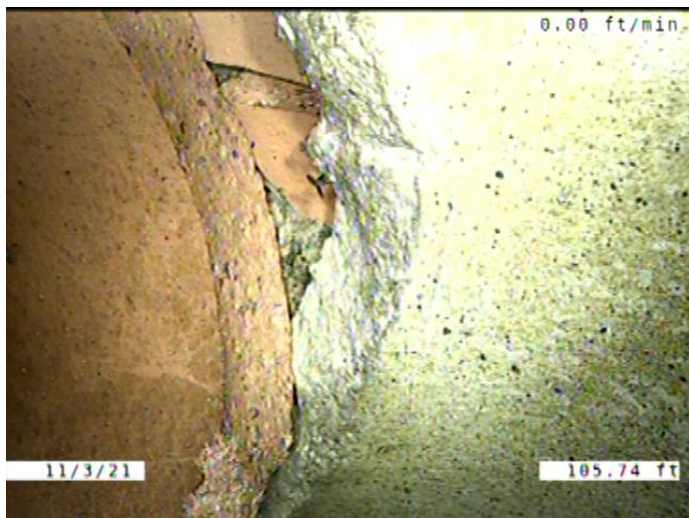
Code: **SSS**  
 Description: **Surface Damage Surface Spalling**

Distance (ft): **105.7**  
 Structural Grade: **2**  
 O&M Grade: **0**  
 Clock Start/From: **8**  
 Clock To: **11**  
 1st Value:  
 2nd Value:  
 Value Percent:  
 Continuous Index:  
 Within 8" of Joint: **YES**  
 Remarks:

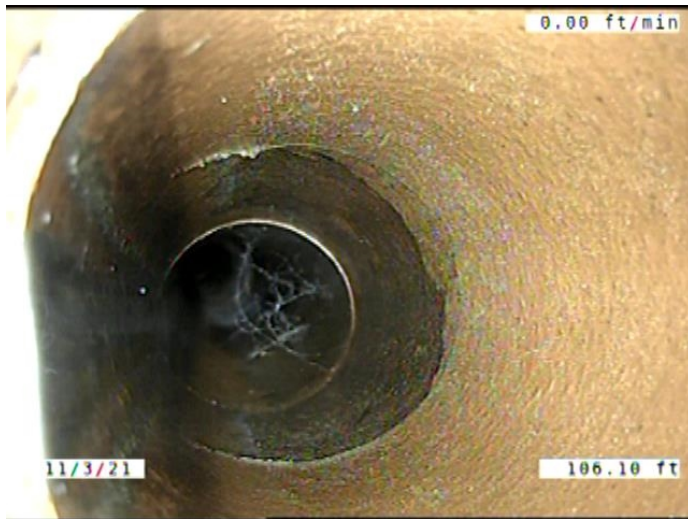
Code: **TBI**  
 Description: **Tap Break-in Intruding**

Distance (ft): **106.1**  
 Structural Grade: **0**  
 O&M Grade: **2**  
 Clock Start/From: **9**  
 Clock To:  
 1st Value: **4.000**  
 2nd Value: **3.000**  
 Value Percent:  
 Continuous Index:  
 Within 8" of Joint: **YES**  
 Remarks:

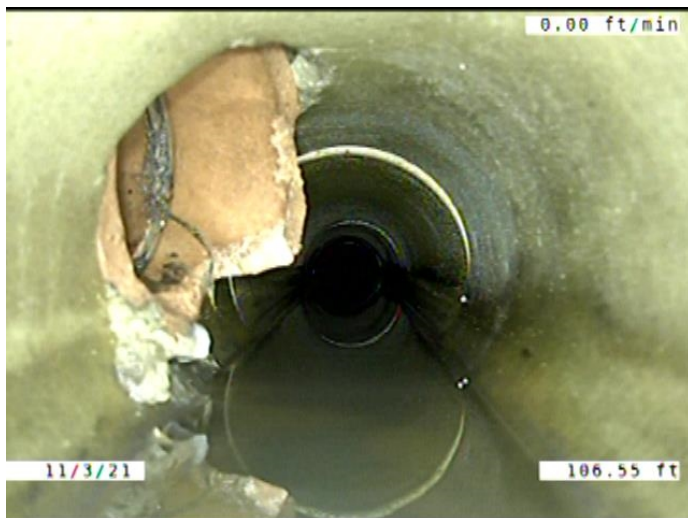
Code: **MSA**  
 Description: **Miscellaneous Survey Abandoned**

Distance (ft): **106.6**  
 Structural Grade: **0**  
 O&M Grade: **0**  
 Clock Start/From:  
 Clock To:  
 1st Value:  
 2nd Value:  
 Value Percent:  
 Continuous Index:  
 Within 8" of Joint: **NO**  
 Remarks: **CAMERA CANT MAKE IT PAST  
 PROTUDING TAP. MADE IT TO THE P**
