## Profile/Photo Observation Report

Street:	<b>ALLEY BETWEEN W 2ND ST &amp; W 1ST</b>	Flow Control:	<b>Not Controlled</b>
City:	<b>Hobart, IN</b>	Year Renewed:	
Location:	<b>Light Highway</b>	Tape/Media #:	
Purpose:	<b>Routine Assessment</b>	Dia/Height:	<b>10"</b>
Use:	<b>Sanitary</b>	Material:	<b>VCP</b>
Drain Area:	<b>NA</b>	Lining:	
Category:	<b>NA</b>		
Comment:

Location Details:		Direction of Survey:	<b>Downstream</b>
US MH:	<b>M-505-066</b>	DS MH:	<b>M-505-065</b>
		Total Length Surveyed (ft):	<b>24.3</b>

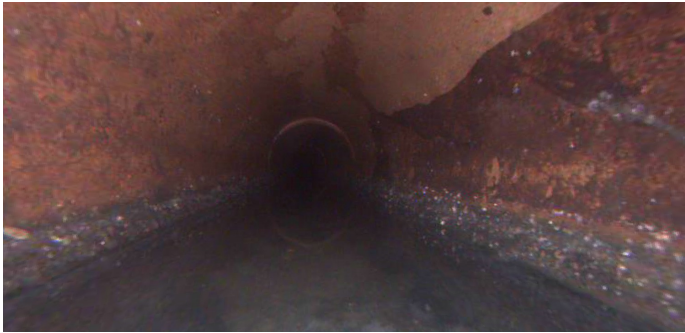
Code:	<b>MWL</b>
Description:	<b>Water Level</b>

Distance (ft):	<b>.0</b>
Structural Grade:	<b>0</b>
O&M Grade:	<b>0</b>
Clock Start/From:	
Clock To:	
1st Value:	
2nd Value:	
Value Percent:	<b>30.000</b>
Continuous Index:	
Within 8" of Joint:	<b>NO</b>
Remarks:

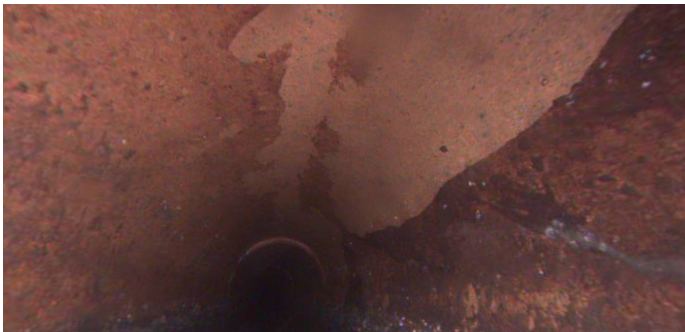
Code:	<b>FL</b>
Description:	<b>Fracture Longitudinal</b>

Distance (ft):	<b>.0</b>
Structural Grade:	<b>3</b>
O&M Grade:	<b>0</b>
Clock Start/From:	<b>2</b>
Clock To:	
1st Value:	
2nd Value:	
Value Percent:	
Continuous Index:	
Within 8" of Joint:	
Remarks:

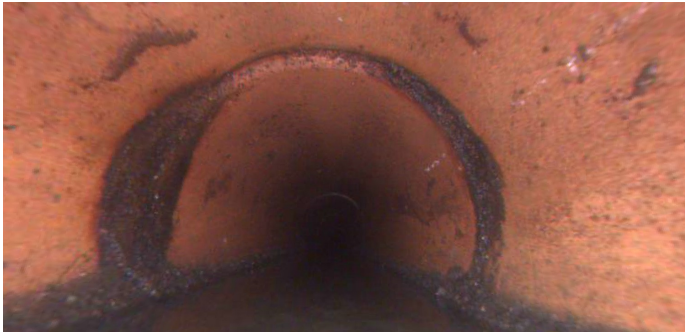
Code: **IW**  
Description: **Infil Weeper**

Distance (ft): **9.3**  
Structural Grade: **0**  
O&M Grade: **2**  
Clock Start/From: **8**  
Clock To: **4**  
1st Value:  
2nd Value:  
Value Percent:  
Continuous Index: **S02**  
Within 8" of Joint: **YES**  
Remarks:

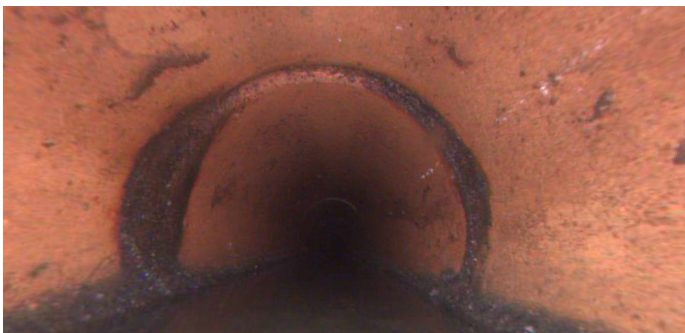
Code: **DAE**  
Description: **Deposits Attached Encrustation**

Distance (ft): **9.3**  
Structural Grade: **0**  
O&M Grade: **2**  
Clock Start/From: **8**  
Clock To: **4**  
1st Value:  
2nd Value:  
Value Percent: **5.000**  
Continuous Index: **S03**  
Within 8" of Joint: **NO**  
Remarks:

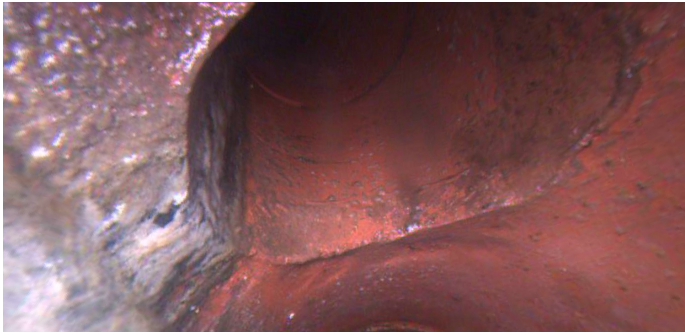
Code: **TF**  
Description: **Tap Factory**

Distance (ft): **24.3**  
Structural Grade: **0**  
O&M Grade: **0**  
Clock Start/From: **9**  
Clock To:  
1st Value: **4.000**  
2nd Value:  
Value Percent:  
Continuous Index:  
Within 8" of Joint:  
Remarks:

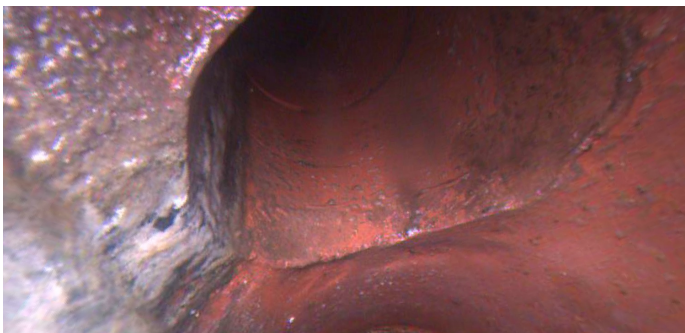
Code: **DAE**  
Description: **Deposits Attached Encrustation**

Distance (ft): **24.3**  
Structural Grade: **0**  
O&M Grade: **2**  
Clock Start/From: **8**  
Clock To: **4**  
1st Value:  
2nd Value:  
Value Percent: **5.000**  
Continuous Index: **F03**  
Within 8" of Joint: **NO**  
Remarks:

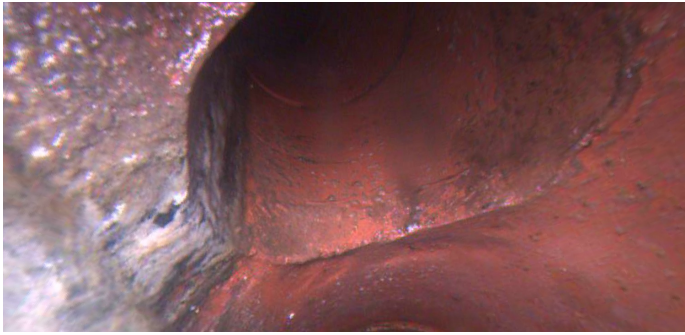
Code: **IW**  
Description: **Infil Weeper**

Distance (ft): **24.3**  
Structural Grade: **0**  
O&M Grade: **2**  
Clock Start/From: **8**  
Clock To: **4**  
1st Value:  
2nd Value:  
Value Percent:  
Continuous Index: **F02**  
Within 8" of Joint: **YES**  
Remarks:

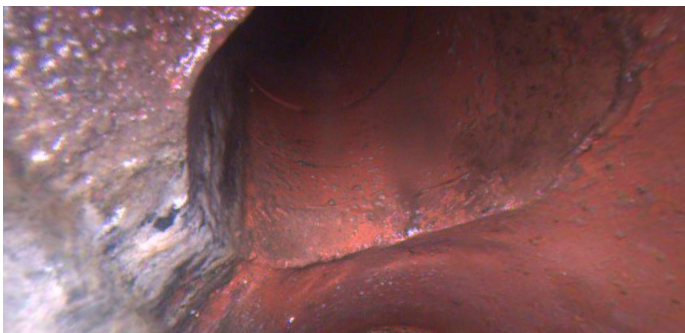
Code: **MSA**  
Description: **Abandoned Survey**

Distance (ft): **24.3**  
Structural Grade: **0**  
O&M Grade: **0**  
Clock Start/From:  
Clock To:  
1st Value:  
2nd Value:  
Value Percent:  
Continuous Index:  
Within 8" of Joint: **NO**  
Remarks: **overturned**
