Profile/Photo Observation Report

Date:	04/22/2018	Weather:		Coding:	PACP 6.0
Pipe Length (ft):	254.0	Owner:	NA	Pre Clean:	No Pre-Cleaning
P.O.#:		Surveyor:	Jen Costello	PSR:	P-505-065-066
Customer:		Clean Date:	01/01/1900	Shape:	C

Street:	FOXCROFT STREET	Flow Control:	Not Controlled
City:	Hobart, IN	Year Renewed:	
Location:	Light Highway	Tape/Media #:	
Purpose:	Routine Assessment	Dia/Height:	10"
Use:	Sanitary	Material:	VCP
Drain Area:	NA	Lining:	
Category:	NA		
Comment:			
Location Details:		Direction of Survey:	Downstream
US MH:	M-505-066	DS MH:	M-505-065
		Total Length Surveyed (ft):	24.3

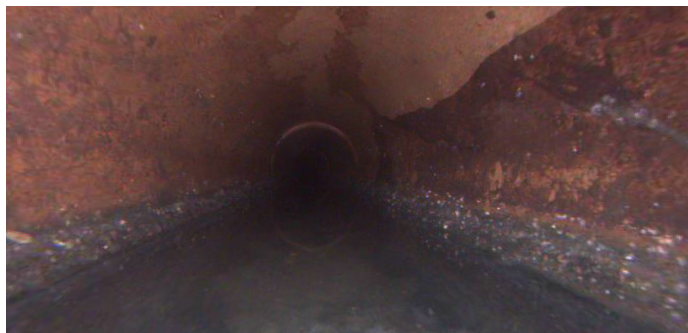
Code: **AMH**
 Description: **Manhole**

Distance (ft): **.0**
 Structural Grade: **0**
 O&M Grade: **0**
 Clock Start/From:
 Clock To:
 1st Value:
 2nd Value:
 Value Percent:
 Continuous Index:
 Within 8" of Joint: **NO**
 Remarks: **M-505-066**

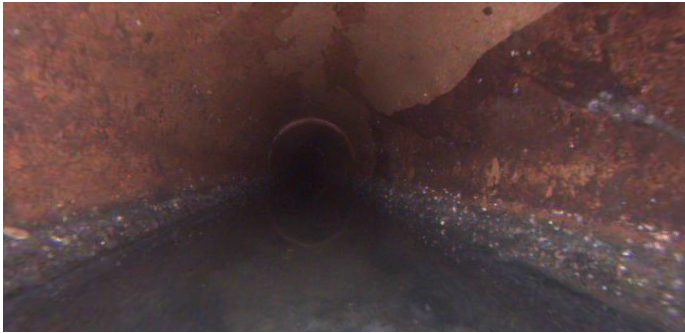
Code:	MWL
Description:	Water Level

Distance (ft):	.0
Structural Grade:	0
O&M Grade:	0
Clock Start/From:	
Clock To:	
1st Value:	
2nd Value:	
Value Percent:	30.000
Continuous Index:	
Within 8" of Joint:	NO
Remarks:

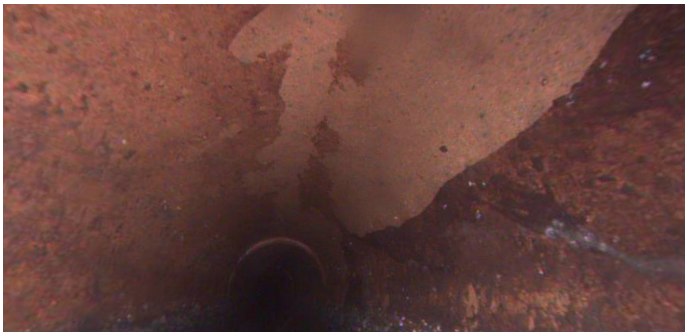
Code:	FL
Description:	Fracture Longitudinal

Distance (ft):	.0
Structural Grade:	3
O&M Grade:	0
Clock Start/From:	2
Clock To:	
1st Value:	
2nd Value:	
Value Percent:	
Continuous Index:	
Within 8" of Joint:	
Remarks:

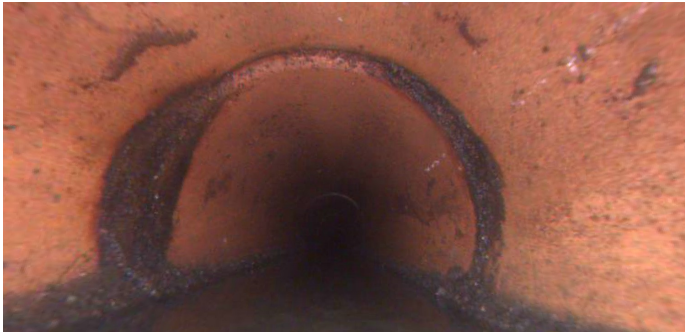
Code: **IW**
Description: **Infil Weeper**

Distance (ft): **9.3**
Structural Grade: **0**
O&M Grade: **2**
Clock Start/From: **8**
Clock To: **4**
1st Value:
2nd Value:
Value Percent:
Continuous Index: **S02**
Within 8" of Joint: **YES**
Remarks:

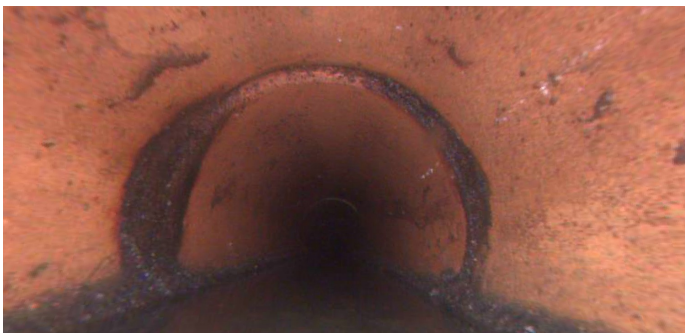
Code: **DAE**
Description: **Deposits Attached Encrustation**

Distance (ft): **9.3**
Structural Grade: **0**
O&M Grade: **2**
Clock Start/From: **8**
Clock To: **4**
1st Value:
2nd Value:
Value Percent: **5.000**
Continuous Index: **S03**
Within 8" of Joint: **NO**
Remarks:

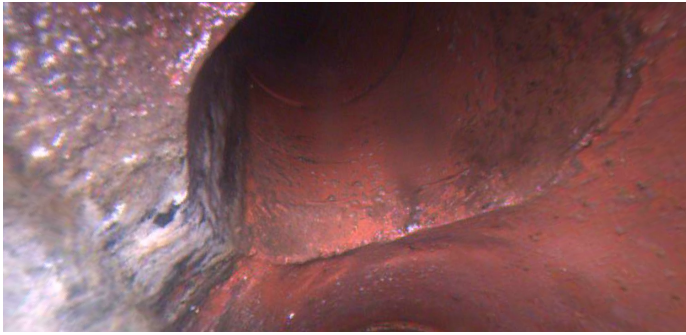
Code: **TF**
Description: **Tap Factory**

Distance (ft): **24.3**
Structural Grade: **0**
O&M Grade: **0**
Clock Start/From: **9**
Clock To:
1st Value: **4.000**
2nd Value:
Value Percent:
Continuous Index:
Within 8" of Joint:
Remarks:

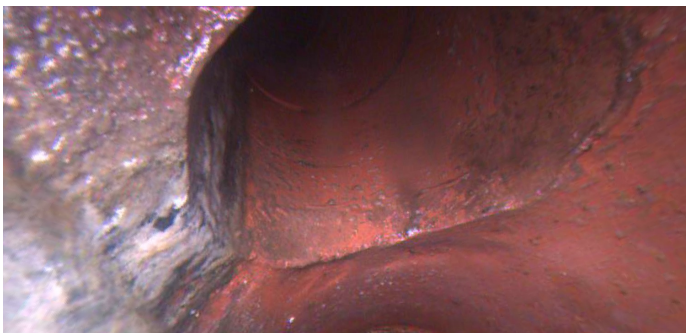
Code: **DAE**
Description: **Deposits Attached Encrustation**

Distance (ft): **24.3**
Structural Grade: **0**
O&M Grade: **2**
Clock Start/From: **8**
Clock To: **4**
1st Value:
2nd Value:
Value Percent: **5.000**
Continuous Index: **F03**
Within 8" of Joint: **NO**
Remarks:

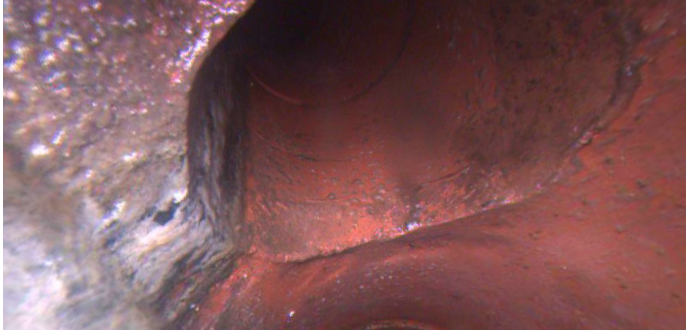
Code: **IW**
Description: **Infil Weeper**

Distance (ft): **24.3**
Structural Grade: **0**
O&M Grade: **2**
Clock Start/From: **8**
Clock To: **4**
1st Value:
2nd Value:
Value Percent:
Continuous Index: **F02**
Within 8" of Joint: **YES**
Remarks:

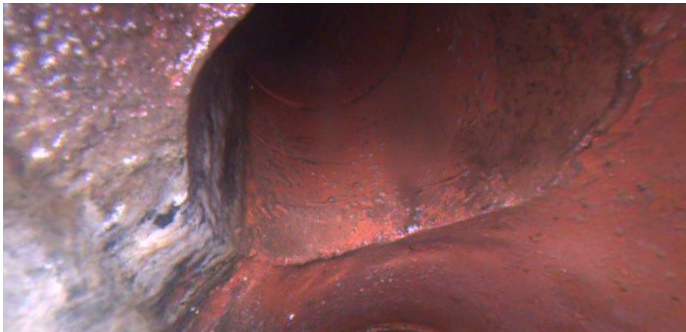
Code: **MSA**
Description: **Abandoned Survey**

Distance (ft): **24.3**
Structural Grade: **0**
O&M Grade: **0**
Clock Start/From:
Clock To:
1st Value:
2nd Value:
Value Percent:
Continuous Index:
Within 8" of Joint: **NO**
Remarks: **overturned**
