Profile/Photo Observation Report

Date:	04/22/2018	Weather:		Coding:	PACP 6.0
Pipe Length (ft):	265.4	Owner:	NA	Pre Clean:	No Pre-Cleaning
P.O.#:		Surveyor:	Erik Redinger	PSR:	P-505-066-067
Customer:		Clean Date:	01/01/1900	Shape:	C

Street:	S WILSON ST	Flow Control:	Not Controlled
City:	Hobart, IN	Year Renewed:	
Location:	Light Highway	Tape/Media #:	
Purpose:	Routine Assessment	Dia/Height:	10"
Use:	Sanitary	Material:	VCP
Drain Area:	NA	Lining:	
Category:	NA		
Comment:	P_C at 47 ft debris . Flow direction wrong		
Location Details:		Direction of Survey:	Downstream
US MH:	M-505-067	DS MH:	M-505-066
		Total Length Surveyed (ft):	48.3

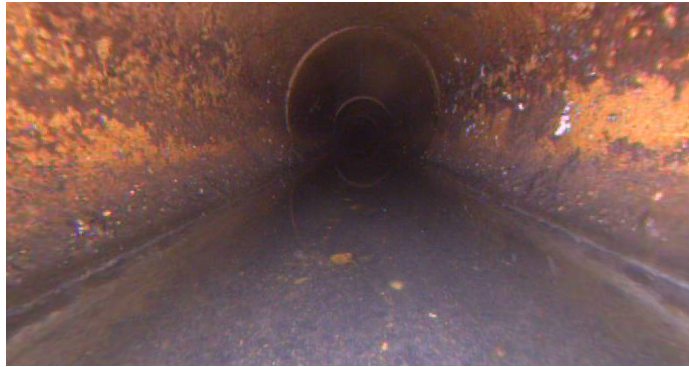
Code: **MWL**
Description: **Water Level**

Distance (ft): **.0**
Structural Grade: **0**
O&M Grade: **0**
Clock Start/From:
Clock To:
1st Value:
2nd Value:
Value Percent: **10.000**
Continuous Index:
Within 8" of Joint: **NO**
Remarks:

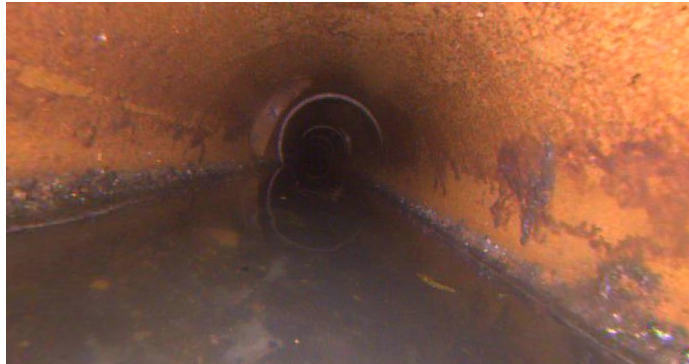
Code: **MSA**
Description: **Abandoned Survey**

Distance (ft): **48.3**
Structural Grade: **0**
O&M Grade: **0**
Clock Start/From:
Clock To:
1st Value:
2nd Value:
Value Percent:
Continuous Index:
Within 8" of Joint: **NO**
Remarks: **No blockage**
