## Profile/Photo Observation Report

Street:	<b>S WILSON ST</b>	Flow Control:	<b>Not Controlled</b>
City:	<b>Hobart, IN</b>	Year Renewed:	
Location:	<b>Light Highway</b>	Tape/Media #:	
Purpose:	<b>Routine Assessment</b>	Dia/Height:	<b>10"</b>
Use:	<b>Sanitary</b>	Material:	<b>VCP</b>
Drain Area:	<b>NA</b>	Lining:	
Category:	<b>NA</b>		
Comment:	<b>P_C at 39 ft nothing visible . Flow direction wrong</b>		
Location Details:		Direction of Survey:	<b>Upstream</b>
US MH:	<b>M-505-067</b>	DS MH:	<b>M-505-066</b>
		Total Length Surveyed (ft):	<b>40.3</b>

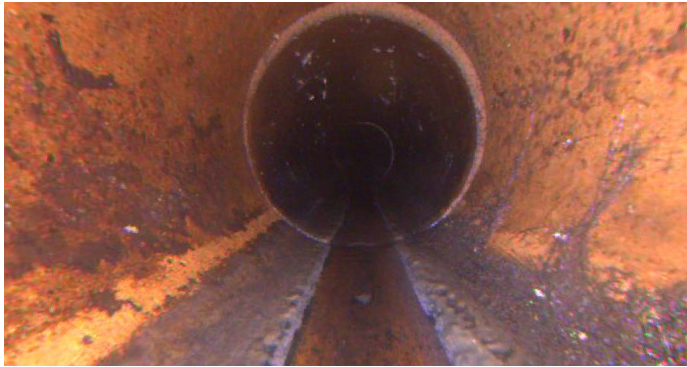
Code: **MWL**  
Description: **Water Level**

Distance (ft): **.0**  
Structural Grade: **0**  
O&M Grade: **0**  
Clock Start/From:  
Clock To:  
1st Value:  
2nd Value:  
Value Percent: **10.000**  
Continuous Index:  
Within 8" of Joint: **NO**  
Remarks:

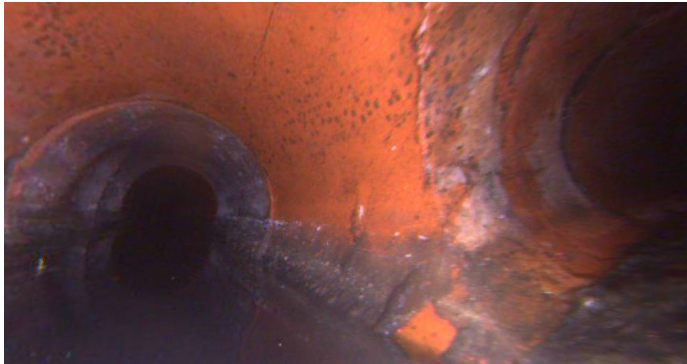
Code: **TF**  
Description: **Tap Factory**

Distance (ft): **24.9**  
Structural Grade: **0**  
O&M Grade: **0**  
Clock Start/From: **4**  
Clock To:  
1st Value: **4.000**  
2nd Value:  
Value Percent:  
Continuous Index:  
Within 8" of Joint:  
Remarks:

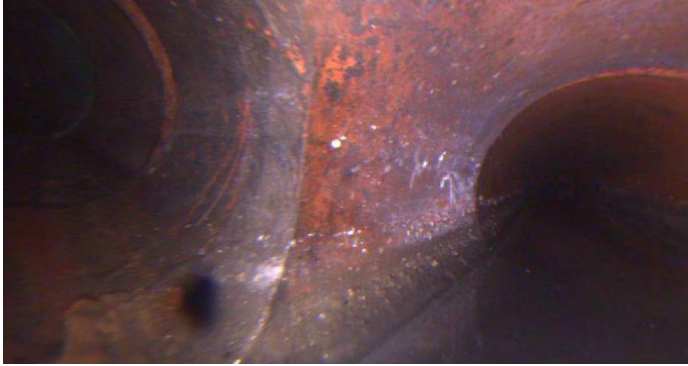
Code: **TF**  
Description: **Tap Factory**

Distance (ft): **27.1**  
Structural Grade: **0**  
O&M Grade: **0**  
Clock Start/From: **8**  
Clock To:  
1st Value: **4.000**  
2nd Value:  
Value Percent:  
Continuous Index:  
Within 8" of Joint:  
Remarks:

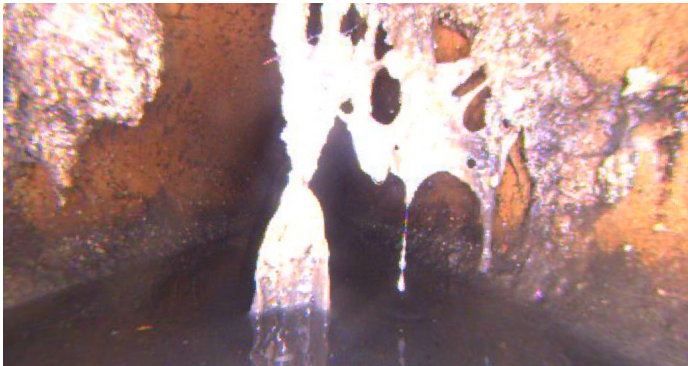
Code: **DAZ**  
Description: **Deposits Attached Other**

Distance (ft): **40.2**  
Structural Grade: **0**  
O&M Grade: **2**  
Clock Start/From: **7**  
Clock To: **5**  
1st Value:  
2nd Value:  
Value Percent: **10.000**  
Continuous Index:  
Within 8" of Joint: **YES**  
Remarks:

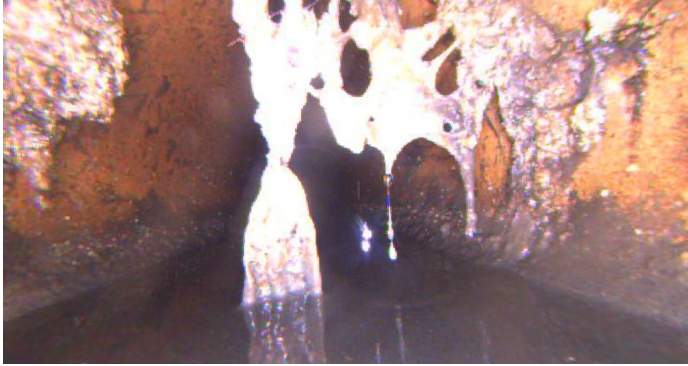
Code:	<b>MSA</b>
Description:	<b>Abandoned Survey</b>
Distance (ft):	<b>40.3</b>
Structural Grade:	<b>0</b>
O&M Grade:	<b>0</b>
Clock Start/From:	
Clock To:	
1st Value:	
2nd Value:	
Value Percent:	
Continuous Index:	
Within 8" of Joint:	<b>NO</b>
Remarks:	<b>DAZ</b>
