Profile/Photo Observation Report

| Street: | FOXCROFT STREET | Flow Control: | Not Controlled |
| City: | Hobart, IN | Year Renewed: | |
| US MH: | M-505-067 | DS MH: | M-505-066 |

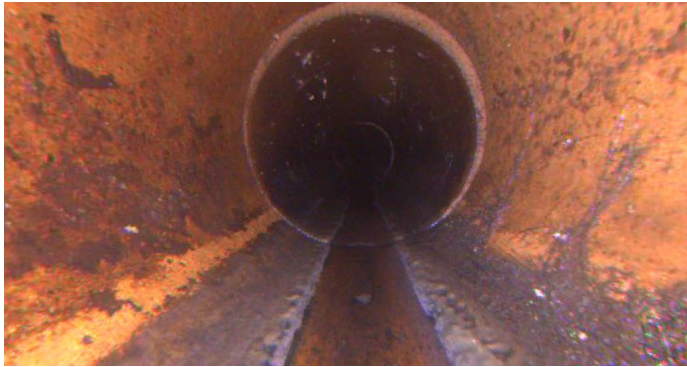
Code: **MWL**
Description: **Water Level**

Distance (ft): **.0**
Structural Grade: **0**
O&M Grade: **0**
Clock Start/From:
Clock To:
1st Value:
2nd Value:
Value Percent: **10.000**
Continuous Index:
Within 8" of Joint: **NO**
Remarks:

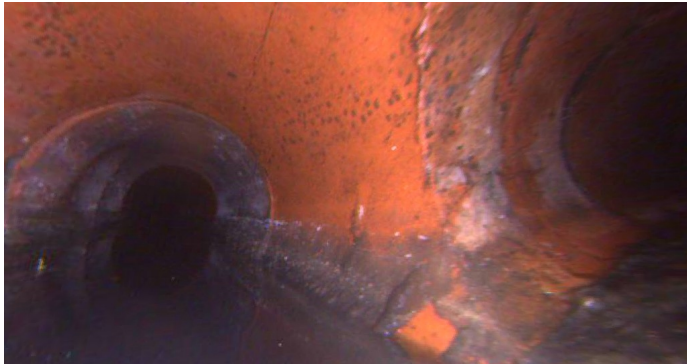
Code: **TF**
Description: **Tap Factory**

Distance (ft): **24.9**
Structural Grade: **0**
O&M Grade: **0**
Clock Start/From: **4**
Clock To:
1st Value: **4.000**
2nd Value:
Value Percent:
Continuous Index:
Within 8" of Joint:
Remarks:

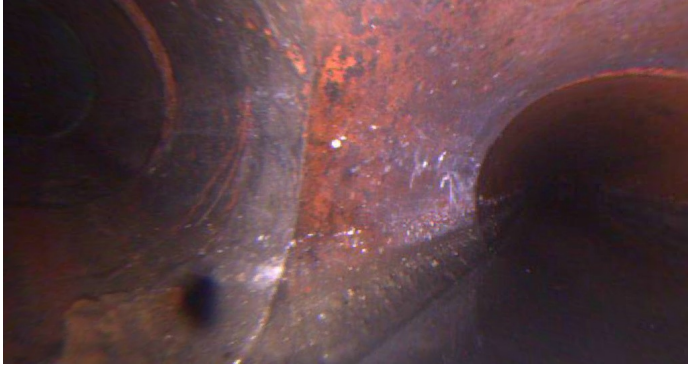
Code: **TF**
Description: **Tap Factory**

Distance (ft): **27.1**
Structural Grade: **0**
O&M Grade: **0**
Clock Start/From: **8**
Clock To:
1st Value: **4.000**
2nd Value:
Value Percent:
Continuous Index:
Within 8" of Joint:
Remarks:

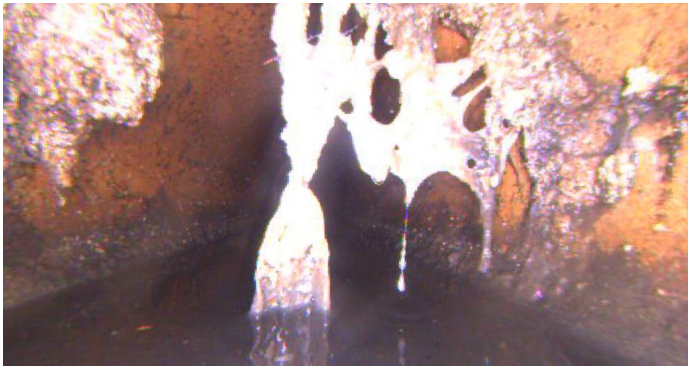
Code: **DAZ**
Description: **Deposits Attached Other**

Distance (ft): **40.2**
Structural Grade: **0**
O&M Grade: **2**
Clock Start/From: **7**
Clock To: **5**
1st Value:
2nd Value:
Value Percent: **10.000**
Continuous Index:
Within 8" of Joint: **YES**
Remarks:

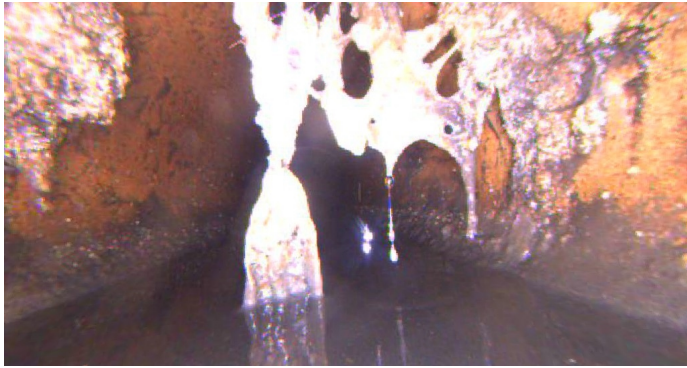
| Code: | MSA |
| Description: | Abandoned Survey |
| Distance (ft): | 40.3 |
| Remarks: | DAZ |
