Profile/Photo Observation Report

Date: 11/07/2021 Weather: **PACP 7.0** Coding: Pipe Length (ft): 259.9 Owner: **City of Hobart** Pre Clean: **Heavy Cleaning** P.O.#: Surveyor: Steven Bucklin PSR: P-505-066-067 YES502259

Street: West 2nd Street Flow Control: Not Controlled

US MH: M-505-067 DS MH: M-505-066 Total Length Surveyed (ft): 259.9

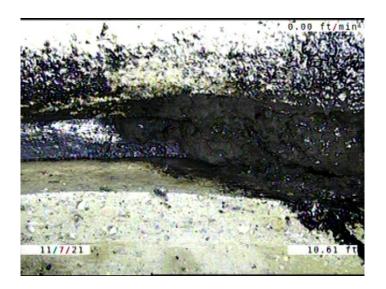
Code: DAE

Description: Deposits Attached Encrustation

Distance (ft): 10.6
Structural Grade: 0
O&M Grade: 2
Clock Start/From: 12
Clock To: 4

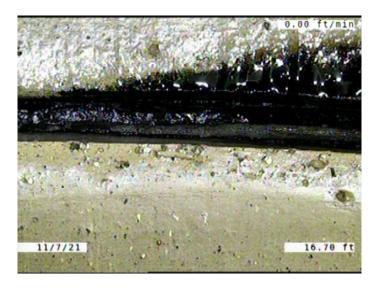
Code: ISJ

Description: Infiltration Stain Joint

Distance (ft): 16.7
Structural Grade: 0
O&M Grade: 1
Clock Start/From: 1
Clock To: 4
1st Value:
2nd Value:
Value Percent:
Continuous Index:

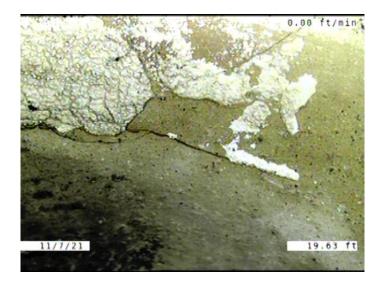
Code: FS

Description: **Fracture Spiral**

Distance (ft): 19.6 Structural Grade: 3 0 O&M Grade: Clock Start/From: 1 Clock To: 3

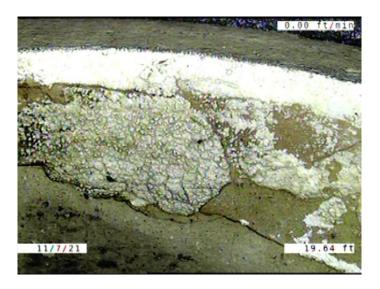
Code: DAE

Description: **Deposits Attached Encrustation**

Distance (ft): 19.6 Structural Grade: 0 O&M Grade: 2 Clock Start/From: 1 Clock To: 3 1st Value: 2nd Value:

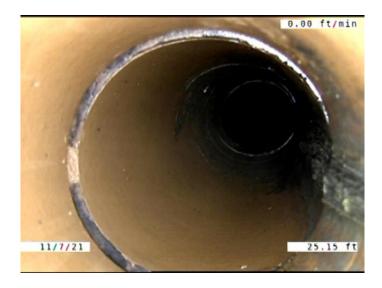
Code: **TF**

Description: Tap Factory

Remarks: ROOTS GROWING INTO THE MAIN

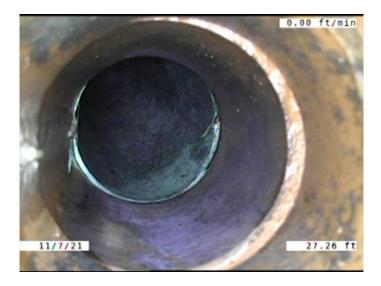
Code: **TF**

Description: Tap Factory

Remarks: CONSTANTLY RUNNING WATER.

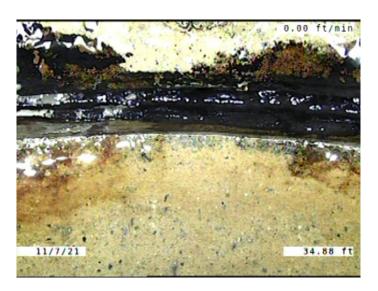
Code: IRJ

Description: Infiltration Runner Joint

Distance (ft): 34.9
Structural Grade: 0
O&M Grade: 4
Clock Start/From: 12

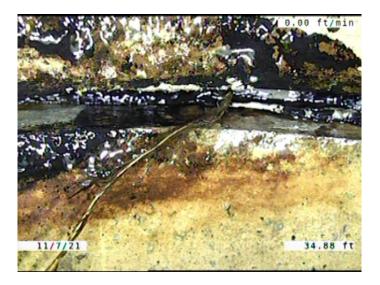
Code: RFJ

Description: Roots Fine Joint

O&M Grade: 1

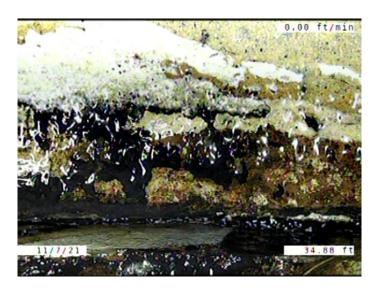
Code: DAE

Description: Deposits Attached Encrustation

O&M Grade: 2

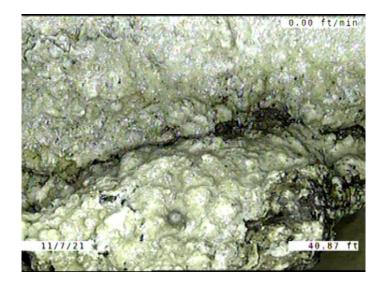
Code: DAE

Description: Deposits Attached Encrustation

Distance (ft): 40.9
Structural Grade: 0
O&M Grade: 2
Clock Start/From: 8
Clock To: 3

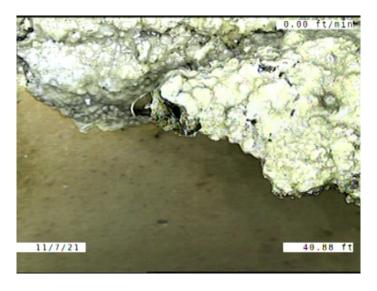
Code: IWJ

Description: Infiltration Weeper Joint

O&M Grade: 2

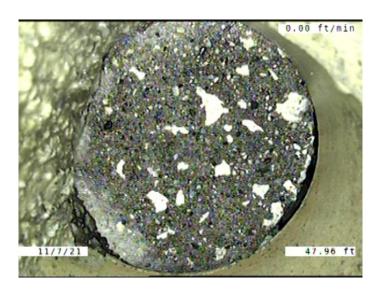
Code: TFC

Description: Tap Factory Capped

Remarks: ENCUSTATION AROUND THE CAP

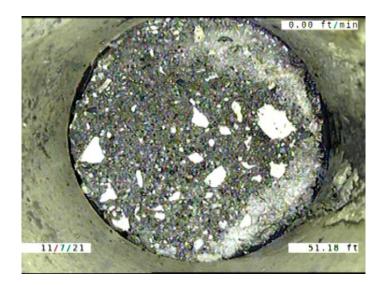
Code: **TFC**

Description: Tap Factory Capped

Remarks: ENCRUSTATION AROUND THE CAP.
LOOKS TO BE DRIPPING WATER

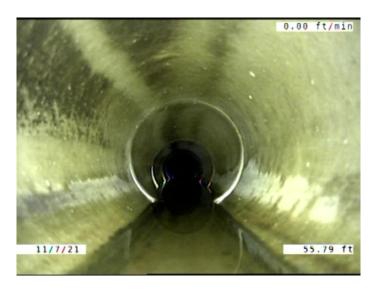
Code: DAE

Description: Deposits Attached Encrustation

O&M Grade: 2

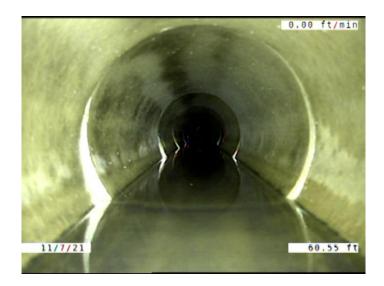
Code: **MWLS**

Description: **Miscellaneous Water Level Sag**

Distance (ft): 60.6 Structural Grade: 2 0 O&M Grade:

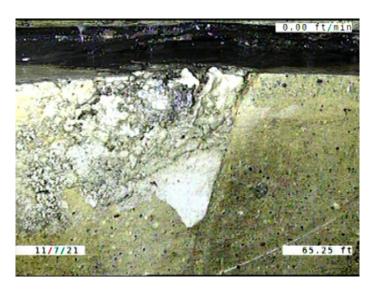
Code: DAE

Description: **Deposits Attached Encrustation**

Distance (ft): 65.3 Structural Grade: 0 O&M Grade: 2 Clock Start/From: 9 Clock To:

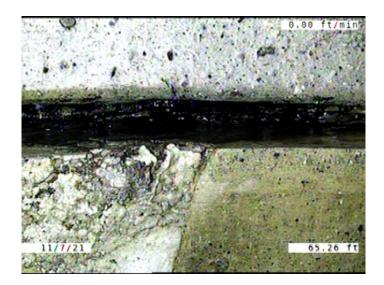
Code: IWJ

Description: Infiltration Weeper Joint

O&M Grade: 2

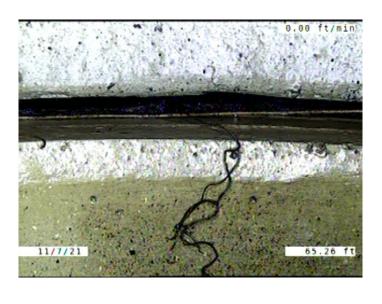
Code: RFJ

Description: Roots Fine Joint

Distance (ft): 65.3
Structural Grade: 0
O&M Grade: 1
Clock Start/From: 10
Clock To: 12
1st Value:
2nd Value:
Value Percent:
Continuous Index:

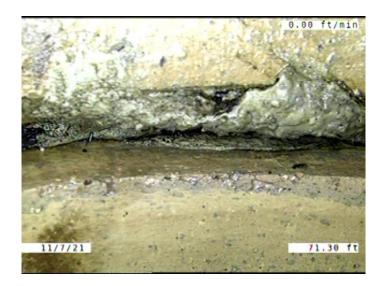
Code: DAE

Description: Deposits Attached Encrustation

Distance (ft): 71.3
Structural Grade: 0
O&M Grade: 2
Clock Start/From: 9
Clock To: 3

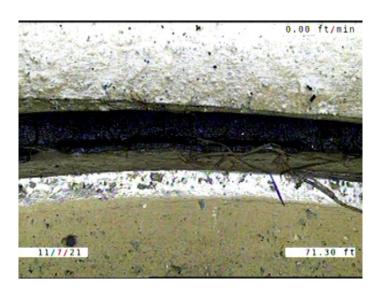
Code: RFJ

Description: Roots Fine Joint

Distance (ft): 71.3
Structural Grade: 0
O&M Grade: 1
Clock Start/From: 11
Clock To: 1
1st Value:
2nd Value:
Value Percent:
Continuous Index:

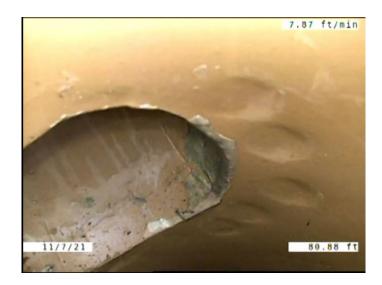
Code: SZ

Description: Surface Damage Other

Remarks: Indentations. Factory defect.

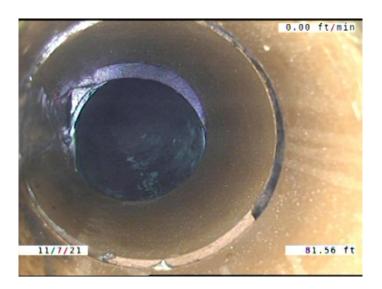
Code: TF

Description: Tap Factory

Remarks: CONSTANTLY RUNNING WATER.

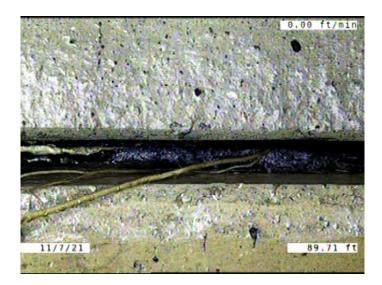
Code: RFJ

Description: Roots Fine Joint

O&M Grade: 1

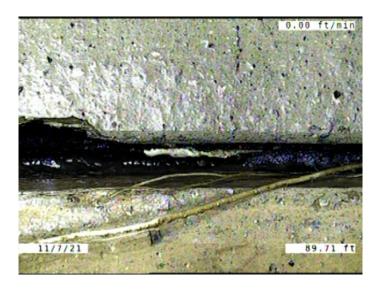
Code: IRJ

Description: Infiltration Runner Joint

Distance (ft): 89.7
Structural Grade: 0
O&M Grade: 4
Clock Start/From: 10

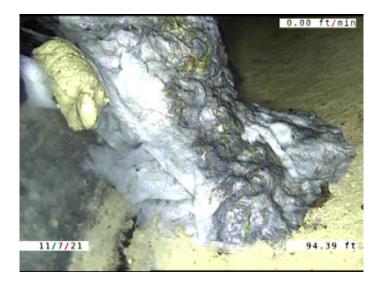
Code: DAR

Description: Deposits Attached Ragging

Distance (ft): 94.4
Structural Grade: 0
O&M Grade: 2
Clock Start/From: 4
Clock To: 5

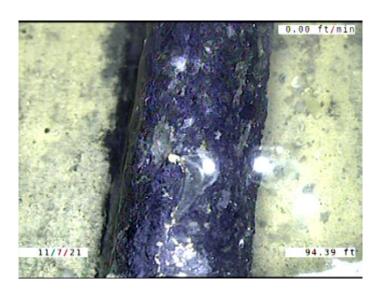
Code: OBN

Description: Obstruction Construction Debris

Within 8" of Joint: YES
Remarks: REBAR

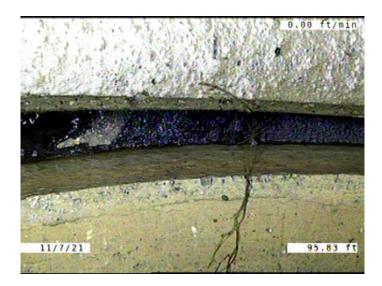
Code: RFJ

Description: Roots Fine Joint

Distance (ft): 95.8
Structural Grade: 0
O&M Grade: 1
Clock Start/From: 10
Clock To: 1

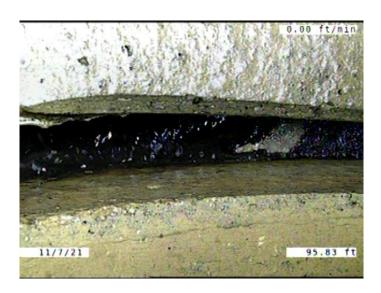
Code: IRJ

Description: Infiltration Runner Joint

Distance (ft): 95.8
Structural Grade: 0
O&M Grade: 4
Clock Start/From: 9
Clock To:

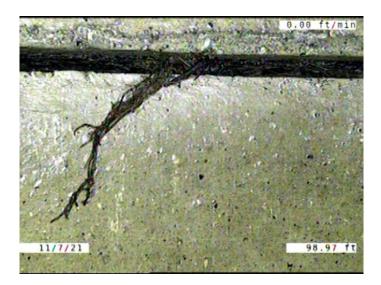
Code: RFJ

Description: **Roots Fine Joint**

Distance (ft): 99.0 Structural Grade: 0 O&M Grade: 1 Clock Start/From: 10 Clock To: 11

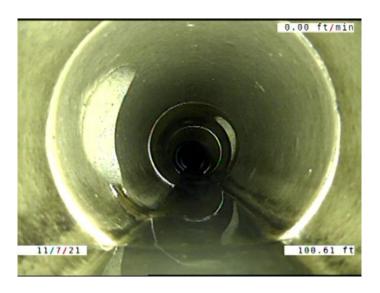
Code: **MWLS**

Description: **Miscellaneous Water Level Sag**

Distance (ft): 100.6 Structural Grade: 2 O&M Grade: 0

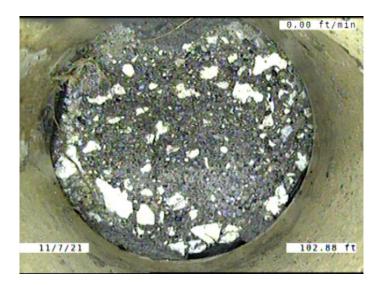
Code: TFC

Description: Tap Factory Capped

Remarks: CAP LOOKS TO BE BREAKING DOWN.
ROOTS GROWING AROUND THE CAP

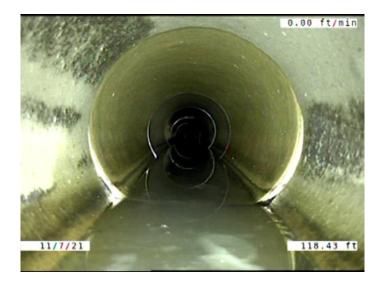
Code: MWLS

Description: Miscellaneous Water Level Sag

Distance (ft): 118.4
Structural Grade: 2
O&M Grade: 0

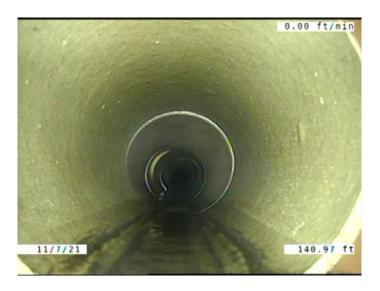
Code: **MWLS**

Description: **Miscellaneous Water Level Sag**

Distance (ft): 141.0 Structural Grade: 2 O&M Grade: 0

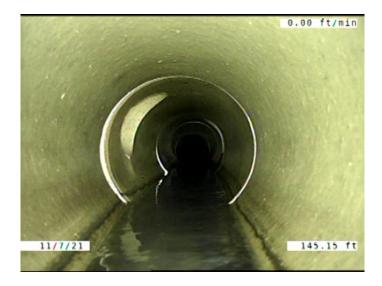
Code: MWLS

Description: Miscellaneous Water Level Sag

Distance (ft): 145.2
Structural Grade: 2
O&M Grade: 0

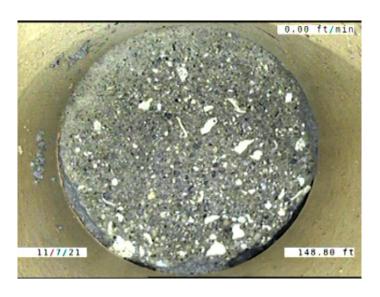
Code: TFC

Description: Tap Factory Capped

Remarks: CAP LOOKS TO BE BREAKING DOWN

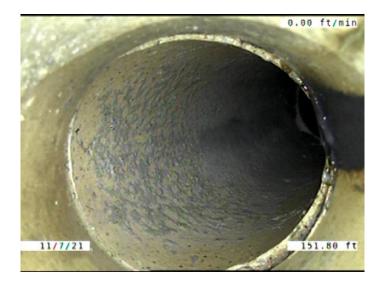
Code: TF

Description: **Tap Factory**

Remarks: **CONSTANTLY RUNNING WATER.**

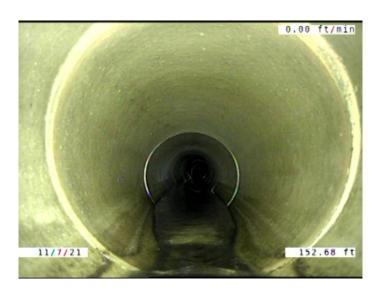
Code: **MWLS**

Description: **Miscellaneous Water Level Sag**

Distance (ft): 152.7 Structural Grade: 2 O&M Grade: 0

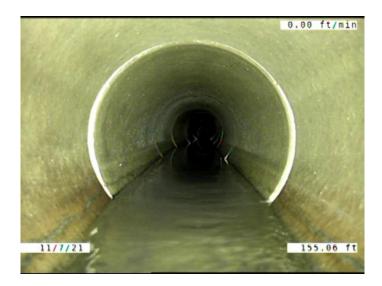
Code: **MWLS**

Description: **Miscellaneous Water Level Sag**

Distance (ft): 155.1 Structural Grade: 2 0 O&M Grade:

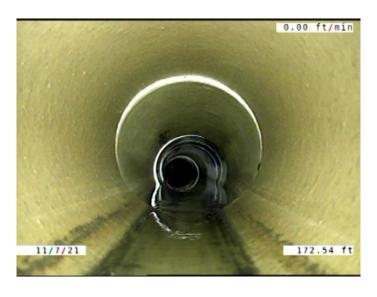
Code: **MWLS**

Description: **Miscellaneous Water Level Sag**

Distance (ft): 172.5 Structural Grade: 2 O&M Grade: 0

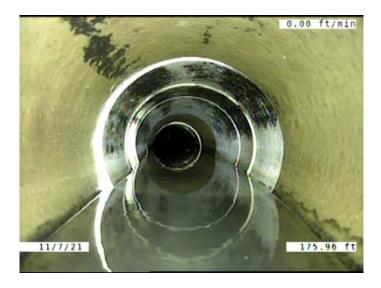
Code: MWLS

Description: Miscellaneous Water Level Sag

Distance (ft): 176.0
Structural Grade: 3
O&M Grade: 0

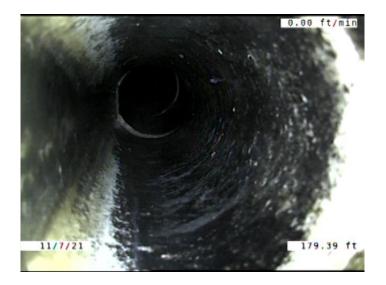
Code: TF

Description: **Tap Factory**

Remarks: **CONSTANTLY RUNNING WATER.**

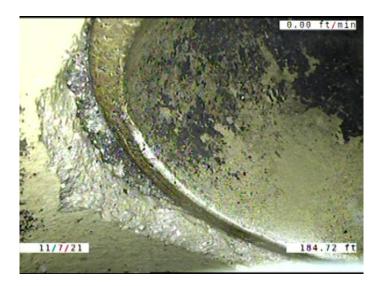
Code: SSS

Description: Surface Damage Surface Spalling

Distance (ft): 184.7
Structural Grade: 2
O&M Grade: 0
Clock Start/From: 12
Clock To: 2

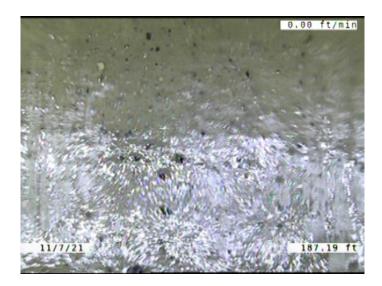
Code: MCU

Description: Miscellaneous Camera Underwater

Distance (ft): 187.2
Structural Grade: 0
O&M Grade: 4

Remarks: Out at 189.6

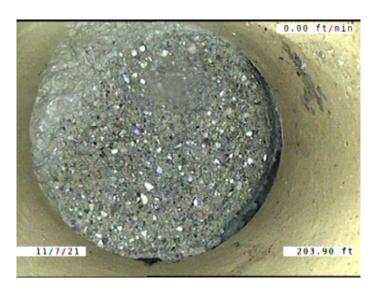
Code: **TFD**

Description: Tap Factory Defective

Distance (ft): 203.9
Structural Grade: 0
O&M Grade: 3
Clock Start/From: 10

Remarks: CAPPED. SOIL VISIBLE ARUND THAT

CAP

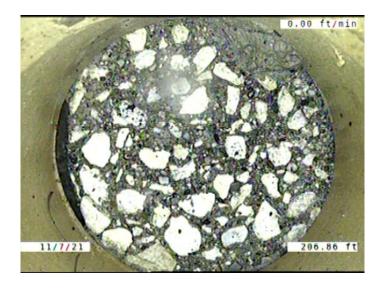
Code: **TFD**

Description: **Tap Factory Defective**

Distance (ft): 206.9 Structural Grade: 0 O&M Grade: 3 Clock Start/From: 2

Remarks: **CAPPED. SOIL VISIBLE ARUND THAT**

CAP

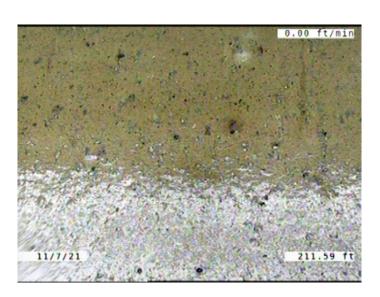
MCU Code:

Description: **Miscellaneous Camera Underwater**

Distance (ft): 211.6 Structural Grade: 0 O&M Grade:

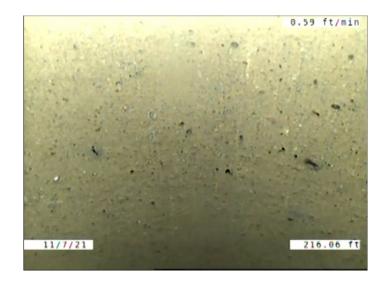
Code: MCU

Description: Miscellaneous Camera Underwater

Distance (ft): 216.1
Structural Grade: 0
O&M Grade: 4

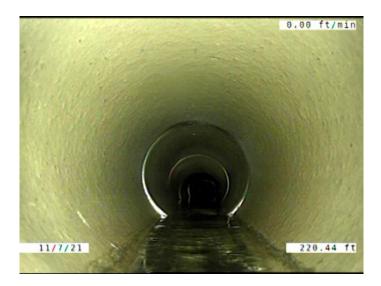
Code: **MWLS**

Description: **Miscellaneous Water Level Sag**

Distance (ft): 220.4 Structural Grade: 3 0 O&M Grade:

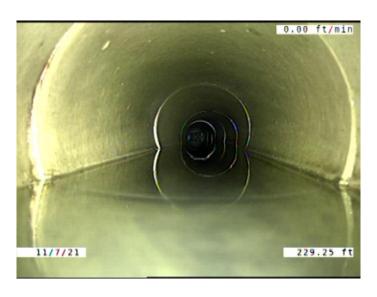
Code: **MWLS**

Description: **Miscellaneous Water Level Sag**

Distance (ft): 229.3 Structural Grade: 2 O&M Grade: 0

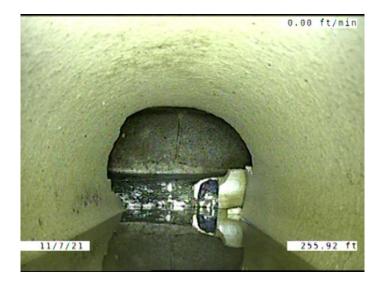
Code: DAE

Description: **Deposits Attached Encrustation**

Distance (ft): 255.9 Structural Grade: 0 2 O&M Grade: Clock Start/From: 9 Clock To: 3

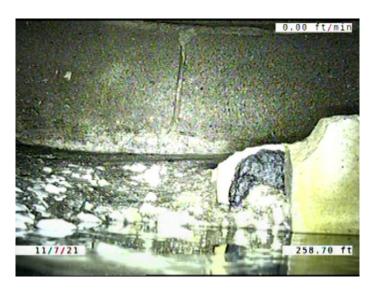
Code: **MWLS**

Description: **Miscellaneous Water Level Sag**

Distance (ft): 258.7 Structural Grade: 2 O&M Grade: 0
