# Profile/Photo Observation Report

Date:	<b>11/07/2021</b>	Weather:		Coding:	<b>PACP 7.0</b>
Pipe Length (ft):	<b>259.9</b>	Owner:	<b>City of Hobart</b>	Pre Clean:	<b>Heavy Cleaning</b>
P.O.#:	<b>YES502259</b>	Surveyor:	<b>Steven Bucklin</b>	PSR:	<b>P-505-066-067</b>
Customer:	<b>City of Hobart, IN (Red</b>	Clean Date:	<b>11/06/2021</b>	Shape:	<b>C</b>

Street:	<b>West 2nd Street</b>	Flow Control:	<b>Not Controlled</b>
City:	<b>City of Hobart</b>	Year Renewed:	
Location:	<b>Alley</b>	Tape/Media #:	
Purpose:	<b>Routine Assessment</b>	Dia/Height:	<b>10"</b>
Use:	<b>Sanitary Sewage Pipe</b>	Material:	<b>VCP</b>
Drain Area:		Lining:	<b>None</b>
Category:	<b>NA</b>		
Comment:			
Location Details:		Direction of Survey:	<b>Downstream</b>
US MH:	<b>M-505-067</b>	DS MH:	<b>M-505-066</b>
		Total Length Surveyed (ft):	<b>259.9</b>

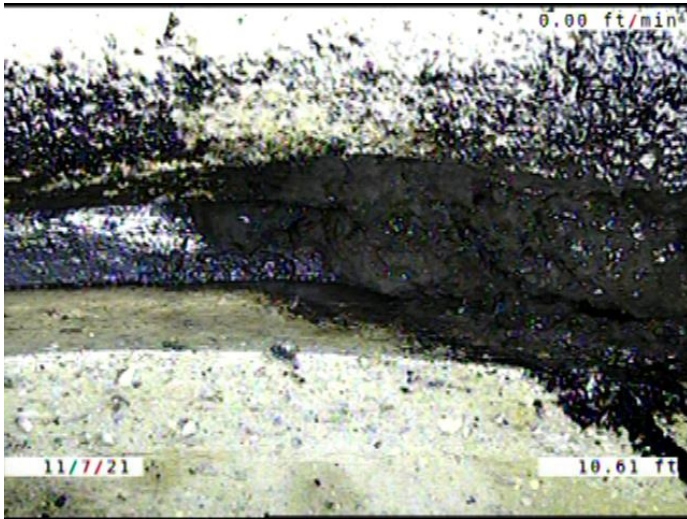
Code: **DAE**  
Description: **Deposits Attached Encrustation**

Distance (ft): **10.6**  
Structural Grade: **0**  
O&M Grade: **2**  
Clock Start/From: **12**  
Clock To: **4**  
1st Value:  
2nd Value:  
Value Percent: **5.000**  
Continuous Index:  
Within 8" of Joint: **YES**  
Remarks:

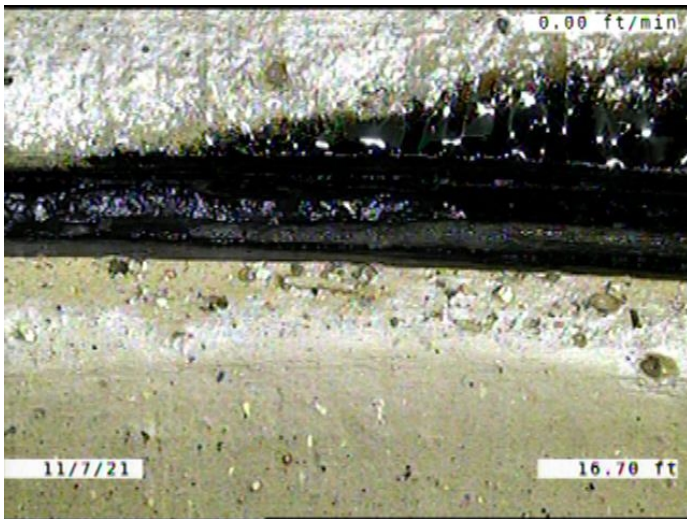
Code: **ISJ**  
Description: **Infiltration Stain Joint**

Distance (ft): **16.7**  
Structural Grade: **0**  
O&M Grade: **1**  
Clock Start/From: **1**  
Clock To: **4**  
1st Value:  
2nd Value:  
Value Percent:  
Continuous Index:  
Within 8" of Joint: **YES**  
Remarks:

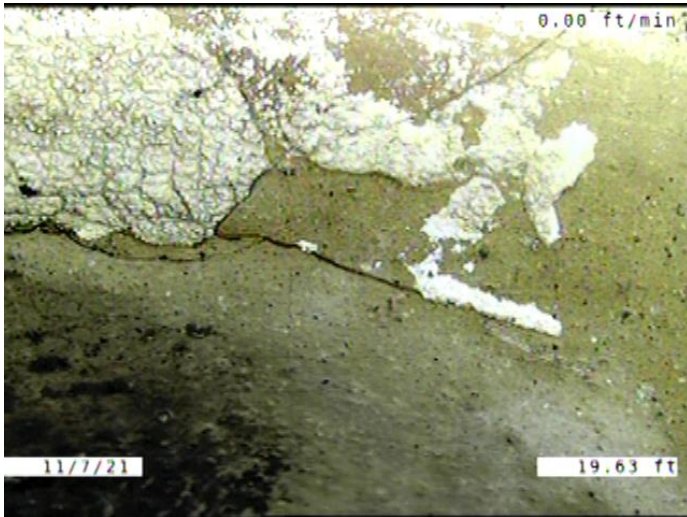
Code: **FS**  
 Description: **Fracture Spiral**

Distance (ft): **19.6**  
 Structural Grade: **3**  
 O&M Grade: **0**  
 Clock Start/From: **1**  
 Clock To: **3**  
 1st Value:  
 2nd Value:  
 Value Percent:  
 Continuous Index:  
 Within 8" of Joint: **YES**  
 Remarks:

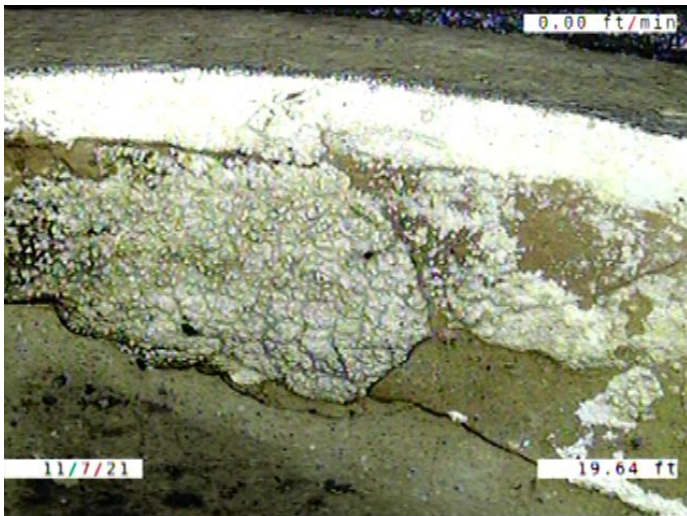
Code: **DAE**  
 Description: **Deposits Attached Encrustation**

Distance (ft): **19.6**  
 Structural Grade: **0**  
 O&M Grade: **2**  
 Clock Start/From: **1**  
 Clock To: **3**  
 1st Value:  
 2nd Value:  
 Value Percent: **5.000**  
 Continuous Index:  
 Within 8" of Joint: **YES**  
 Remarks:

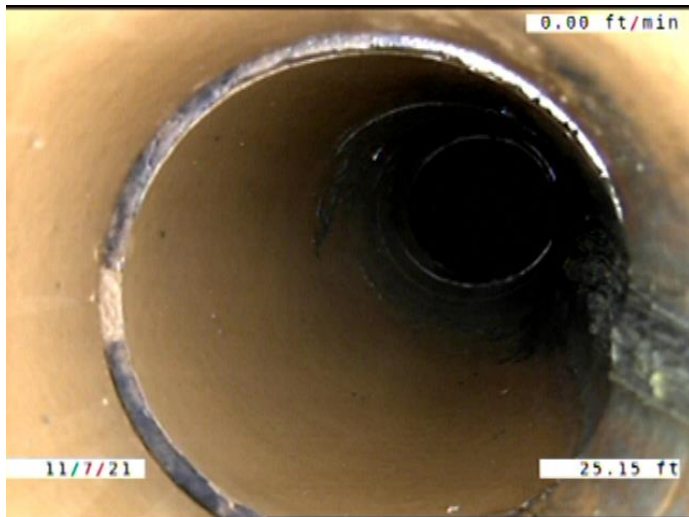
Code:	<b>TF</b>
Description:	<b>Tap Factory</b>
Distance (ft):	<b>25.2</b>
Structural Grade:	<b>0</b>
O&M Grade:	<b>0</b>
Clock Start/From:	<b>2</b>
Clock To:	
1st Value:	<b>4.000</b>
2nd Value:	
Value Percent:	
Continuous Index:	
Within 8" of Joint:	<b>YES</b>
Remarks:	<b>ROOTS GROWING INTO THE MAIN</b>

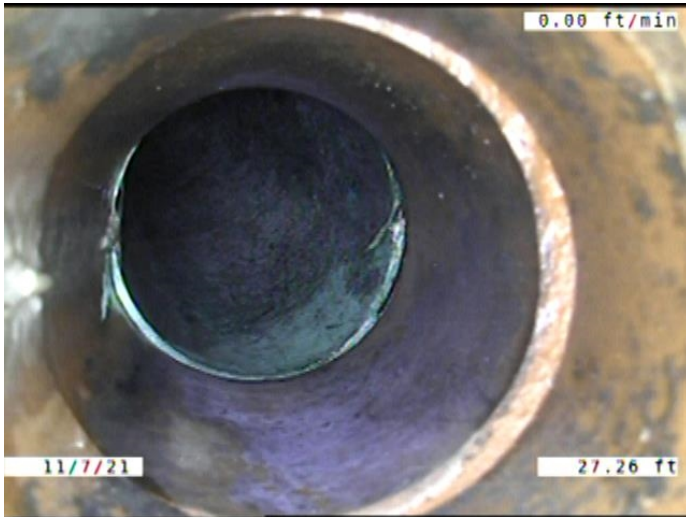
Code: **TF**  
Description: **Tap Factory**

Distance (ft): **27.3**  
Structural Grade: **0**  
O&M Grade: **0**  
Clock Start/From: **10**  
Clock To:  
1st Value: **4.000**  
2nd Value:  
Value Percent:  
Continuous Index:  
Within 8" of Joint: **YES**  
Remarks: **CONSTANTLY RUNNING WATER.**

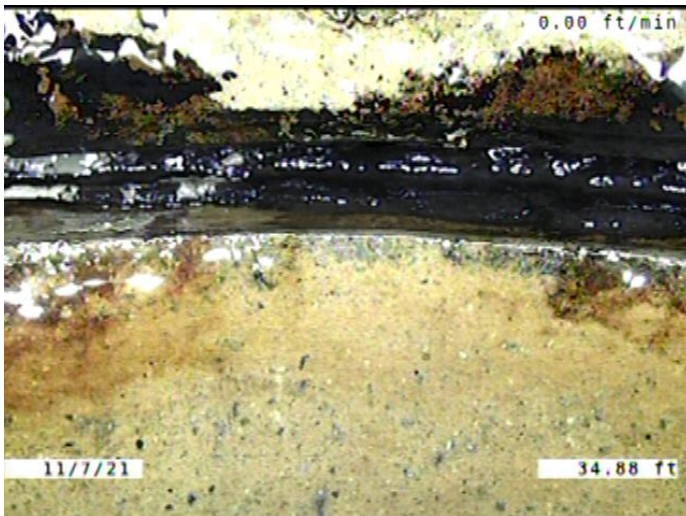
Code: **IRJ**  
Description: **Infiltration Runner Joint**

Distance (ft): **34.9**  
Structural Grade: **0**  
O&M Grade: **4**  
Clock Start/From: **12**  
Clock To:  
1st Value:  
2nd Value:  
Value Percent:  
Continuous Index:  
Within 8" of Joint: **YES**  
Remarks:

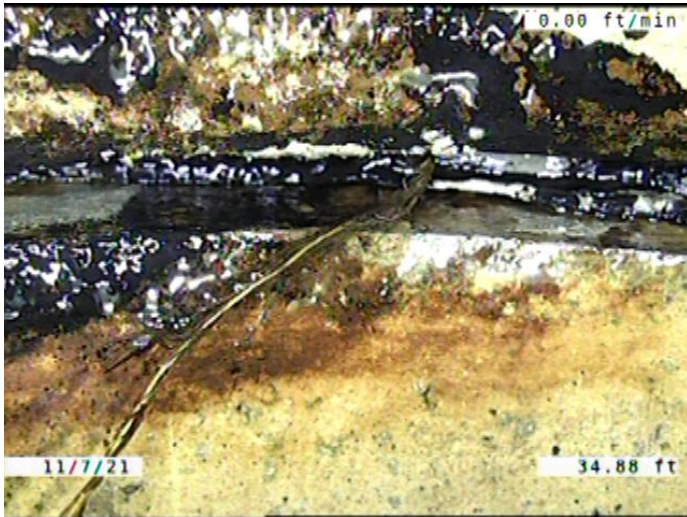
Code: **RFJ**  
 Description: **Roots Fine Joint**

Distance (ft): **34.9**  
 Structural Grade: **0**  
 O&M Grade: **1**  
 Clock Start/From: **11**  
 Clock To:  
 1st Value:  
 2nd Value:  
 Value Percent:  
 Continuous Index:  
 Within 8" of Joint: **YES**  
 Remarks:

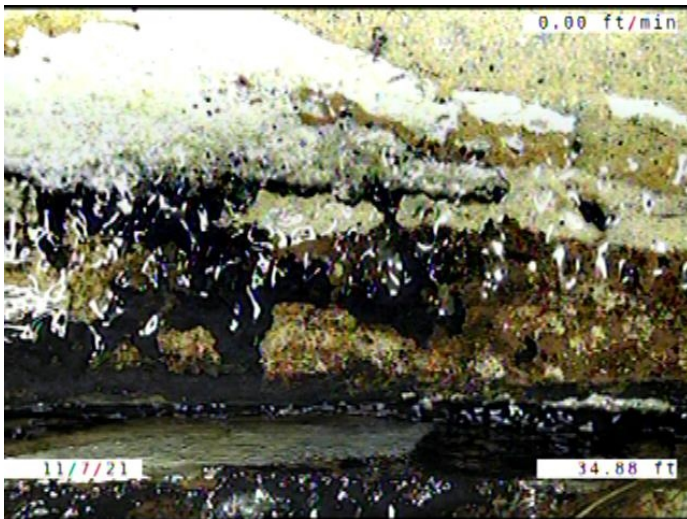
Code: **DAE**  
 Description: **Deposits Attached Encrustation**

Distance (ft): **34.9**  
 Structural Grade: **0**  
 O&M Grade: **2**  
 Clock Start/From: **8**  
 Clock To: **4**  
 1st Value:  
 2nd Value:  
 Value Percent: **5.000**  
 Continuous Index:  
 Within 8" of Joint: **YES**  
 Remarks:

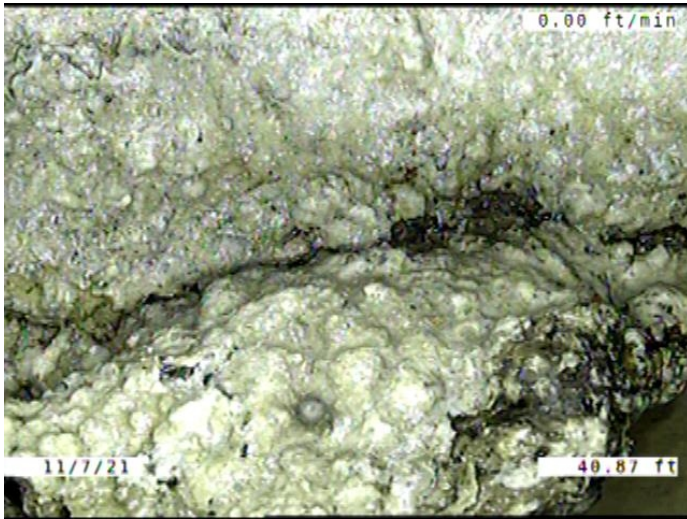
Code: **DAE**  
 Description: **Deposits Attached Encrustation**

Distance (ft): **40.9**  
 Structural Grade: **0**  
 O&M Grade: **2**  
 Clock Start/From: **8**  
 Clock To: **3**  
 1st Value:  
 2nd Value:  
 Value Percent: **5.000**  
 Continuous Index: **S01**  
 Within 8" of Joint: **YES**  
 Remarks:

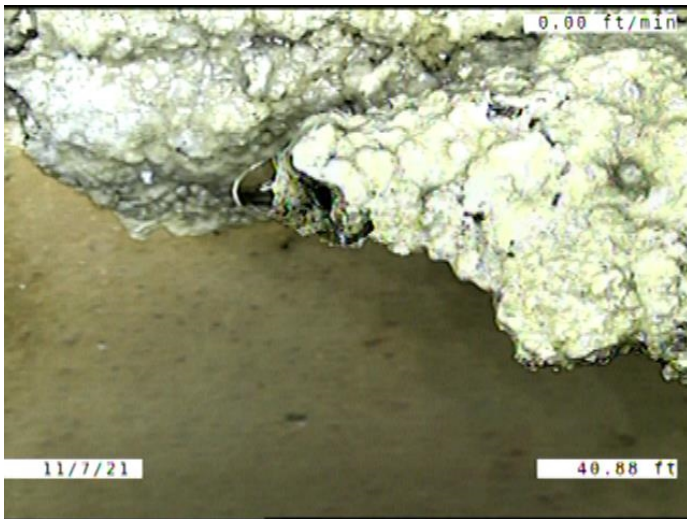
Code: **IWJ**  
 Description: **Infiltration Weeper Joint**

Distance (ft): **40.9**  
 Structural Grade: **0**  
 O&M Grade: **2**  
 Clock Start/From: **10**  
 Clock To:  
 1st Value:  
 2nd Value:  
 Value Percent:  
 Continuous Index:  
 Within 8" of Joint: **YES**  
 Remarks:

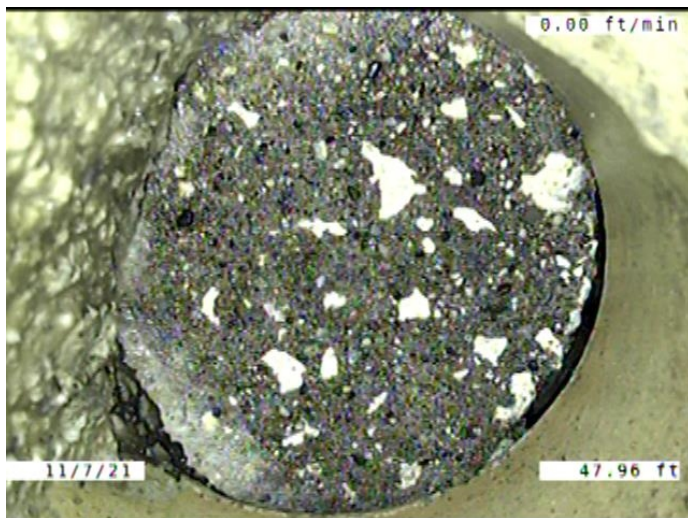
Code: **TFC**  
 Description: **Tap Factory Capped**

Distance (ft): **48.0**  
 Structural Grade: **0**  
 O&M Grade: **0**  
 Clock Start/From: **10**  
 Clock To:  
 1st Value: **4.000**  
 2nd Value:  
 Value Percent:  
 Continuous Index:  
 Within 8" of Joint: **YES**  
 Remarks: **ENCUSTATION AROUND THE CAP**

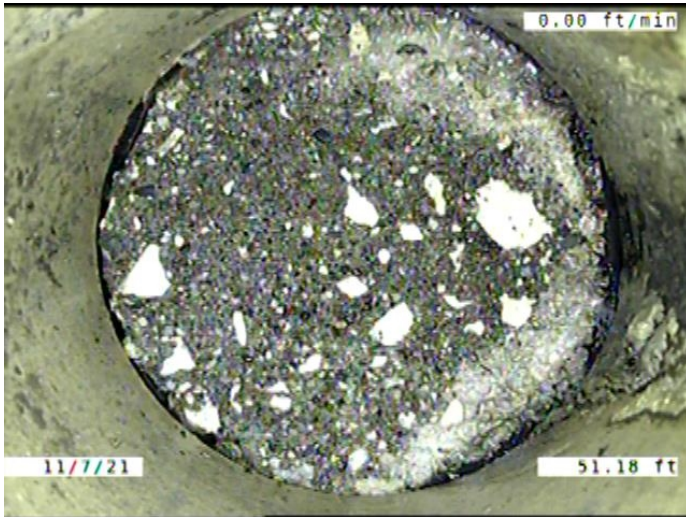
Code: **TFC**  
 Description: **Tap Factory Capped**

Distance (ft): **51.2**  
 Structural Grade: **0**  
 O&M Grade: **0**  
 Clock Start/From: **2**  
 Clock To:  
 1st Value: **4.000**  
 2nd Value:  
 Value Percent:  
 Continuous Index:  
 Within 8" of Joint: **YES**  
 Remarks: **ENCrustATION AROUND THE CAP.  
 LOOKS TO BE DRIPPING WATER**

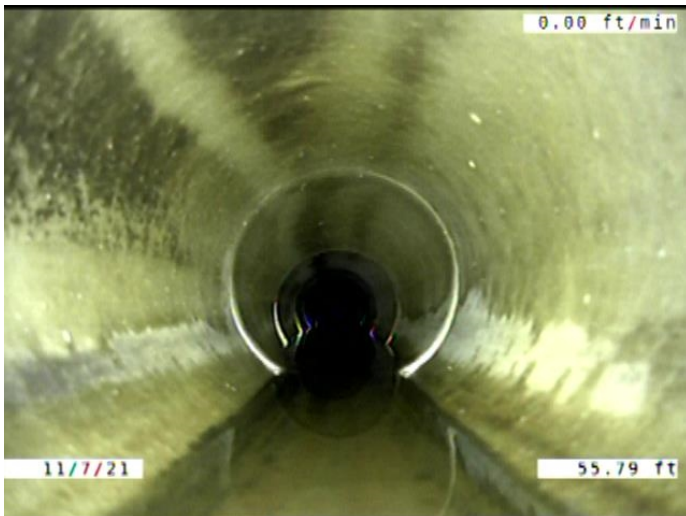
Code: **DAE**  
 Description: **Deposits Attached Encrustation**

Distance (ft): **55.8**  
 Structural Grade: **0**  
 O&M Grade: **2**  
 Clock Start/From: **8**  
 Clock To: **3**  
 1st Value:  
 2nd Value:  
 Value Percent: **5.000**  
 Continuous Index: **F01**  
 Within 8" of Joint: **YES**  
 Remarks:

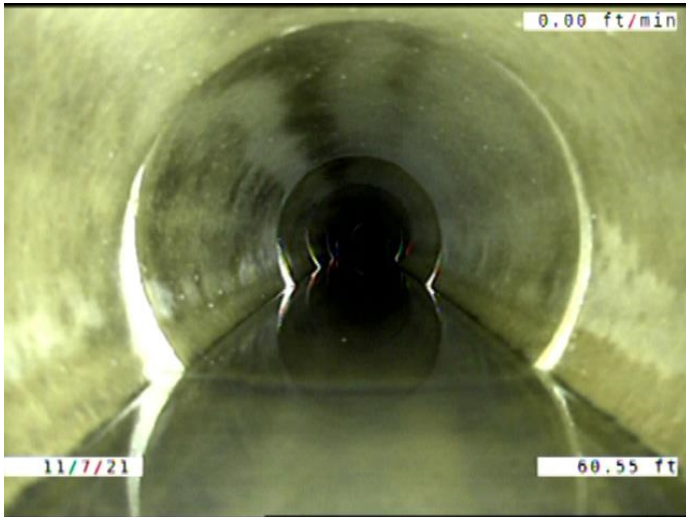
Code: **MWLS**  
 Description: **Miscellaneous Water Level Sag**

Distance (ft): **60.6**  
 Structural Grade: **2**  
 O&M Grade: **0**  
 Clock Start/From:  
 Clock To:  
 1st Value:  
 2nd Value:  
 Value Percent: **10.000**  
 Continuous Index: **S02**  
 Within 8" of Joint: **NO**  
 Remarks:

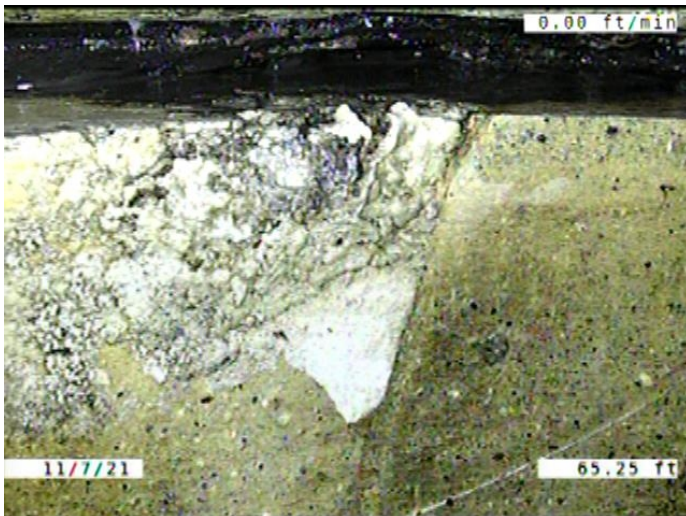
Code: **DAE**  
 Description: **Deposits Attached Encrustation**

Distance (ft): **65.3**  
 Structural Grade: **0**  
 O&M Grade: **2**  
 Clock Start/From: **9**  
 Clock To:  
 1st Value:  
 2nd Value:  
 Value Percent: **5.000**  
 Continuous Index:  
 Within 8" of Joint: **YES**  
 Remarks:

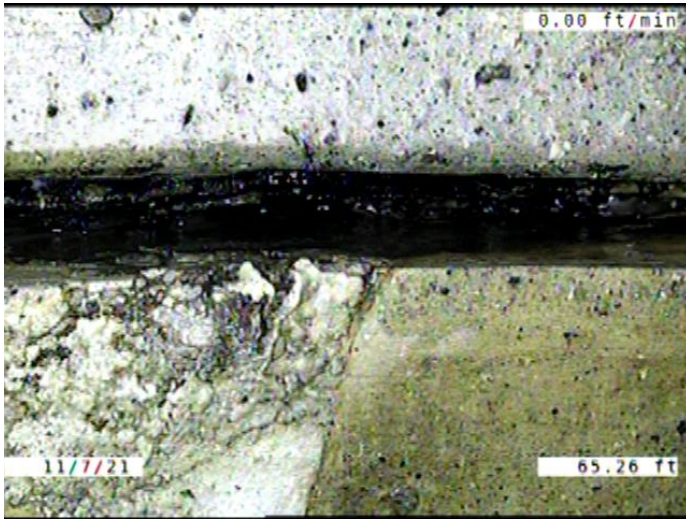
Code: **IWJ**  
 Description: **Infiltration Weeper Joint**

Distance (ft): **65.3**  
 Structural Grade: **0**  
 O&M Grade: **2**  
 Clock Start/From: **9**  
 Clock To:  
 1st Value:  
 2nd Value:  
 Value Percent:  
 Continuous Index:  
 Within 8" of Joint: **YES**  
 Remarks:

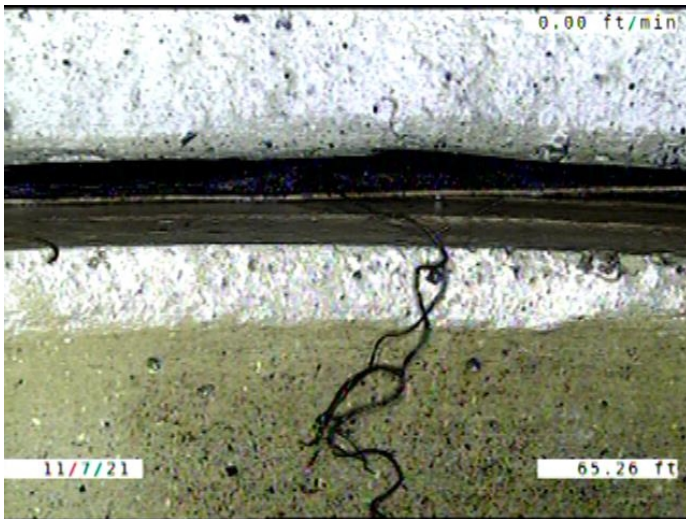
Code: **RFJ**  
 Description: **Roots Fine Joint**

Distance (ft): **65.3**  
 Structural Grade: **0**  
 O&M Grade: **1**  
 Clock Start/From: **10**  
 Clock To: **12**  
 1st Value:  
 2nd Value:  
 Value Percent:  
 Continuous Index:  
 Within 8" of Joint: **YES**  
 Remarks:

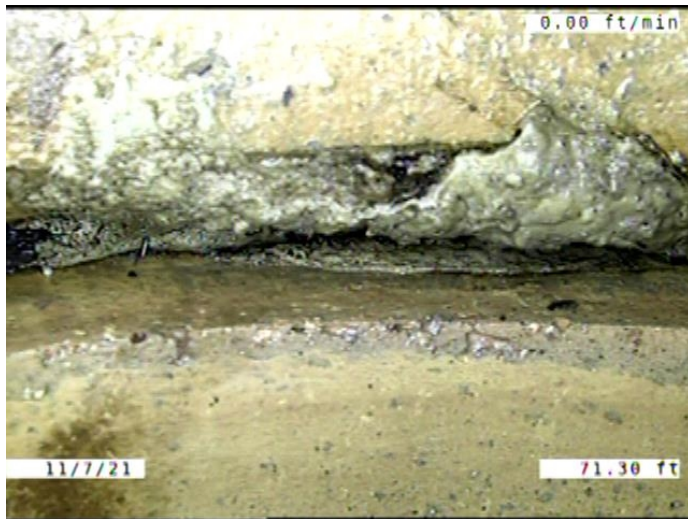
Code: **DAE**  
Description: **Deposits Attached Encrustation**

Distance (ft): **71.3**  
Structural Grade: **0**  
O&M Grade: **2**  
Clock Start/From: **9**  
Clock To: **3**  
1st Value:  
2nd Value:  
Value Percent: **5.000**  
Continuous Index: **S03**  
Within 8" of Joint: **YES**  
Remarks:

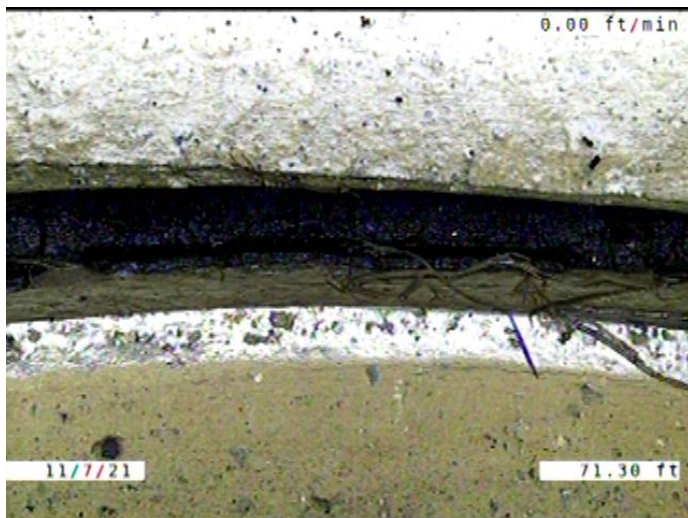
Code: **RFJ**  
Description: **Roots Fine Joint**

Distance (ft): **71.3**  
Structural Grade: **0**  
O&M Grade: **1**  
Clock Start/From: **11**  
Clock To: **1**  
1st Value:  
2nd Value:  
Value Percent:  
Continuous Index:  
Within 8" of Joint: **YES**  
Remarks:

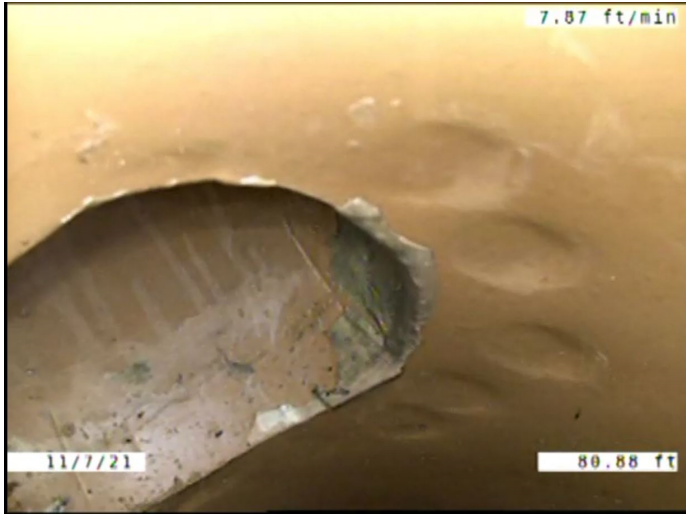
Code: **SZ**  
Description: **Surface Damage Other**

Distance (ft): **80.9**  
Structural Grade: **0**  
O&M Grade: **0**  
Clock Start/From: **10**  
Clock To:  
1st Value:  
2nd Value:  
Value Percent:  
Continuous Index:  
Within 8" of Joint: **NO**  
Remarks: **Indentations. Factory defect.**

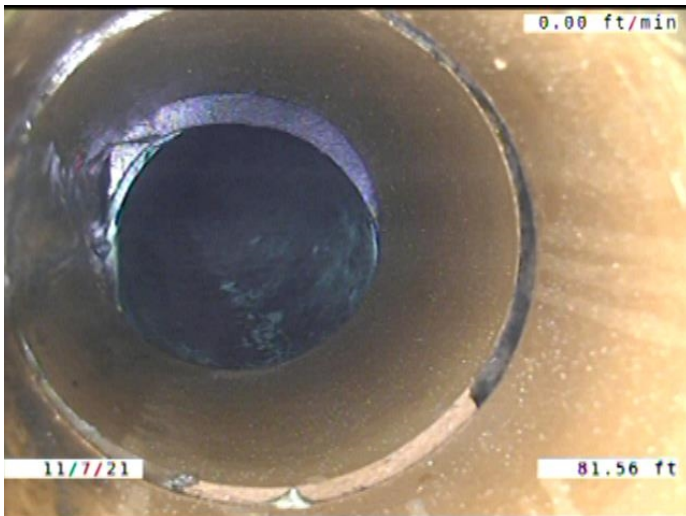
Code: **TF**  
Description: **Tap Factory**

Distance (ft): **81.6**  
Structural Grade: **0**  
O&M Grade: **0**  
Clock Start/From: **10**  
Clock To:  
1st Value: **4.000**  
2nd Value:  
Value Percent:  
Continuous Index:  
Within 8" of Joint: **YES**  
Remarks: **CONSTANTLY RUNNING WATER.**

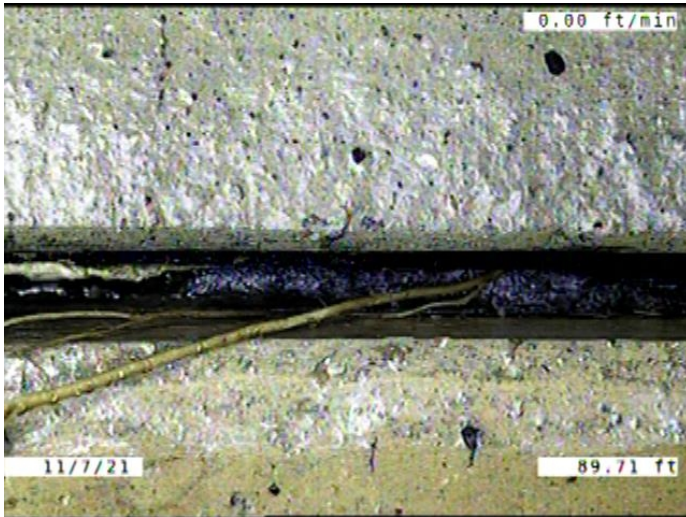
Code: **RFJ**  
 Description: **Roots Fine Joint**

Distance (ft): **89.7**  
 Structural Grade: **0**  
 O&M Grade: **1**  
 Clock Start/From: **10**  
 Clock To: **2**  
 1st Value:  
 2nd Value:  
 Value Percent:  
 Continuous Index:  
 Within 8" of Joint: **YES**  
 Remarks:

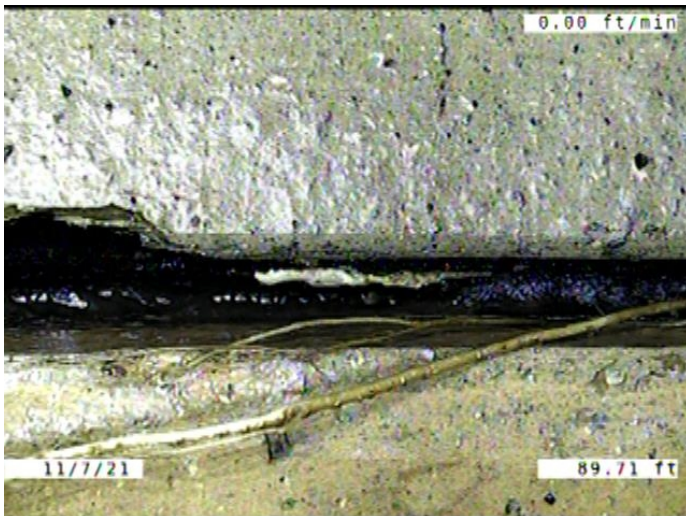
Code: **IRJ**  
 Description: **Infiltration Runner Joint**

Distance (ft): **89.7**  
 Structural Grade: **0**  
 O&M Grade: **4**  
 Clock Start/From: **10**  
 Clock To:  
 1st Value:  
 2nd Value:  
 Value Percent:  
 Continuous Index:  
 Within 8" of Joint: **YES**  
 Remarks:

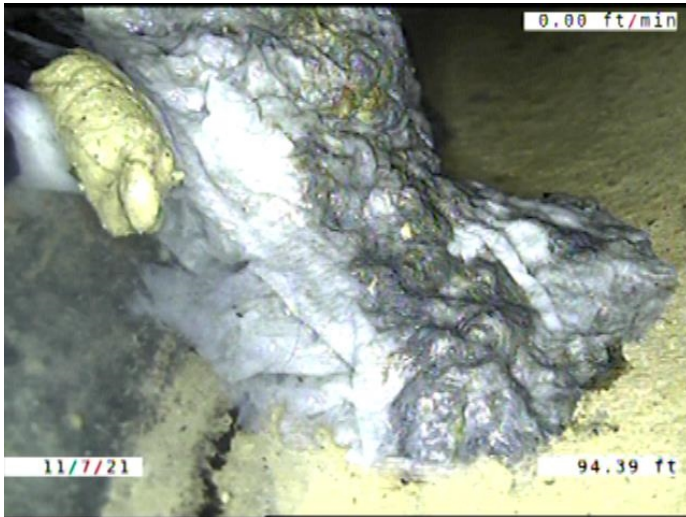
Code:	<b>DAR</b>
Description:	<b>Deposits Attached Ragging</b>
Distance (ft):	<b>94.4</b>
Structural Grade:	<b>0</b>
O&M Grade:	<b>2</b>
Clock Start/From:	<b>4</b>
Clock To:	<b>5</b>
1st Value:	
2nd Value:	
Value Percent:	<b>5.000</b>
Continuous Index:	
Within 8" of Joint:	<b>NO</b>
Remarks:

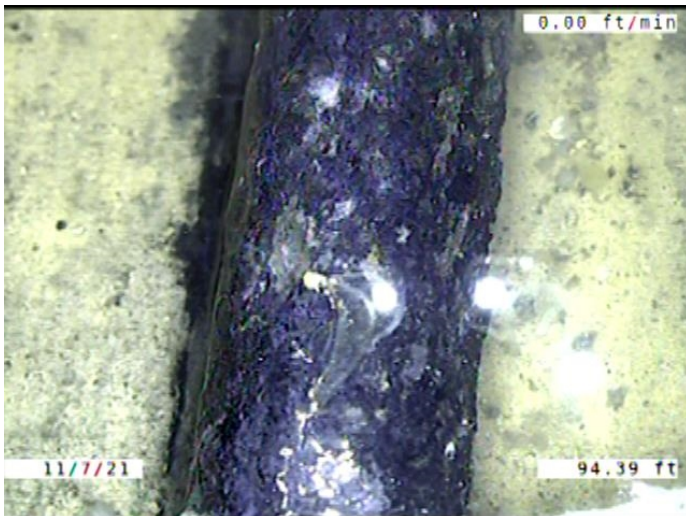
Code:	<b>OBN</b>
Description:	<b>Obstruction Construction Debris</b>
Distance (ft):	<b>94.4</b>
Structural Grade:	<b>0</b>
O&M Grade:	<b>2</b>
Clock Start/From:	<b>6</b>
Clock To:	
1st Value:	
2nd Value:	
Value Percent:	<b>5.000</b>
Continuous Index:	
Within 8" of Joint:	<b>YES</b>
Remarks:	<b>REBAR</b>

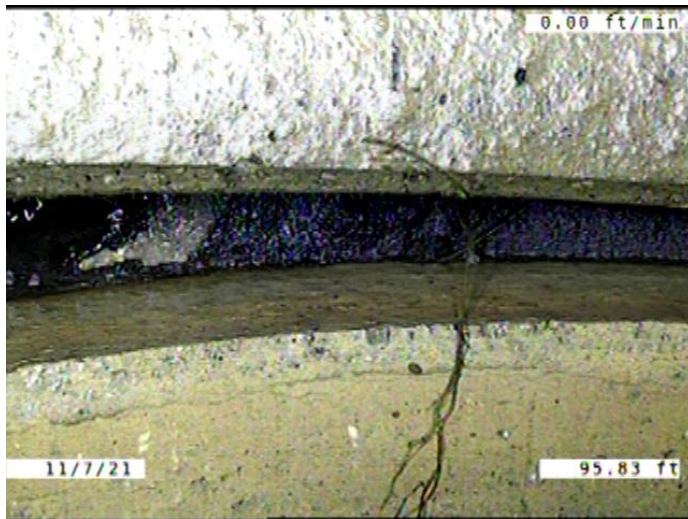
Code: **RFJ**  
Description: **Roots Fine Joint**

Distance (ft): **95.8**  
Structural Grade: **0**  
O&M Grade: **1**  
Clock Start/From: **10**  
Clock To: **1**  
1st Value:  
2nd Value:  
Value Percent:  
Continuous Index:  
Within 8" of Joint: **YES**  
Remarks:

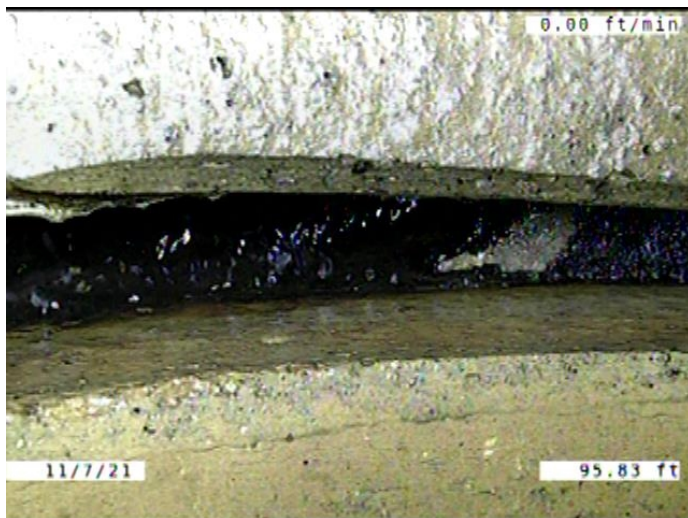
Code: **IRJ**  
Description: **Infiltration Runner Joint**

Distance (ft): **95.8**  
Structural Grade: **0**  
O&M Grade: **4**  
Clock Start/From: **9**  
Clock To:  
1st Value:  
2nd Value:  
Value Percent:  
Continuous Index:  
Within 8" of Joint: **YES**  
Remarks:

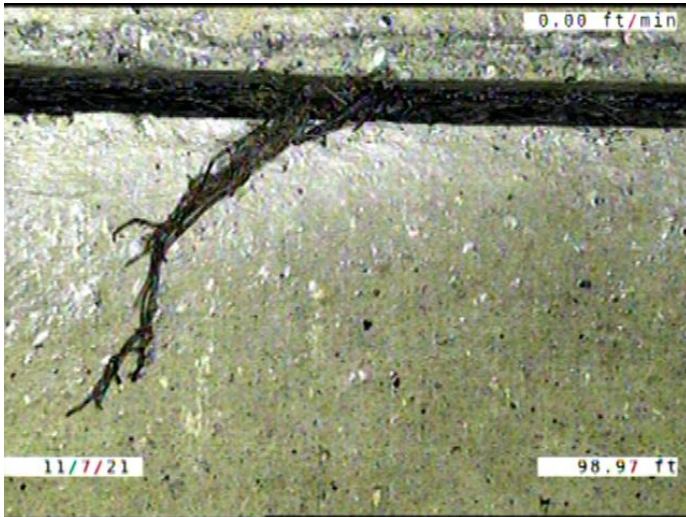
Code: **RFJ**  
 Description: **Roots Fine Joint**

Distance (ft): **99.0**  
 Structural Grade: **0**  
 O&M Grade: **1**  
 Clock Start/From: **10**  
 Clock To: **11**  
 1st Value:  
 2nd Value:  
 Value Percent:  
 Continuous Index:  
 Within 8" of Joint: **YES**  
 Remarks:

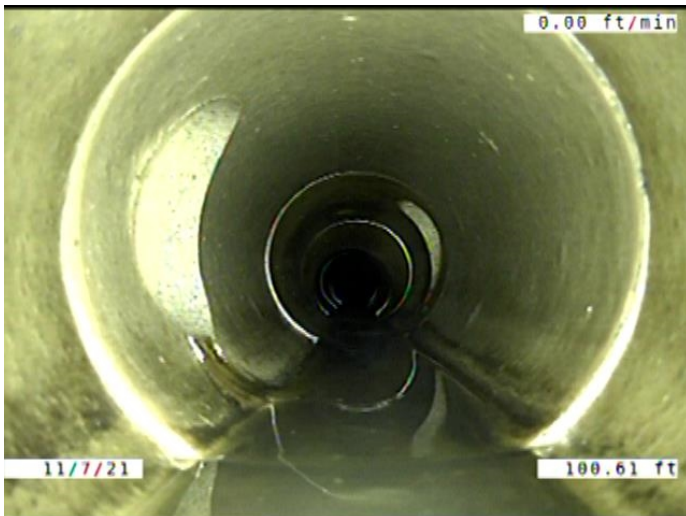
Code: **MWLS**  
 Description: **Miscellaneous Water Level Sag**

Distance (ft): **100.6**  
 Structural Grade: **2**  
 O&M Grade: **0**  
 Clock Start/From:  
 Clock To:  
 1st Value:  
 2nd Value:  
 Value Percent: **10.000**  
 Continuous Index: **F02**  
 Within 8" of Joint: **NO**  
 Remarks:

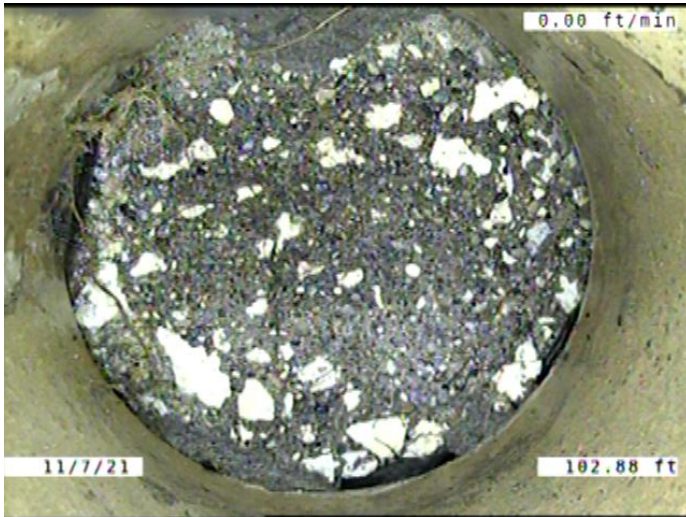
Code:	<b>TFC</b>
Description:	<b>Tap Factory Capped</b>
Distance (ft):	<b>102.9</b>
Structural Grade:	<b>0</b>
O&M Grade:	<b>0</b>
Clock Start/From:	<b>10</b>
Clock To:	
1st Value:	<b>4.000</b>
2nd Value:	
Value Percent:	
Continuous Index:	
Within 8" of Joint:	<b>YES</b>
Remarks:	<b>CAP LOOKS TO BE BREAKING DOWN. ROOTS GROWING AROUND THE CAP</b>

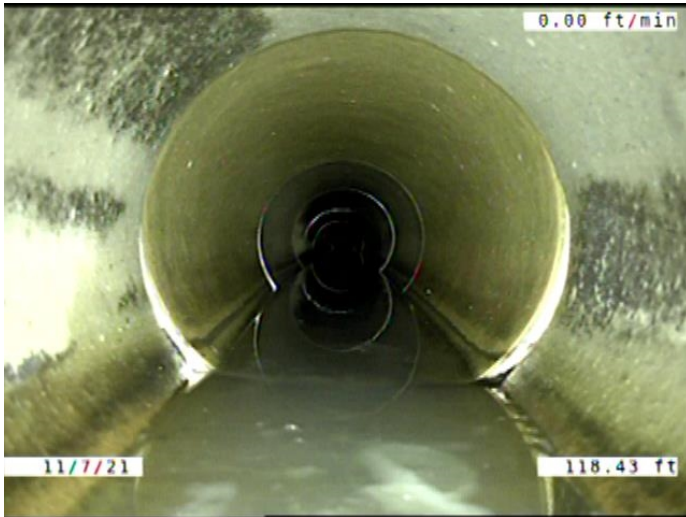
Code: **MWLS**  
Description: **Miscellaneous Water Level Sag**

Distance (ft): **118.4**  
Structural Grade: **2**  
O&M Grade: **0**  
Clock Start/From:  
Clock To:  
1st Value:  
2nd Value:  
Value Percent: **10.000**  
Continuous Index: **S04**  
Within 8" of Joint: **NO**  
Remarks:

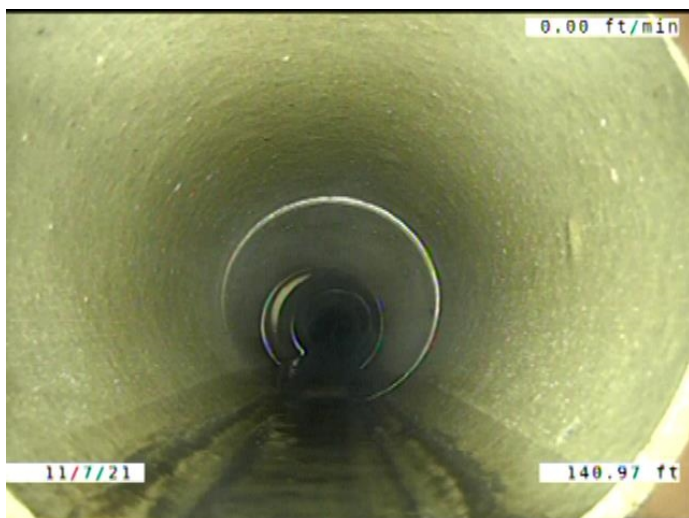
Code: **MWLS**  
 Description: **Miscellaneous Water Level Sag**

Distance (ft): **141.0**  
 Structural Grade: **2**  
 O&M Grade: **0**  
 Clock Start/From:  
 Clock To:  
 1st Value:  
 2nd Value:  
 Value Percent: **10.000**  
 Continuous Index: **F04**  
 Within 8" of Joint: **NO**  
 Remarks:

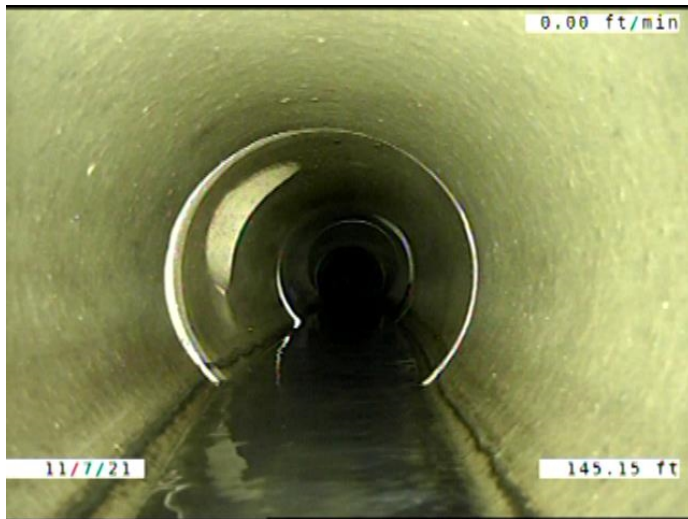
Code: **MWLS**  
 Description: **Miscellaneous Water Level Sag**

Distance (ft): **145.2**  
 Structural Grade: **2**  
 O&M Grade: **0**  
 Clock Start/From:  
 Clock To:  
 1st Value:  
 2nd Value:  
 Value Percent: **10.000**  
 Continuous Index: **S05**  
 Within 8" of Joint: **NO**  
 Remarks:

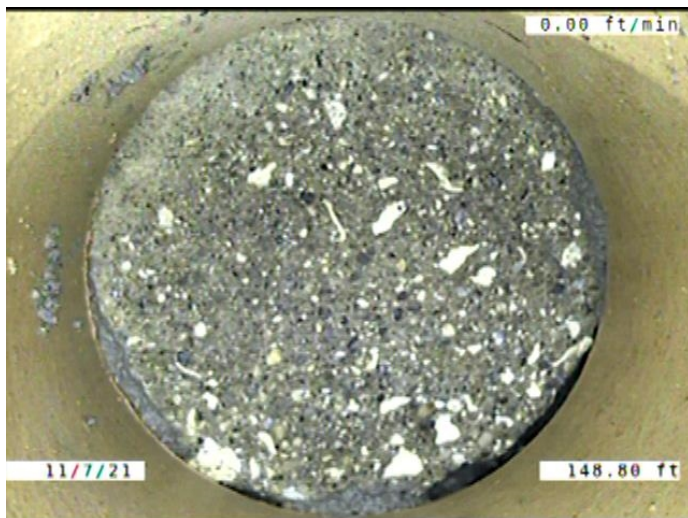
Code: **TFC**  
 Description: **Tap Factory Capped**

Distance (ft): **148.8**  
 Structural Grade: **0**  
 O&M Grade: **0**  
 Clock Start/From: **10**  
 Clock To:  
 1st Value: **4.000**  
 2nd Value:  
 Value Percent:  
 Continuous Index:  
 Within 8" of Joint: **YES**  
 Remarks: **CAP LOOKS TO BE BREAKING DOWN**

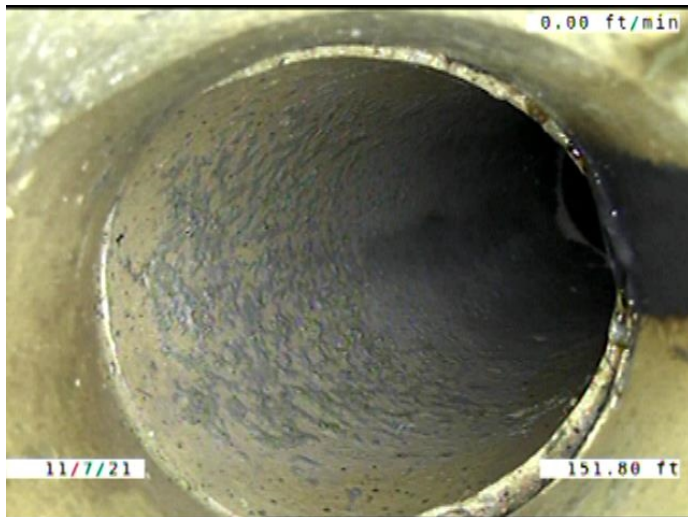
Code: **TF**  
 Description: **Tap Factory**

Distance (ft): **151.8**  
 Structural Grade: **0**  
 O&M Grade: **0**  
 Clock Start/From: **2**  
 Clock To:  
 1st Value: **4.000**  
 2nd Value:  
 Value Percent:  
 Continuous Index:  
 Within 8" of Joint: **YES**  
 Remarks: **CONSTANTLY RUNNING WATER.**

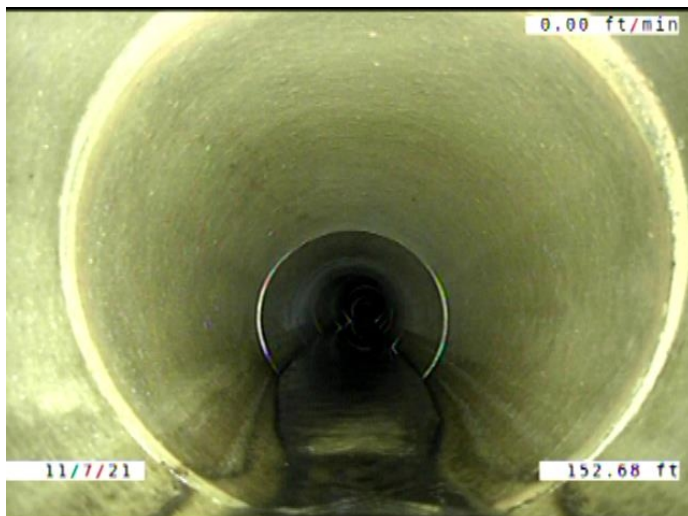
Code: **MWLS**  
 Description: **Miscellaneous Water Level Sag**

Distance (ft): **152.7**  
 Structural Grade: **2**  
 O&M Grade: **0**  
 Clock Start/From:  
 Clock To:  
 1st Value:  
 2nd Value:  
 Value Percent: **10.000**  
 Continuous Index: **F05**  
 Within 8" of Joint: **NO**  
 Remarks:

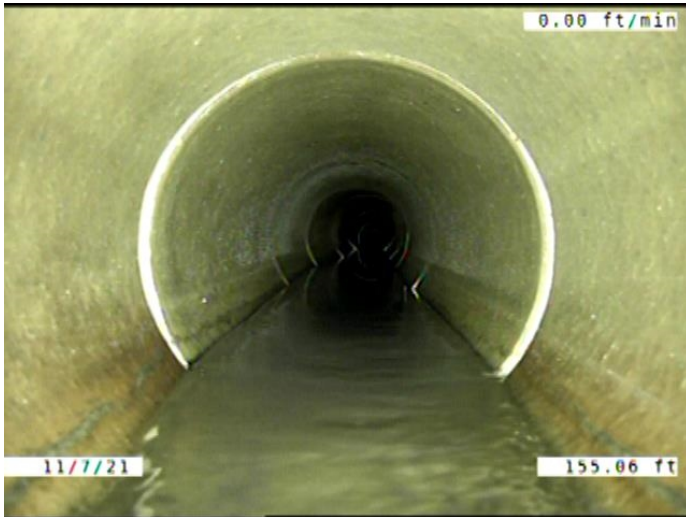
Code: **MWLS**  
Description: **Miscellaneous Water Level Sag**

Distance (ft): **155.1**  
Structural Grade: **2**  
O&M Grade: **0**  
Clock Start/From:  
Clock To:  
1st Value:  
2nd Value:  
Value Percent: **10.000**  
Continuous Index: **S06**  
Within 8" of Joint: **NO**  
Remarks:

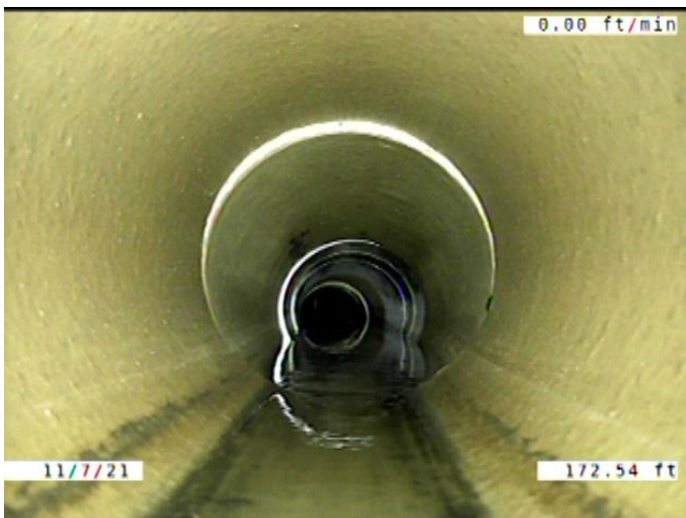
Code: **MWLS**  
Description: **Miscellaneous Water Level Sag**

Distance (ft): **172.5**  
Structural Grade: **2**  
O&M Grade: **0**  
Clock Start/From:  
Clock To:  
1st Value:  
2nd Value:  
Value Percent: **10.000**  
Continuous Index: **F06**  
Within 8" of Joint: **NO**  
Remarks:

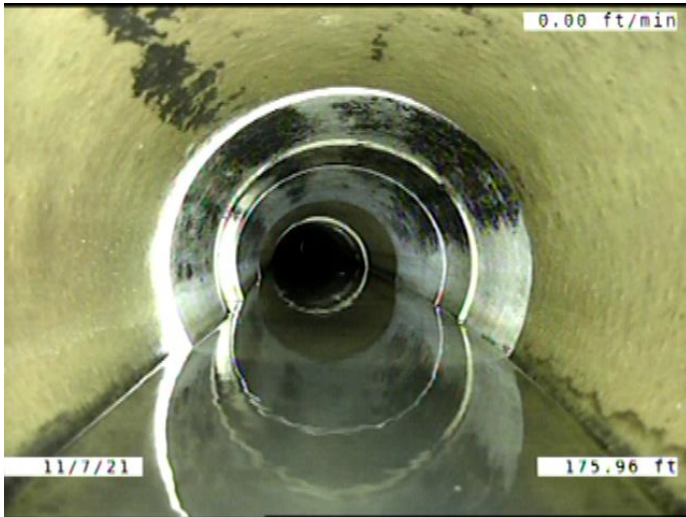
Code: **MWLS**  
 Description: **Miscellaneous Water Level Sag**

Distance (ft): **176.0**  
 Structural Grade: **3**  
 O&M Grade: **0**  
 Clock Start/From:  
 Clock To:  
 1st Value:  
 2nd Value:  
 Value Percent: **35.000**  
 Continuous Index: **S07**  
 Within 8" of Joint: **NO**  
 Remarks:

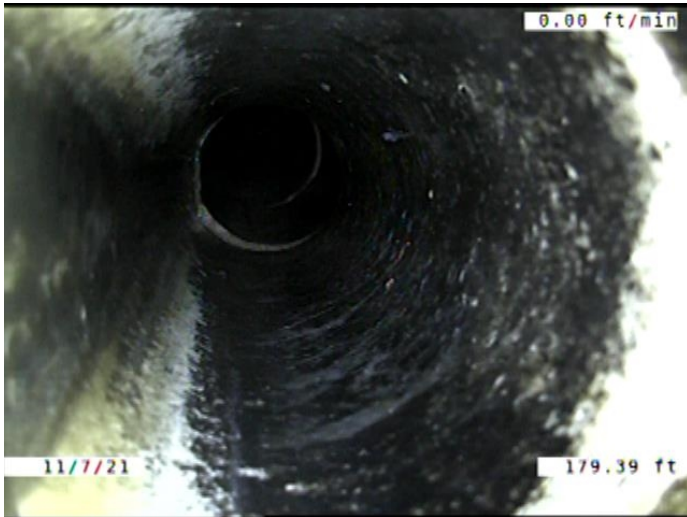
Code: **TF**  
Description: **Tap Factory**

Distance (ft): **179.4**  
Structural Grade: **0**  
O&M Grade: **0**  
Clock Start/From: **9**  
Clock To:  
1st Value: **4.000**  
2nd Value:  
Value Percent:  
Continuous Index:  
Within 8" of Joint: **YES**  
Remarks: **CONSTANTLY RUNNING WATER.**

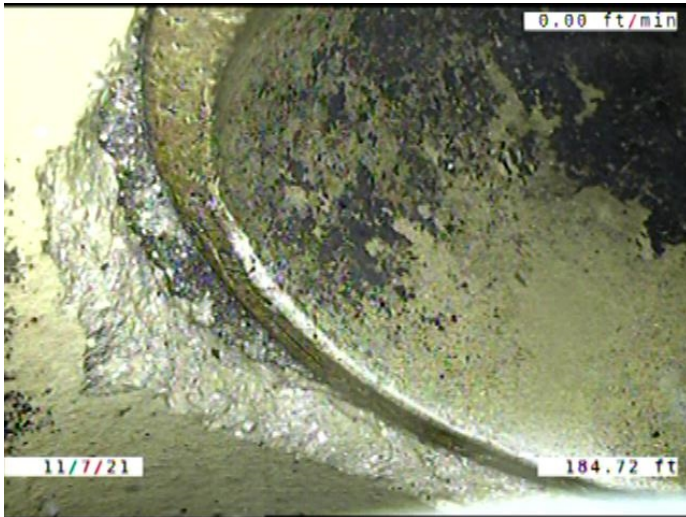
Code: **SSS**  
 Description: **Surface Damage Surface Spalling**

Distance (ft): **184.7**  
 Structural Grade: **2**  
 O&M Grade: **0**  
 Clock Start/From: **12**  
 Clock To: **2**  
 1st Value:  
 2nd Value:  
 Value Percent:  
 Continuous Index:  
 Within 8" of Joint: **YES**  
 Remarks:

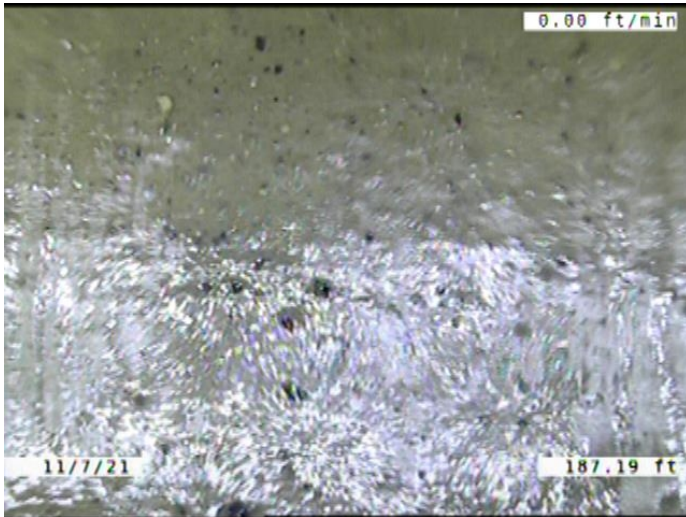
Code:	<b>MCU</b>
Description:	<b>Miscellaneous Camera Underwater</b>
Distance (ft):	<b>187.2</b>
Structural Grade:	<b>0</b>
O&M Grade:	<b>4</b>
Clock Start/From:	
Clock To:	
1st Value:	
2nd Value:	
Value Percent:	
Continuous Index:	
Within 8" of Joint:	<b>NO</b>
Remarks:	<b>Out at 189.6</b>

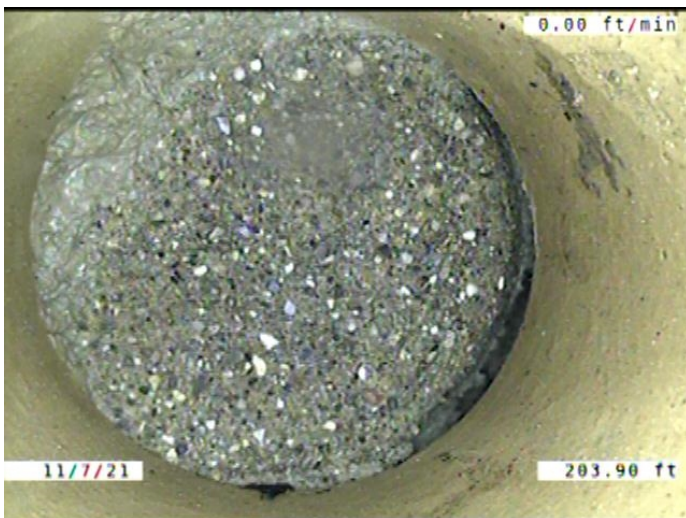
Code:	<b>TFD</b>
Description:	<b>Tap Factory Defective</b>
Distance (ft):	<b>203.9</b>
Structural Grade:	<b>0</b>
O&M Grade:	<b>3</b>
Clock Start/From:	<b>10</b>
Clock To:	
1st Value:	<b>4.000</b>
2nd Value:	
Value Percent:	
Continuous Index:	
Within 8" of Joint:	<b>YES</b>
Remarks:	<b>CAPPED. SOIL VISIBLE ARUND THAT CAP</b>

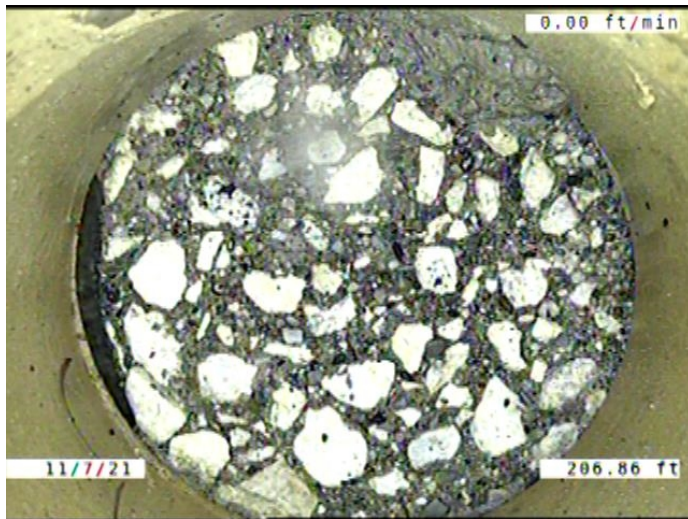
Code:	<b>TFD</b>
Description:	<b>Tap Factory Defective</b>
Distance (ft):	<b>206.9</b>
Structural Grade:	<b>0</b>
O&M Grade:	<b>3</b>
Clock Start/From:	<b>2</b>
Clock To:	
1st Value:	<b>4.000</b>
2nd Value:	
Value Percent:	
Continuous Index:	
Within 8" of Joint:	<b>YES</b>
Remarks:	<b>CAPPED. SOIL VISIBLE ARUND THAT CAP</b>

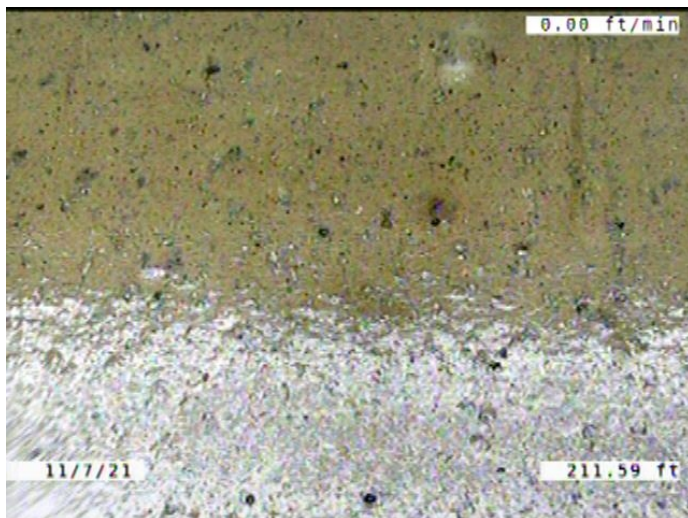
Code:	<b>MCU</b>
Description:	<b>Miscellaneous Camera Underwater</b>
Distance (ft):	<b>211.6</b>
Structural Grade:	<b>0</b>
O&M Grade:	<b>4</b>
Clock Start/From:	
Clock To:	
1st Value:	
2nd Value:	
Value Percent:	
Continuous Index:	<b>S09</b>
Within 8" of Joint:	<b>NO</b>
Remarks:

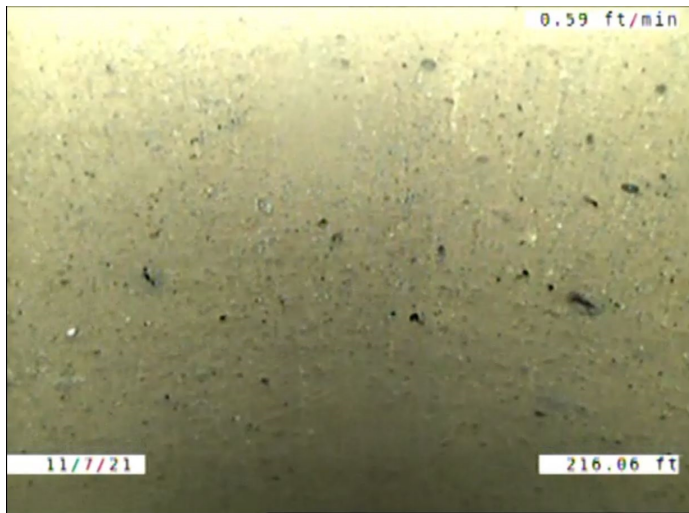
Code: **MCU**  
 Description: **Miscellaneous Camera Underwater**

Distance (ft): **216.1**  
 Structural Grade: **0**  
 O&M Grade: **4**  
 Clock Start/From:  
 Clock To:  
 1st Value:  
 2nd Value:  
 Value Percent:  
 Continuous Index: **F09**  
 Within 8" of Joint: **NO**  
 Remarks:

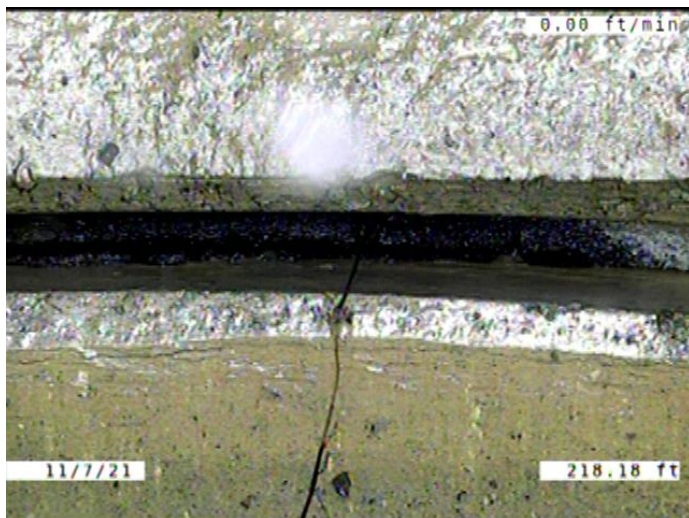
Code: **RFJ**  
 Description: **Roots Fine Joint**

Distance (ft): **218.2**  
 Structural Grade: **0**  
 O&M Grade: **1**  
 Clock Start/From: **1**  
 Clock To:  
 1st Value:  
 2nd Value:  
 Value Percent:  
 Continuous Index:  
 Within 8" of Joint: **YES**  
 Remarks:

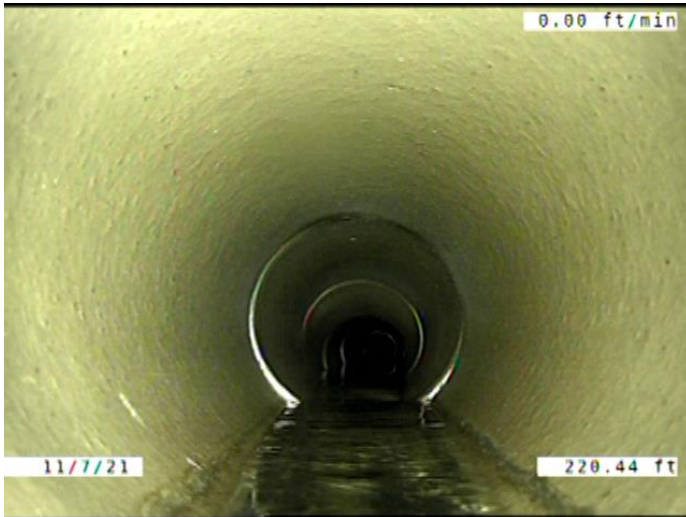
Code: **MWLS**  
Description: **Miscellaneous Water Level Sag**

Distance (ft): **220.4**  
Structural Grade: **3**  
O&M Grade: **0**  
Clock Start/From:  
Clock To:  
1st Value:  
2nd Value:  
Value Percent: **35.000**  
Continuous Index: **F07**  
Within 8" of Joint: **NO**  
Remarks:

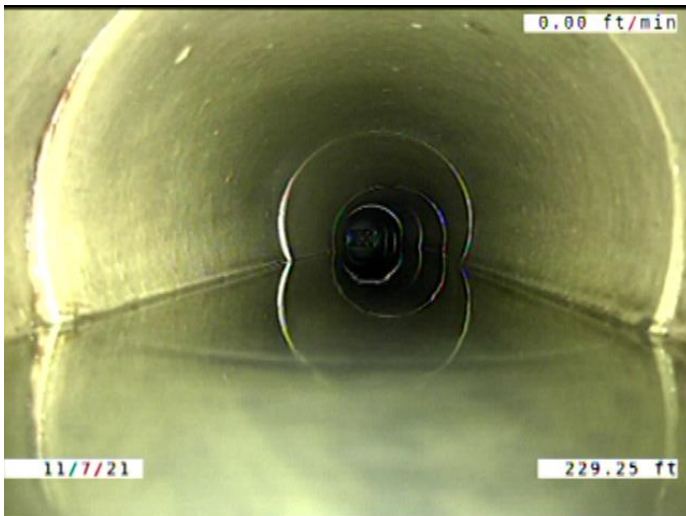
Code: **MWLS**  
Description: **Miscellaneous Water Level Sag**

Distance (ft): **229.3**  
Structural Grade: **2**  
O&M Grade: **0**  
Clock Start/From:  
Clock To:  
1st Value:  
2nd Value:  
Value Percent: **15.000**  
Continuous Index: **S08**  
Within 8" of Joint: **NO**  
Remarks:

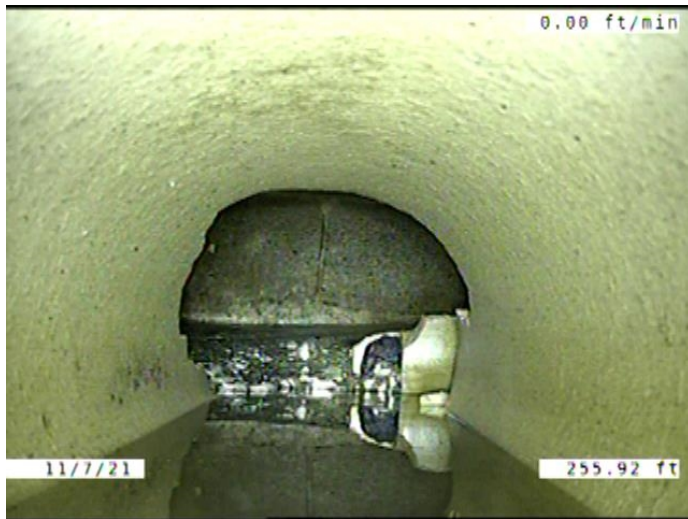
Code: **DAE**  
 Description: **Deposits Attached Encrustation**

Distance (ft): **255.9**  
 Structural Grade: **0**  
 O&M Grade: **2**  
 Clock Start/From: **9**  
 Clock To: **3**  
 1st Value:  
 2nd Value:  
 Value Percent: **5.000**  
 Continuous Index: **F03**  
 Within 8" of Joint: **YES**  
 Remarks:
