# Profile/Photo Observation Report

Date:	<b>11/07/2021</b>	Weather:		Coding:	<b>PACP 7.0</b>
Pipe Length (ft):	<b>259.9</b>	Owner:	<b>City of Hobart</b>	Pre Clean:	<b>Heavy Cleaning</b>
P.O.#:	<b>YES502259</b>	Surveyor:	<b>Steven Bucklin</b>	PSR:	<b>P-505-066-067</b>
Customer:	<b>City of Hobart, IN (Red</b>	Clean Date:	<b>11/06/2021</b>	Shape:	<b>C</b>

Street:	<b>West 2nd Street</b>	Flow Control:	<b>Not Controlled</b>
City:	<b>City of Hobart</b>	Year Renewed:	
Location:	<b>Alley</b>	Tape/Media #:	
Purpose:	<b>Routine Assessment</b>	Dia/Height:	<b>10"</b>
Use:	<b>Sanitary Sewage Pipe</b>	Material:	<b>VCP</b>
Drain Area:		Lining:	<b>None</b>
Category:	<b>NA</b>		
Comment:			
Location Details:		Direction of Survey:	<b>Downstream</b>
US MH:	<b>M-505-067</b>	DS MH:	<b>M-505-066</b>
		Total Length Surveyed (ft):	<b>259.9</b>

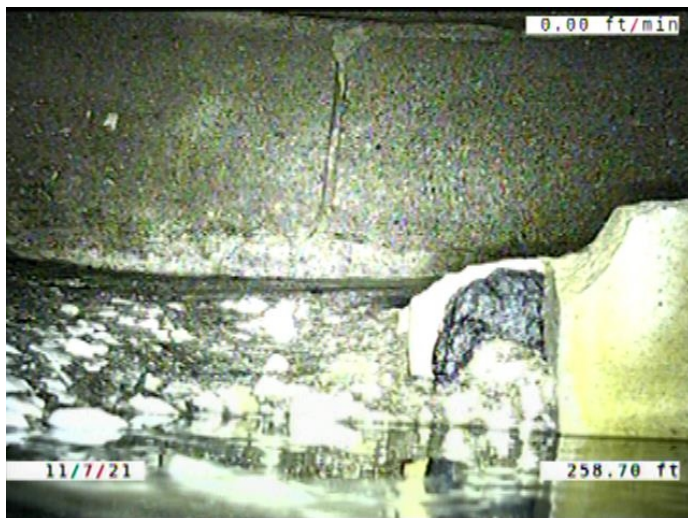
Code: **MWLS**  
 Description: **Miscellaneous Water Level Sag**

Distance (ft): **258.7**  
 Structural Grade: **2**  
 O&M Grade: **0**  
 Clock Start/From:  
 Clock To:  
 1st Value:  
 2nd Value:  
 Value Percent: **15.000**  
 Continuous Index: **F08**  
 Within 8" of Joint: **NO**  
 Remarks:
