Profile/Photo Observation Report

Street:	ALLEY BETWEEN W CLEVELAND AVE	Flow Control:	Not Controlled
City:	Hobart, IN	Year Renewed:	
Location:	Light Highway	Tape/Media #:	
Purpose:	Routine Assessment	Dia/Height:	10"
Use:	Sanitary	Material:	VCP
Drain Area:	NA	Lining:	
Category:	NA		
Comment:	P_C at 20 ft roots. Flow direction wrong		
Location Details:		Direction of Survey:	Downstream
US MH:	M-505-069	DS MH:	M-505-068
		Total Length Surveyed (ft):	21.8

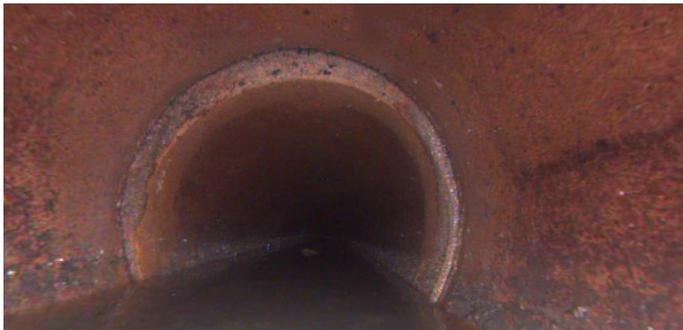
Code: **AMH**
 Description: **Manhole**

Distance (ft): **.0**
 Structural Grade: **0**
 O&M Grade: **0**
 Clock Start/From:
 Clock To:
 1st Value:
 2nd Value:
 Value Percent:
 Continuous Index:
 Within 8" of Joint: **NO**
 Remarks: **M-505-069**

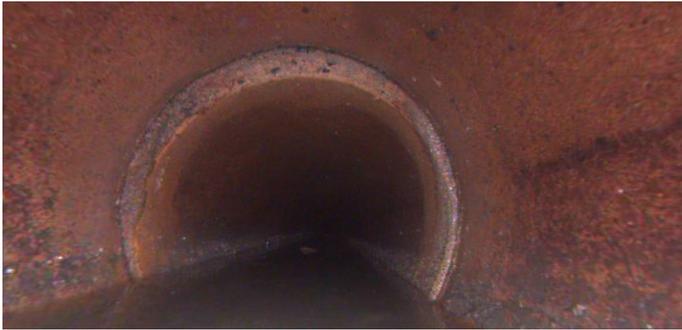
Code: **MWL**
Description: **Water Level**

Distance (ft): **.0**
Structural Grade: **0**
O&M Grade: **0**
Clock Start/From:
Clock To:
1st Value:
2nd Value:
Value Percent: **20.000**
Continuous Index:
Within 8" of Joint: **NO**
Remarks:

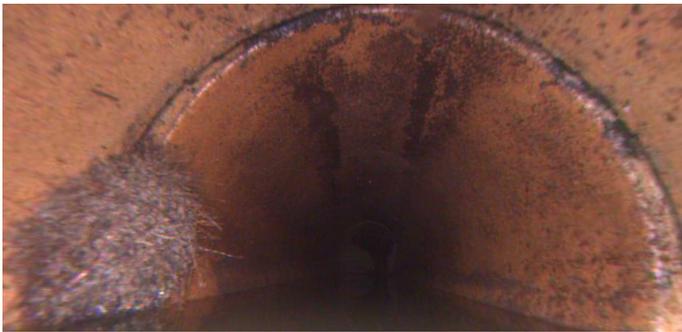
Code: **RMJ**
Description: **Roots Medium Joint**

Distance (ft): **17.3**
Structural Grade: **0**
O&M Grade: **3**
Clock Start/From: **8**
Clock To: **9**
1st Value:
2nd Value:
Value Percent: **5.000**
Continuous Index:
Within 8" of Joint: **YES**
Remarks:

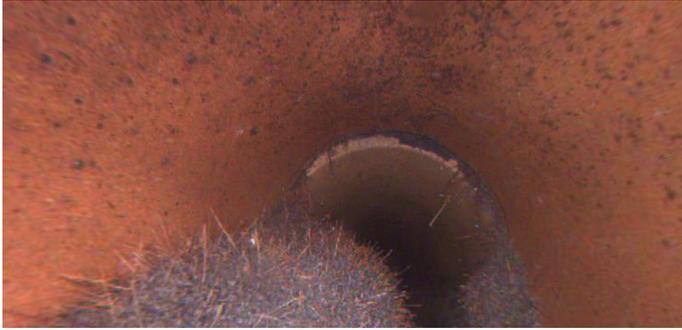
Code: **RMJ**
Description: **Roots Medium Joint**

Distance (ft): **20.7**
Structural Grade: **0**
O&M Grade: **3**
Clock Start/From: **7**
Clock To: **5**
1st Value:
2nd Value:
Value Percent: **30.000**
Continuous Index:
Within 8" of Joint: **YES**
Remarks:

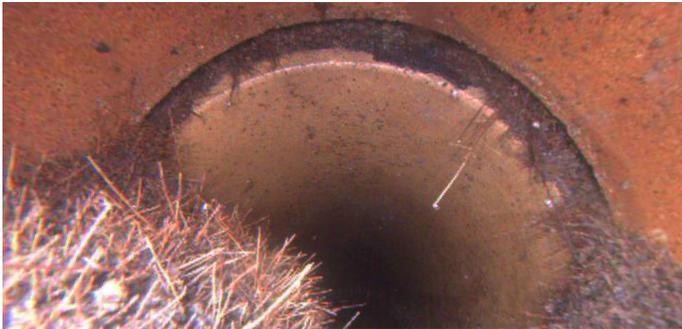
Code: **MSA**
Description: **Abandoned Survey**

Distance (ft): **21.8**
Structural Grade: **0**
O&M Grade: **0**
Clock Start/From:
Clock To:
1st Value:
2nd Value:
Value Percent:
Continuous Index:
Within 8" of Joint: **NO**
Remarks: **rmj**
