Profile/Photo Observation Report

Street:	ALLEY BETWEEN W CLEVELAND AVE	Flow Control:	Not Controlled
City:	Hobart, IN	Year Renewed:	
Location:	Light Highway	Tape/Media #:	
Purpose:	Routine Assessment	Dia/Height:	10"
Use:	Sanitary	Material:	VCP
Drain Area:	NA	Lining:	
Category:	NA		
Comment:	P_C at 49 ft debris . Flow direction wrong		
Location Details:		Direction of Survey:	Upstream
US MH:	M-505-069	DS MH:	M-505-068
		Total Length Surveyed (ft):	50.4

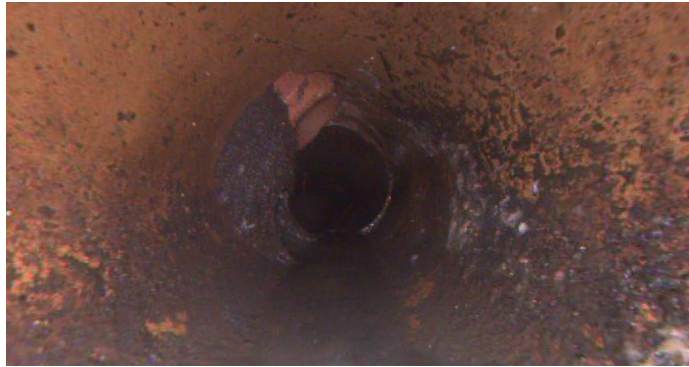
Code: **MWL**
Description: **Water Level**

Distance (ft): **.0**
Structural Grade: **0**
O&M Grade: **0**
Clock Start/From:
Clock To:
1st Value:
2nd Value:
Value Percent: **10.000**
Continuous Index:
Within 8" of Joint: **NO**
Remarks:

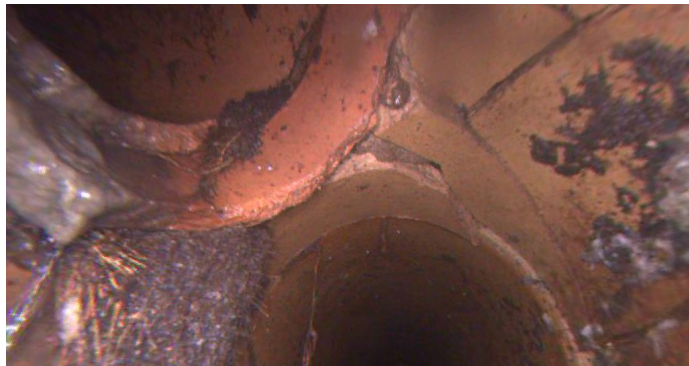
Code: **FM**
Description: **Fracture Multiple**

Distance (ft): **2.8**
Structural Grade: **4**
O&M Grade: **0**
Clock Start/From: **12**
Clock To: **5**
1st Value:
2nd Value:
Value Percent:
Continuous Index:
Within 8" of Joint:
Remarks:

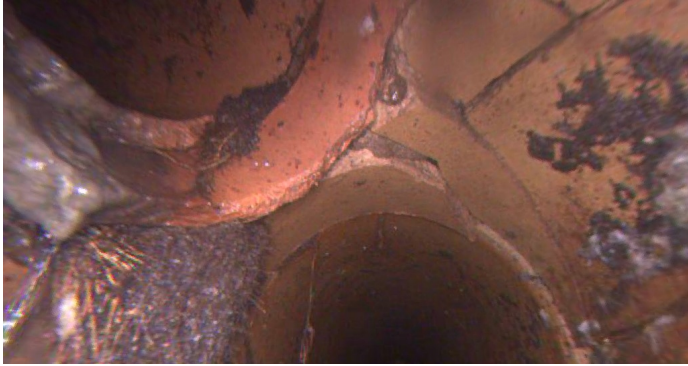
Code: **TBD**
Description: **Tap Break-in Defective**

Distance (ft): **2.8**
Structural Grade: **0**
O&M Grade: **3**
Clock Start/From: **10**
Clock To:
1st Value: **4.000**
2nd Value:
Value Percent:
Continuous Index:
Within 8" of Joint:
Remarks: **RFL**

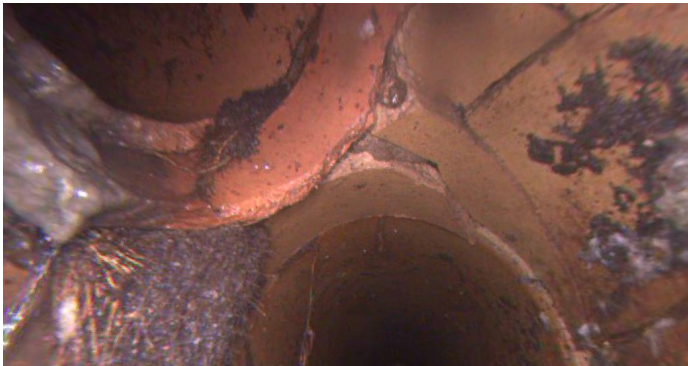
Code: **RFL**
Description: **Roots Fine Lateral**

Distance (ft): **2.8**
Structural Grade: **0**
O&M Grade: **1**
Clock Start/From: **10**
Clock To:
1st Value:
2nd Value:
Value Percent:
Continuous Index:
Within 8" of Joint: **NO**
Remarks:

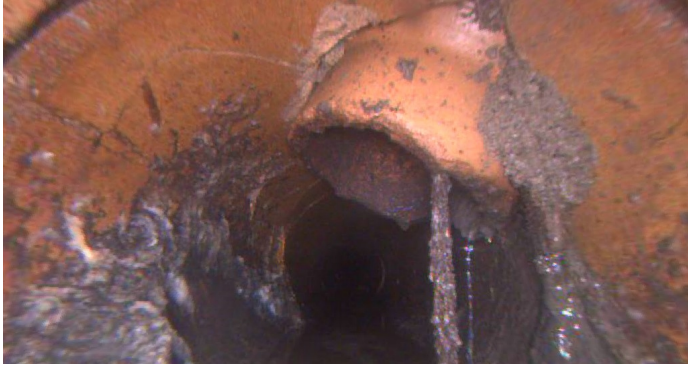
Code: **FM**
Description: **Fracture Multiple**

Distance (ft): **11.2**
Structural Grade: **4**
O&M Grade: **0**
Clock Start/From: **8**
Clock To: **12**
1st Value:
2nd Value:
Value Percent:
Continuous Index:
Within 8" of Joint:
Remarks:

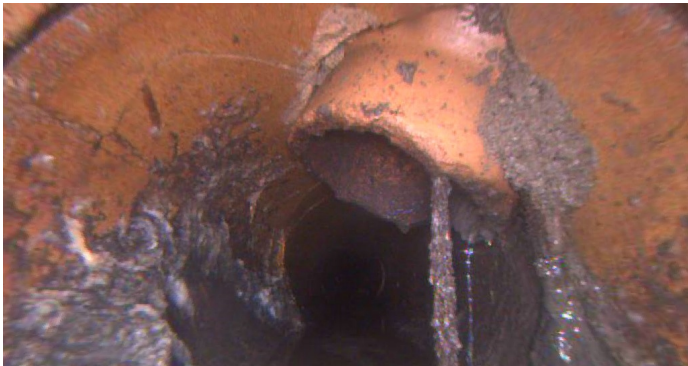
Code: **TBI**
Description: **Tap Break-in Intruding**

Distance (ft): **11.2**
Structural Grade: **0**
O&M Grade: **2**
Clock Start/From: **2**
Clock To:
1st Value: **4.000**
2nd Value: **3.000**
Value Percent:
Continuous Index:
Within 8" of Joint:
Remarks:

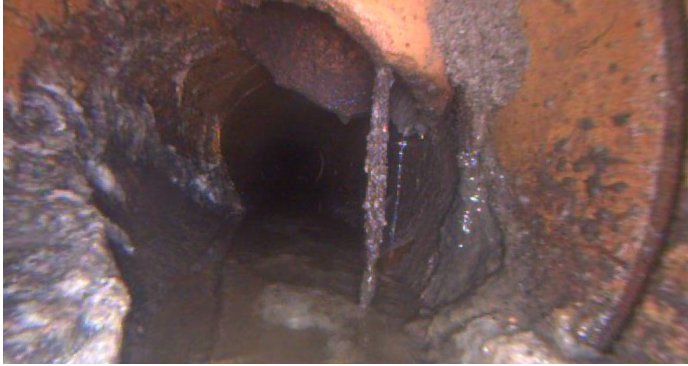
Code: **RFL**
Description: **Roots Fine Lateral**

Distance (ft): **11.2**
Structural Grade: **0**
O&M Grade: **1**
Clock Start/From: **2**
Clock To:
1st Value:
2nd Value:
Value Percent:
Continuous Index:
Within 8" of Joint: **NO**
Remarks:

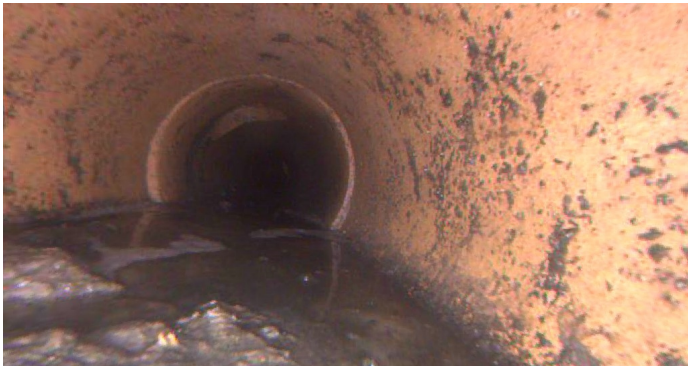
Code: **MSA**
Description: **Abandoned Survey**

Distance (ft): **50.4**
Structural Grade: **0**
O&M Grade: **0**
Clock Start/From:
Clock To:
1st Value:
2nd Value:
Value Percent:
Continuous Index:
Within 8" of Joint: **NO**
Remarks: **Debris**
