Profile/Photo Observation Report

Street:	FOXCROFT STREET	Flow Control:	Not Controlled
City:	Hobart, IN	Year Renewed:	
Location:	Light Highway	Tape/Media #:	
Purpose:	Routine Assessment	Dia/Height:	10"
Use:	Sanitary	Material:	VCP
Drain Area:	NA	Lining:	
Category:	NA		
Comment:	P_C at 49 ft debris . Flow direction wrong		
Location Details:		Direction of Survey:	Upstream
US MH:	M-505-069	DS MH:	M-505-068
		Total Length Surveyed (ft):	50.4

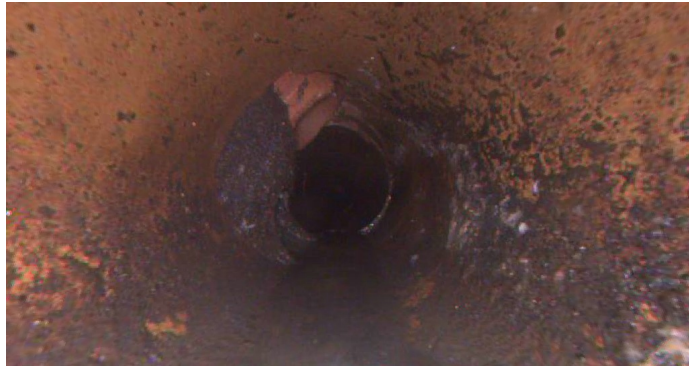
Code: **MWL**
Description: **Water Level**

Distance (ft): **.0**
Structural Grade: **0**
O&M Grade: **0**
Clock Start/From:
Clock To:
1st Value:
2nd Value:
Value Percent: **10.000**
Continuous Index:
Within 8" of Joint: **NO**
Remarks:

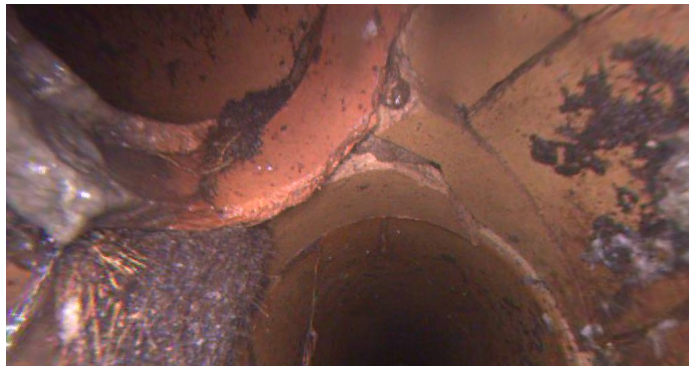
Code: **FM**
Description: **Fracture Multiple**

Distance (ft): **2.8**
Structural Grade: **4**
O&M Grade: **0**
Clock Start/From: **12**
Clock To: **5**
1st Value:
2nd Value:
Value Percent:
Continuous Index:
Within 8" of Joint:
Remarks:

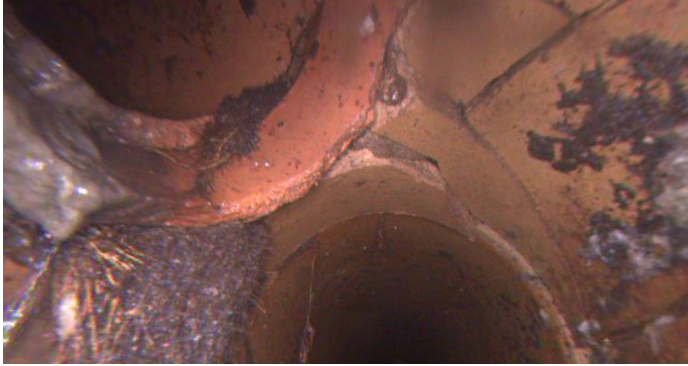
Code: **TBD**
Description: **Tap Break-in Defective**

Distance (ft): **2.8**
Structural Grade: **0**
O&M Grade: **3**
Clock Start/From: **10**
Clock To:
1st Value: **4.000**
2nd Value:
Value Percent:
Continuous Index:
Within 8" of Joint:
Remarks: **RFL**

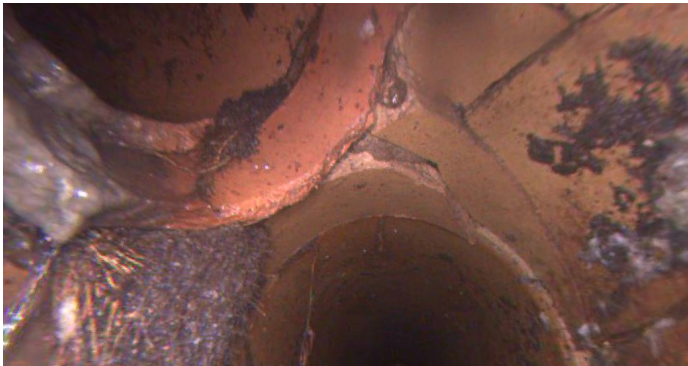
Code: **RFL**
Description: **Roots Fine Lateral**

Distance (ft): **2.8**
Structural Grade: **0**
O&M Grade: **1**
Clock Start/From: **10**
Clock To:
1st Value:
2nd Value:
Value Percent:
Continuous Index:
Within 8" of Joint: **NO**
Remarks:

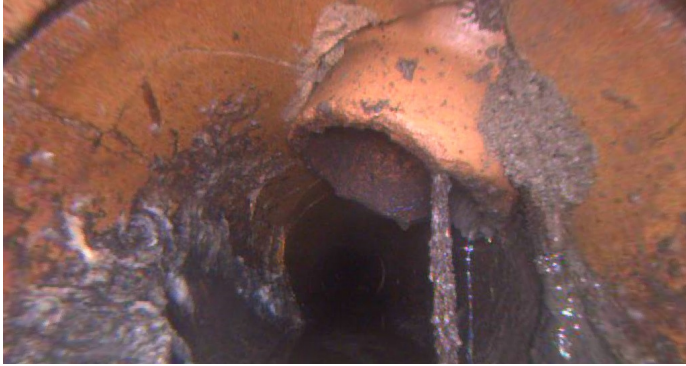
Code: **FM**
Description: **Fracture Multiple**

Distance (ft): **11.2**
Structural Grade: **4**
O&M Grade: **0**
Clock Start/From: **8**
Clock To: **12**
1st Value:
2nd Value:
Value Percent:
Continuous Index:
Within 8" of Joint:
Remarks:

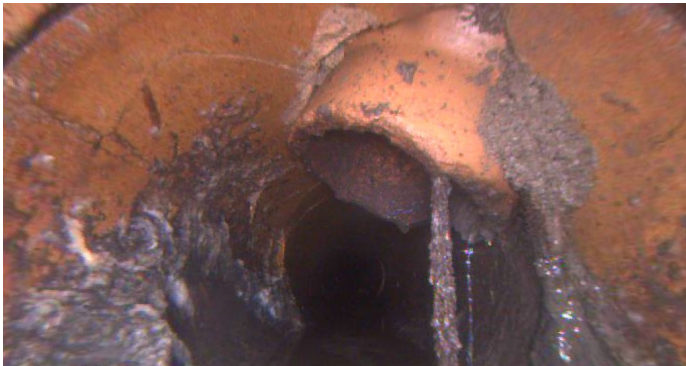
Code: **TBI**
Description: **Tap Break-in Intruding**

Distance (ft): **11.2**
Structural Grade: **0**
O&M Grade: **2**
Clock Start/From: **2**
Clock To:
1st Value: **4.000**
2nd Value: **3.000**
Value Percent:
Continuous Index:
Within 8" of Joint:
Remarks:

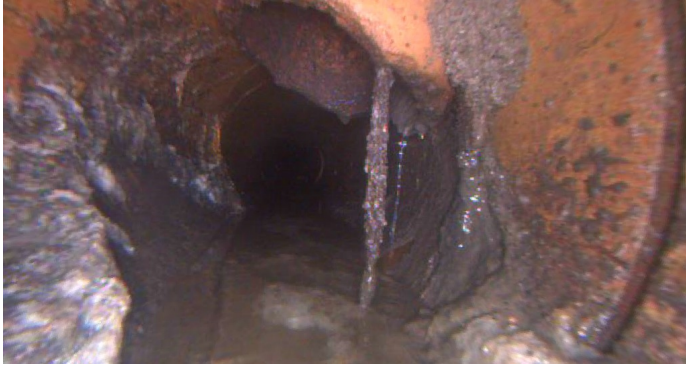
Code: **RFL**
Description: **Roots Fine Lateral**

Distance (ft): **11.2**
Structural Grade: **0**
O&M Grade: **1**
Clock Start/From: **2**
Clock To:
1st Value:
2nd Value:
Value Percent:
Continuous Index:
Within 8" of Joint: **NO**
Remarks:

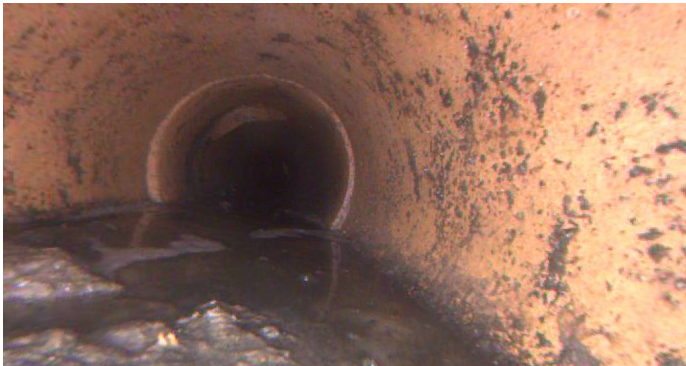
Code: **MSA**
Description: **Abandoned Survey**

Distance (ft): **50.4**
Structural Grade: **0**
O&M Grade: **0**
Clock Start/From:
Clock To:
1st Value:
2nd Value:
Value Percent:
Continuous Index:
Within 8" of Joint: **NO**
Remarks: **Debris**
