Profile/Photo Observation Report

Date: **11/07/2021** Weather: _____ Coding: **PACP 7.0**
 Pipe Length (ft): **260.2** Owner: **City of Hobart** Pre Clean: **Heavy Cleaning**
 P.O.#: **YES502259** Surveyor: **Steven Bucklin** PSR: **P-505-068-069**
 Customer: **City of Hobart, IN (Red** Clean Date: **11/07/2021** Shape: **C**

Street: **West 1st Place** Flow Control: **Not Controlled**
 City: **City of Hobart** Year Renewed: _____
 Location: **Alley** Tape/Media #: _____
 Purpose: **Routine Assessment** Dia/Height: **10"**
 Use: **Sanitary Sewage Pipe** Material: **VCP**
 Drain Area: _____ Lining: **None**
 Category: **NA**
 Comment: _____
 Location Details: _____ Direction of Survey: **Downstream**
 US MH: **M-505-069** DS MH: **M-505-068** Total Length Surveyed (ft): **260.2**

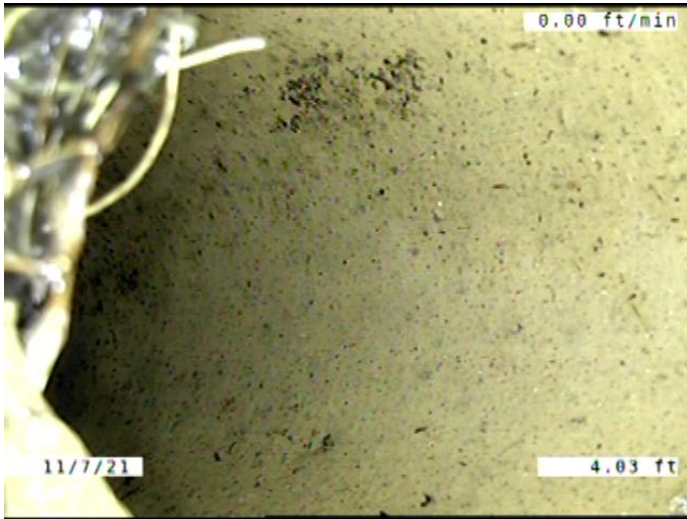
Code: **TBI**
Description: **Tap Break-in Intruding**

Distance (ft): **4.0**
Structural Grade: **0**
O&M Grade: **2**
Clock Start/From: **11**
Clock To:
1st Value: **4.000**
2nd Value: **2.000**
Value Percent:
Continuous Index:
Within 8" of Joint: **YES**
Remarks: **CONSTANTLY RUNNING WATER.**

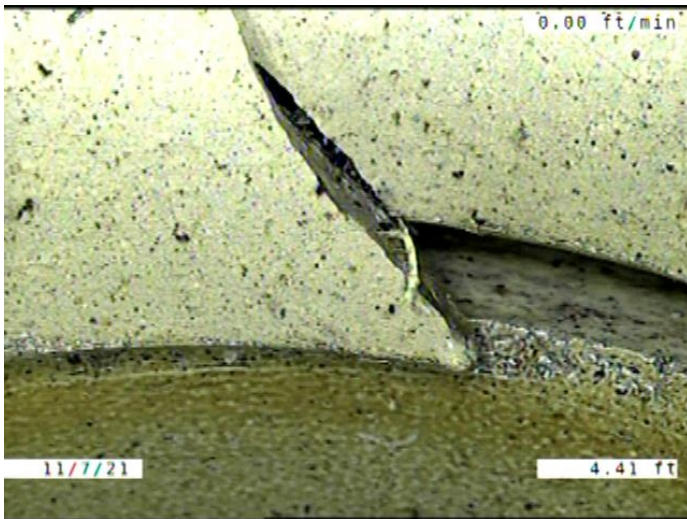
Code: **DR**
Description: **Deformed Rigid**

Distance (ft): **4.4**
Structural Grade: **4**
O&M Grade: **0**
Clock Start/From:
Clock To:
1st Value:
2nd Value:
Value Percent: **5.000**
Continuous Index:
Within 8" of Joint: **NO**
Remarks:

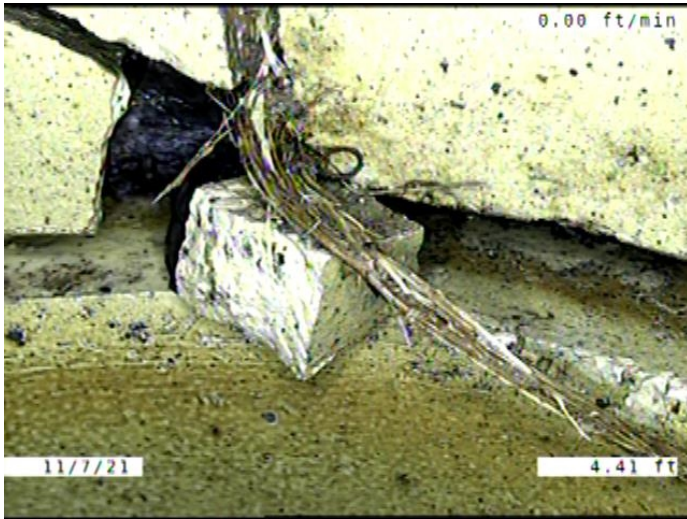
Code: **RFB**
 Description: **Roots Fine Barrel**

Distance (ft): **4.4**
 Structural Grade: **0**
 O&M Grade: **2**
 Clock Start/From: **1**
 Clock To: **3**
 1st Value:
 2nd Value:
 Value Percent:
 Continuous Index:
 Within 8" of Joint: **NO**
 Remarks:

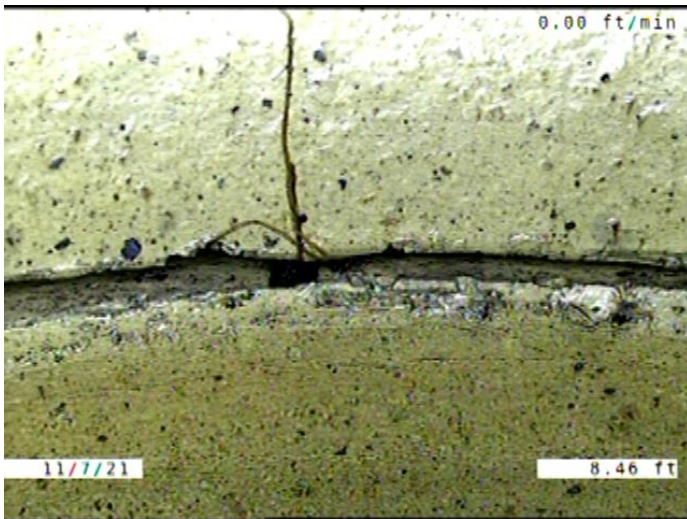
Code: **RFJ**
 Description: **Roots Fine Joint**

Distance (ft): **8.5**
 Structural Grade: **0**
 O&M Grade: **1**
 Clock Start/From: **10**
 Clock To:
 1st Value:
 2nd Value:
 Value Percent:
 Continuous Index:
 Within 8" of Joint: **YES**
 Remarks:

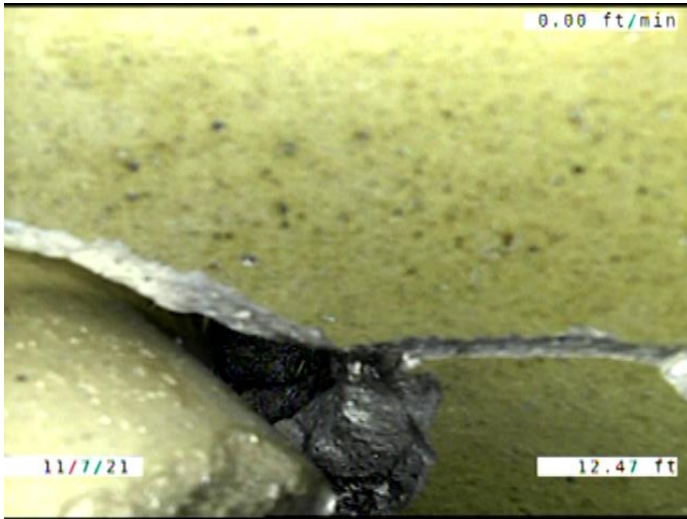
Code: **BSV**
Description: **Broken Soil Visible**

Distance (ft): **12.5**
Structural Grade: **5**
O&M Grade: **0**
Clock Start/From: **10**
Clock To: **6**
1st Value:
2nd Value:
Value Percent:
Continuous Index:
Within 8" of Joint: **YES**
Remarks:

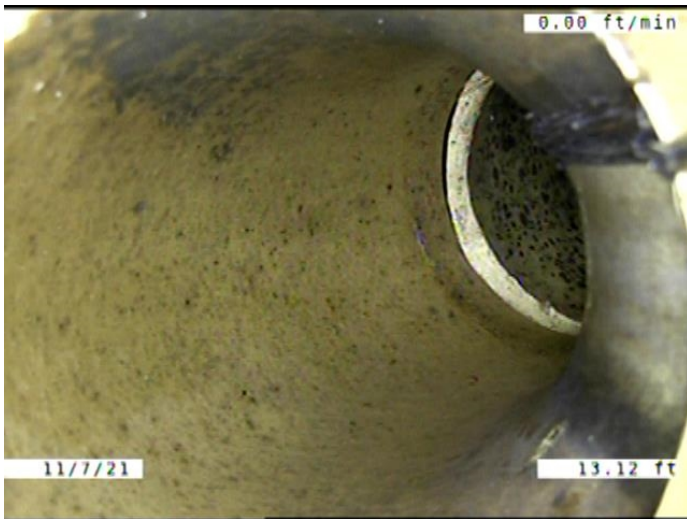
Code: **TBI**
Description: **Tap Break-in Intruding**

Distance (ft): **13.1**
Structural Grade: **0**
O&M Grade: **2**
Clock Start/From: **1**
Clock To:
1st Value: **4.000**
2nd Value: **3.000**
Value Percent:
Continuous Index:
Within 8" of Joint: **YES**
Remarks: **CONSTANTLY RUNNING WATER.
ROOTS GROWING INTO THE MAIN.**

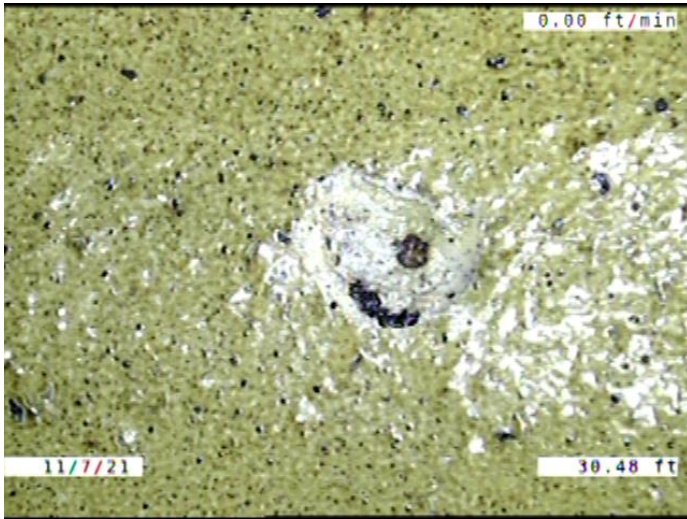
Code: **SSS**
Description: **Surface Damage Surface Spalling**

Distance (ft): **30.5**
Structural Grade: **2**
O&M Grade: **0**
Clock Start/From: **1**
Clock To: **3**
1st Value:
2nd Value:
Value Percent:
Continuous Index:
Within 8" of Joint: **NO**
Remarks:

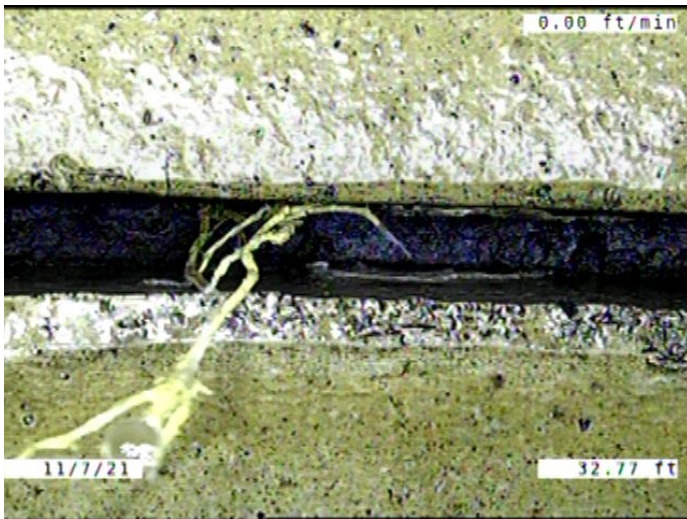
Code: **RFJ**
Description: **Roots Fine Joint**

Distance (ft): **32.8**
Structural Grade: **0**
O&M Grade: **1**
Clock Start/From: **11**
Clock To:
1st Value:
2nd Value:
Value Percent:
Continuous Index:
Within 8" of Joint: **YES**
Remarks:

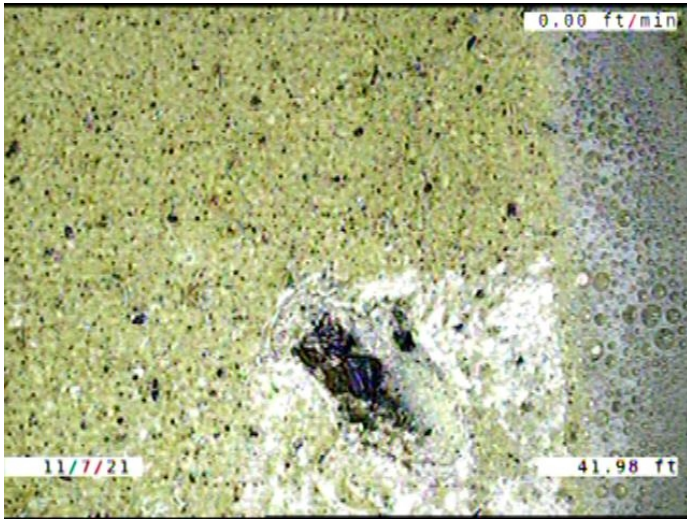
Code: **SSS**
Description: **Surface Damage Surface Spalling**

Distance (ft): **42.0**
Structural Grade: **2**
O&M Grade: **0**
Clock Start/From: **8**
Clock To:
1st Value:
2nd Value:
Value Percent:
Continuous Index:
Within 8" of Joint: **YES**
Remarks:

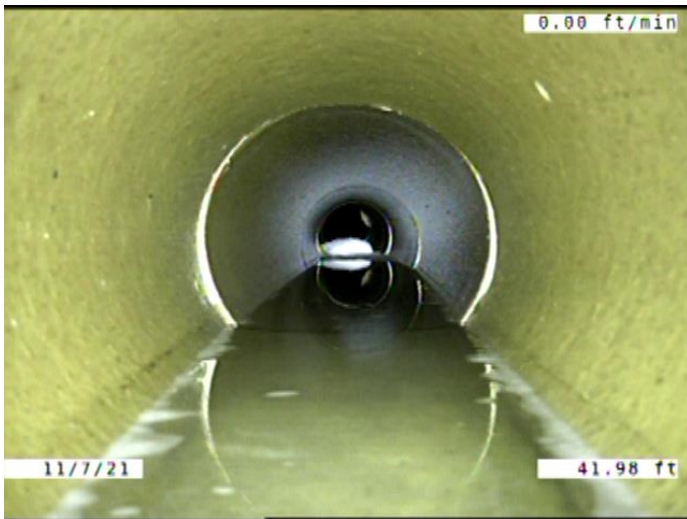
Code: **MWLS**
Description: **Miscellaneous Water Level Sag**

Distance (ft): **42.0**
Structural Grade: **2**
O&M Grade: **0**
Clock Start/From:
Clock To:
1st Value:
2nd Value:
Value Percent: **5.000**
Continuous Index: **S01**
Within 8" of Joint: **NO**
Remarks:

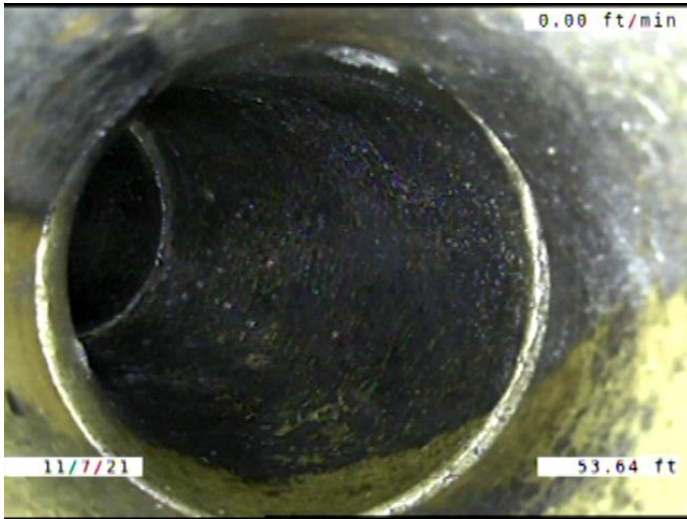
Code: **TF**
 Description: **Tap Factory**

Distance (ft): **53.6**
 Structural Grade: **0**
 O&M Grade: **0**
 Clock Start/From: **11**
 Clock To:
 1st Value: **4.000**
 2nd Value:
 Value Percent:
 Continuous Index:
 Within 8" of Joint: **YES**

Remarks: **CONSTANTLY RUNNING WATER.**

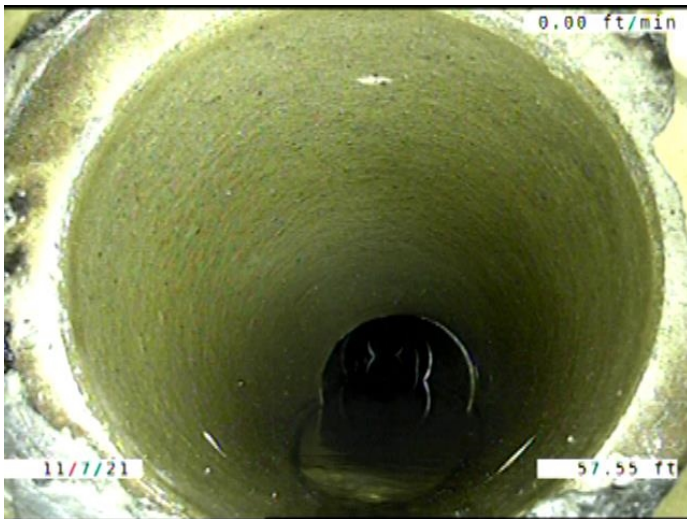
Code: **MWLS**
 Description: **Miscellaneous Water Level Sag**

Distance (ft): **57.5**
 Structural Grade: **2**
 O&M Grade: **0**
 Clock Start/From:
 Clock To:
 1st Value:
 2nd Value:
 Value Percent: **5.000**
 Continuous Index: **F01**
 Within 8" of Joint: **NO**

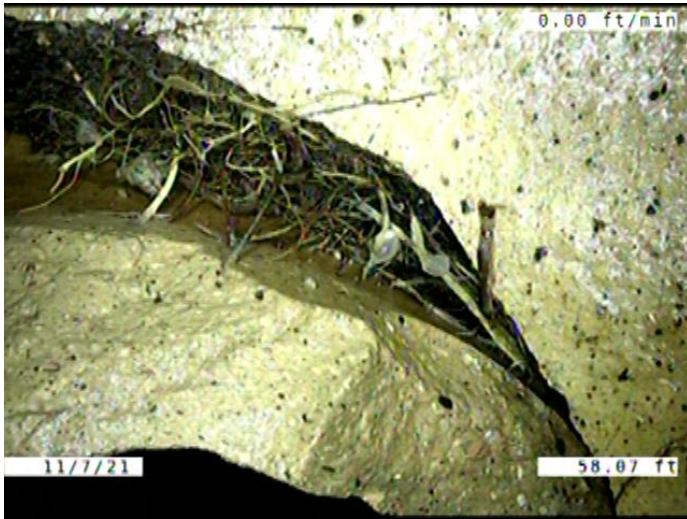
Code: **RFJ**
 Description: **Roots Fine Joint**

Distance (ft): **58.1**
 Structural Grade: **0**
 O&M Grade: **1**
 Clock Start/From: **1**
 Clock To: **3**
 1st Value:
 2nd Value:
 Value Percent:
 Continuous Index:
 Within 8" of Joint: **YES**
 Remarks:

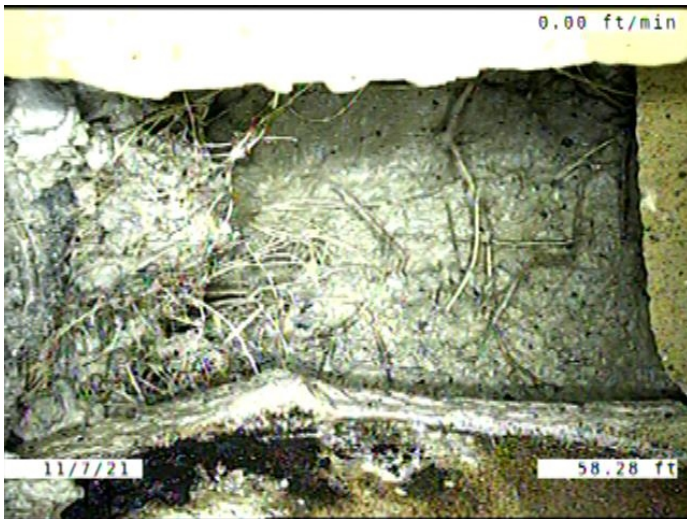
Code: **HVV**
 Description: **Hole Void Visible**

Distance (ft): **58.3**
 Structural Grade: **5**
 O&M Grade: **0**
 Clock Start/From: **3**
 Clock To: **9**
 1st Value:
 2nd Value:
 Value Percent:
 Continuous Index:
 Within 8" of Joint: **YES**
 Remarks: **SOIL VISIBLE TOO**

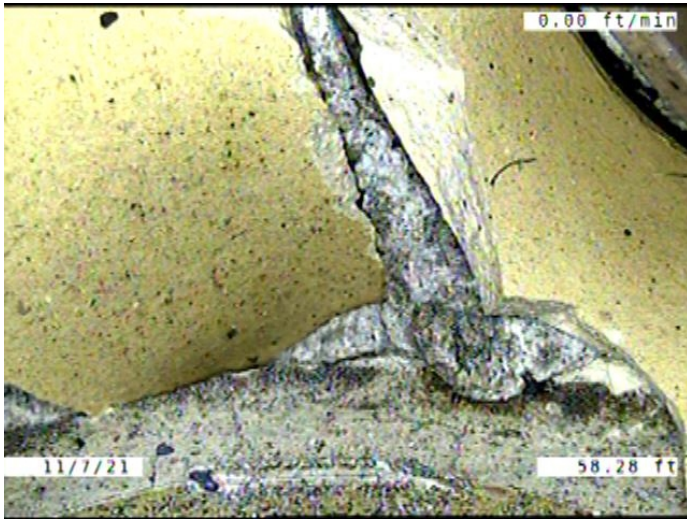
Code: **BSV**
Description: **Broken Soil Visible**

Distance (ft): **58.3**
Structural Grade: **5**
O&M Grade: **0**
Clock Start/From: **9**
Clock To: **3**
1st Value:
2nd Value:
Value Percent:
Continuous Index:
Within 8" of Joint: **YES**
Remarks:

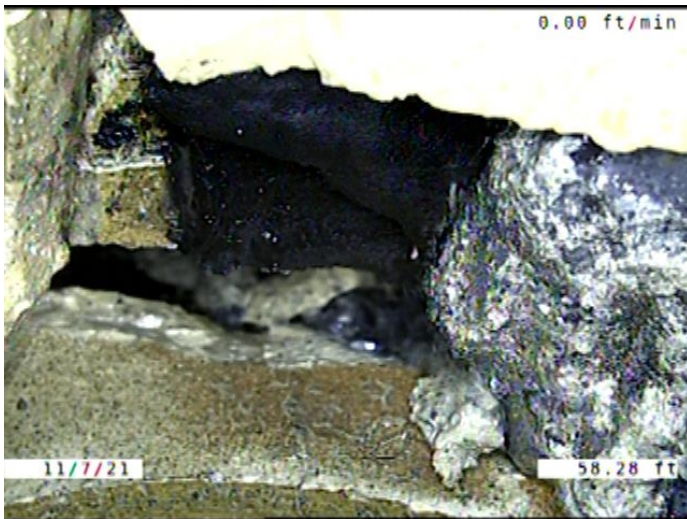
Code: **IRB**
Description: **Infiltration Runner Barrel**

Distance (ft): **58.3**
Structural Grade: **0**
O&M Grade: **4**
Clock Start/From: **4**
Clock To:
1st Value:
2nd Value:
Value Percent:
Continuous Index:
Within 8" of Joint: **YES**
Remarks:

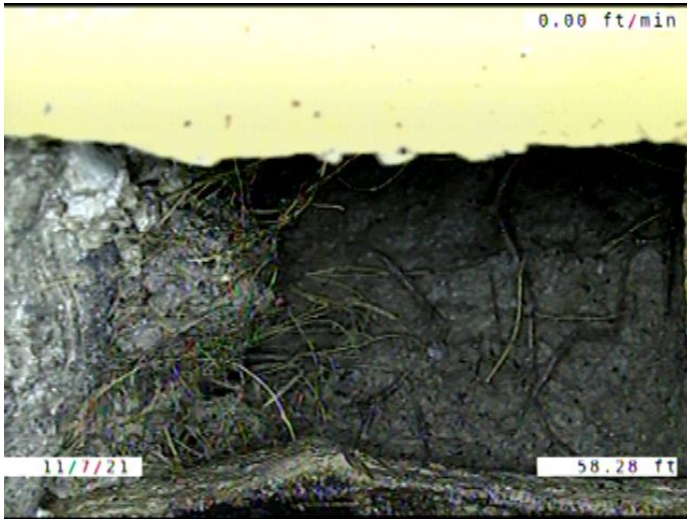
Code: **RFB**
Description: **Roots Fine Barrel**

Distance (ft): **58.3**
Structural Grade: **0**
O&M Grade: **2**
Clock Start/From: **9**
Clock To: **10**
1st Value:
2nd Value:
Value Percent:
Continuous Index:
Within 8" of Joint: **NO**
Remarks:

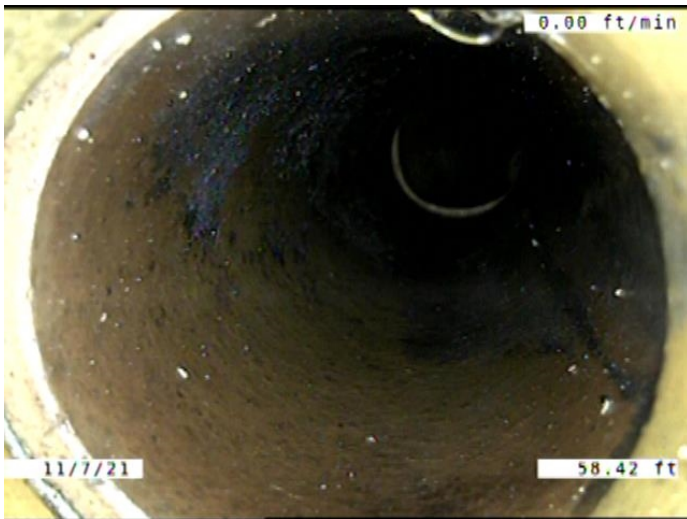
Code: **TBI**
Description: **Tap Break-in Intruding**

Distance (ft): **58.4**
Structural Grade: **0**
O&M Grade: **2**
Clock Start/From: **2**
Clock To:
1st Value: **4.000**
2nd Value: **1.000**
Value Percent:
Continuous Index:
Within 8" of Joint: **YES**
Remarks:

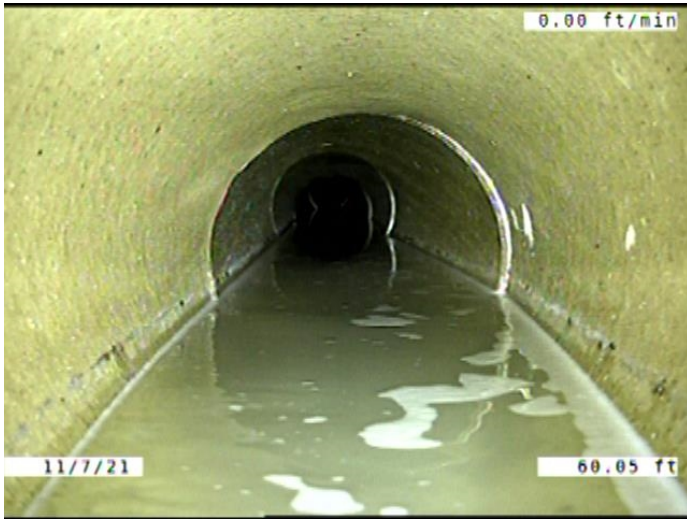
Code: **MWLS**
Description: **Miscellaneous Water Level Sag**

Distance (ft): **60.0**
Structural Grade: **2**
O&M Grade: **0**
Clock Start/From:
Clock To:
1st Value:
2nd Value:
Value Percent: **15.000**
Continuous Index: **S02**
Within 8" of Joint: **NO**
Remarks:

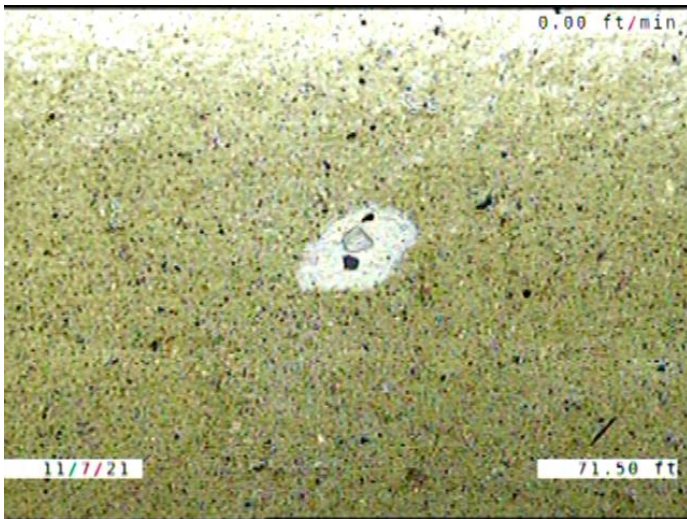
Code: **SSS**
Description: **Surface Damage Surface Spalling**

Distance (ft): **71.5**
Structural Grade: **2**
O&M Grade: **0**
Clock Start/From: **11**
Clock To:
1st Value:
2nd Value:
Value Percent:
Continuous Index:
Within 8" of Joint: **YES**
Remarks:

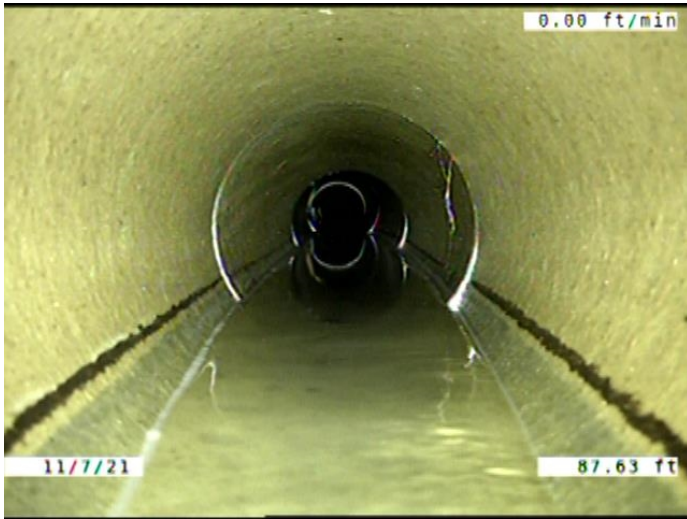
Code: **MWLS**
 Description: **Miscellaneous Water Level Sag**

Distance (ft): **87.6**
 Structural Grade: **2**
 O&M Grade: **0**
 Clock Start/From:
 Clock To:
 1st Value:
 2nd Value:
 Value Percent: **15.000**
 Continuous Index: **S03**
 Within 8" of Joint: **NO**
 Remarks:

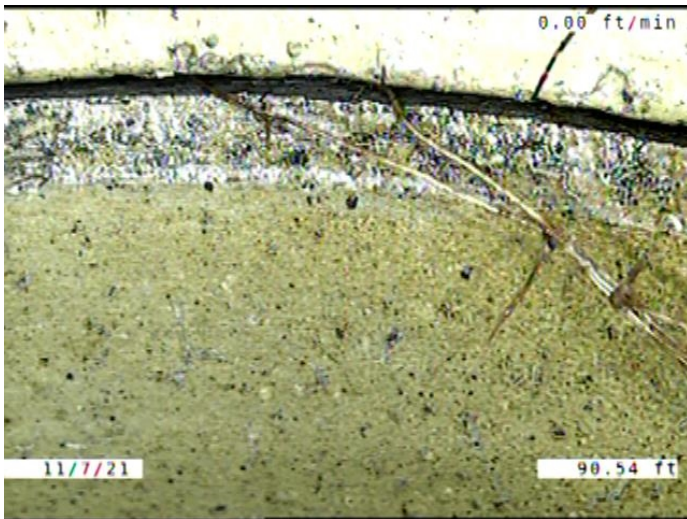
Code: **RFJ**
 Description: **Roots Fine Joint**

Distance (ft): **90.5**
 Structural Grade: **0**
 O&M Grade: **1**
 Clock Start/From: **1**
 Clock To: **2**
 1st Value:
 2nd Value:
 Value Percent:
 Continuous Index:
 Within 8" of Joint: **YES**
 Remarks:

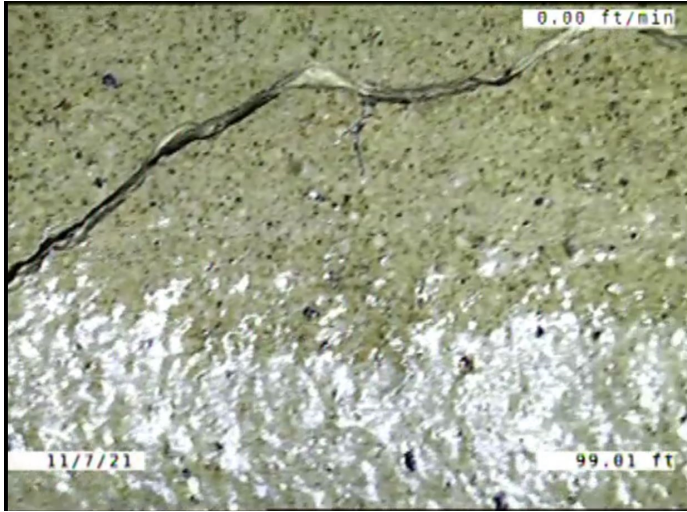
Code: **FM**
 Description: **Fracture Multiple**

Distance (ft): **99.0**
 Structural Grade: **4**
 O&M Grade: **0**
 Clock Start/From: **10**
 Clock To: **5**
 1st Value:
 2nd Value:
 Value Percent:
 Continuous Index:
 Within 8" of Joint: **NO**
 Remarks:

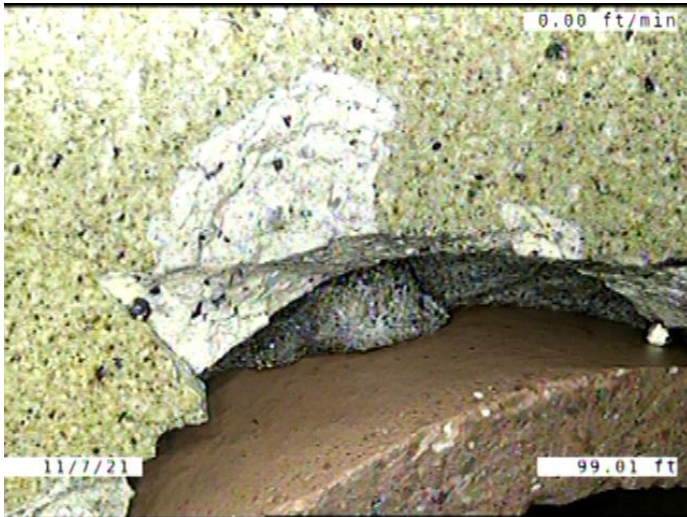
Code: **SSS**
 Description: **Surface Damage Surface Spalling**

Distance (ft): **99.0**
 Structural Grade: **2**
 O&M Grade: **0**
 Clock Start/From: **8**
 Clock To: **10**
 1st Value:
 2nd Value:
 Value Percent:
 Continuous Index:
 Within 8" of Joint: **YES**
 Remarks:

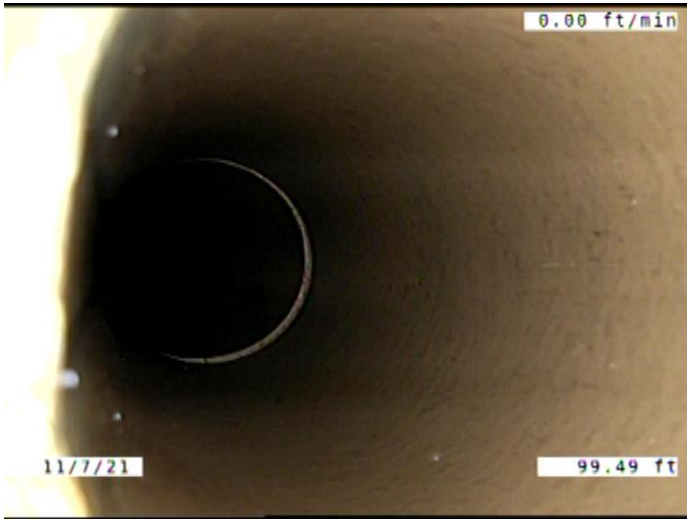
Code: **TBI**
 Description: **Tap Break-in Intruding**

Distance (ft): **99.5**
 Structural Grade: **0**
 O&M Grade: **2**
 Clock Start/From: **10**
 Clock To:
 1st Value: **4.000**
 2nd Value: **1.000**

Value Percent:
 Continuous Index:
 Within 8" of Joint: **YES**
 Remarks: **CONSTANTLY RUNNING WATER.**

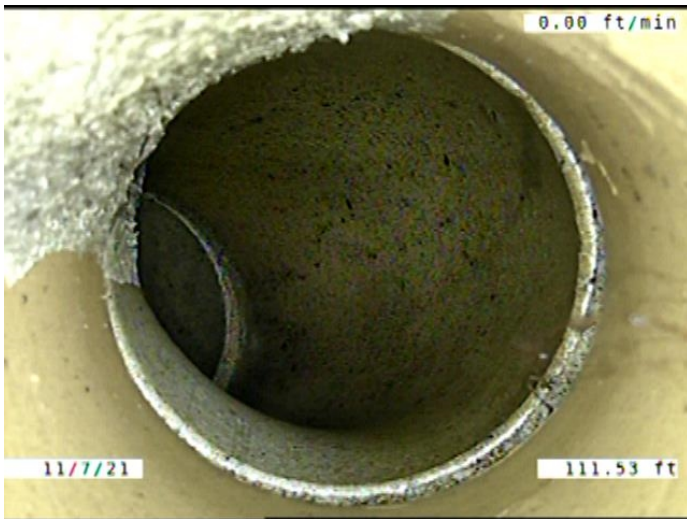
Code: **TF**
 Description: **Tap Factory**

Distance (ft): **111.5**
 Structural Grade: **0**
 O&M Grade: **0**
 Clock Start/From: **11**
 Clock To:
 1st Value: **4.000**
 2nd Value:

Value Percent:
 Continuous Index:
 Within 8" of Joint: **YES**
 Remarks: **ENCRUSTATION COMING DOWN THE TAP**

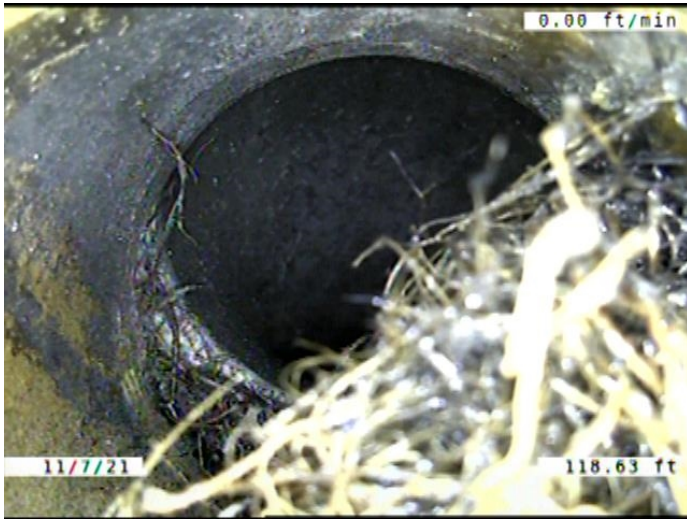
Code: **TFD**
 Description: **Tap Factory Defective**

Distance (ft): **118.6**
 Structural Grade: **0**
 O&M Grade: **3**
 Clock Start/From: **1**
 Clock To:
 1st Value: **4.000**
 2nd Value:
 Value Percent:
 Continuous Index:
 Within 8" of Joint: **YES**
 Remarks: **OFFSET. ROOTS GROWING FROM THE JOINTS**

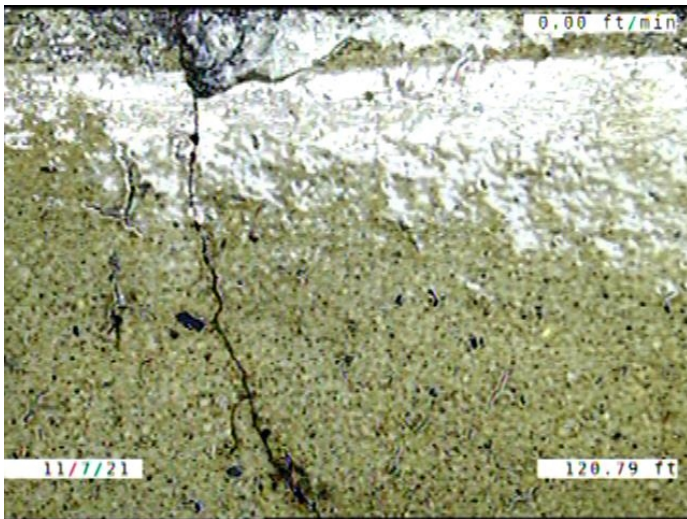
Code: **CL**
 Description: **Crack Longitudinal**

Distance (ft): **120.8**
 Structural Grade: **2**
 O&M Grade: **0**
 Clock Start/From: **1**
 Clock To:
 1st Value:
 2nd Value:
 Value Percent:
 Continuous Index:
 Within 8" of Joint: **YES**
 Remarks:

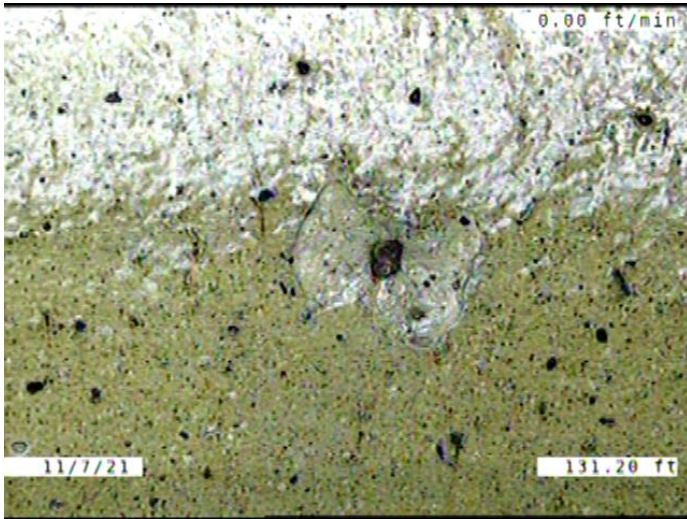
Code: **SSS**
Description: **Surface Damage Surface Spalling**

Distance (ft): **131.2**
Structural Grade: **2**
O&M Grade: **0**
Clock Start/From: **10**
Clock To:
1st Value:
2nd Value:
Value Percent:
Continuous Index:
Within 8" of Joint: **NO**
Remarks:

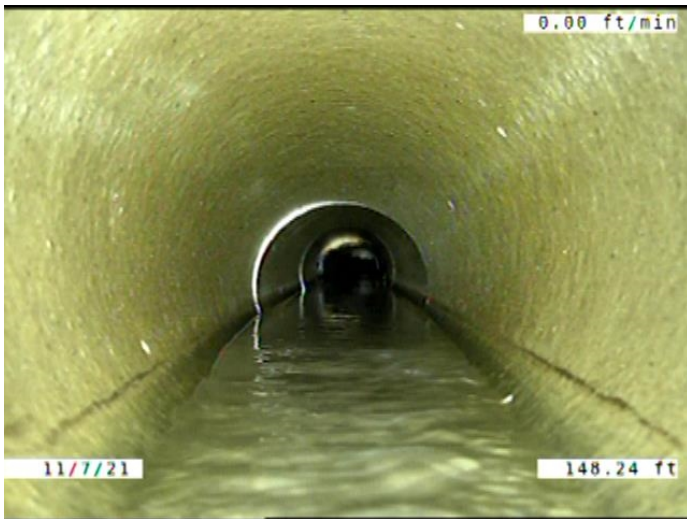
Code: **MWLS**
Description: **Miscellaneous Water Level Sag**

Distance (ft): **148.2**
Structural Grade: **2**
O&M Grade: **0**
Clock Start/From:
Clock To:
1st Value:
2nd Value:
Value Percent: **15.000**
Continuous Index: **F03**
Within 8" of Joint: **NO**
Remarks:

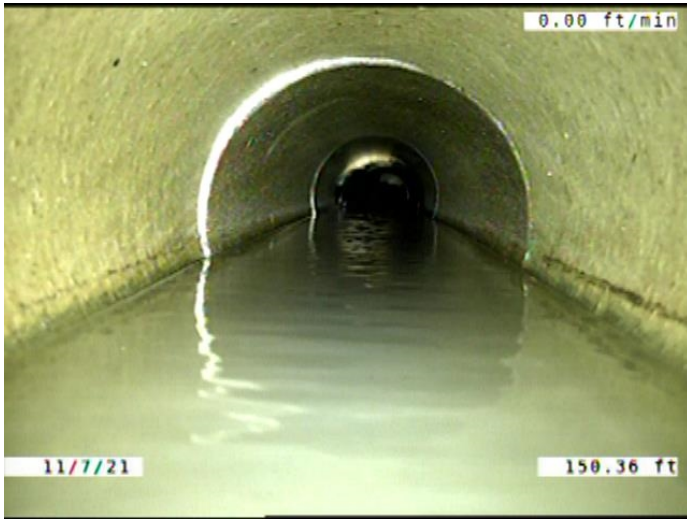
Code: **MWLS**
 Description: **Miscellaneous Water Level Sag**

Distance (ft): **150.4**
 Structural Grade: **2**
 O&M Grade: **0**
 Clock Start/From:
 Clock To:
 1st Value:
 2nd Value:
 Value Percent: **20.000**
 Continuous Index: **S04**
 Within 8" of Joint: **NO**
 Remarks:

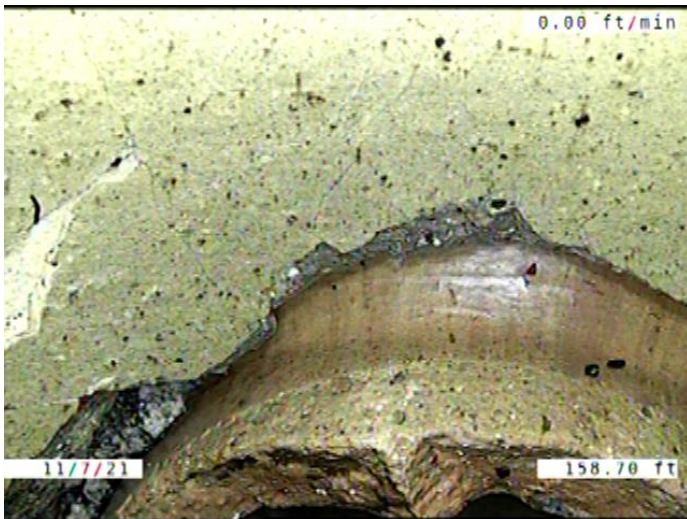
Code: **SSS**
 Description: **Surface Damage Surface Spalling**

Distance (ft): **158.7**
 Structural Grade: **2**
 O&M Grade: **0**
 Clock Start/From: **10**
 Clock To: **1**
 1st Value:
 2nd Value:
 Value Percent:
 Continuous Index:
 Within 8" of Joint: **YES**
 Remarks:

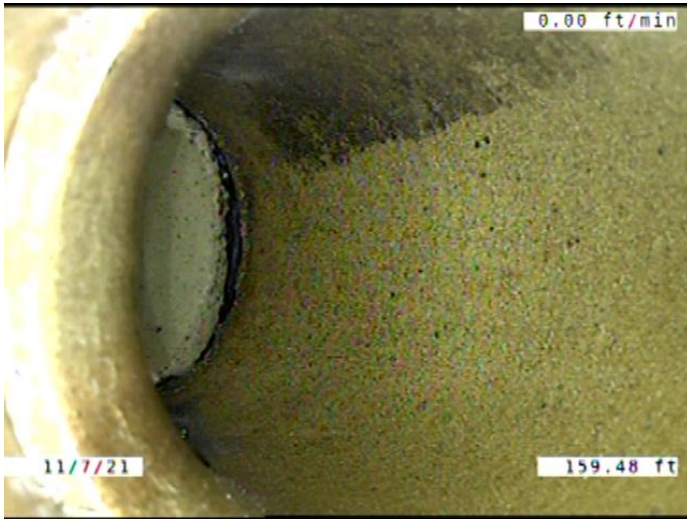
Code: **TBI**
Description: **Tap Break-in Intruding**

Distance (ft): **159.5**
Structural Grade: **0**
O&M Grade: **2**
Clock Start/From: **11**
Clock To:
1st Value: **4.000**
2nd Value: **1.000**
Value Percent:
Continuous Index:
Within 8" of Joint: **YES**
Remarks: **CONSTANTLY RUNNING WATER.**

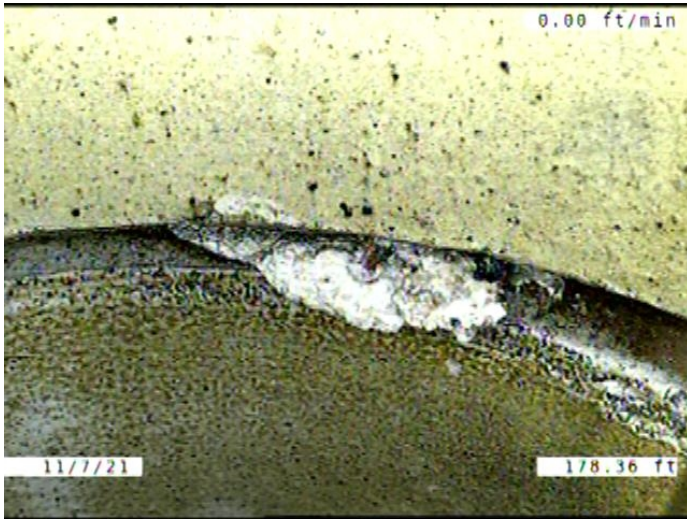
Code: **DAE**
Description: **Deposits Attached Encrustation**

Distance (ft): **178.4**
Structural Grade: **0**
O&M Grade: **2**
Clock Start/From: **2**
Clock To:
1st Value:
2nd Value:
Value Percent: **5.000**
Continuous Index:
Within 8" of Joint: **YES**
Remarks:

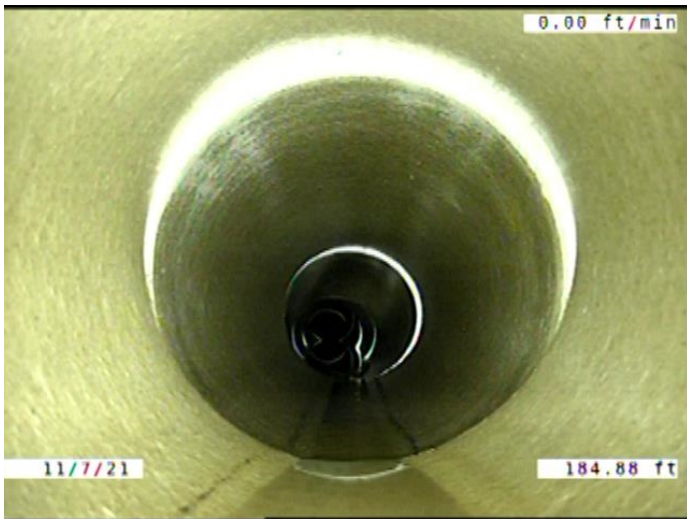
Code: **MWLS**
Description: **Miscellaneous Water Level Sag**

Distance (ft): **184.9**
Structural Grade: **2**
O&M Grade: **0**
Clock Start/From:
Clock To:
1st Value:
2nd Value:
Value Percent: **20.000**
Continuous Index: **F04**
Within 8" of Joint: **NO**
Remarks:

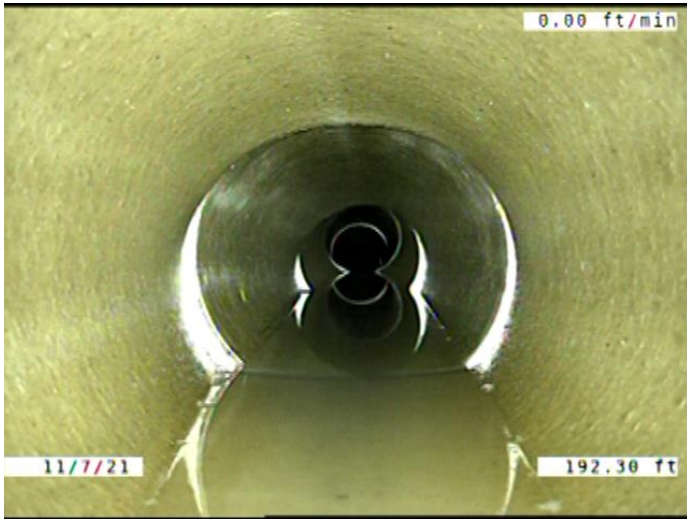
Code: **MWLS**
Description: **Miscellaneous Water Level Sag**

Distance (ft): **192.3**
Structural Grade: **2**
O&M Grade: **0**
Clock Start/From:
Clock To:
1st Value:
2nd Value:
Value Percent: **10.000**
Continuous Index: **S05**
Within 8" of Joint: **NO**
Remarks:

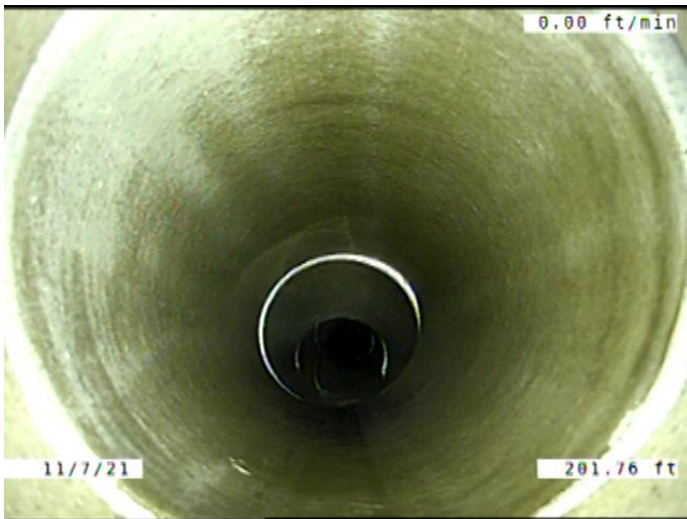
Code: **MWLS**
Description: **Miscellaneous Water Level Sag**

Distance (ft): **201.8**
Structural Grade: **2**
O&M Grade: **0**
Clock Start/From:
Clock To:
1st Value:
2nd Value:
Value Percent: **10.000**
Continuous Index: **F05**
Within 8" of Joint: **NO**
Remarks:

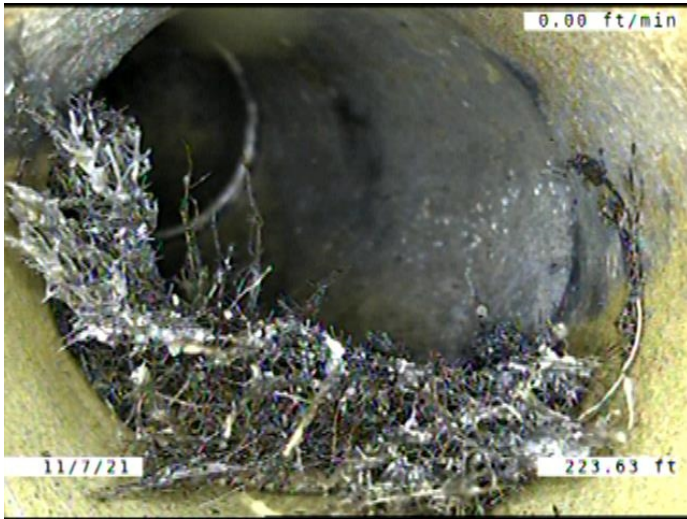
Code: **TF**
 Description: **Tap Factory**

Distance (ft): **223.6**
 Structural Grade: **0**
 O&M Grade: **0**
 Clock Start/From: **12**
 Clock To:
 1st Value: **4.000**

2nd Value:
 Value Percent:
 Continuous Index:
 Within 8" of Joint: **YES**
 Remarks: **ROOTS GROWING FROM THE JOINTS. CONSTANTLY RUNNING WA**

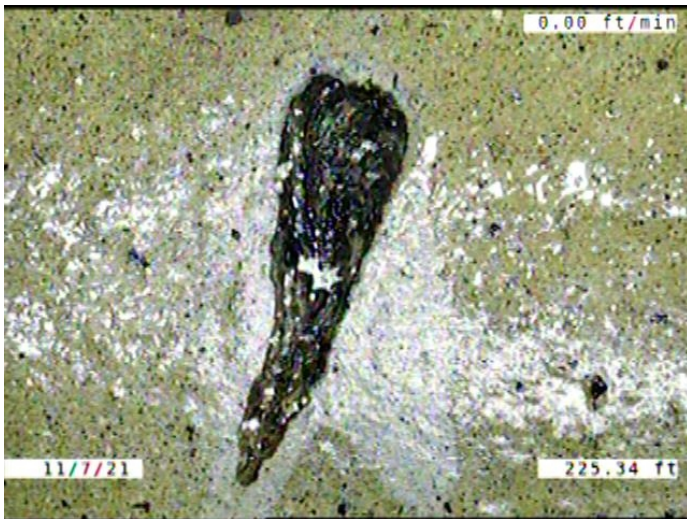
Code: **DAE**
 Description: **Deposits Attached Encrustation**

Distance (ft): **225.3**
 Structural Grade: **0**
 O&M Grade: **2**
 Clock Start/From: **1**
 Clock To: **3**

1st Value:
 2nd Value:
 Value Percent: **5.000**
 Continuous Index:
 Within 8" of Joint: **YES**
 Remarks:

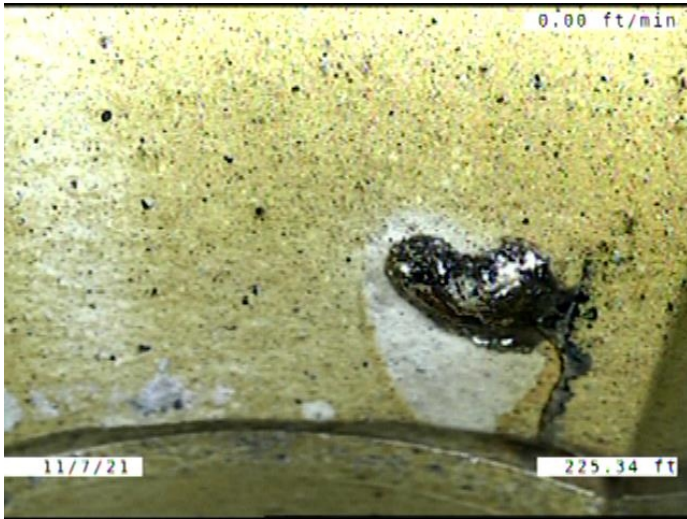
Code: **CL**
Description: **Crack Longitudinal**

Distance (ft): **225.3**
Structural Grade: **2**
O&M Grade: **0**
Clock Start/From: **3**
Clock To:
1st Value:
2nd Value:
Value Percent:
Continuous Index:
Within 8" of Joint: **YES**
Remarks:

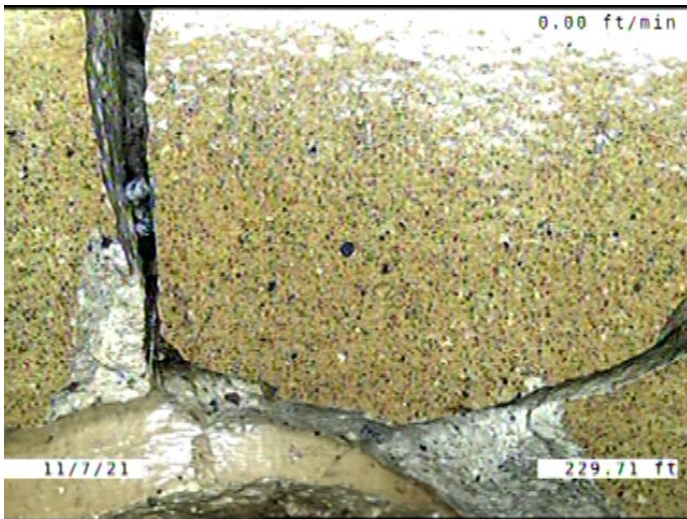
Code: **BSV**
Description: **Broken Soil Visible**

Distance (ft): **229.7**
Structural Grade: **5**
O&M Grade: **0**
Clock Start/From: **8**
Clock To: **4**
1st Value:
2nd Value:
Value Percent:
Continuous Index:
Within 8" of Joint: **YES**
Remarks:

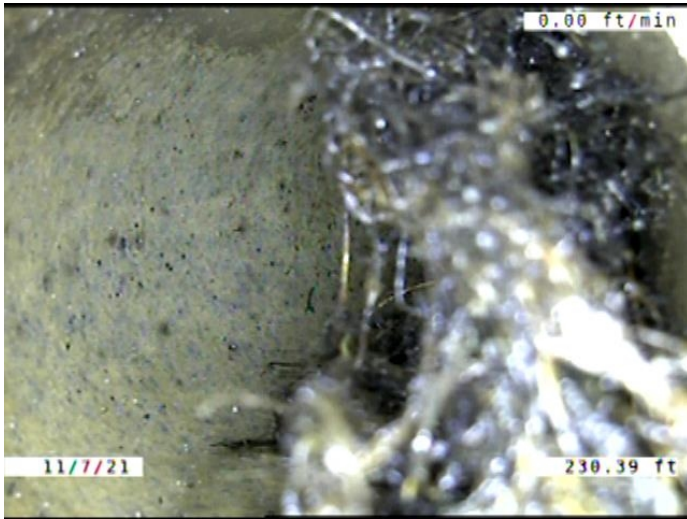
Code: **TBI**
 Description: **Tap Break-in Intruding**

Distance (ft): **230.4**
 Structural Grade: **0**
 O&M Grade: **2**
 Clock Start/From: **1**
 Clock To:
 1st Value: **4.000**
 2nd Value: **1.000**

Value Percent:
 Continuous Index:
 Within 8" of Joint: **YES**
 Remarks: **ROOTS GROWING INTO THE MAIN. CONSTANTLY RUNNING WATER.**

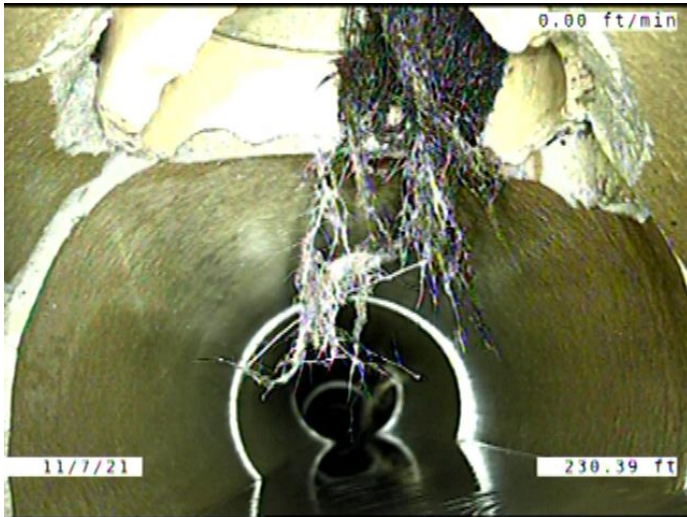
Code: **RFL**
 Description: **Roots Fine Lateral**

Distance (ft): **230.4**
 Structural Grade: **0**
 O&M Grade: **1**
 Clock Start/From: **1**
 Clock To:
 1st Value:
 2nd Value:
 Value Percent:

Continuous Index:
 Within 8" of Joint: **NO**
 Remarks:

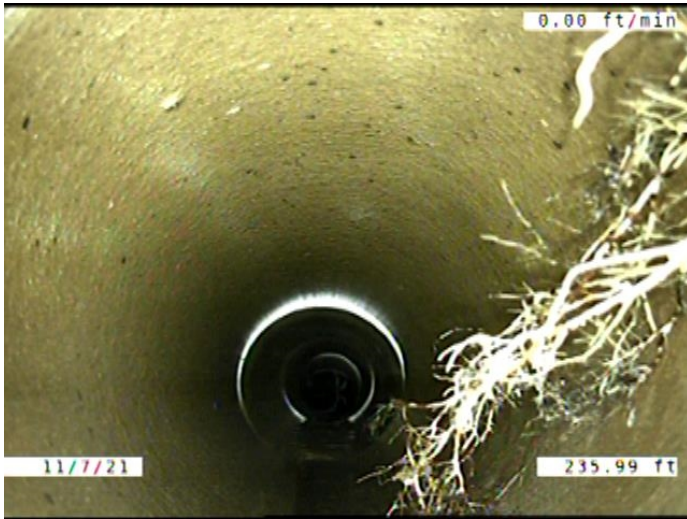
Code: **MWLS**
 Description: **Miscellaneous Water Level Sag**

Distance (ft): **236.0**
 Structural Grade: **2**
 O&M Grade: **0**
 Clock Start/From:
 Clock To:
 1st Value:
 2nd Value:
 Value Percent: **15.000**
 Continuous Index: **F06**
 Within 8" of Joint: **NO**
 Remarks:

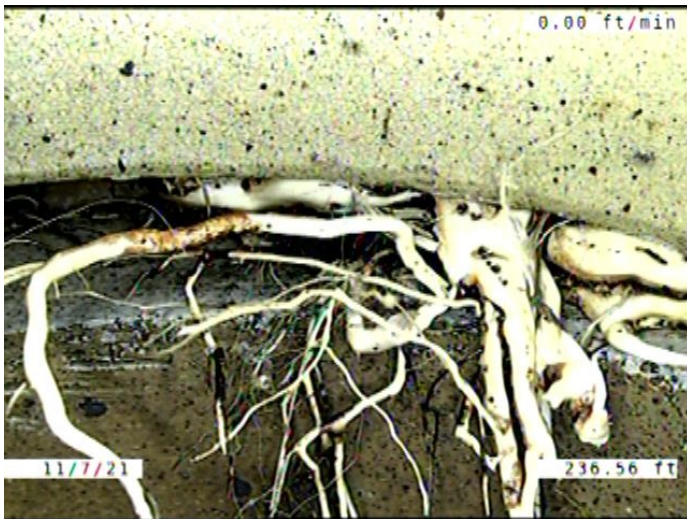
Code: **RMJ**
 Description: **Roots Medium Joint**

Distance (ft): **236.6**
 Structural Grade: **0**
 O&M Grade: **3**
 Clock Start/From: **12**
 Clock To: **3**
 1st Value:
 2nd Value:
 Value Percent: **5.000**
 Continuous Index:
 Within 8" of Joint: **YES**
 Remarks:

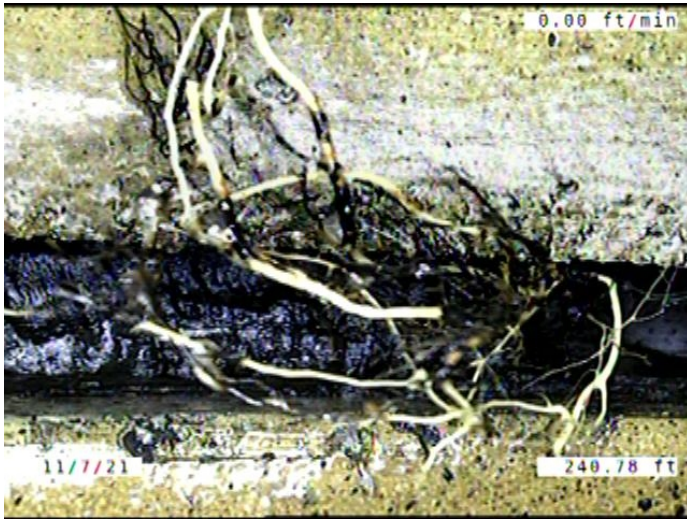
Code: **RFJ**
 Description: **Roots Fine Joint**

Distance (ft): **240.8**
 Structural Grade: **0**
 O&M Grade: **1**
 Clock Start/From: **2**
 Clock To: **3**
 1st Value:
 2nd Value:
 Value Percent:
 Continuous Index:
 Within 8" of Joint: **YES**
 Remarks:

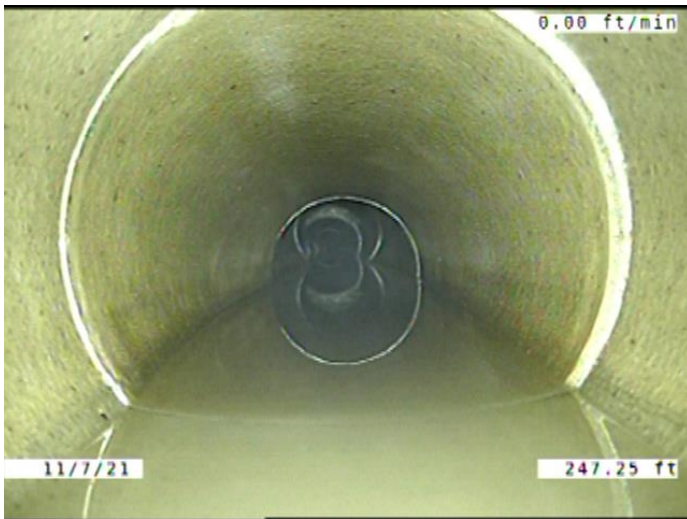
Code: **MWLS**
 Description: **Miscellaneous Water Level Sag**

Distance (ft): **247.2**
 Structural Grade: **2**
 O&M Grade: **0**
 Clock Start/From:
 Clock To:
 1st Value:
 2nd Value:
 Value Percent: **10.000**
 Continuous Index: **S07**
 Within 8" of Joint: **NO**
 Remarks:

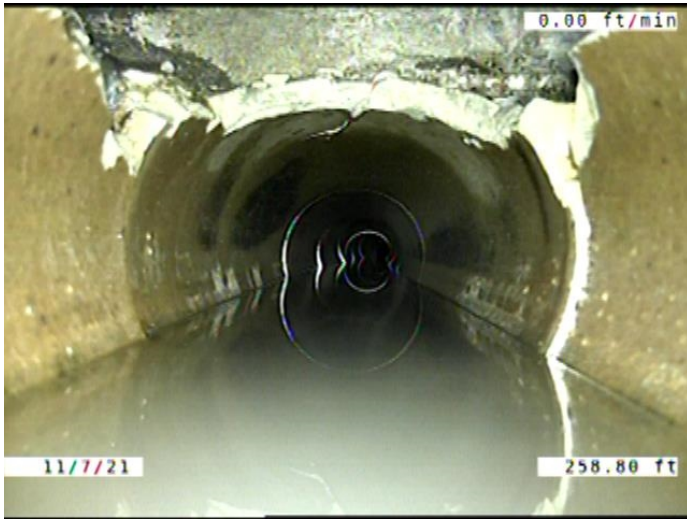
Code: **MWLS**
 Description: **Miscellaneous Water Level Sag**

Distance (ft): **258.8**
 Structural Grade: **2**
 O&M Grade: **0**
 Clock Start/From:
 Clock To:
 1st Value:
 2nd Value:
 Value Percent: **10.000**
 Continuous Index: **F07**
 Within 8" of Joint: **NO**
 Remarks:
